NATAL PARKS BOARD

Stabilisation and protection of the
north bank of the estuary

ST. LUCIA

A.A. LOUDON & PARTNERS
Consulting Engineers

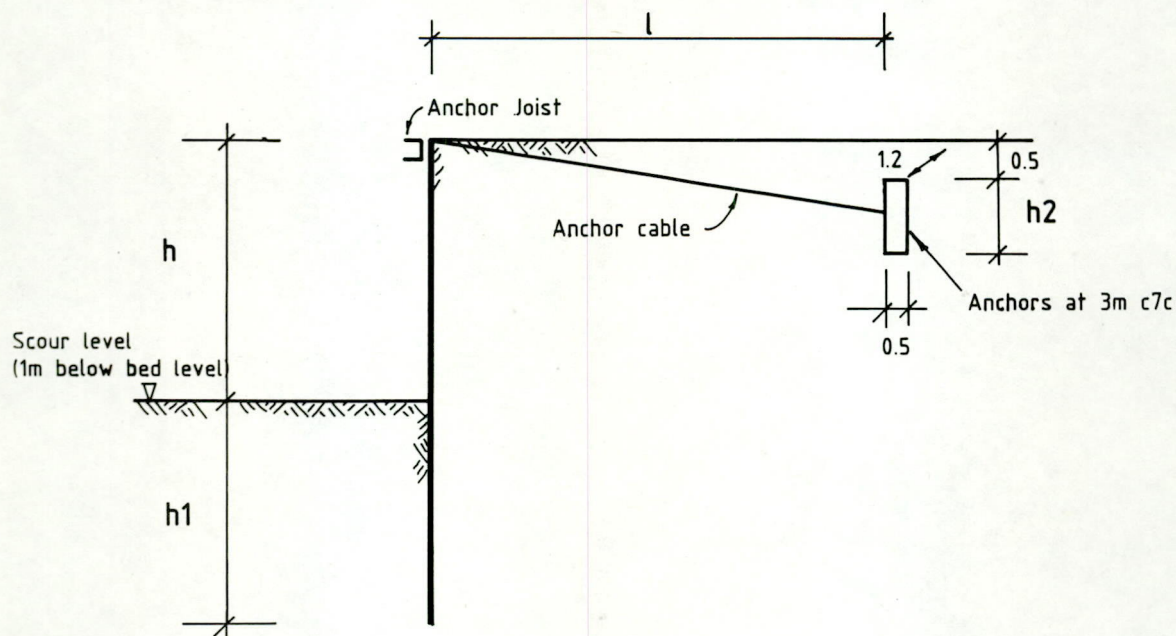
h	h1	l	h2	Anchor Joist	Sheet Piling	Remarks
2	2	2.8	0.5	100x50 C	Armco 2.8 mm	h - height includes for 1m scour
3	2.5	3.9	0.75	178x54 C	Armco 4 mm	
4	3.5	5.2	1.25	200x75 C	Armco 7 mm	
5	4	6.4	1.5	240x85 C	Frodingham 2N

Concrete sheet piling requires some anchorages
