**HYDROLOGICAL/HYDRAULIC STUDY OF NATAL  
ESTUARIES**

**DATA REPORT NO 29**

**UMHLANGA NS 16**

March 1990

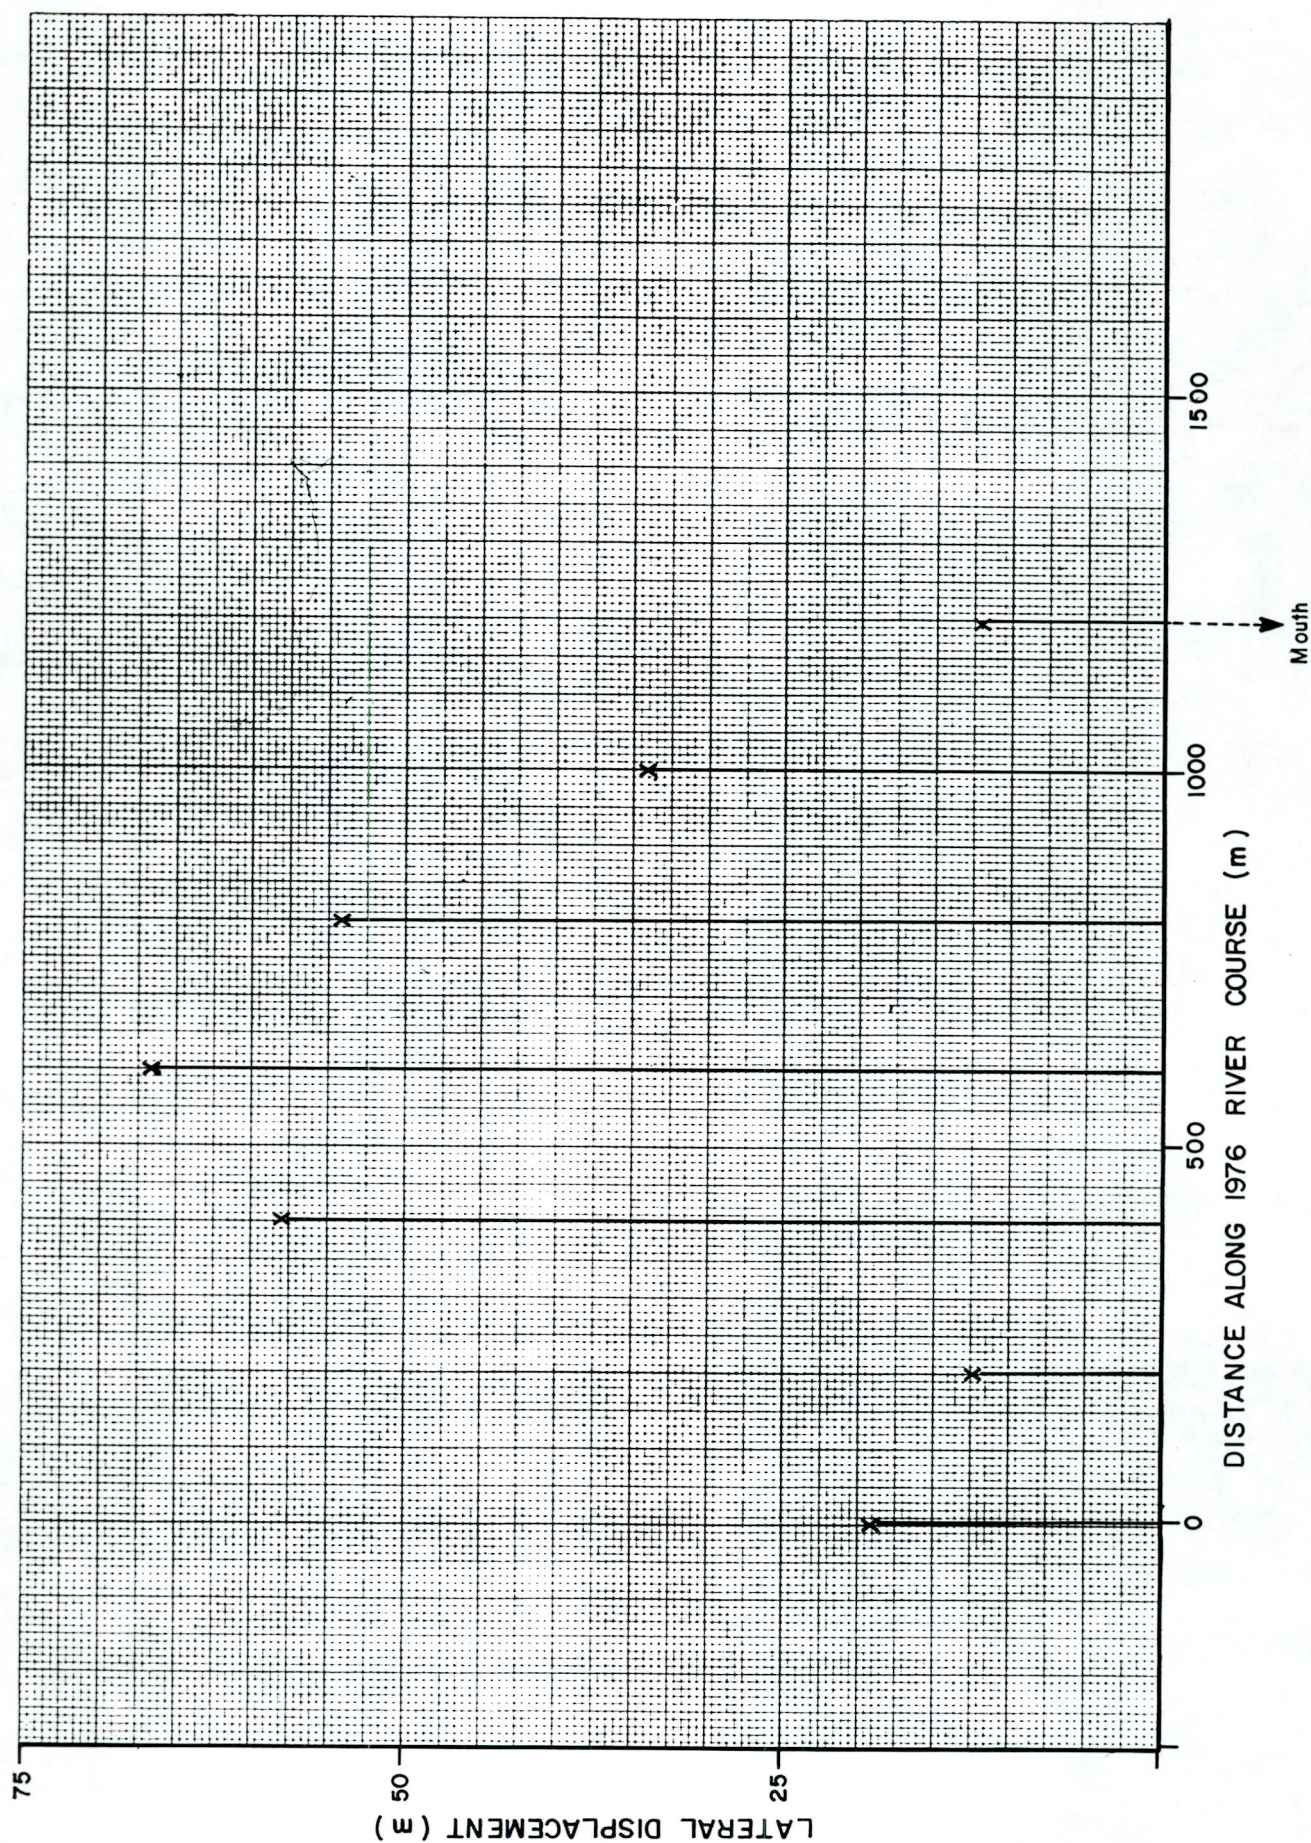
FIGURE  
 NS 16/1

Lateral displacement is greatest at stations 3, 4 and 5 (Figure NS16/1 and Table NS16/XI). Here channel avulsion has occurred. Had an aerial photograph been available for this period with the river in full spate, the lateral shift at the mouth would have been 100 m instead of 12 m. The average lateral displacement of 36,6 m (that is, 118,5 % of the average river width) with a coefficient of variation of 38,8 per cent indicates unstable conditions.

NATAL ESTUARIES : uMHLANGA  
 THALWEG DISPLACEMENT (1937-1985)

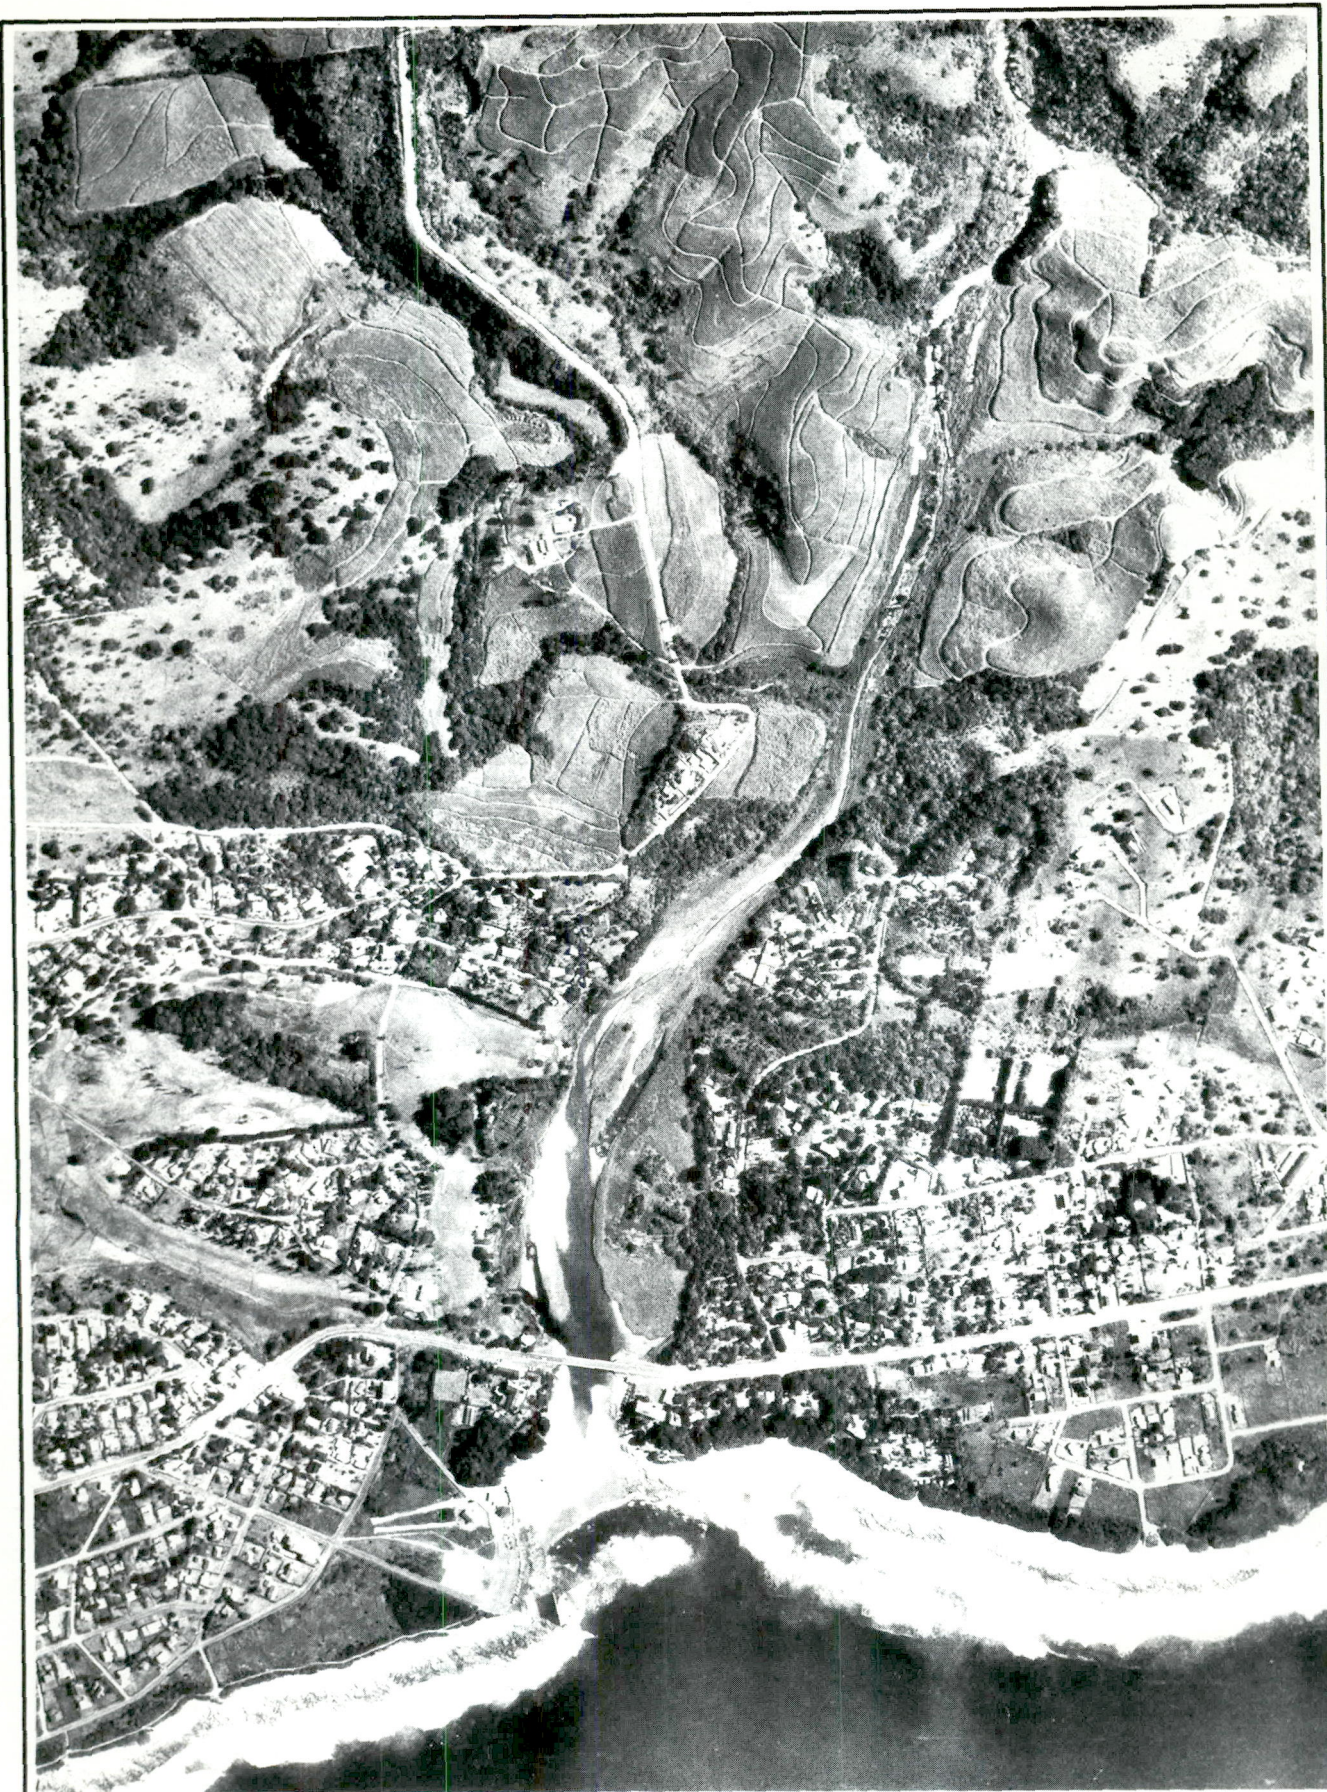
NS 16/5

- (5) The maximum peak discharge (estimated to be 368 cumecs by NPA Roads Department) during the period 1921-1977 was in March 1963. Photograph NS16/5 shows conditions almost two months after this major flood, indicating (a) a small overflow channel persisting against the left (northern) bank (b) a well-developed outer bar (c) a sand-spit/beach with of 52 m and (d) a "relic high-water line" (seen clearly only on the diapositive) which would give a sand-spit/beach width of barely 10 m; the latter representing conditions immediately after the devastating flood.

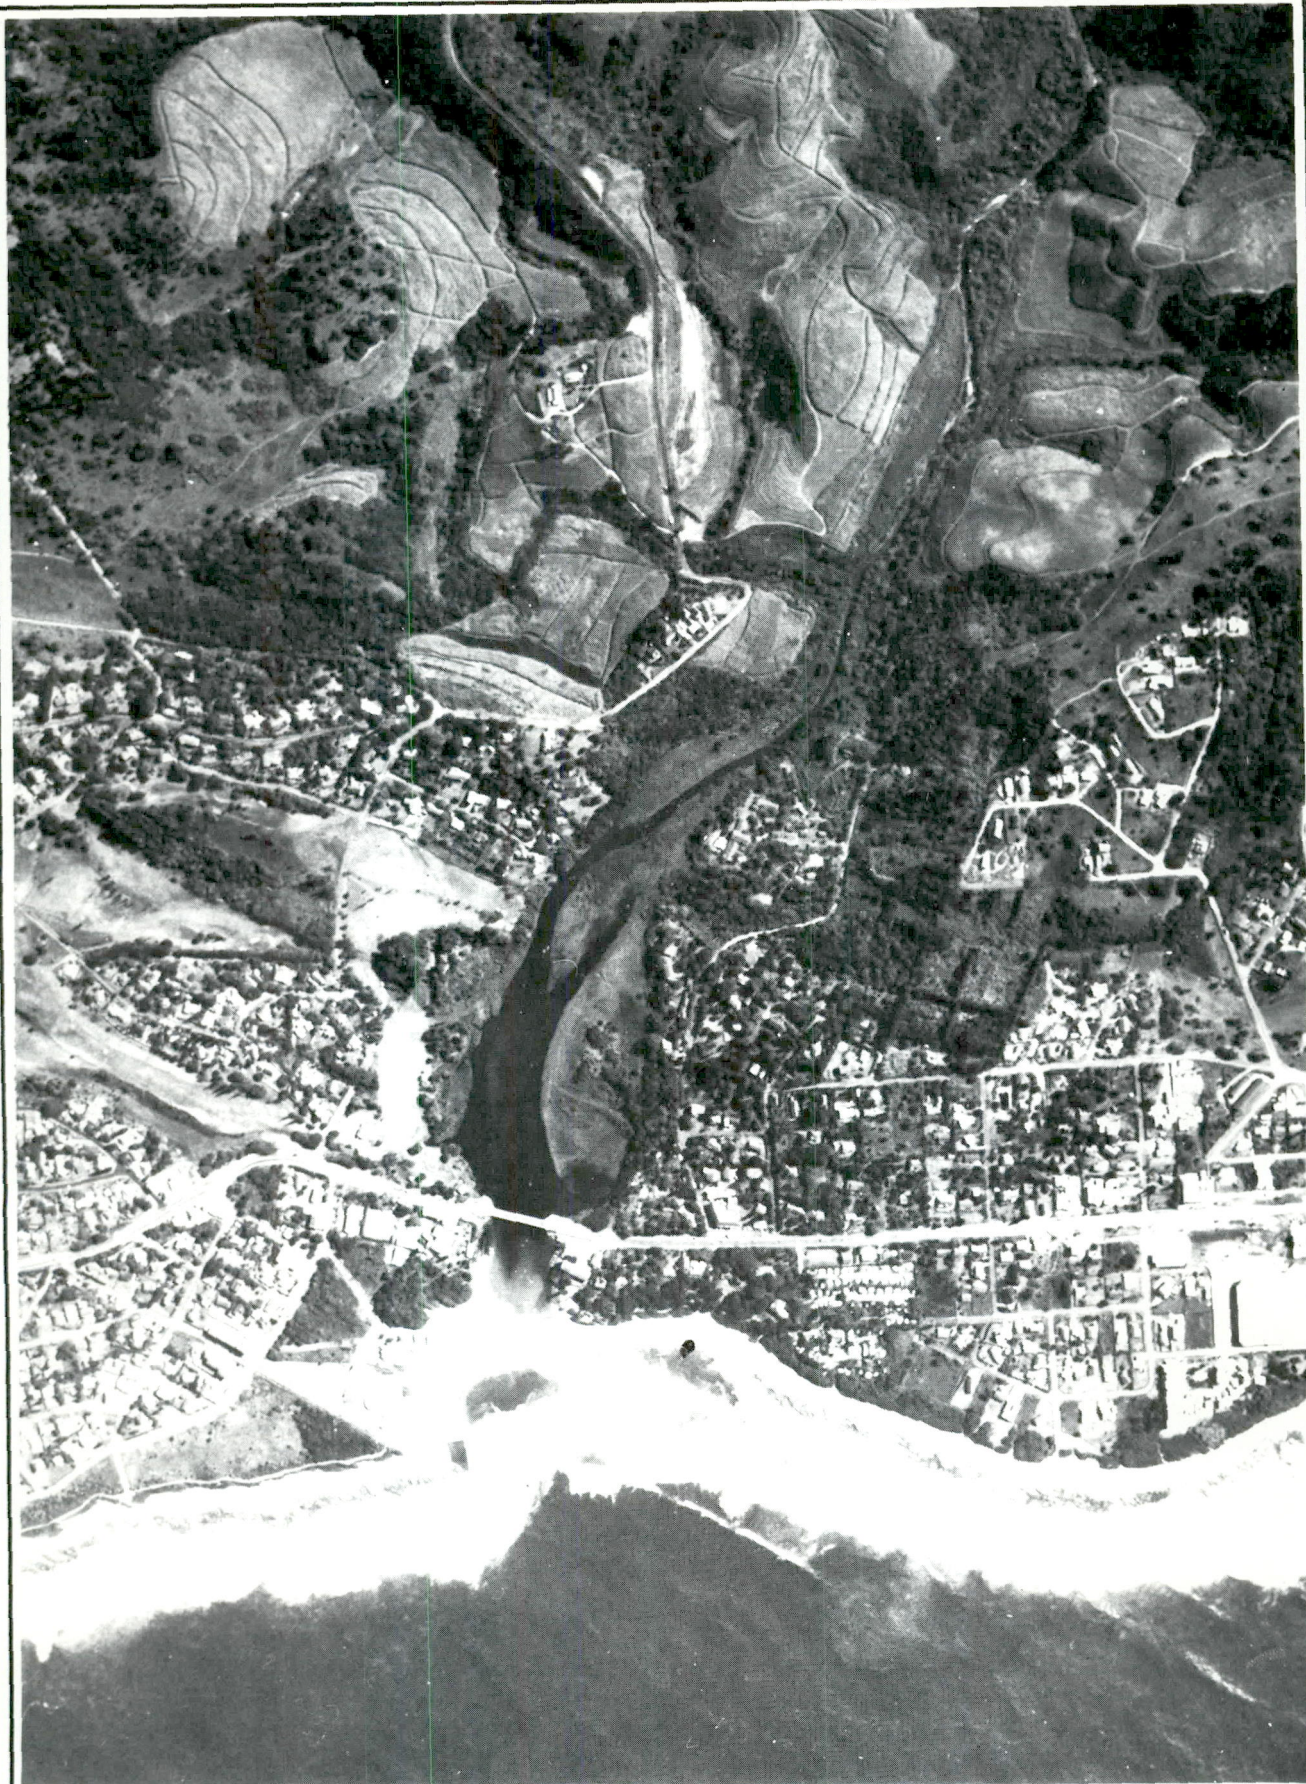
NS 16/8

north-easterly swells entering the cove, the river flow at its seaward limit is diverted towards the rocks on the right (southern) bank. The latter is also true when flood waters have subsided (Photograph NS16/8).

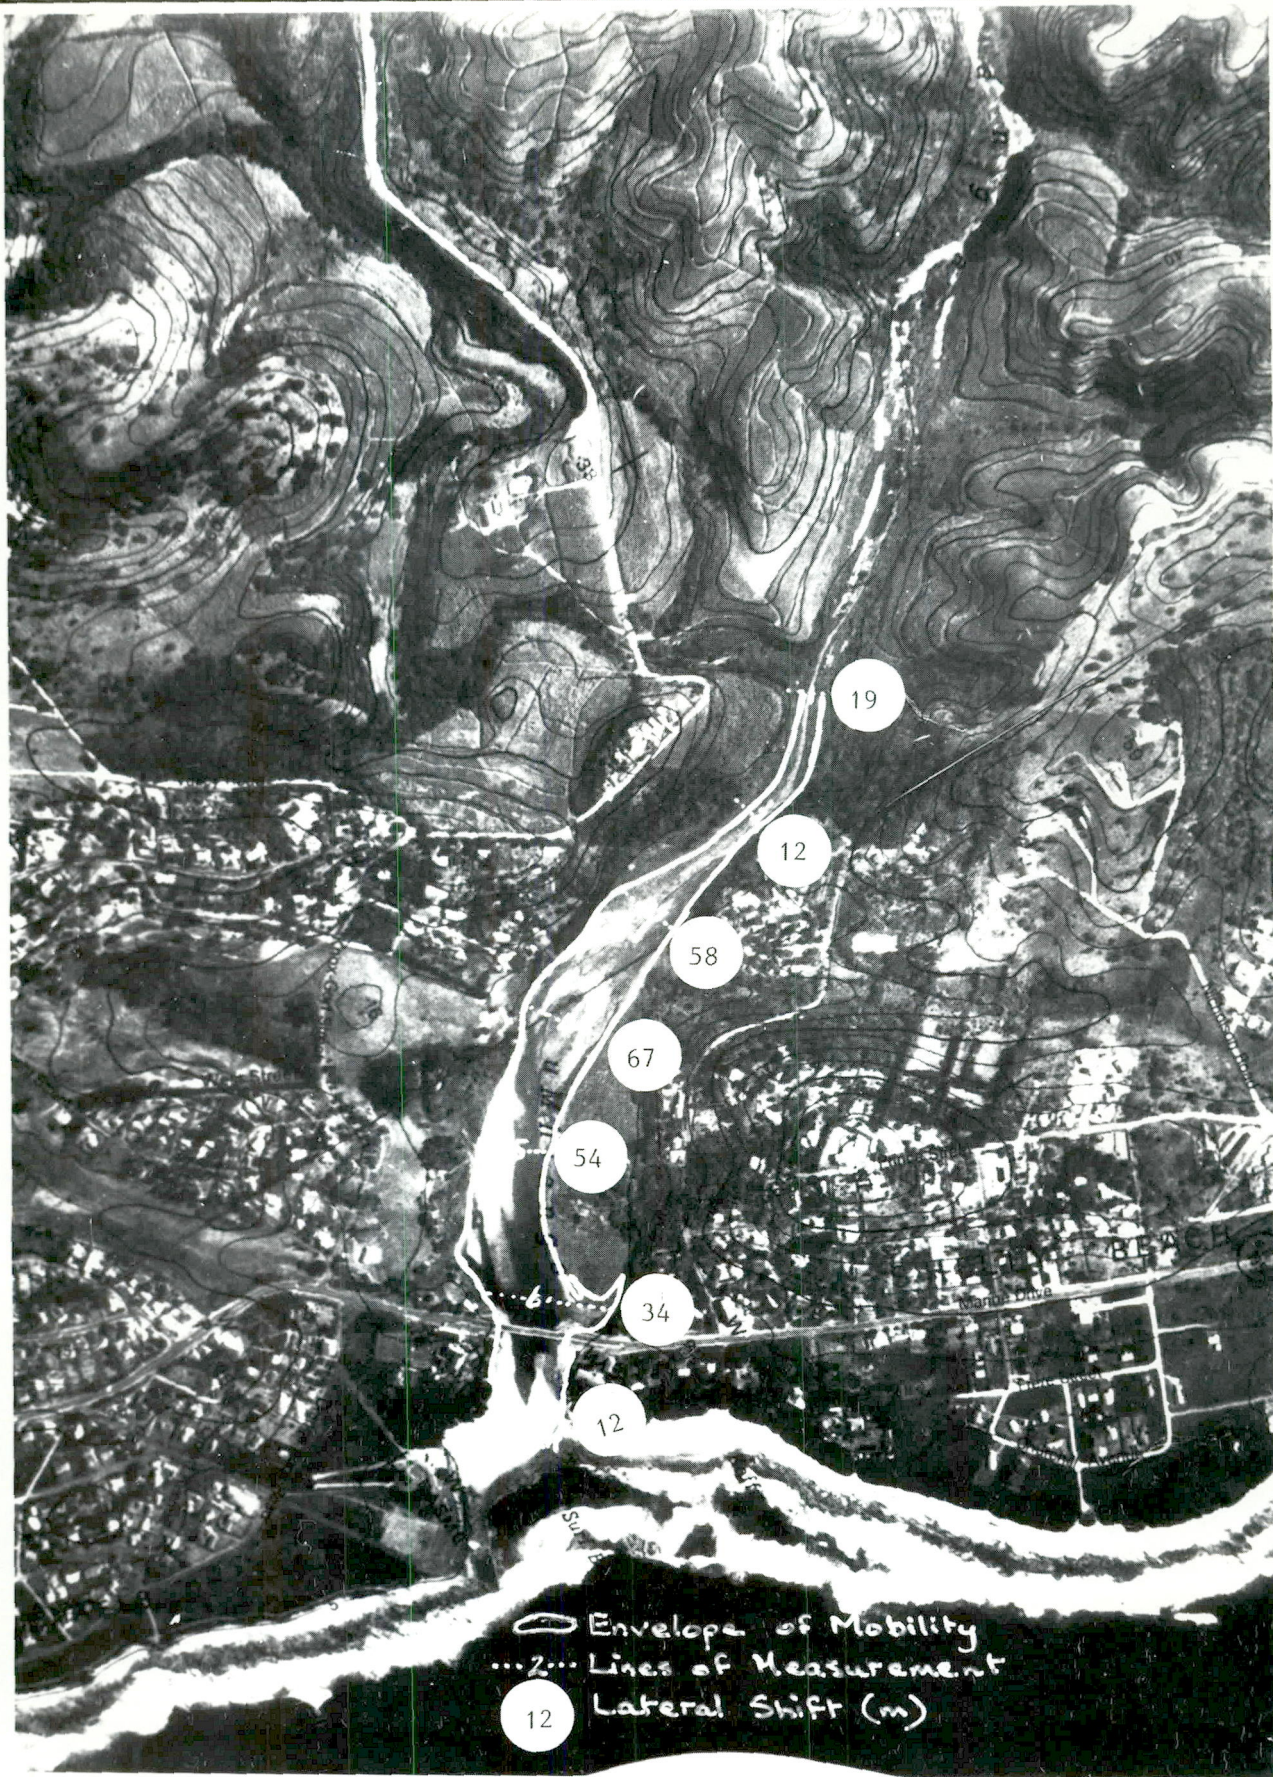
NS 16/11

For easy visual reference, an envelope of mobility, lines of measurement and lateral shift are superimposed on an orthophoto (Photograph NS16/11).

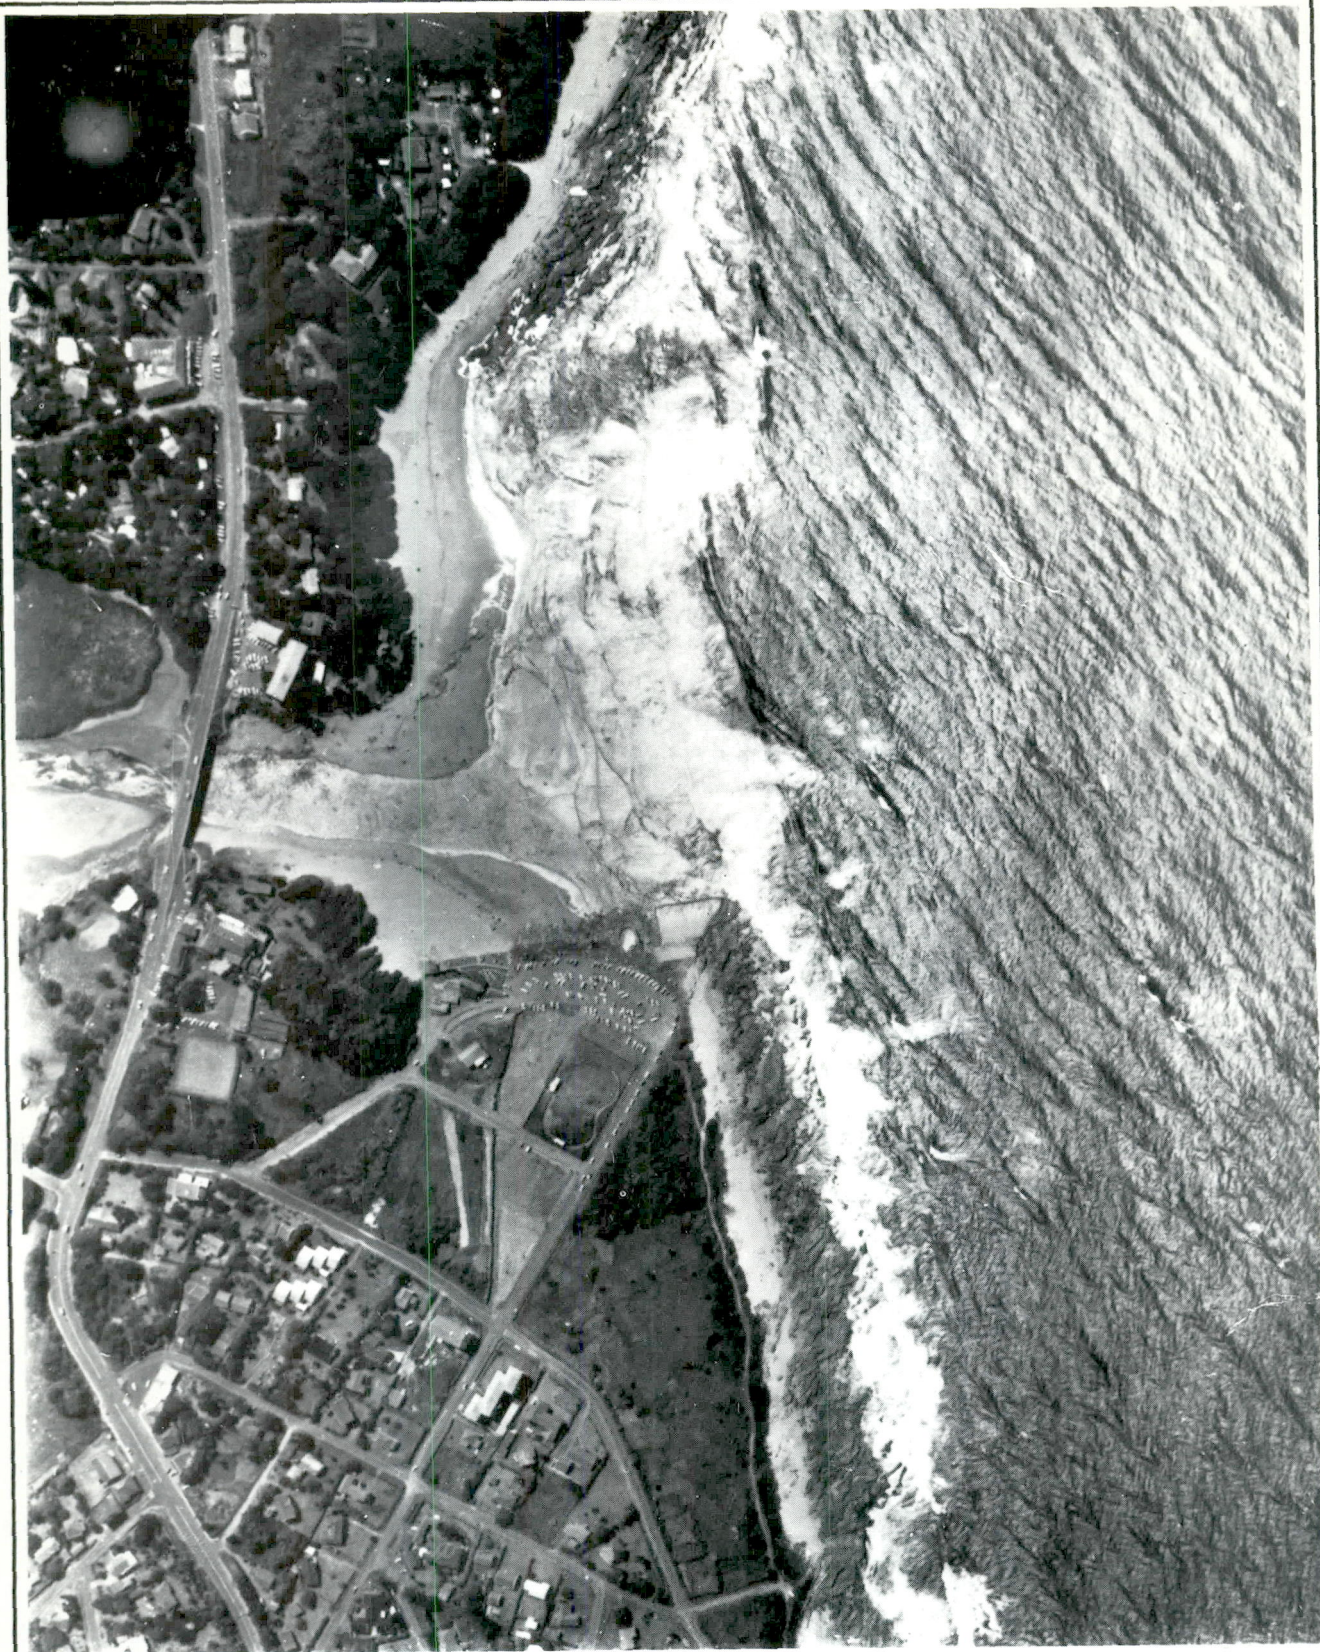
- (1) Typical rainy-season flood flows are exemplified by Photograph NS16/12. The river flows out to sea in the middle of the cove (almost at right angles to the road bridge) over a 60-80 m width. With the common easterly to

- (4) An outer bar (a) affords some protection from sea attack during river break-out conditions (Photograph NS16/12) although the beach width is still understandably reduced by almost half, to 50 m and (b) provides material for the rebuilding of the sand-spits/beaches during subsequent dry season conditions when the onshore component of the onshore-offshore currents will be dominant.

Neither bridge design inhibits the natural flood path of the river in a south-easterly direction to an approximate mid-cove position (Photograph NS16/12). The resultant detailed mouth and beach morphometry depends more on the "natural influences" as outlined in the preceding section.

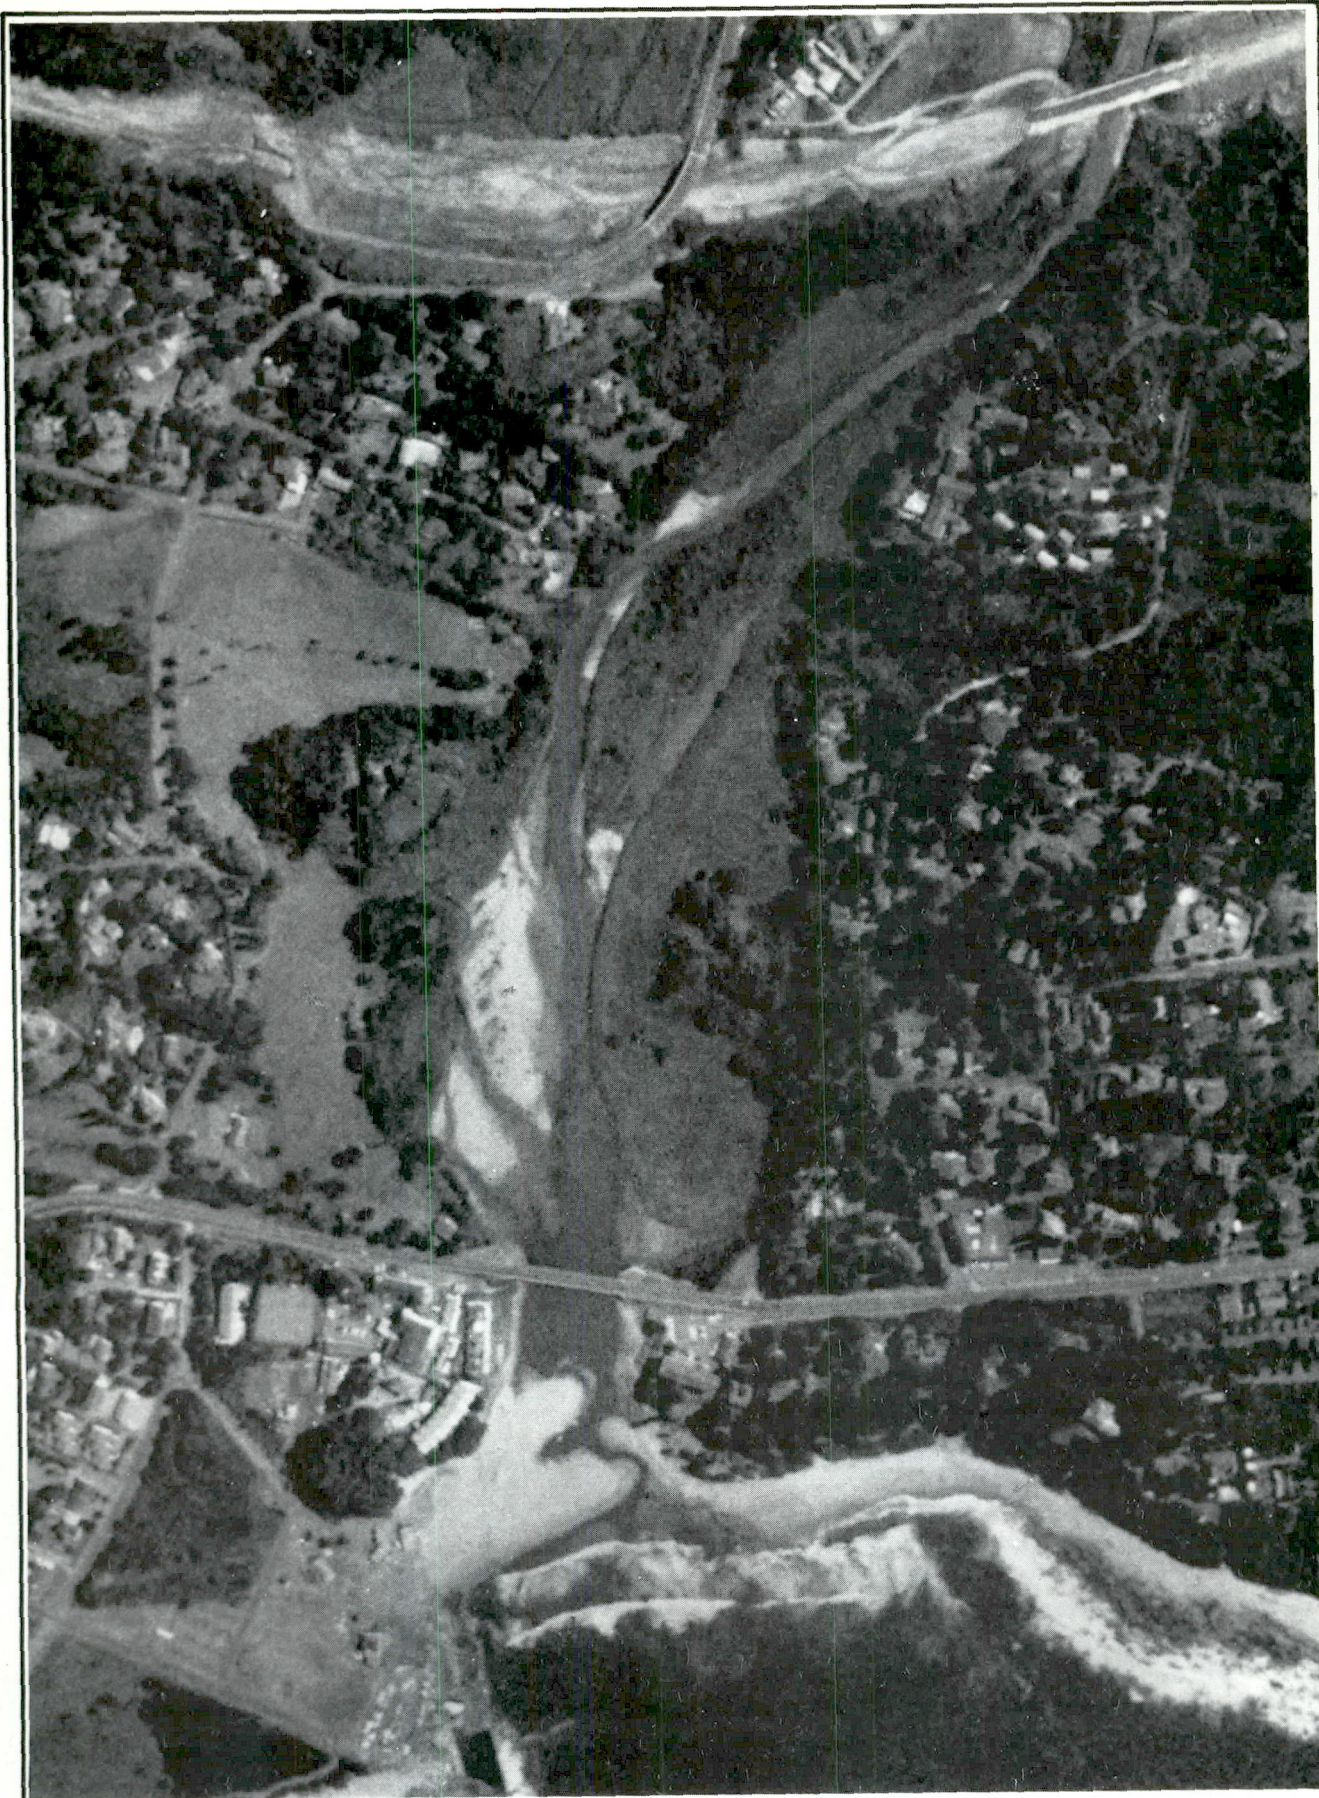
NS 16/1A

- (3) The major flood flows at the end of September 1987 further aggravated the position. It is very interesting to note that the high water line of the March 1963 flood (p 6 of the main text) is almost identical with high water line conditions of the September 1987 flood (Figure NS16/1A): only 10-15 m width of beach remaining in each case.
