**REPORT ON THE INVESTIGATION OF SILTATION IN THE
GREEN HOLE, KNYSNA
AND TECHNICAL EVALUATION OF REMEDIAL MEASURES**

submitted to
The National Parks Board of Trustees
Coastal Areas

January 1989

CSIR CONTRACT REPORT

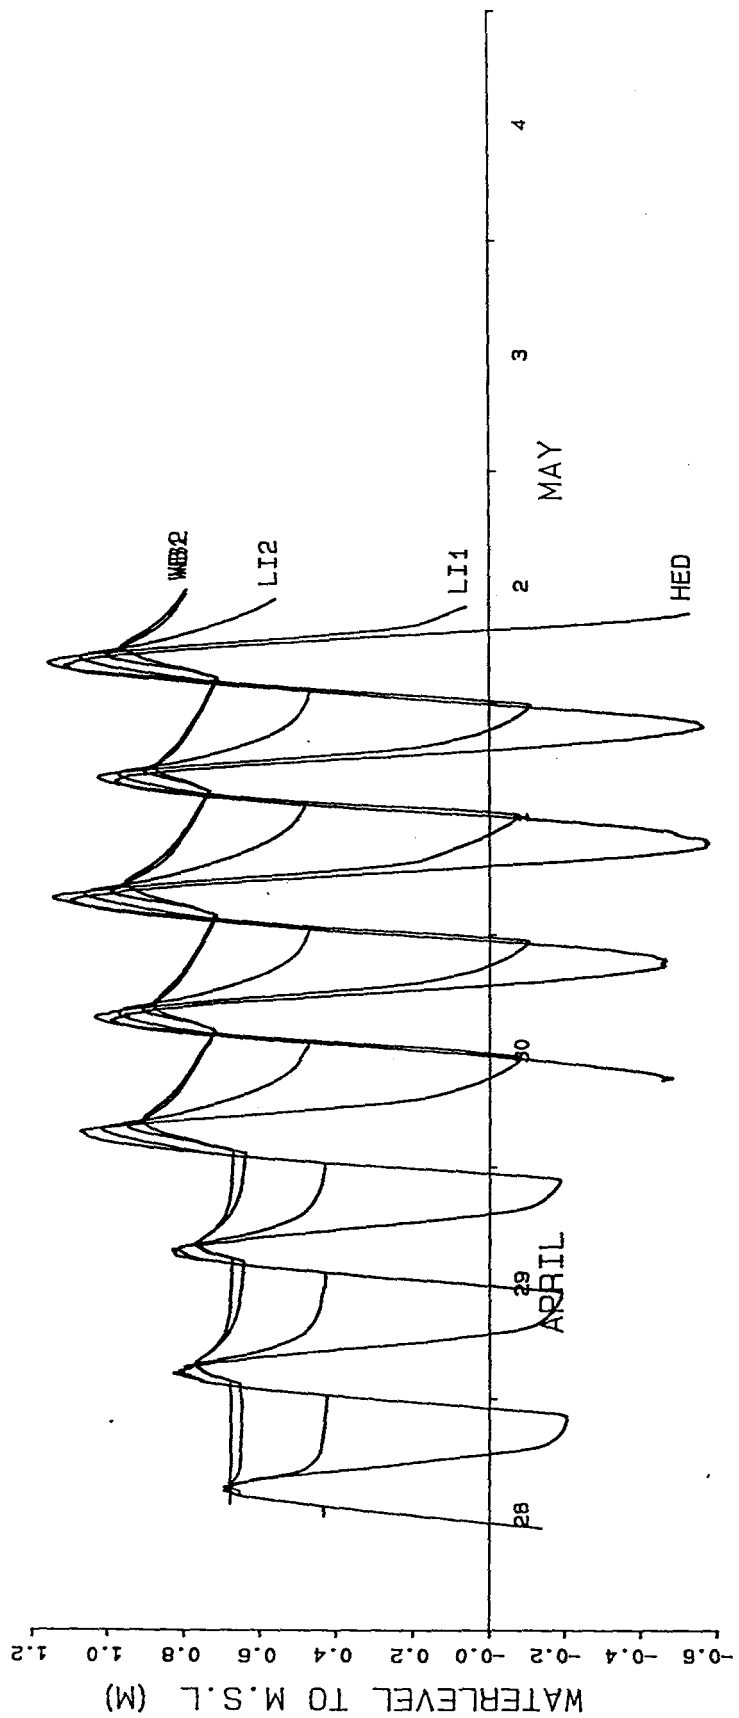
FIGURE
 3

The recorders were installed over the period 28 April 1988 to 2 May 1988. Spring tide occurred on 1 May 1988 and the fluctuations under spring tide conditions were thus monitored. The results for the full period are shown in Figure 3.

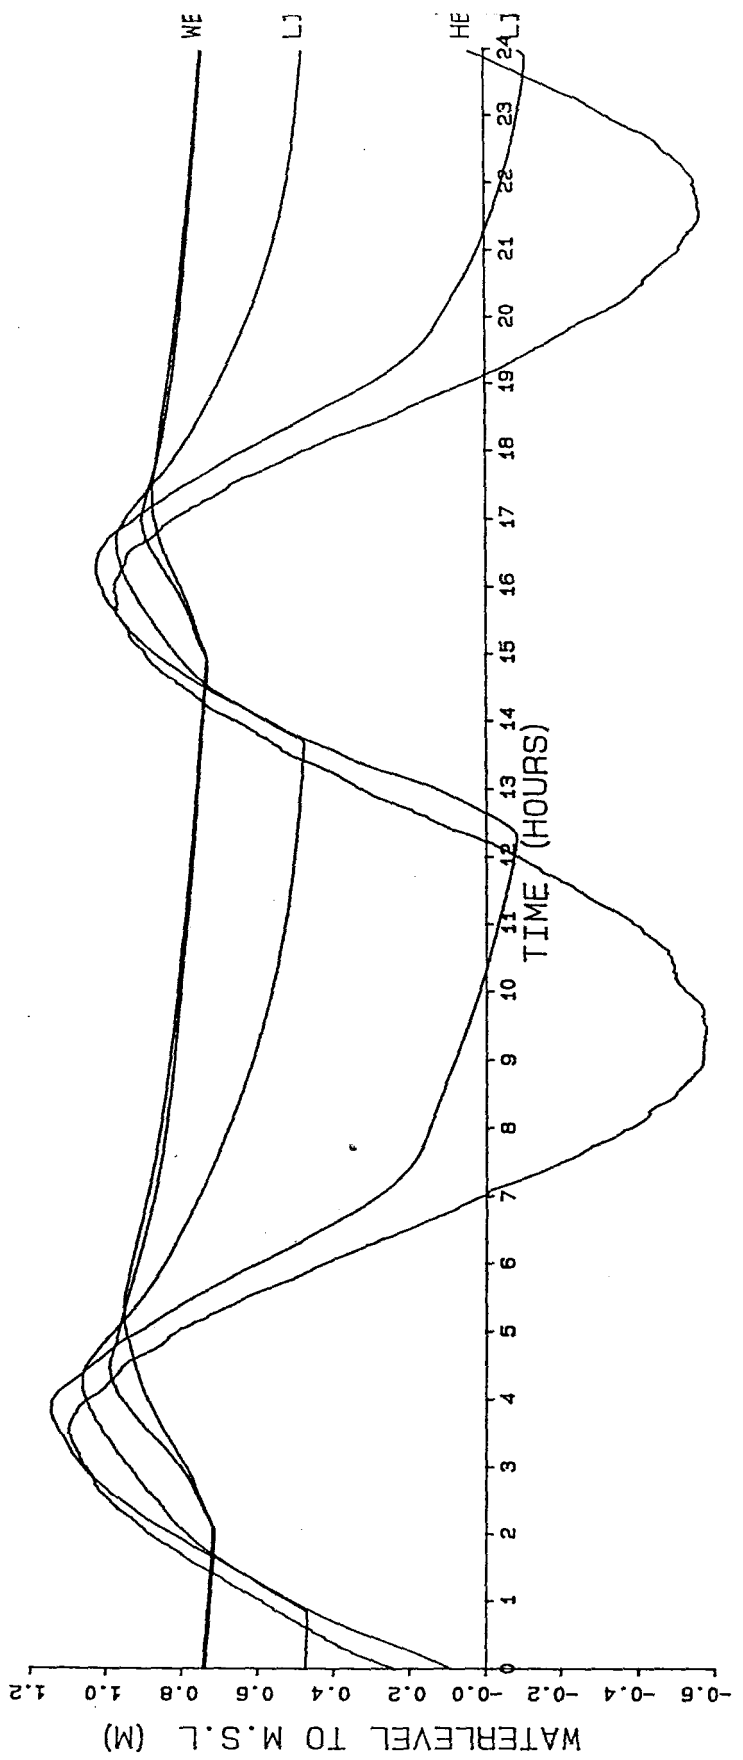
FIGURE
 4

The spring tide data (1 May 1988) are reflected in Figure 4 and allow for a detailed description of the vertical tidal fluctuations in the area:

- i Tidal delays at high tide relative to the reference station at The Heads were 20 min for Leisure Island 1, 35 min for Leisure Island 2, 55 min for Woodbourne 1 and 145 min for Woodbourne 2. An increase of about 0,05 m in the relative high tide level between Leisure Island 1 and The Heads can be observed. This type of increase in water levels is often observed in estuaries and is mostly due to funnel effects influenced by the shape of the channels.

- ii At ebb tide the dropping water levels at Leisure Island 1 closely followed those at The Heads until a level of about +0,20 m above mean sea level (MSL) was reached, after which a distinct kink in the graph could be observed. At this stage bottom effects started playing a role, as did the steady water supply from seepage out of areas that were being exposed by the falling tide. The other recordings bottomed out at much higher levels due to the same influences and the threshold effect of the fixed bottom levels of the culverts.

- iii About 3 h after low tide at The Heads, the incoming tide started affecting the water levels at Leisure Island 1, which then followed those at The Heads with a delay of about

30 min. About 4,5 after low tide the levels at Leisure Island 2 were influenced by the rising tide. The water levels at the Woodbourne culvert were only slightly affected after about 5,5 h.

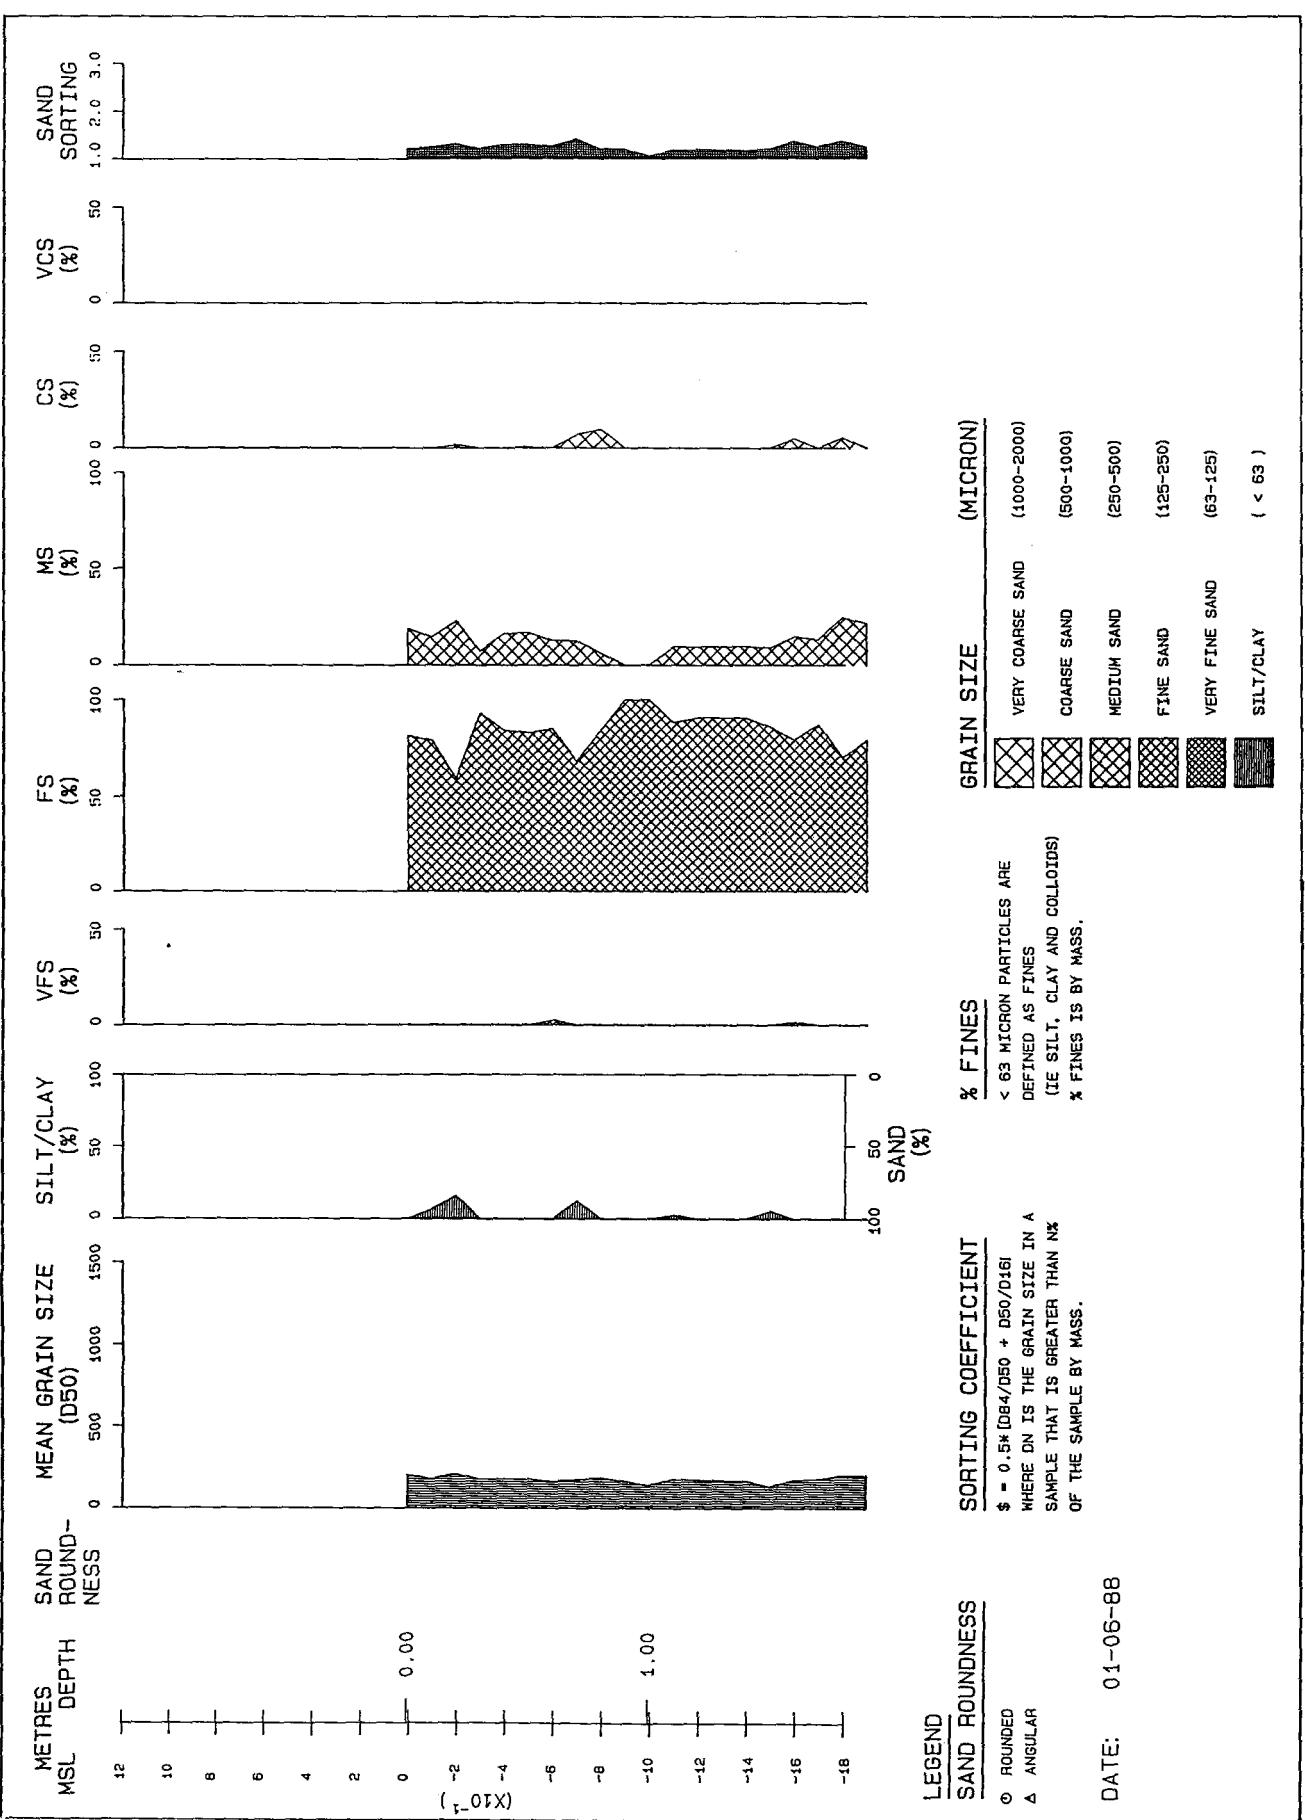
FIGURE 5

Core 1: Located in the entrance channel at the northern side of the Leisure Island causeway, core 1 reflects the siltation outside the Green Hole down to a depth of -1,8 m (MSL).

Four distinct layers of coarse sand (CS) overlain by silt/clay (S/C) and very fine sand (VFS) show up at levels -0,3 m, -0,8 m, -1,6 m and -1,8 m (MSL). These are possibly indicative of periods of scour associated with high flow velocities, probably during river flooding when FS was scoured out, leaving only the coarser fraction. This was followed by the settling out of S/C and FS during post-flood low river flow conditions.

The intermediate periods reflect the continuous influx of FS under normal tidal conditions (Section 2.3).

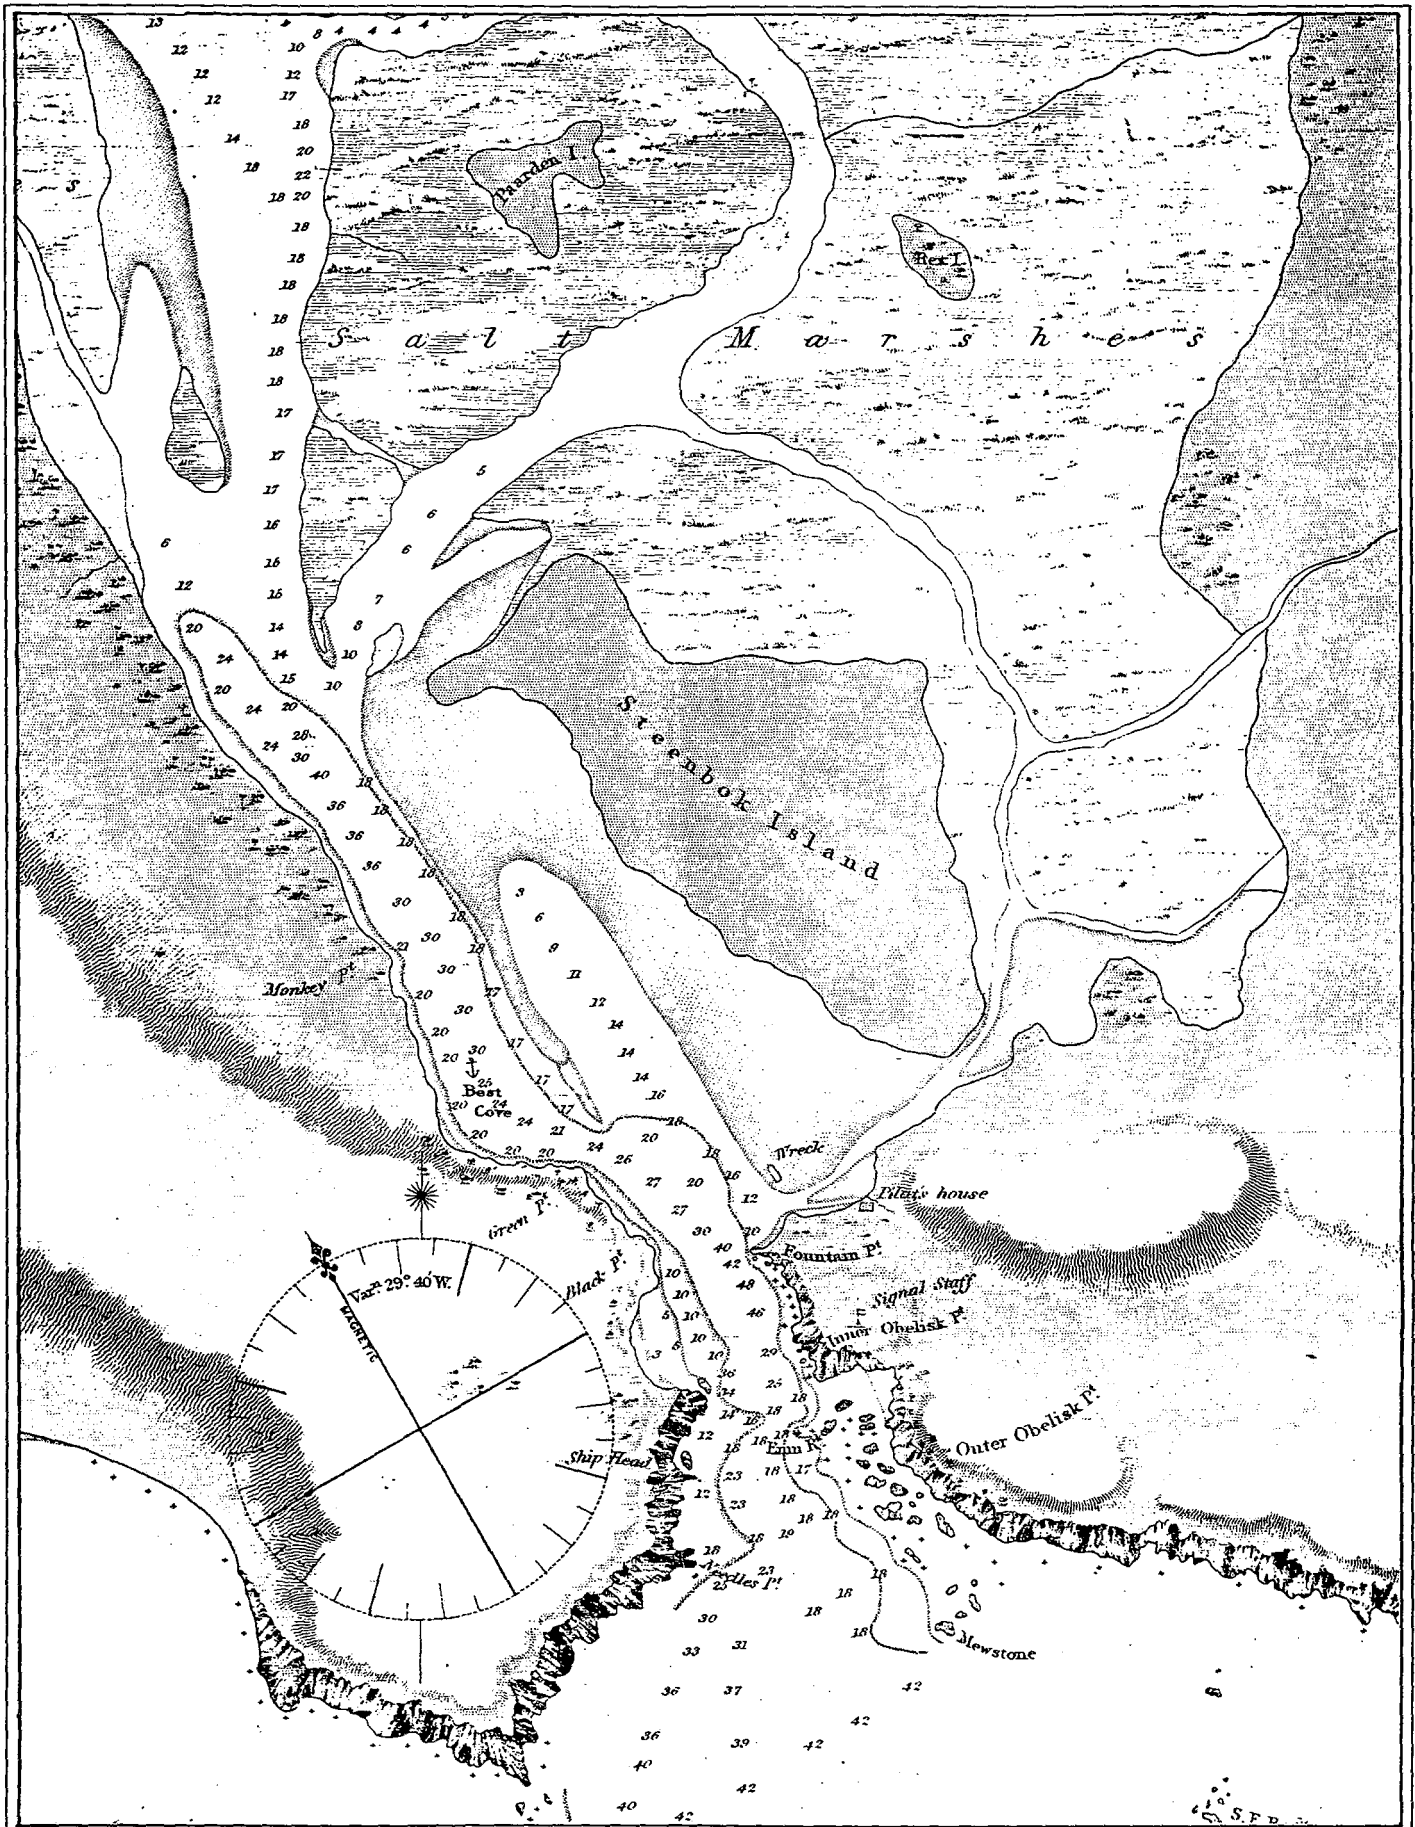
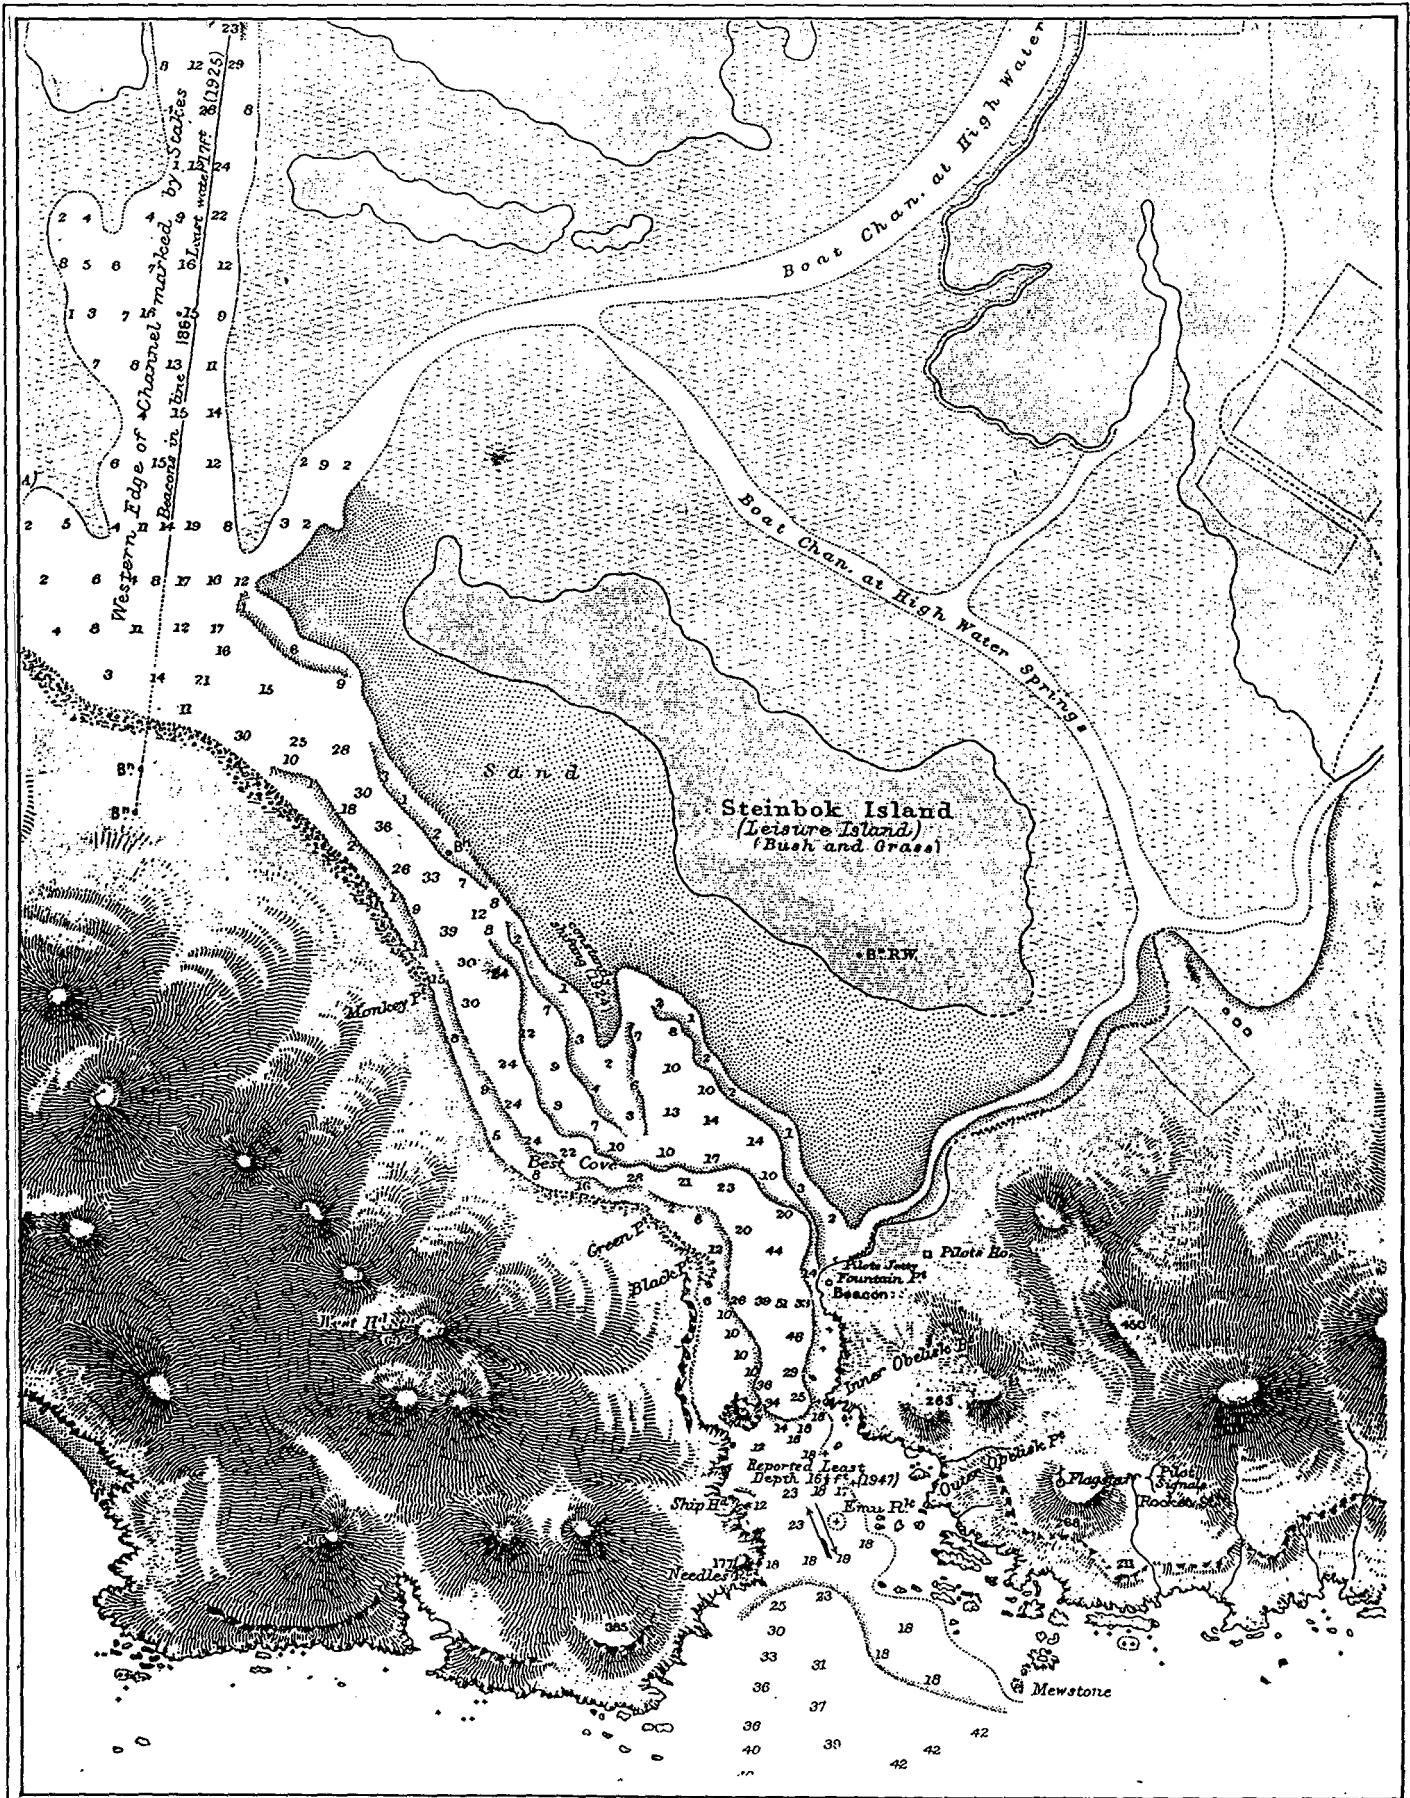
The original situation that existed before the construction of George Rex Drive (before 1903) and the Leisure Island causeway can be estimated from old maps and charts, like the charts of 1818 and 1864, available from the Cape Archives (Cape Town) and other sources (Figures 9 and 10):

Such causeways were often constructed by simply excavating material from both sides of the causeway while the sides were protected from erosion by stony material imported from a nearby quarry. Since the old maps (Figures 9 and 10) indicate that the area consisted of salt marsh prior to development, the existing channels on both sides of the Leisure Island causeway could be remnants of such excavations of material. These channels are already clearly visible on the 1936 aerial photograph (Figure 11).

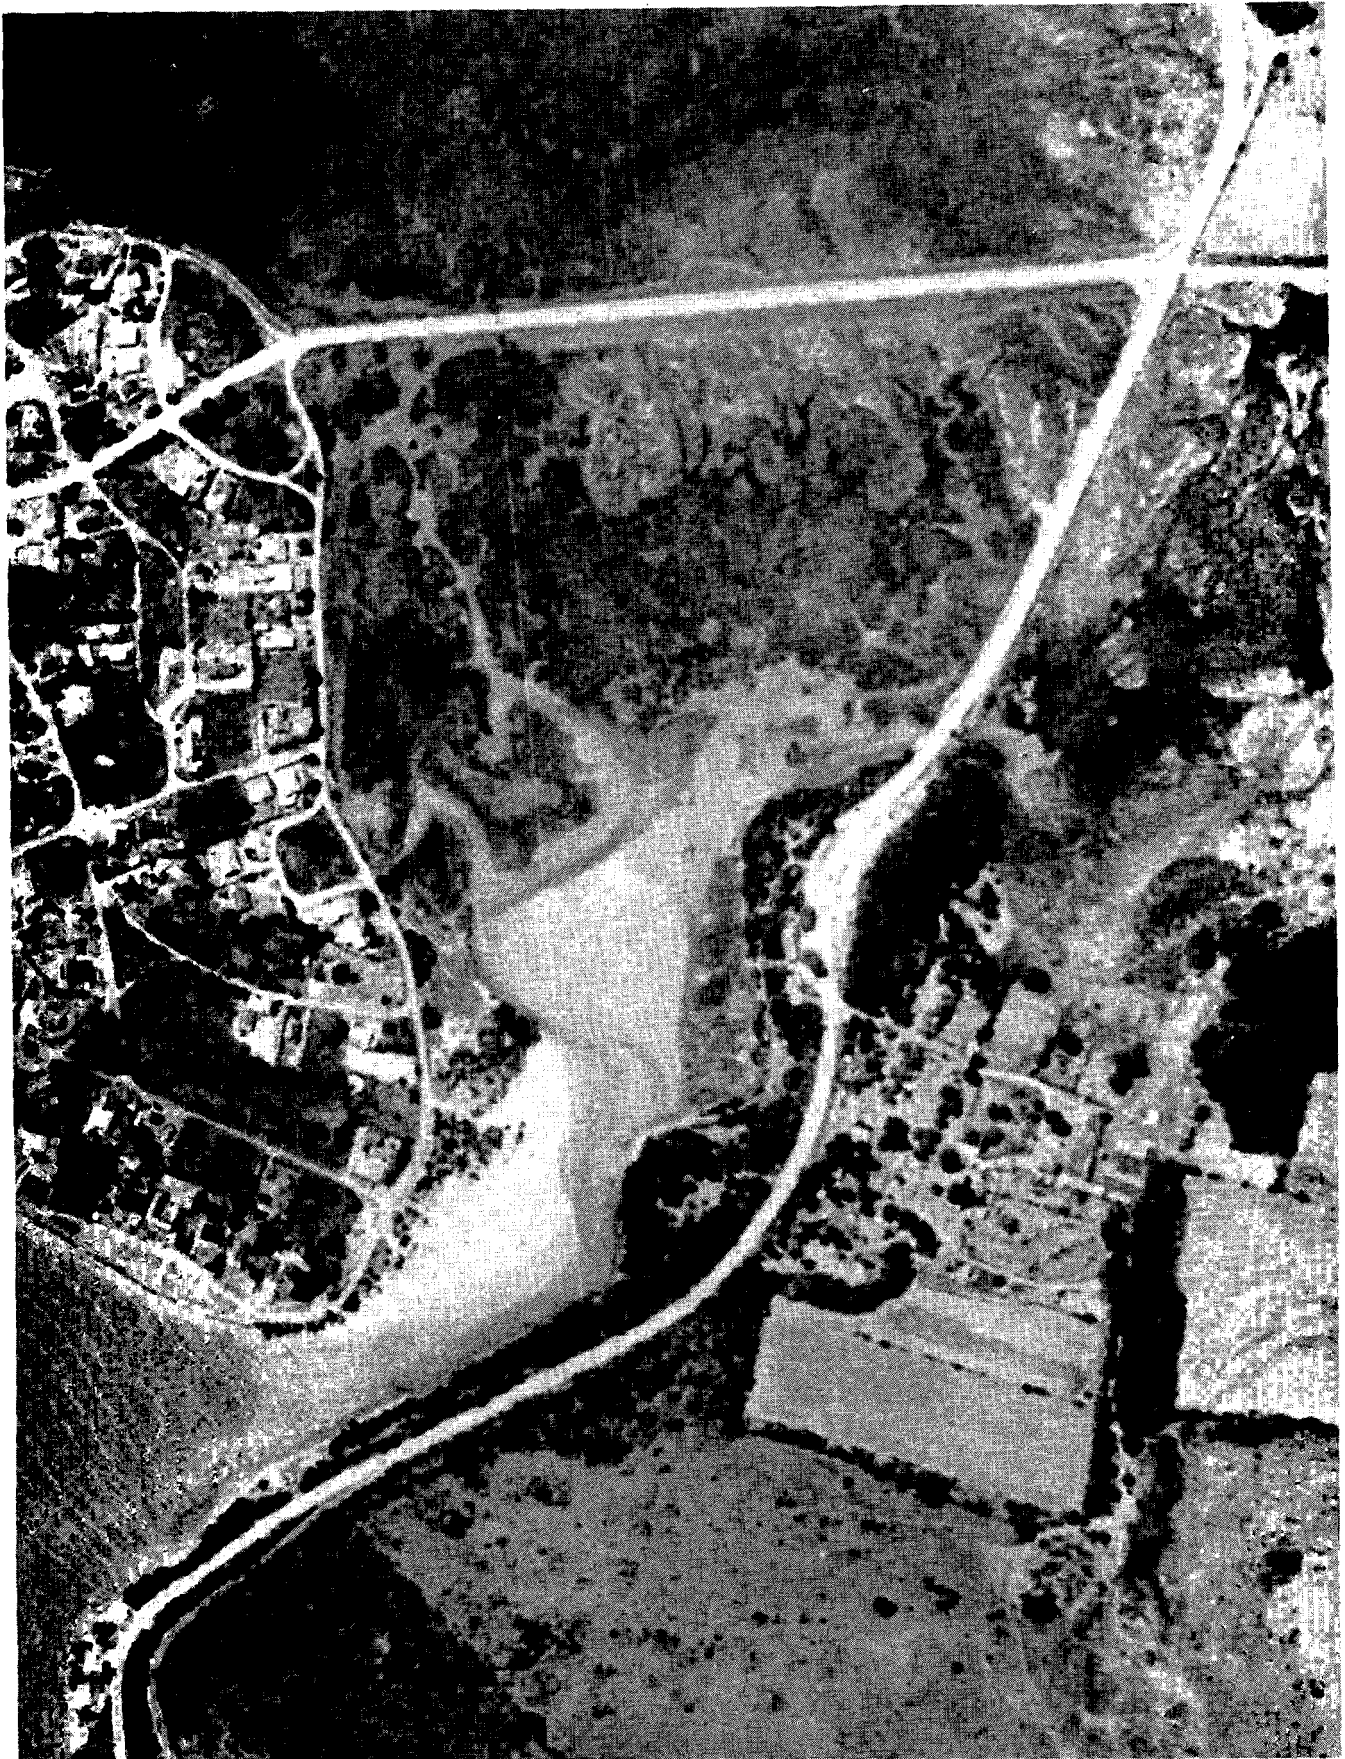
FIGURE
14

The old 4 m box culvert was replaced by 12 30-inch diameter concrete pipes in 1954. The pipe inverts were approximately at MSL (CSIR, unpublished report, 1965). The smaller pipe culverts introduced an increased obstruction against the in and outflow of the Green Hole through the Leisure Island causeway and as a result most probably increased the outgoing tidal flow rate in the channel between the island and The Heads. The resulting higher flow velocities during outgoing tides had a large scouring potential that removed a percentage of the total sediment transported into the area during the previous high tide. Thus a deeper channel would have been maintained. An aerial photograph of 1968 (Figure 14) still shows a reasonably deep channel at this position.

The same photograph shows erosion holes opposite the culverts on both sides of the causeway. These were caused by scour as a result of high flow velocities due to concentrated tidal flows. Inside the Green Hole sand scoured from these holes was mostly deposited within a short distance around the holes due to a
