HYDROLOGICAL / HYDRAULIC STUDY
OF NATAL ESTUARIES

DATA REPORT No. 6

LOVU NS 47

ESTUARINE DYNAMICS (CESD)
NRIO / CSIR
STELLENBOSCH

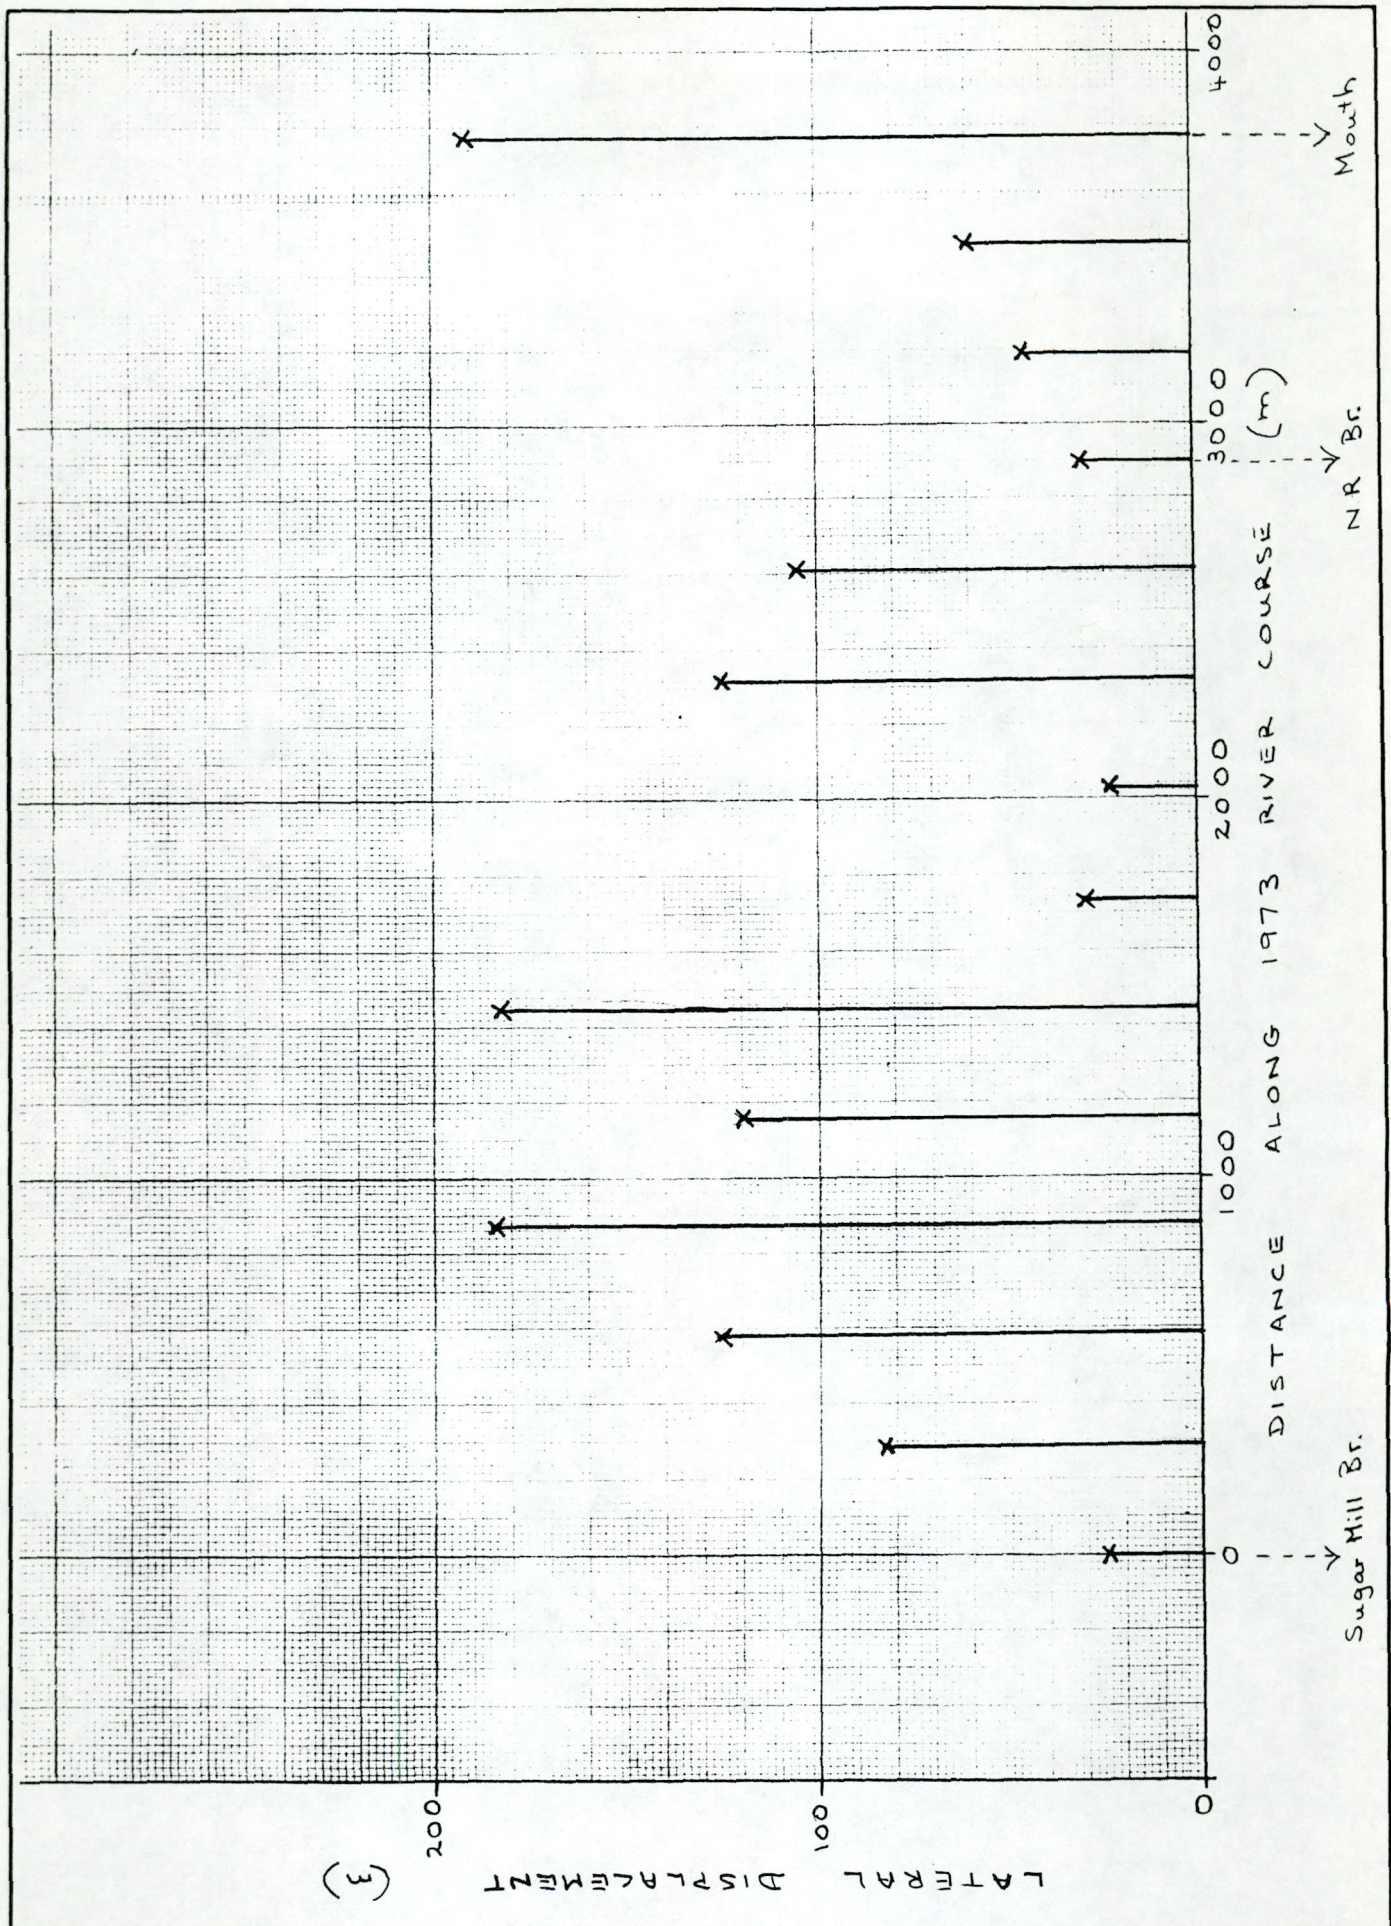
FIGURE
 NS47/1

NATAL ESTUARIES: LOVU
 THALWEG DISPLACEMENT: 1937-76

The estuary is unstable as indicated by a high average lateral displacement of 95,1 m and a high average coefficient of variation of lateral stability (42,2%). The behaviour of the Lovu demonstrates a river trying to adjust to the human influences of bridge building, stabilization of embankments (with part of the sand-spit), sugar-cane farming and canalization.

Average lateral displacement 1937-76 = 95,1 m Average coefficient of variation 1937-76 = 42,2%

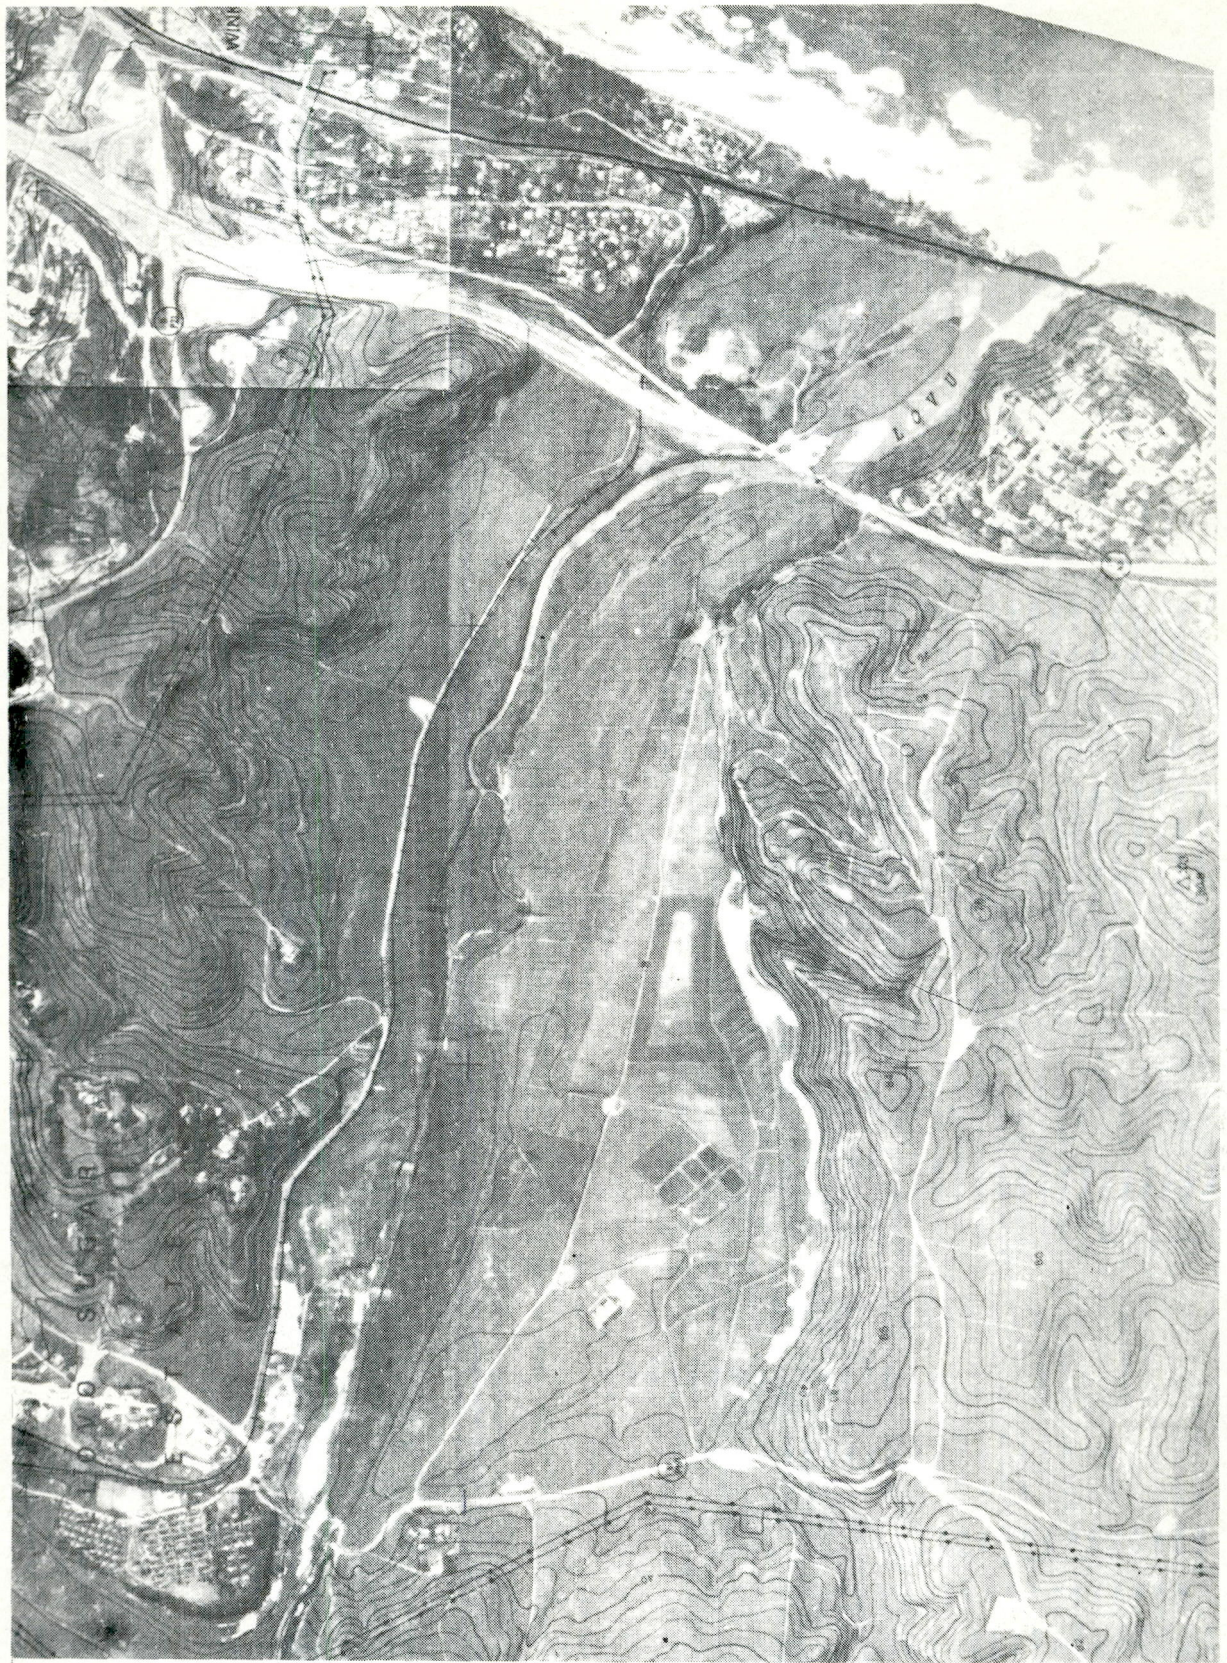
PHOTOGRAPH
NS47/1

18-4-74 (ORTHOPHOTO)

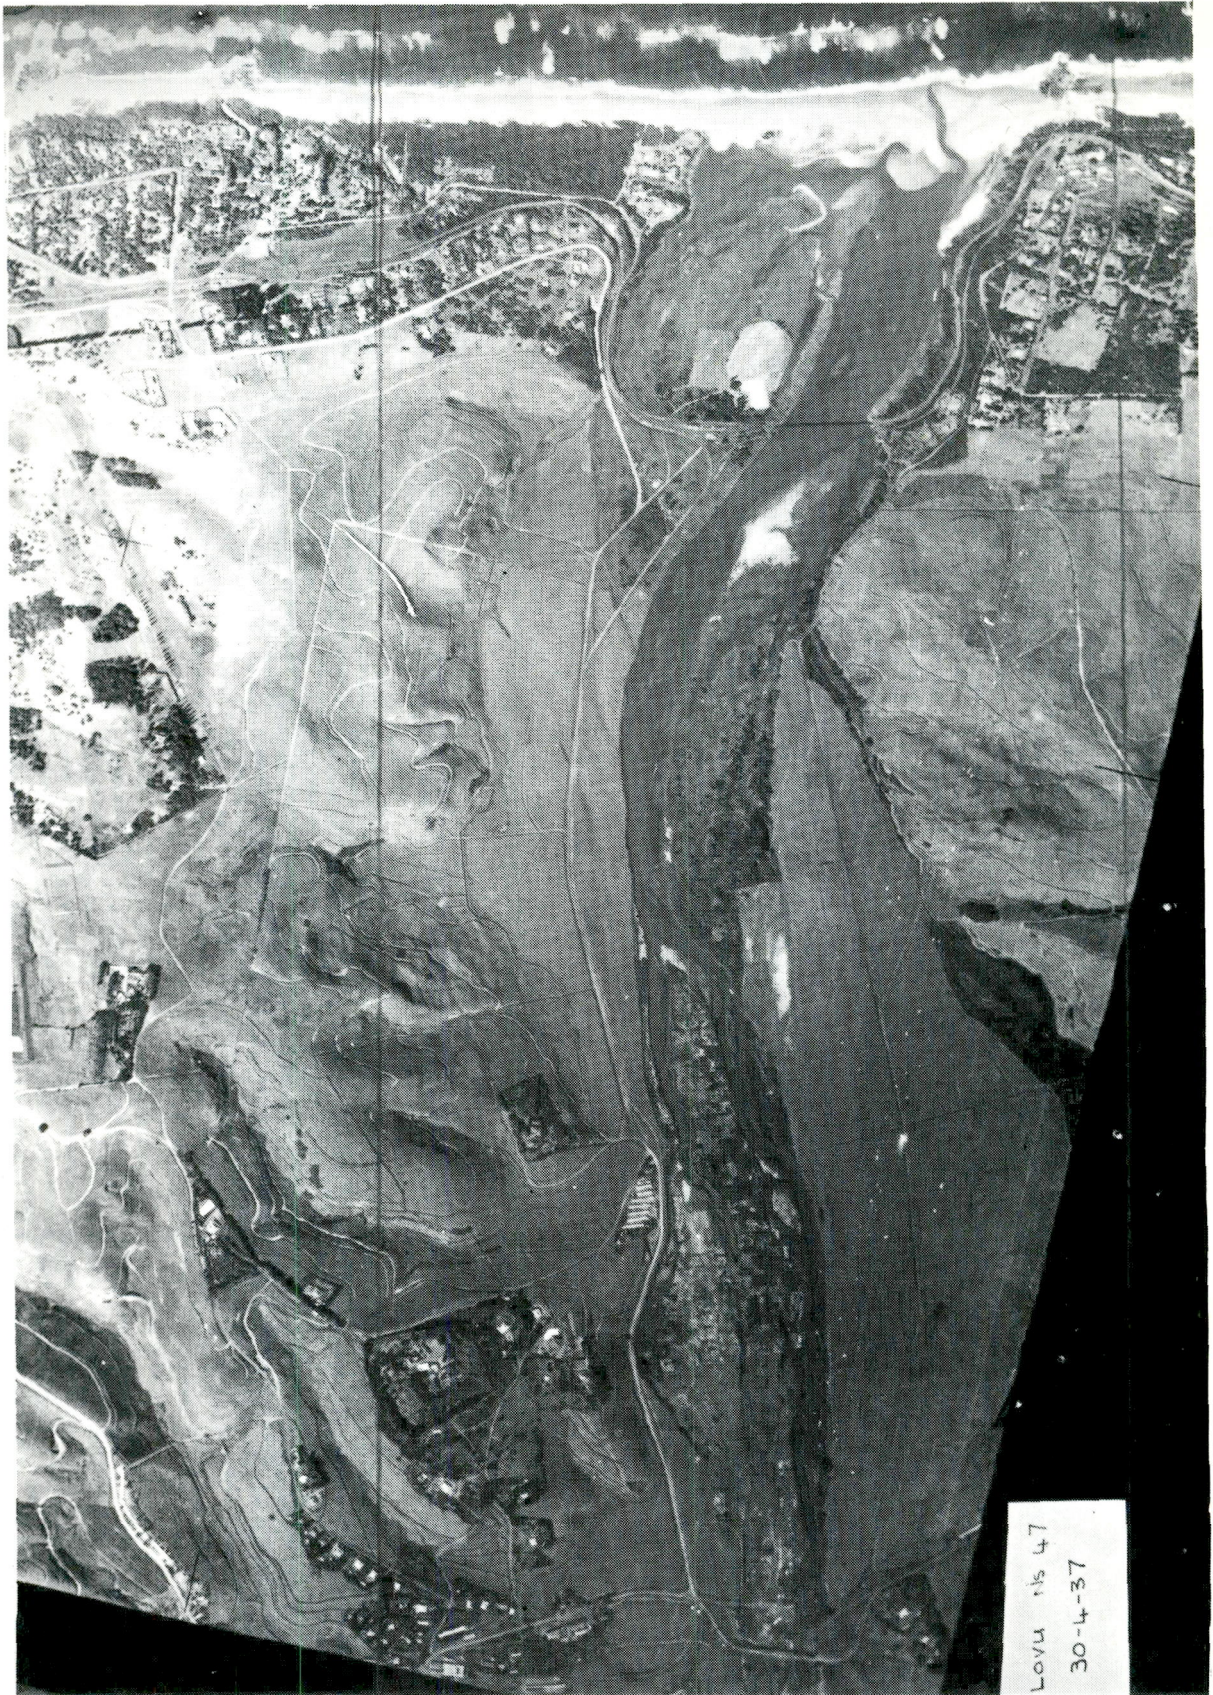
PHOTOGRAPH
NS47/2

30-4-37

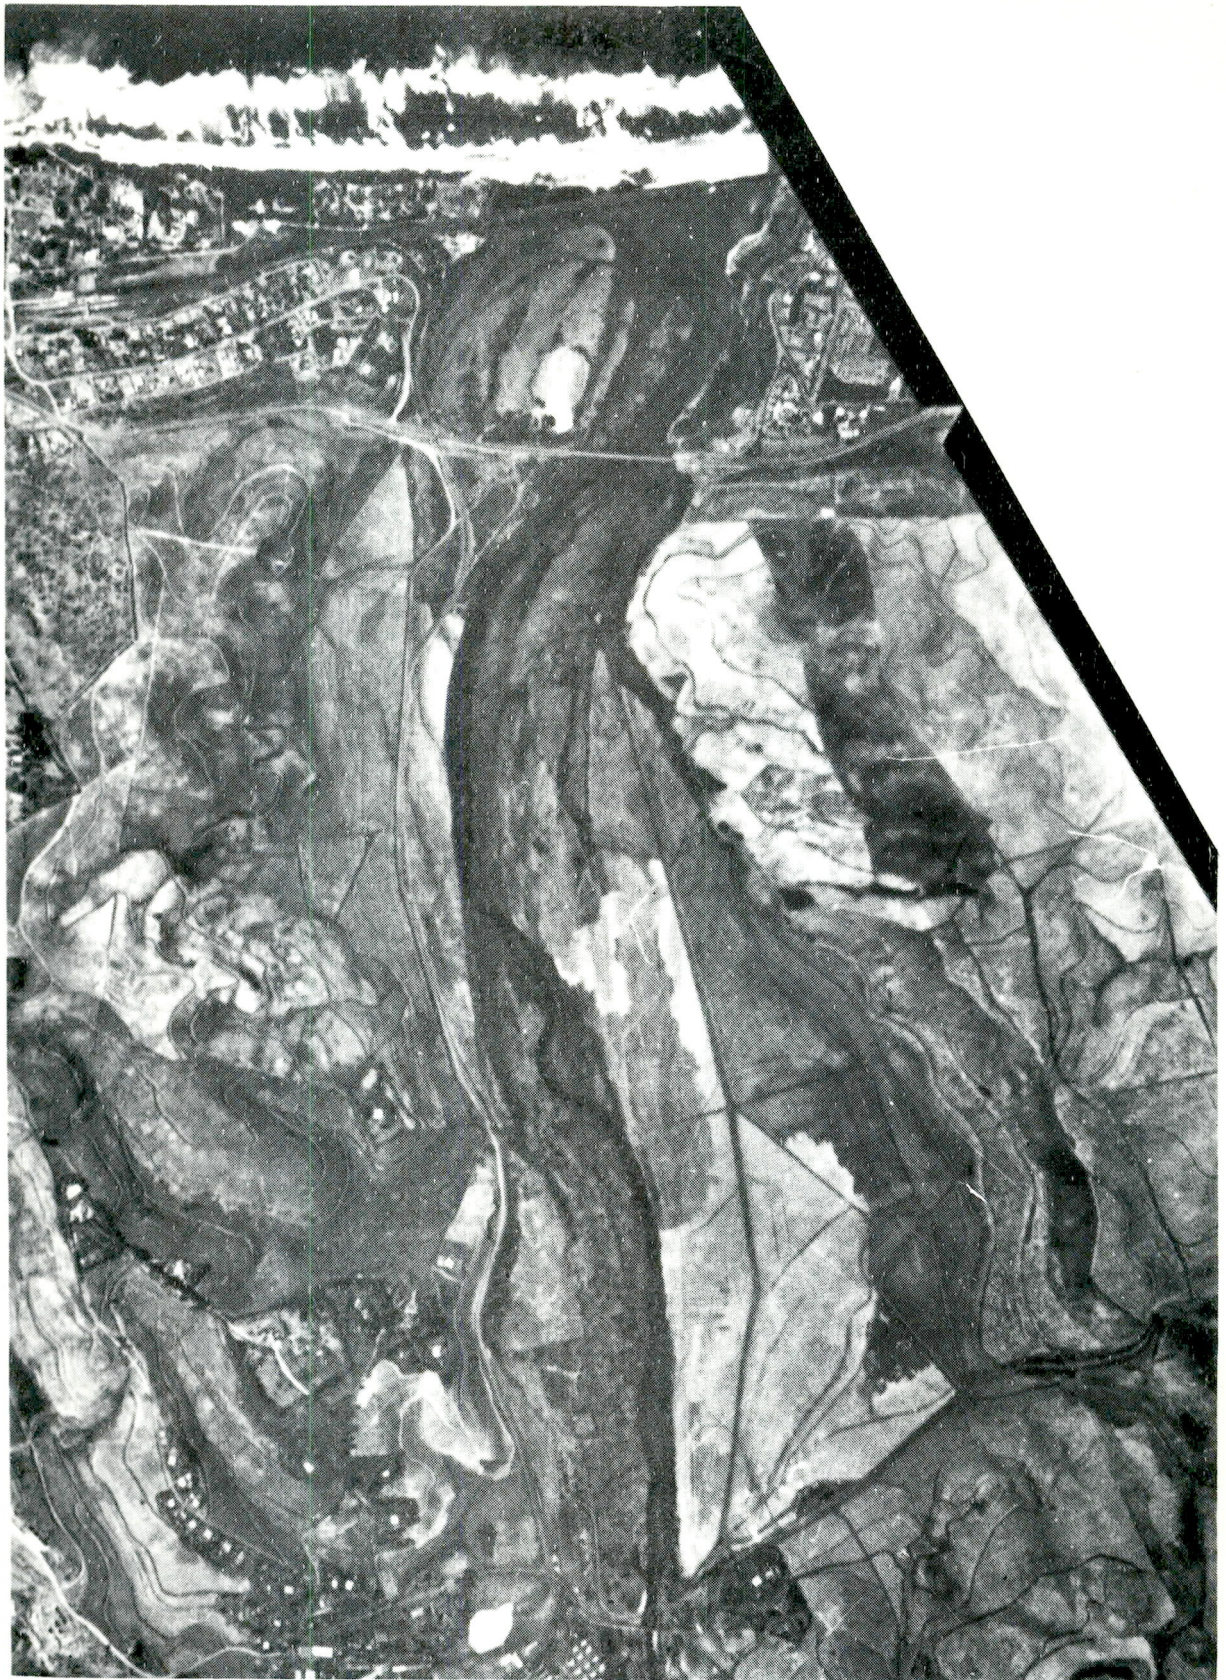
NS47/3

JULY / AUGUST 1953

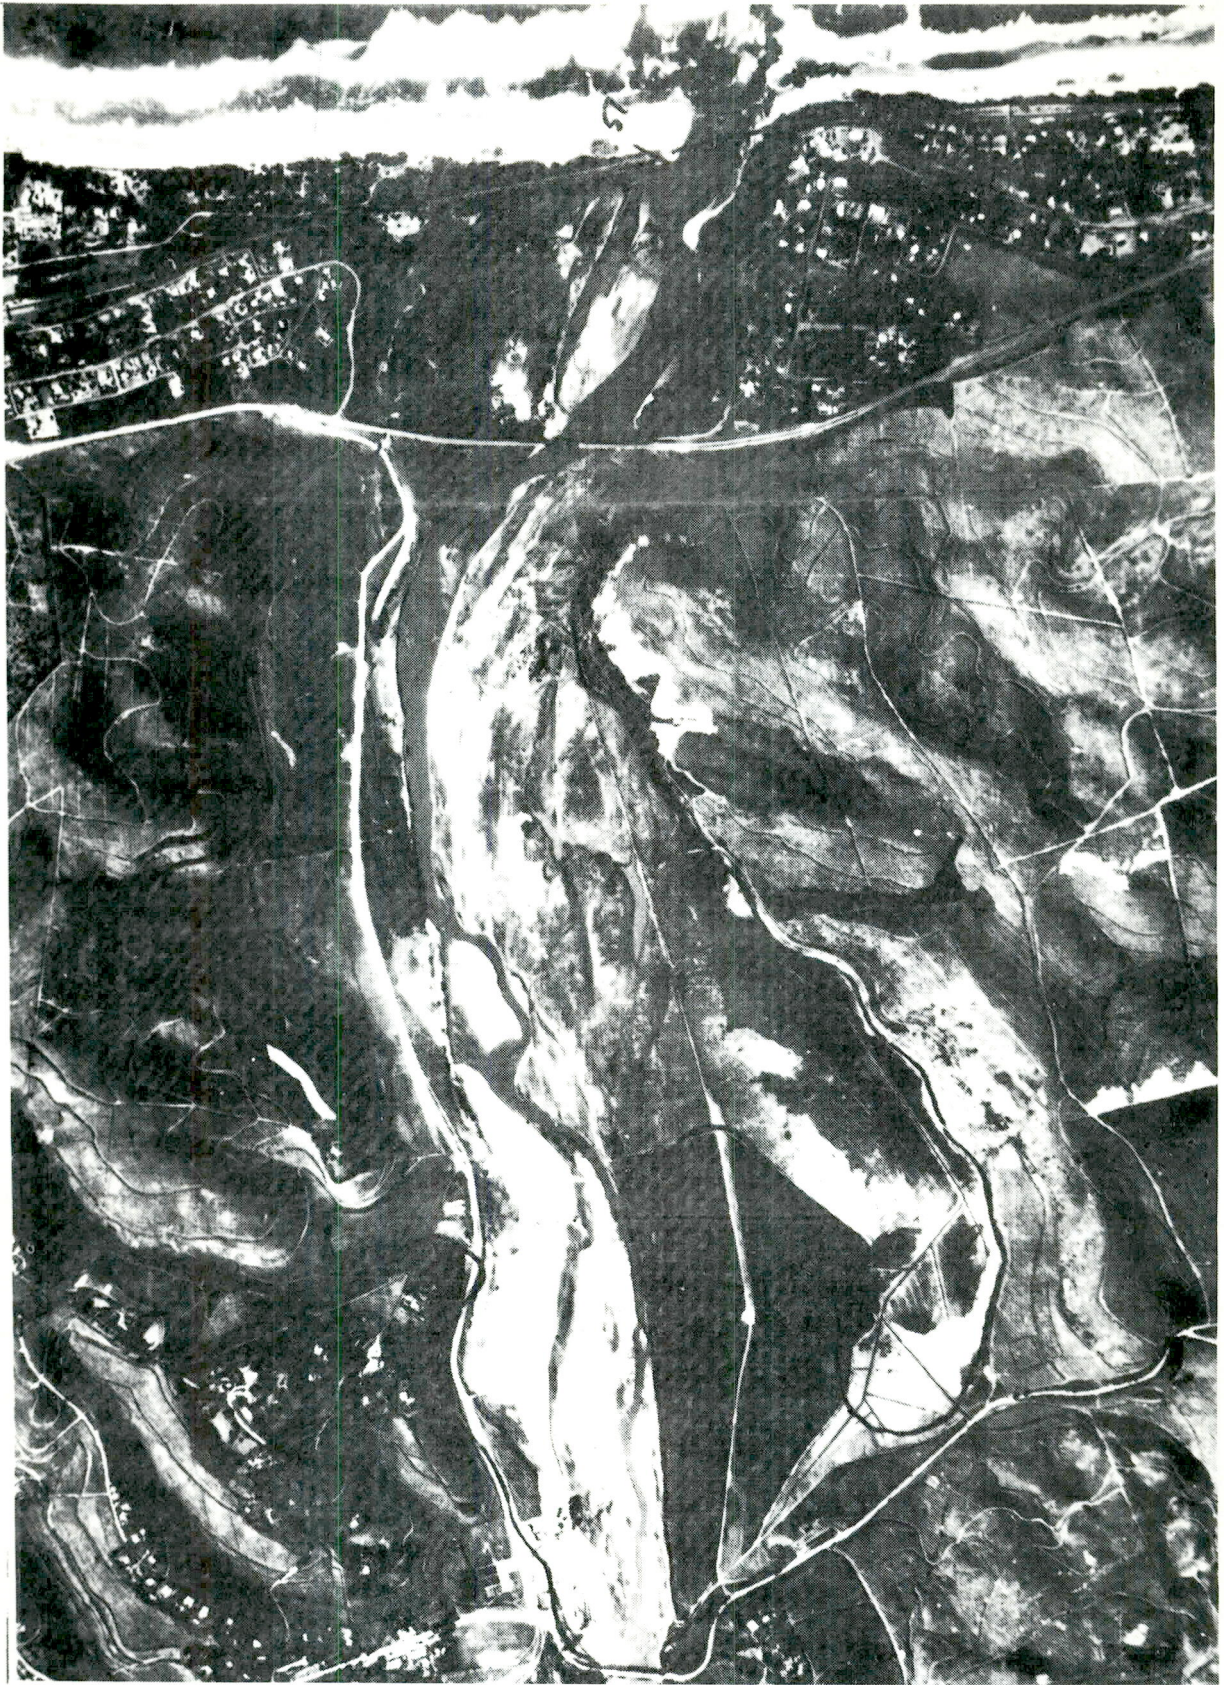
NS47/4

26-5-59

RIVER LOU, 24 % ESTUARINE, REACH from Sugar Mill Br to Mouth, km from mouth. REF. DEA U700d
 AERIAL PHOTO DATE 26-5-59 SCALE 1:10 000 CATCHMENT AREA 938 km², M.A.R. 115 m³x10⁶, No. of DAMS NIL

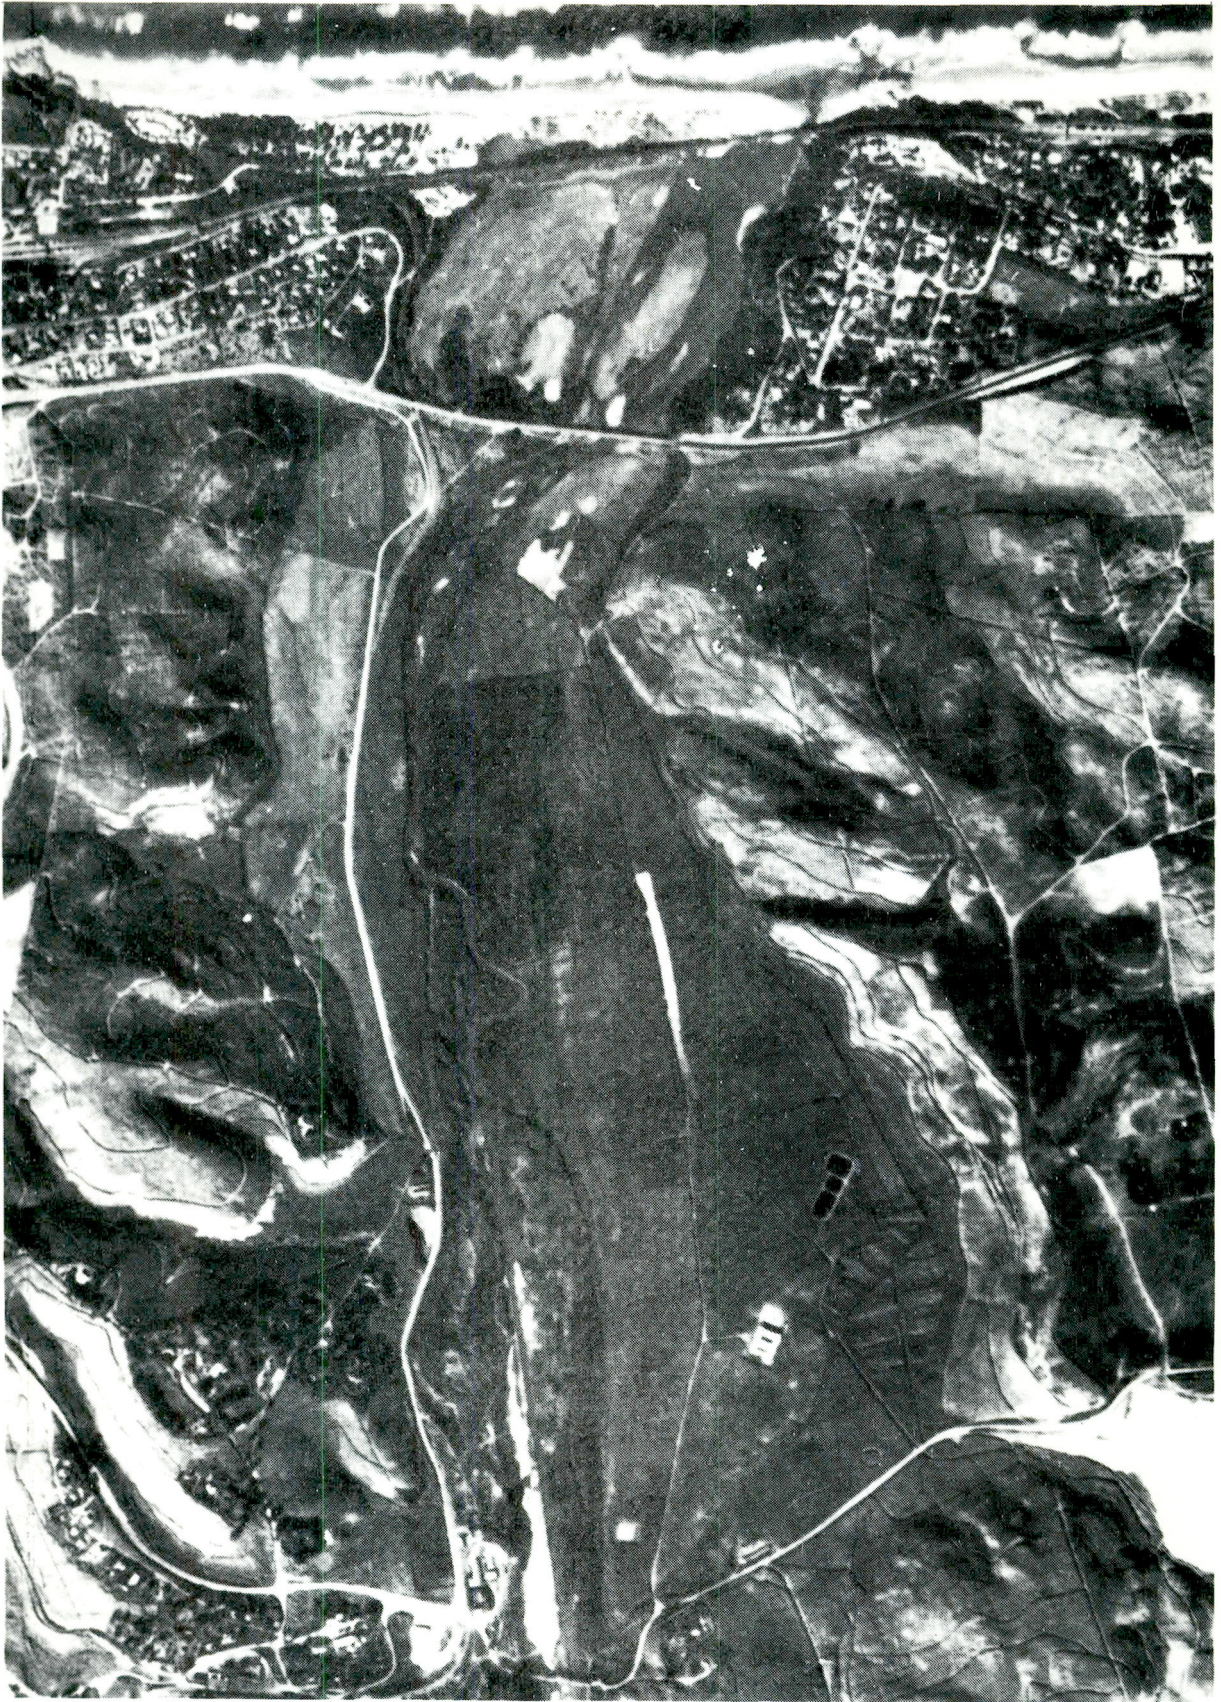
NS47/5

17-6-67

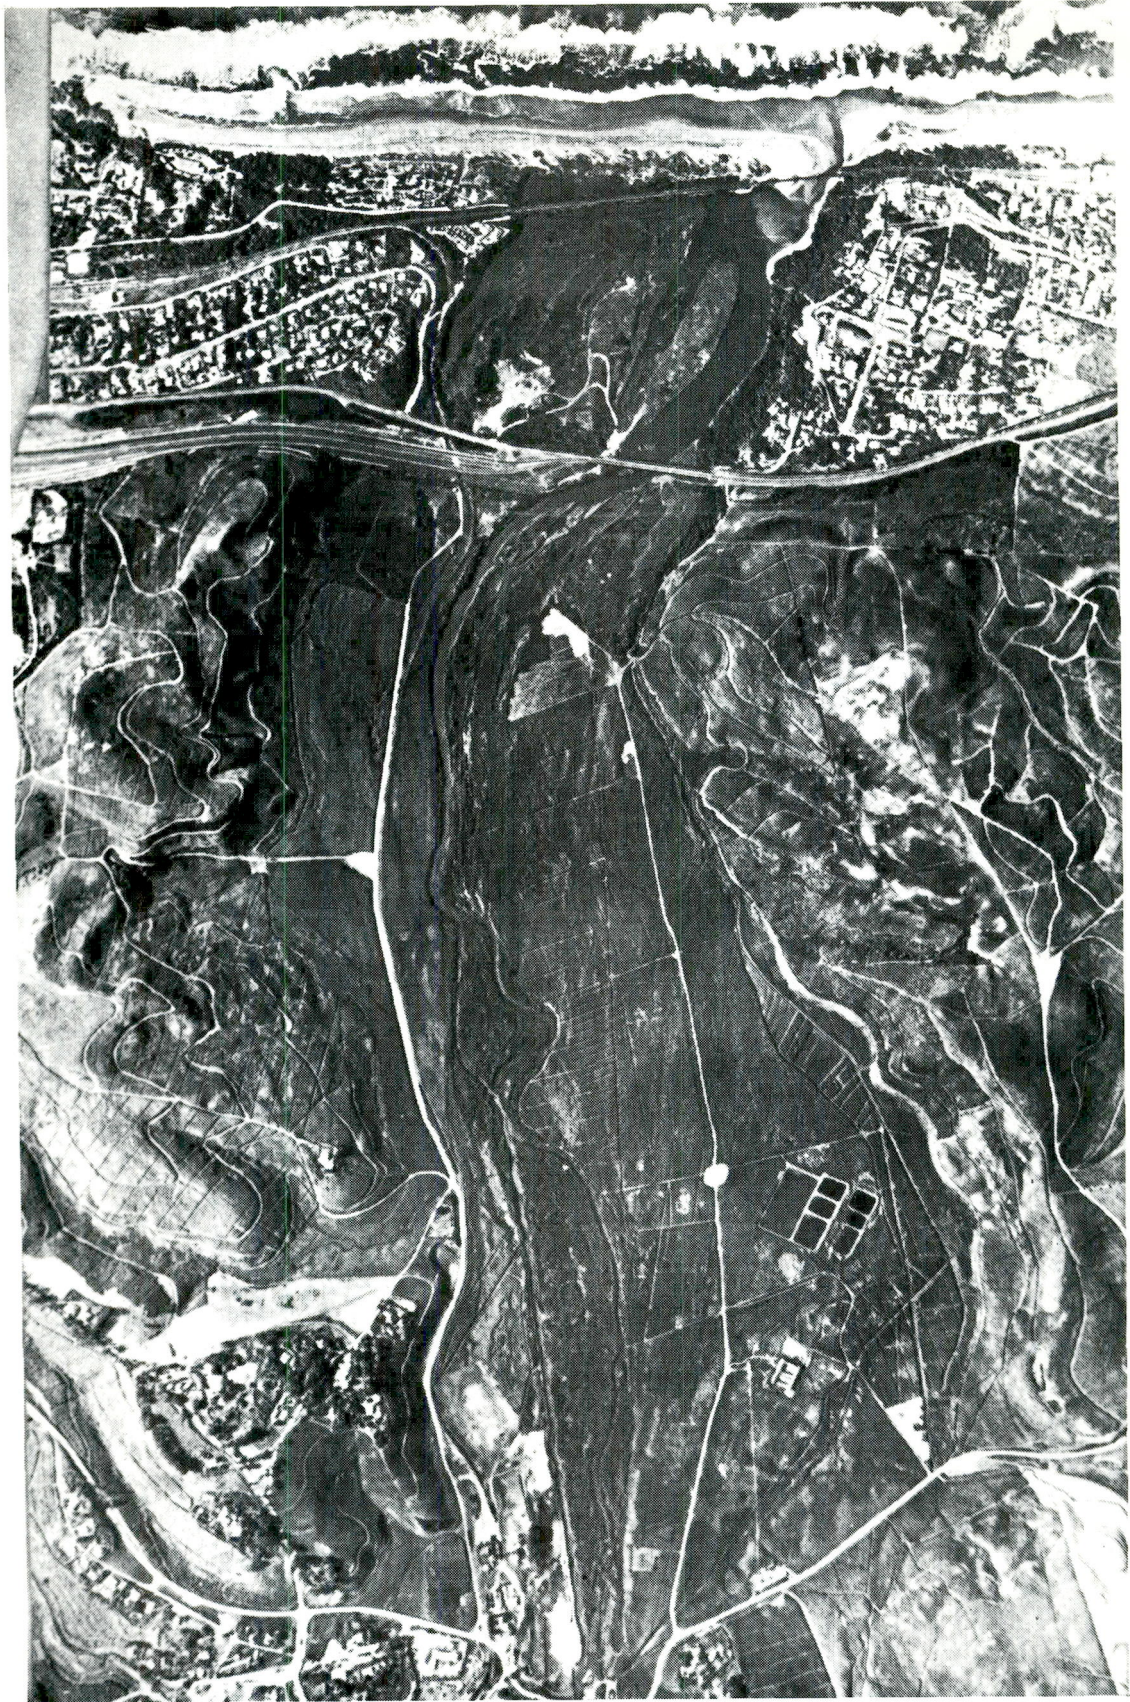
NS47/6

2-6-73

RIVER LOUVU, 24 % ESTUARINE, REACH from Sugar Mill BR to Mouth, km from mouth. REF. DEA U700d
 AERIAL PHOTO DATE 2-6-73 SCALE 1:10 000 CATCHMENT AREA 938 km², M.A.R. 115 m³x10⁶, No. of DAMS NIL

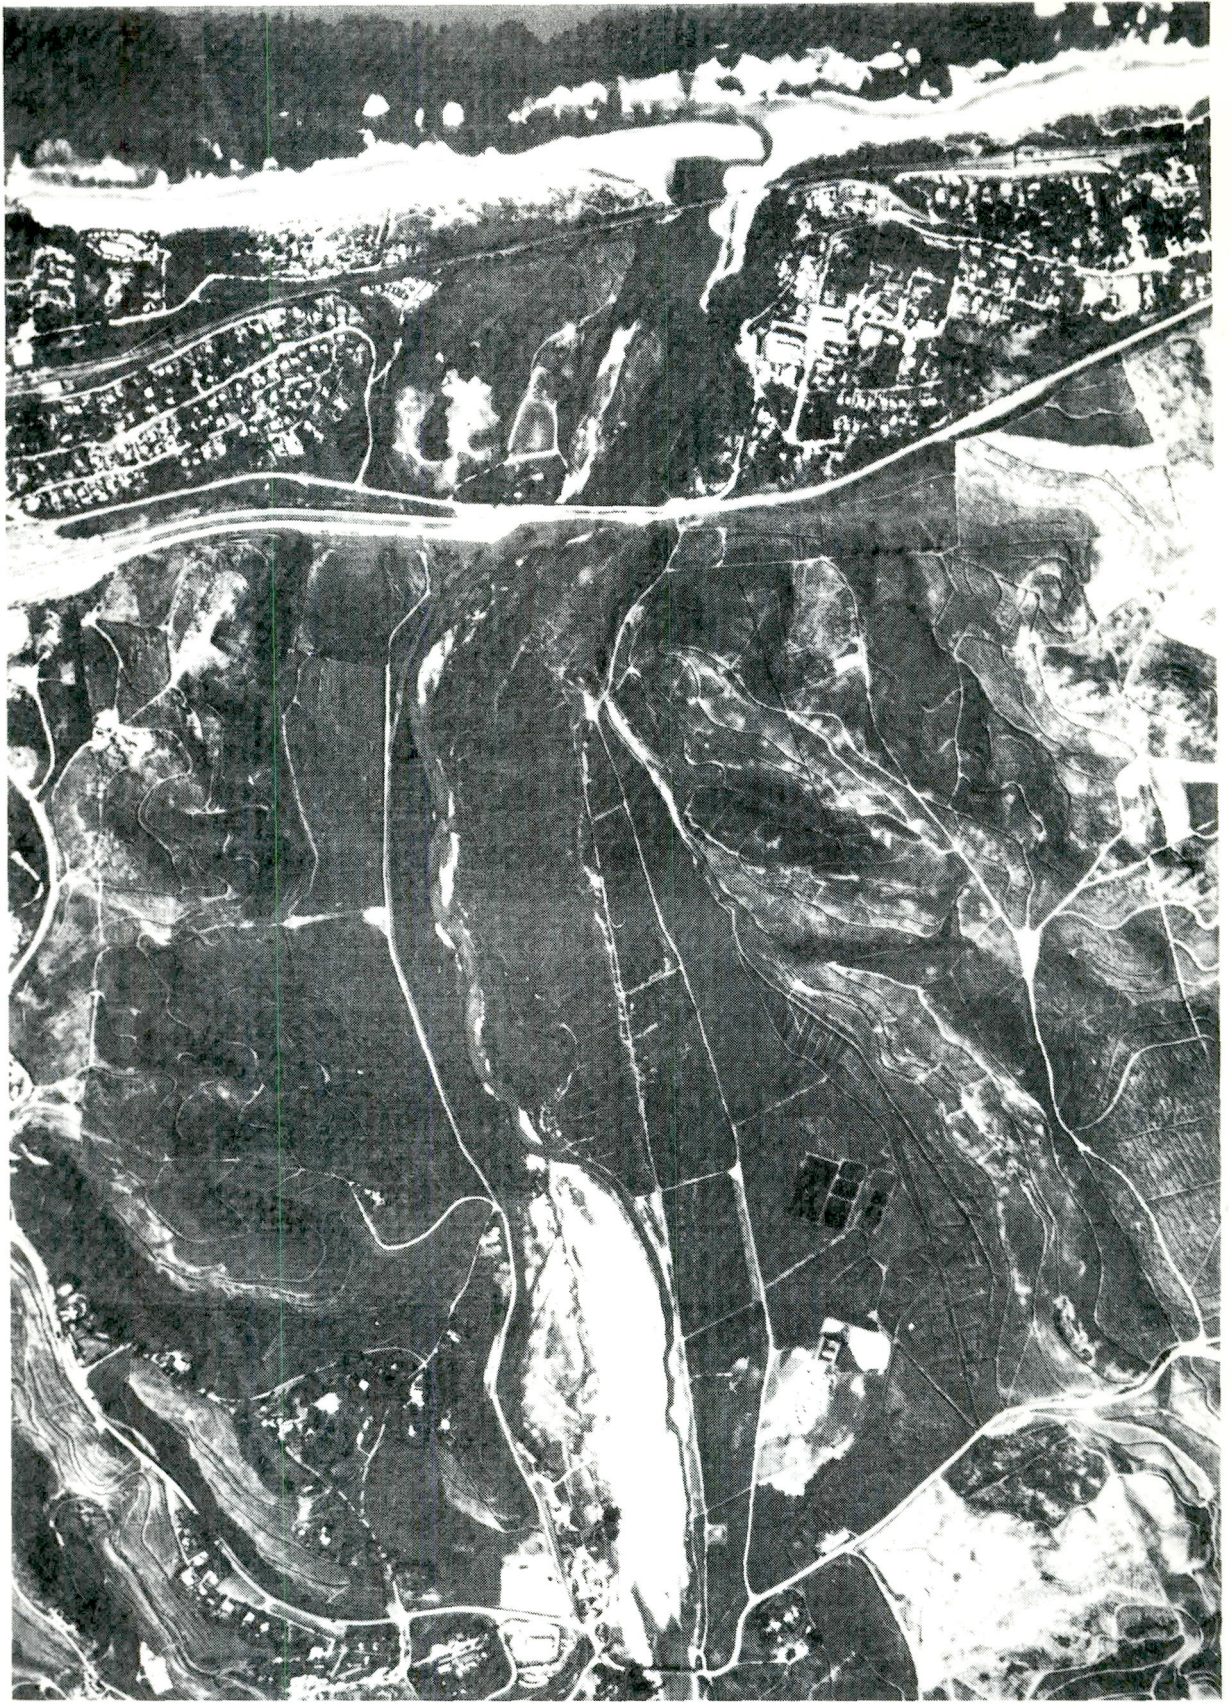
NS47/7

12-6-76
