HYDROLOGICAL / HYDRAULIC STUDY
OF NATAL ESTUARIES

DATA REPORT No. 8

TONGATI NN 4

June 1982

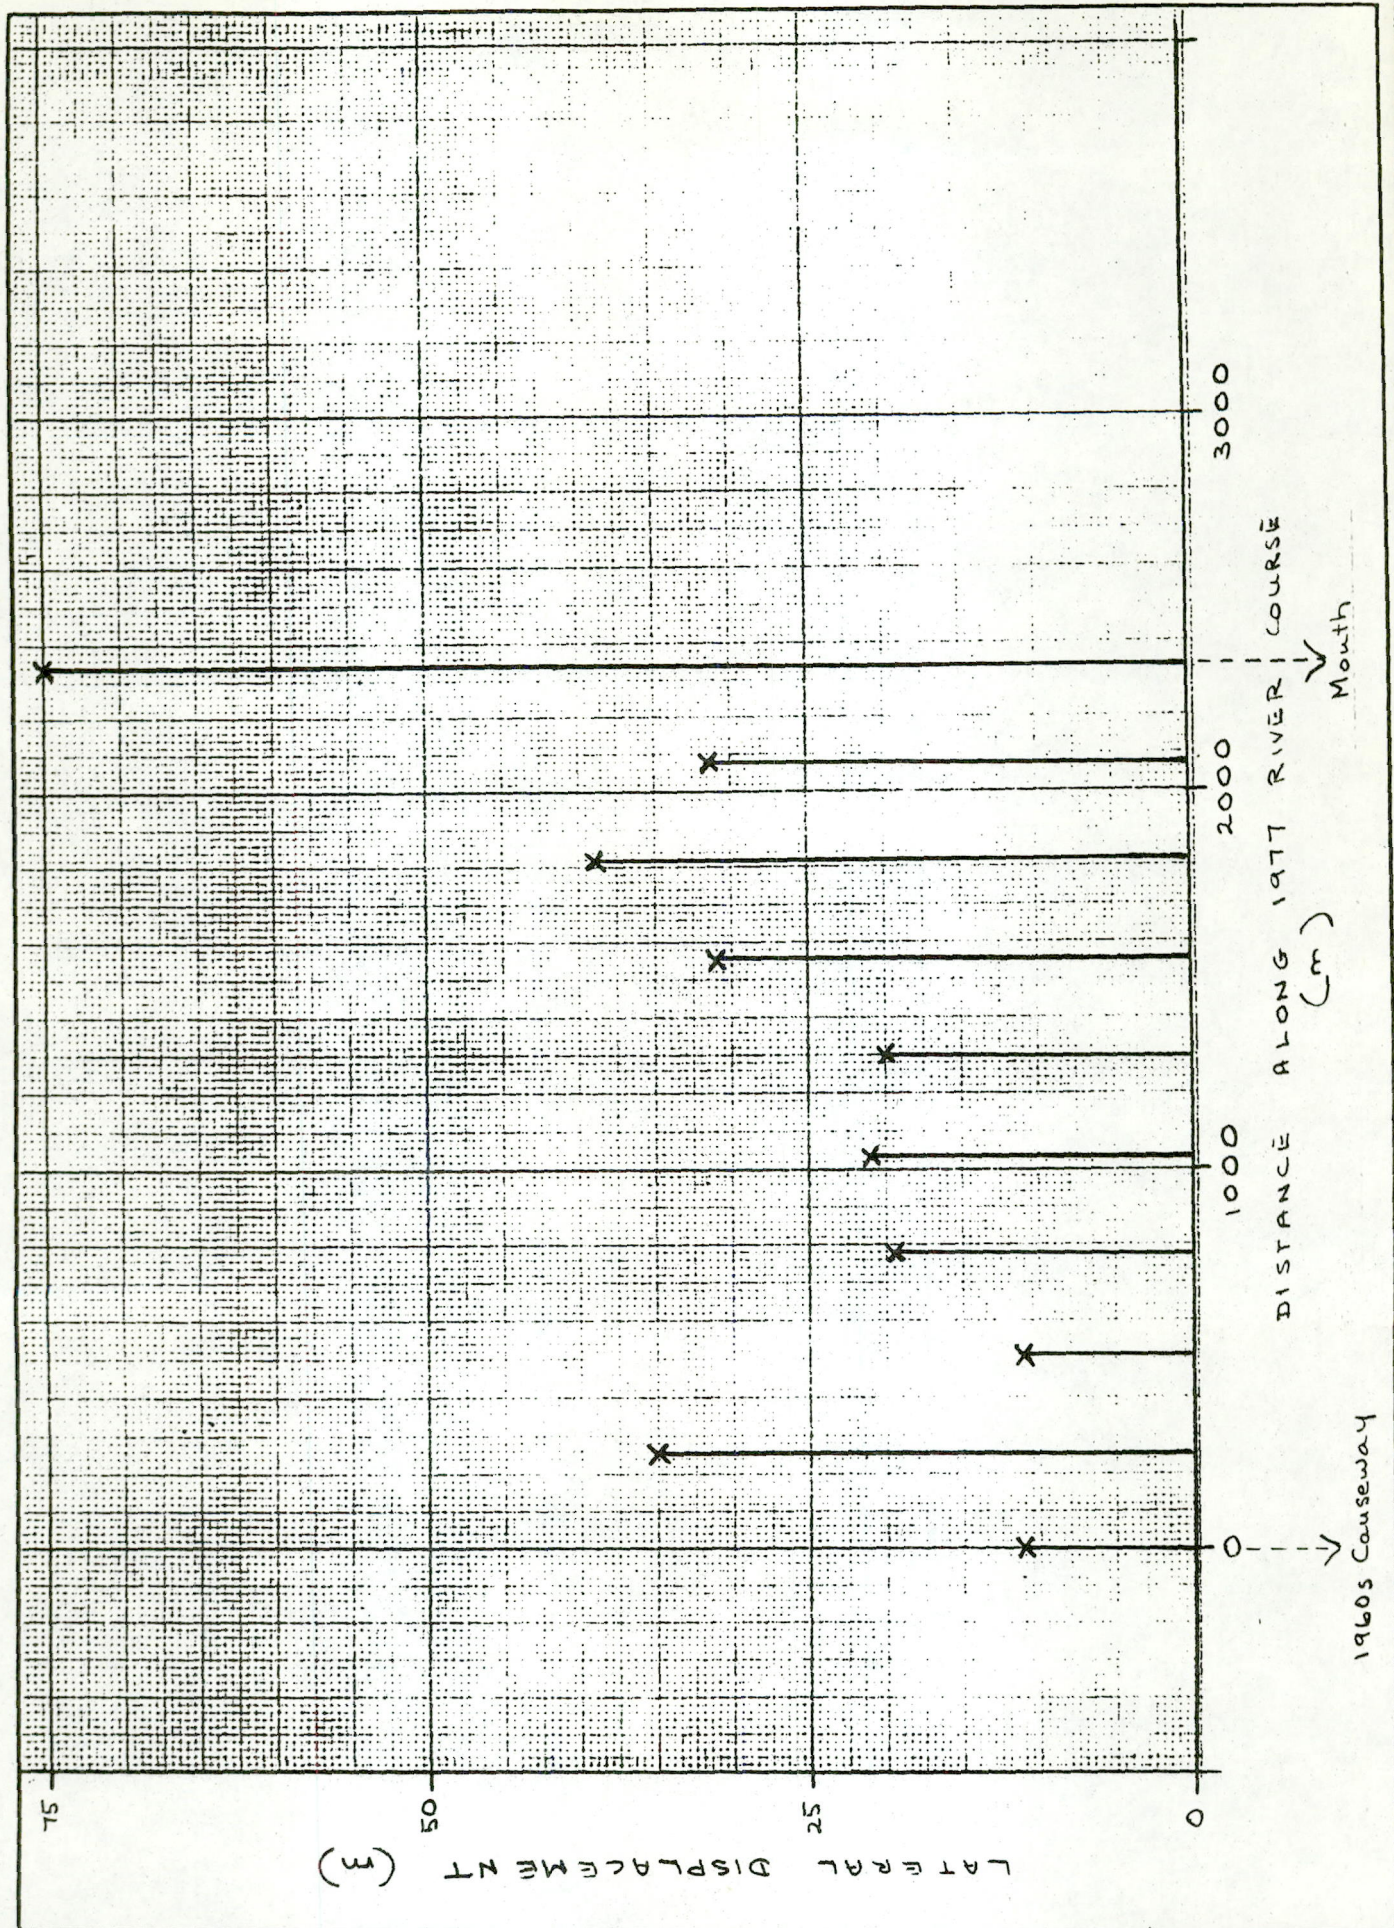
FIGURE
 NN 4 / 1

NATAL ESTUARIES: TONGATI
 THALWEG DISPLACEMENT: 1937-77

The Tongati estuary is silting up and is unstable. The instability is indicated by an average lateral displacement of 29,7 m with a coefficient of variation of 34,8% - both of which are high for a river of this size.

Average lateral displacement 1937 - 77 = 29,7 m
 Average coefficient of variation 1937 - 1977 = 34,8%

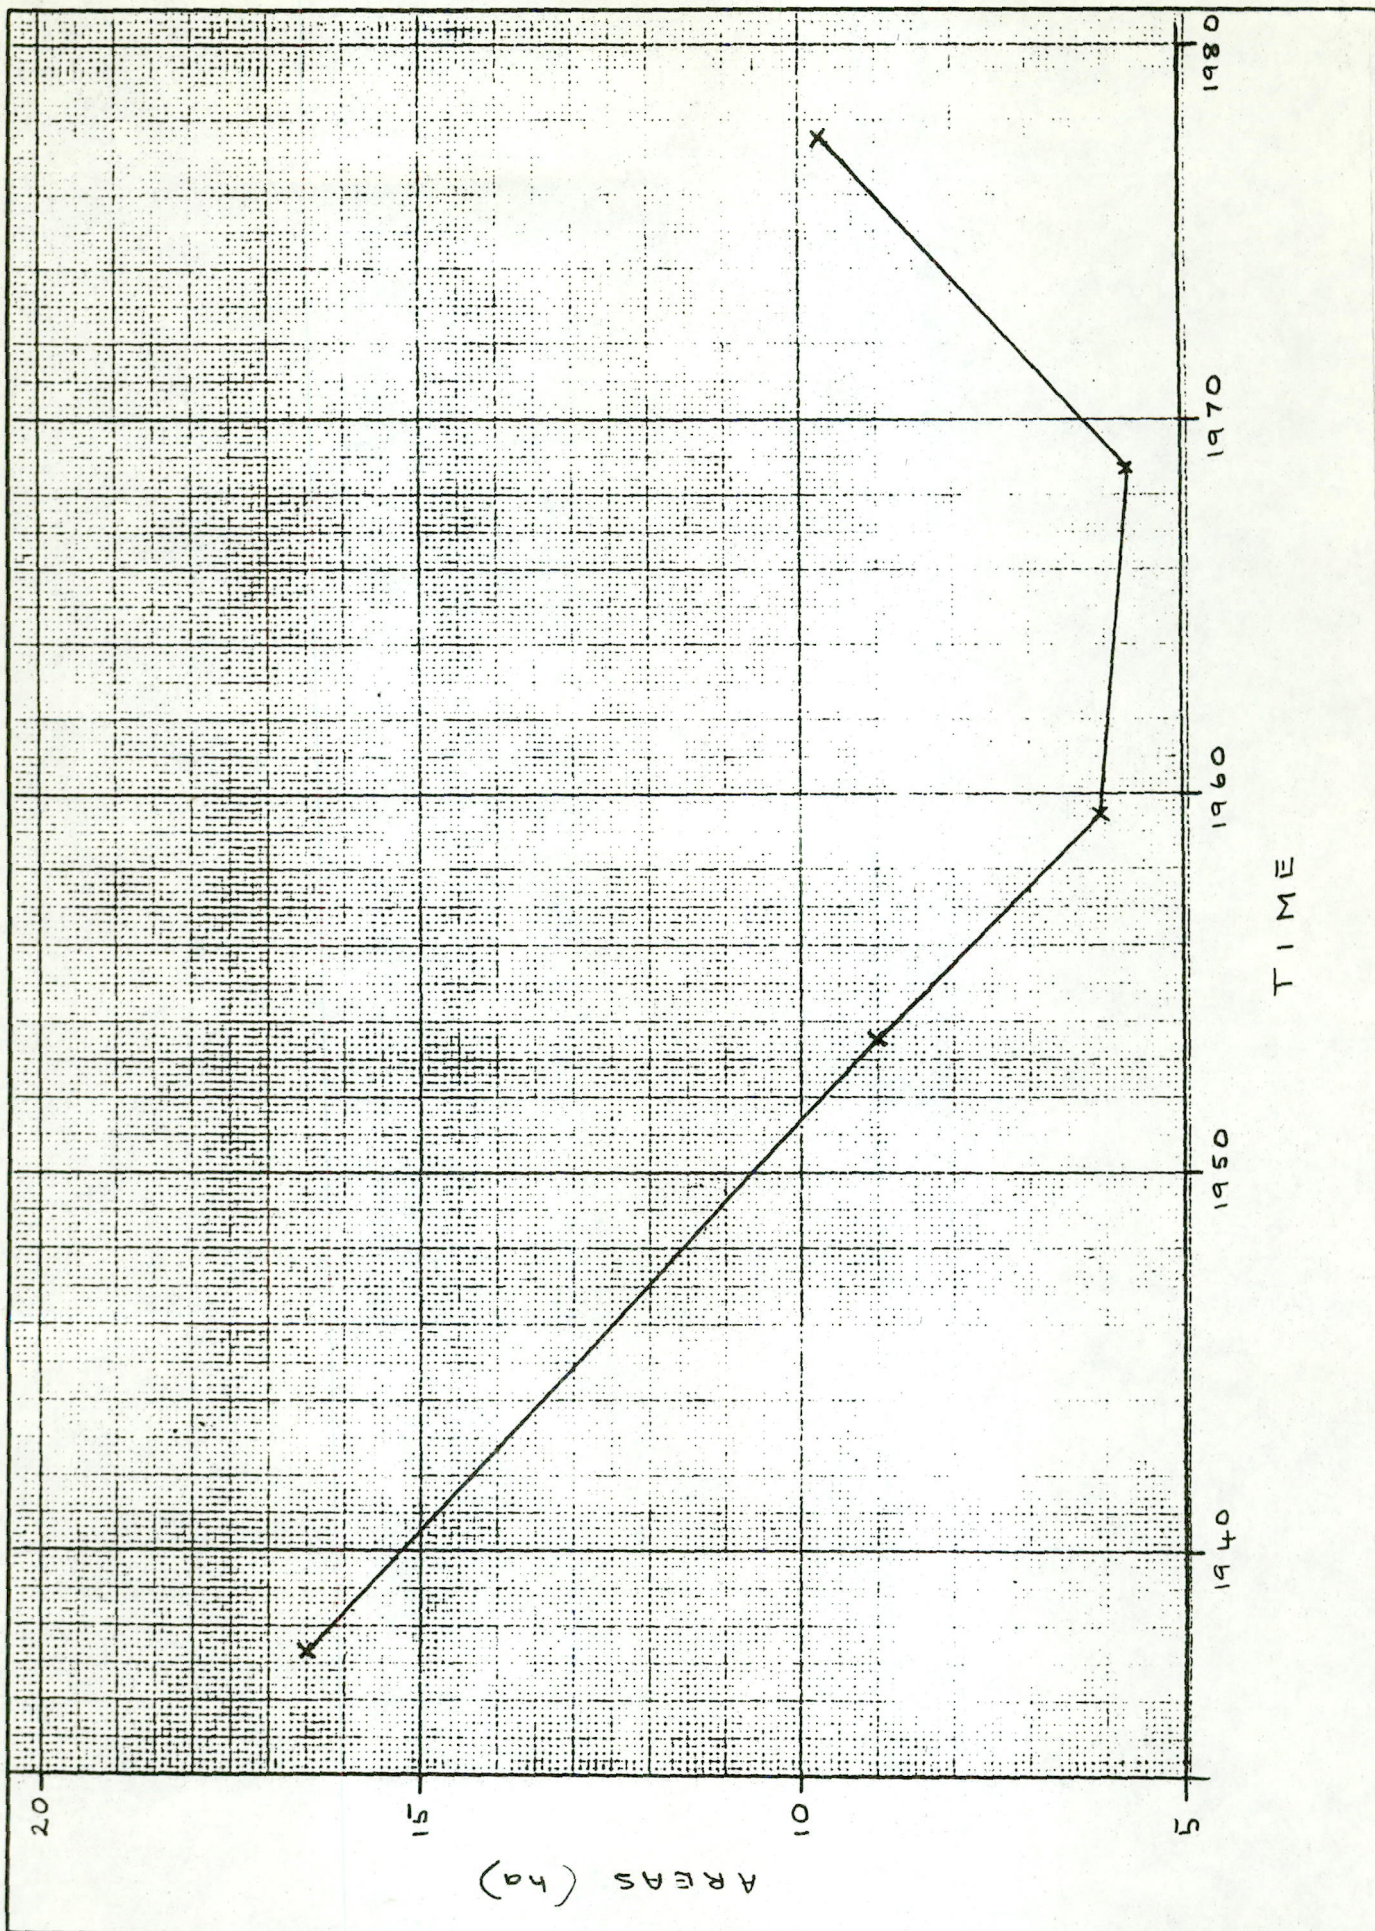
FIGURE
 NN 4 / 2

NATAL ESTUARIES: TONGATI

OPEN WATER AREAS: 1937-77

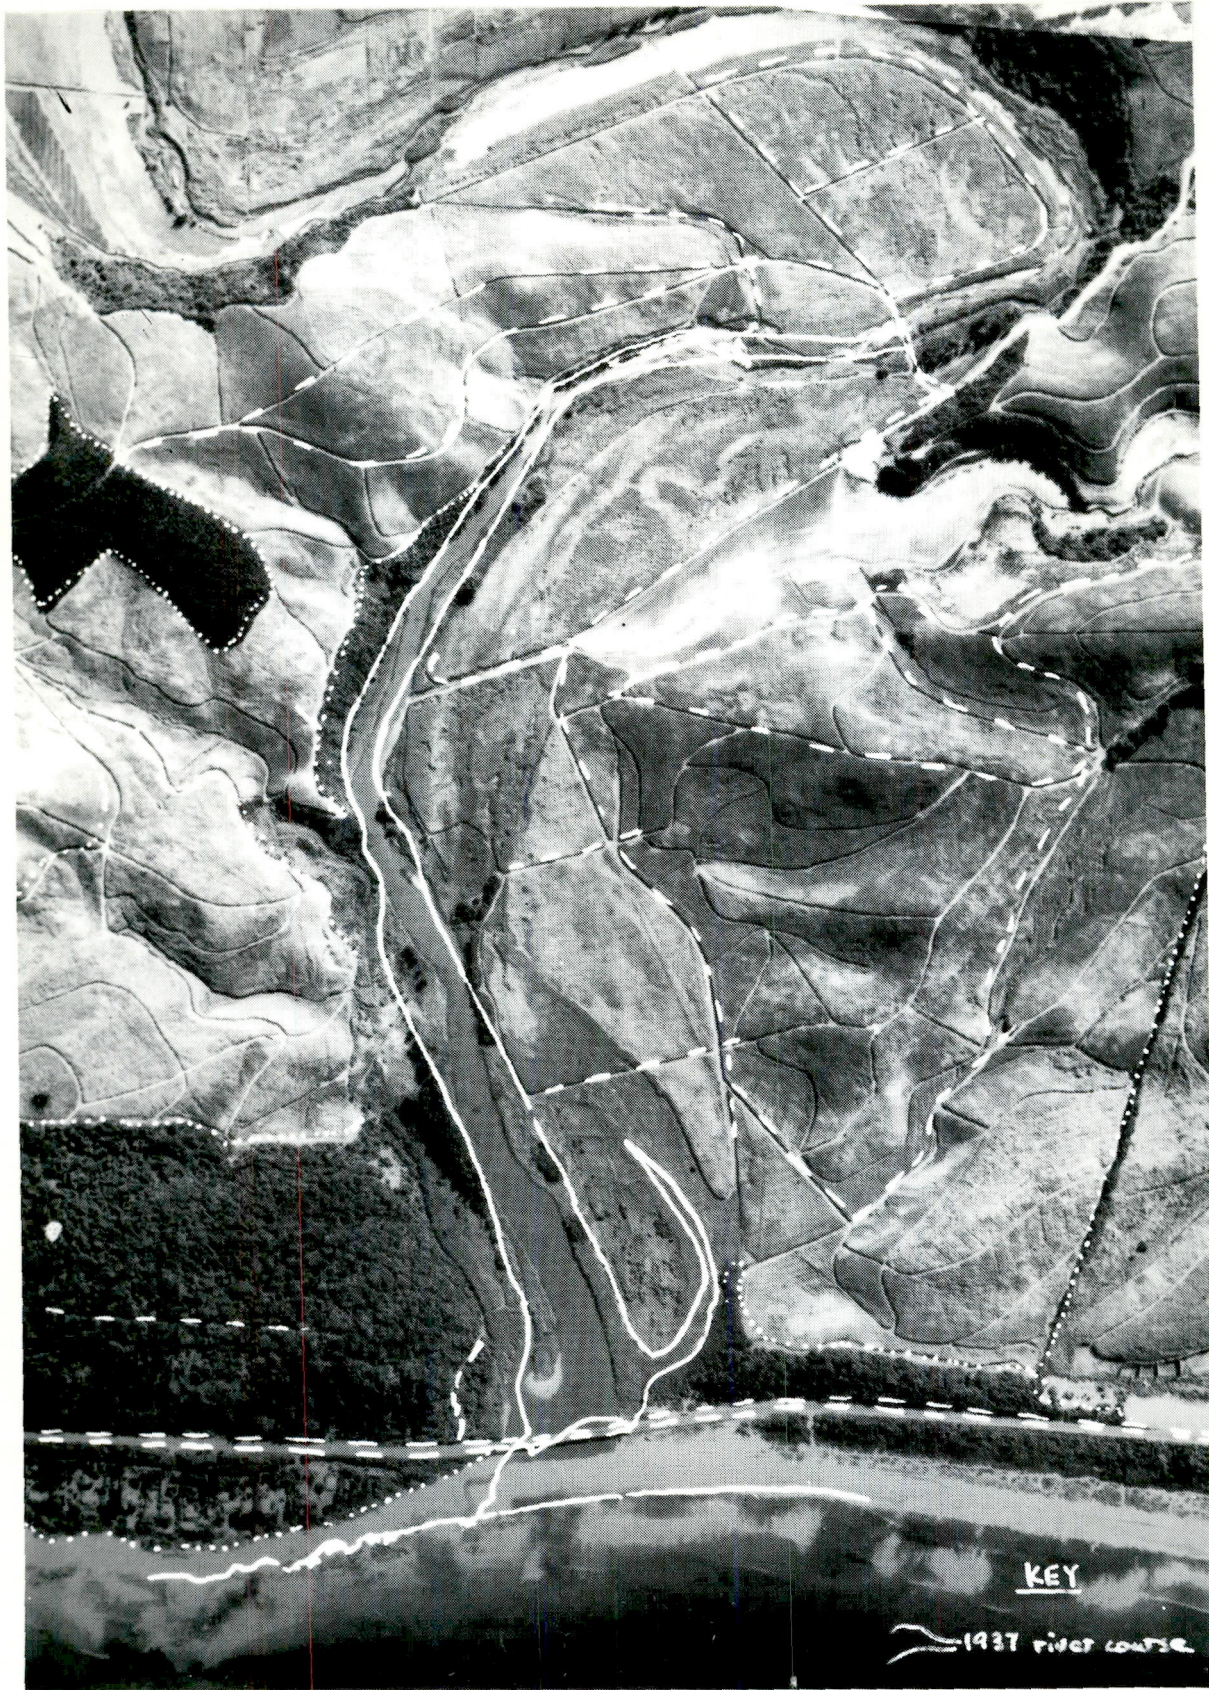
NN 4 / 1

23-6-77 (30-4-37 RIVER COURSE SUPERIMPOSED)

Details of the classification of the lower reaches of the Tongati river for 1937, 1953, 1959, 1968 and 1977 are given in Tables NN4/I - V. Details of river widths and lateral stability appear in Tables NN4/VI and VII and an abstract of results in Table NN4/VIII. Thalweg displacement and open water areas are shown in Figures NN4/1 and 2. Photograph NN4/1 shows the 1937 river course superimposed on a 1977 photograph from the orthophoto series and Photographs NN4/2 - 6 show the river courses for the five years used for classification purposes.

RIVER TONGATI, 47 % ESTUARINE, REACH from ^{1960's} causeway to Mouth, 2.4 km from mouth. REF. DEA U 302a
 AERIAL PHOTO DATE 23-6-77 SCALE 1:10 000 CATCHMENT AREA 412 km², M.A.R. 88.7 m³x10⁶, No. of DAMS 2
 (orthophoto)

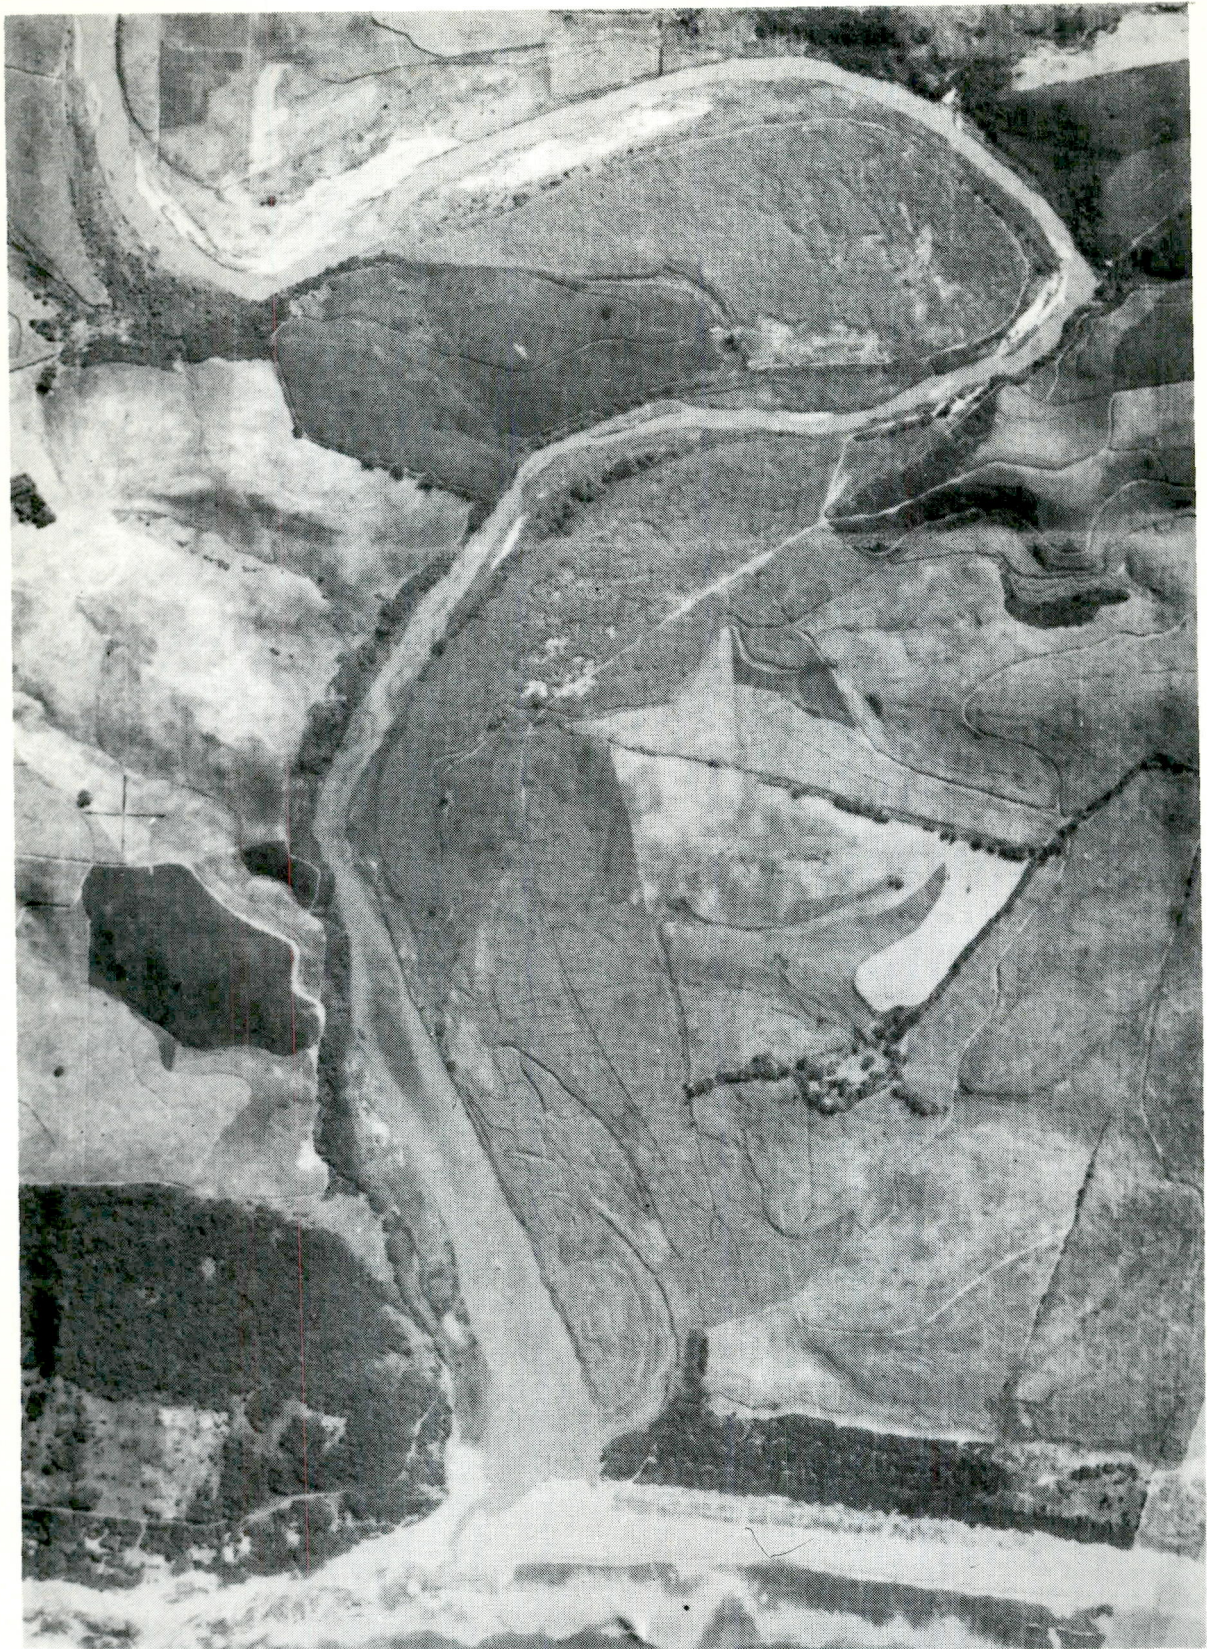
NN 4 / 2

30 - 4 - 37

RIVER TONGATI, 47 % ESTUARINE, REACH from ^{1960's} causeway to Mouth, 2.4 km from mouth. REF. DEA 1302a
 AERIAL PHOTO DATE 30-4-37 SCALE 1:10 000 CATCHMENT AREA 4.12 km², M.A.R. 88.7 m³x10⁶, No. of DAMS 2

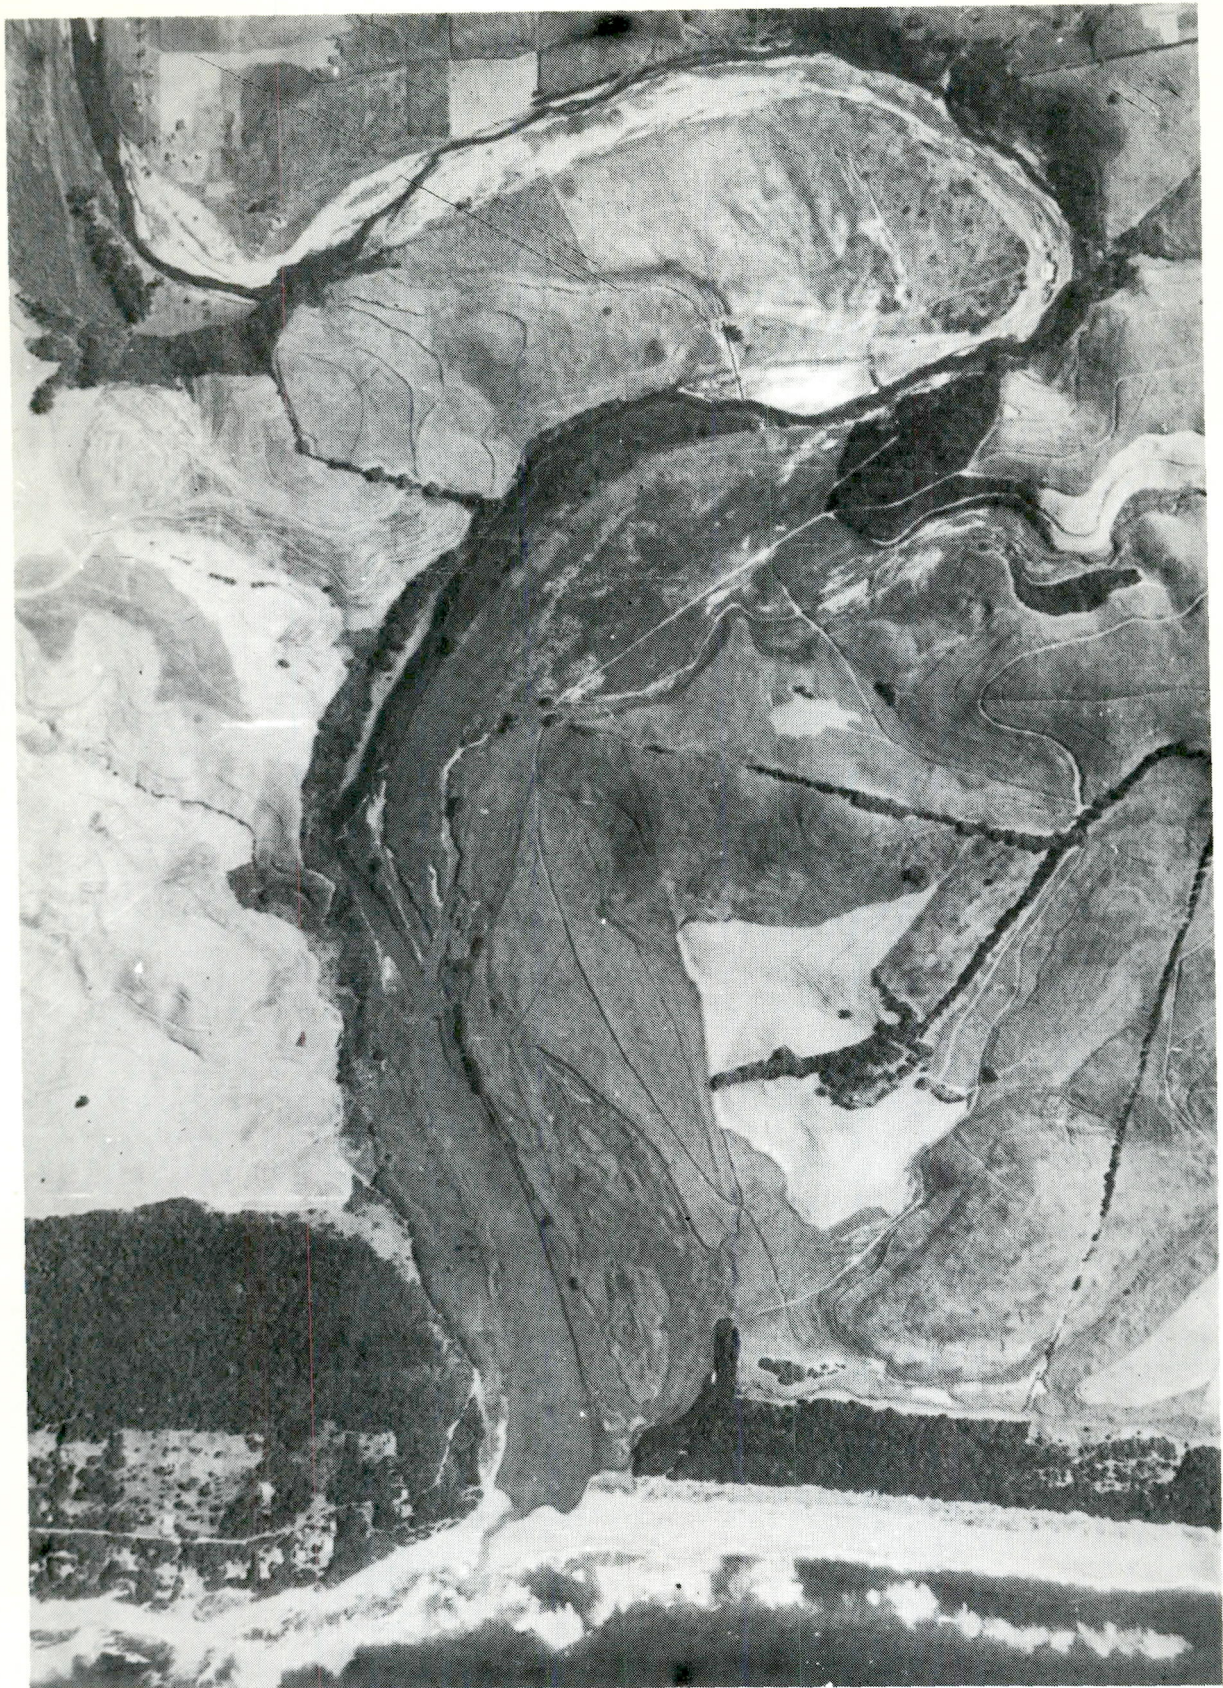
NN 4 / 3

JULY / AUGUST 1953

RIVER TONGATI, 47 % ESTUARINE, REACH from ^{1960's} causeway to Mouth, 2.4 km from mouth. REF. DEA U 302 a
 AERIAL PHOTO DATE July/Aug '53 SCALE 1:10 000 CATCHMENT AREA 412 km², M.A.R. 88.7 m³x10⁶, No. of DAMS 2

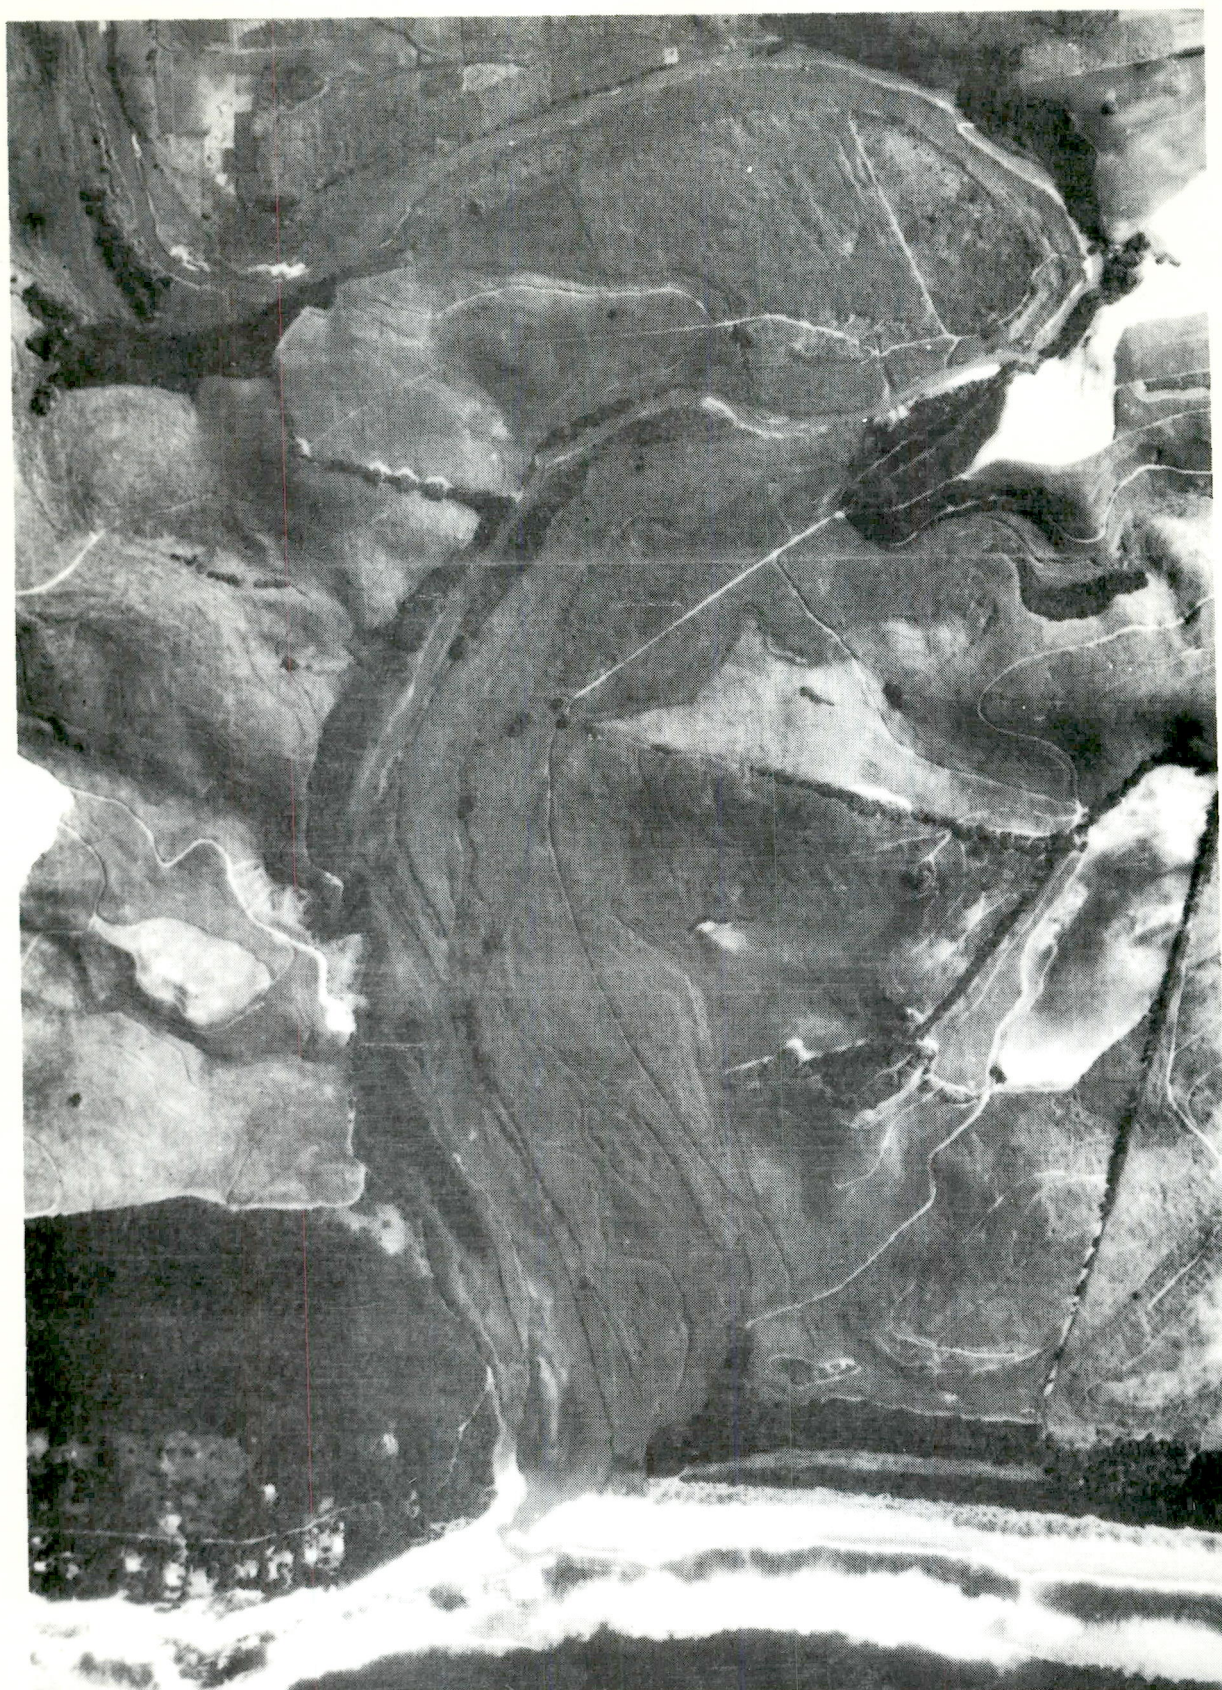
NN 4/4

6 - 6 - 59

RIVER TONGATI, 47 % ESTUARINE, REACH from ^{1960's} causeway to Mouth, 2.4 km from mouth. REF. DEA 4302a
 AERIAL PHOTO DATE 6-6-59 SCALE 1:10 000 CATCHMENT AREA 412 km², M.A.R. 88.7 m³x10⁶, No. of DAMS 2

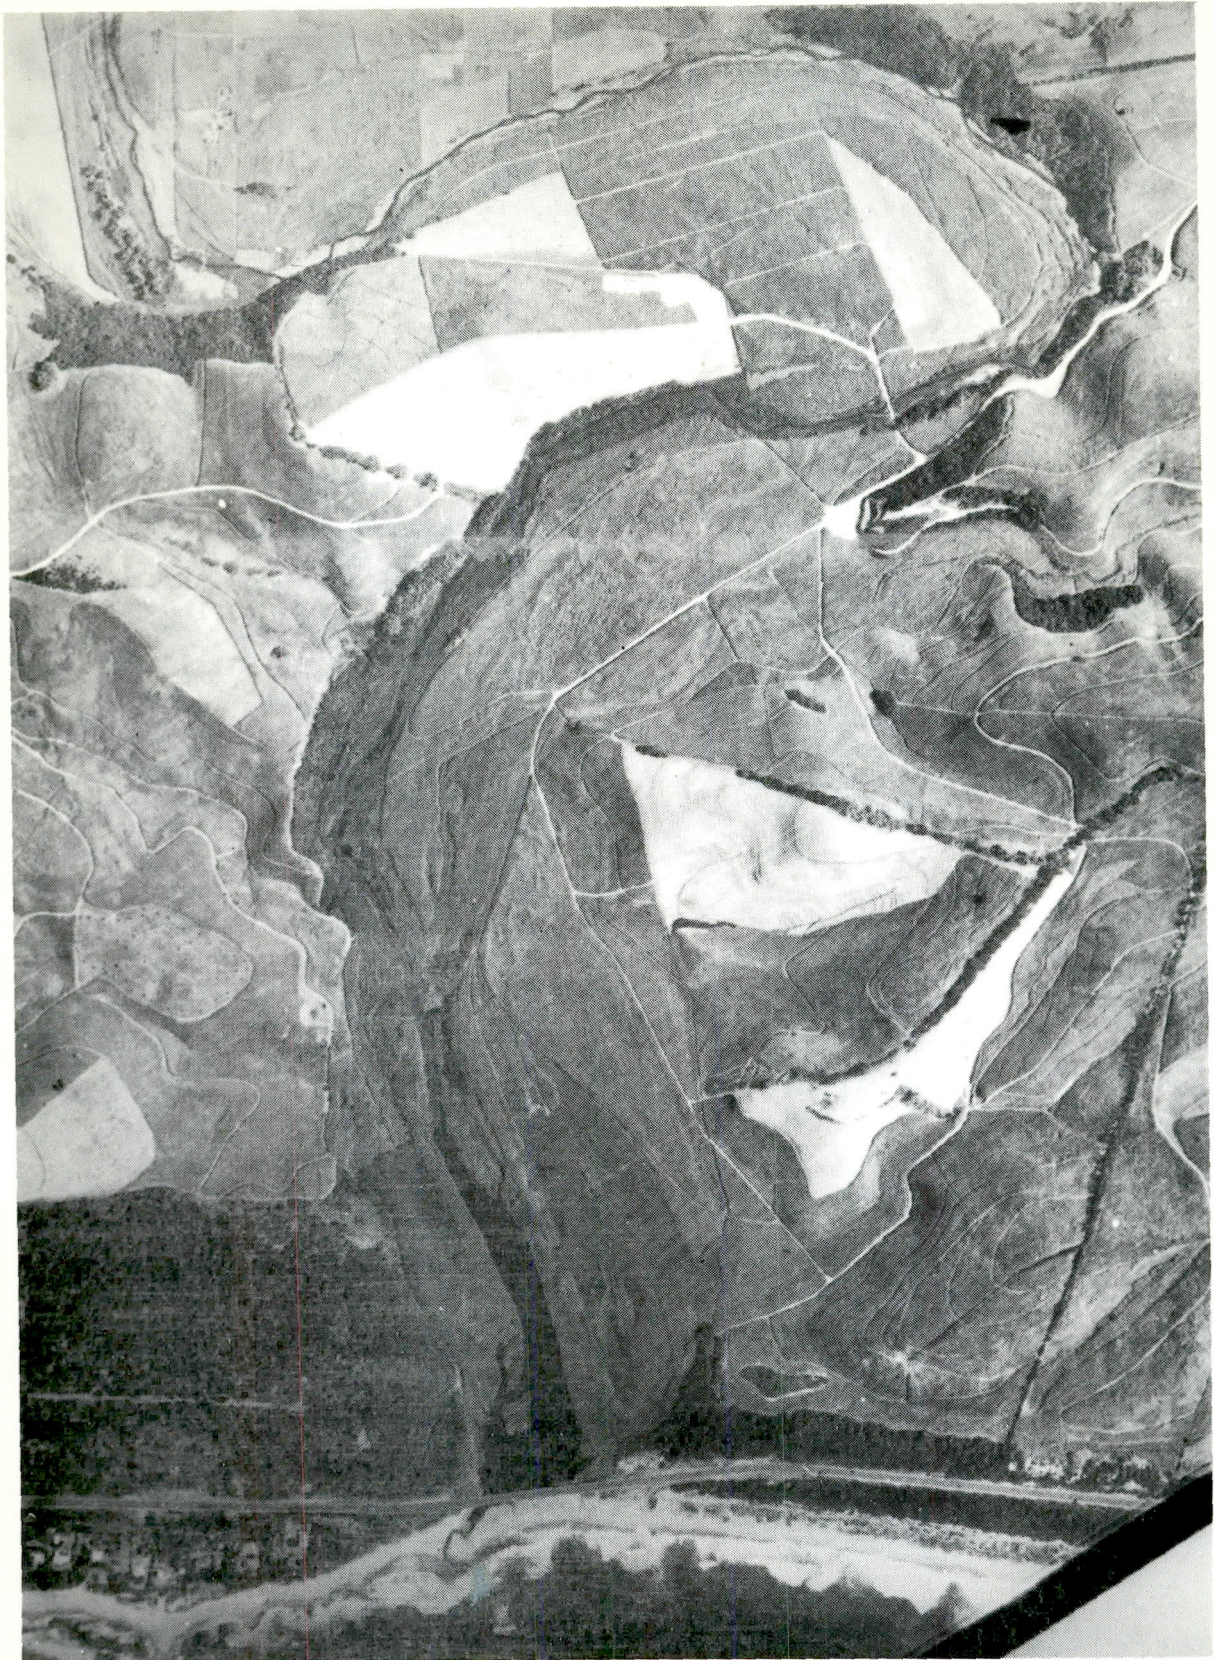
NN 4 / 5

2 - 8 - 68

RIVER TONGATI, 47 % ESTUARINE, REACH from ^{1960's} causeway to Mouth, 2.4 km from mouth. REF. DEA U 302 a
 AERIAL PHOTO DATE 2-8-68 SCALE 1:10 000 CATCHMENT AREA 4.2 km², M.A.R. 88.7 m²x10⁶, No. of DAMS 2

Comments ? water hyacinth covering upper 2/3 reach

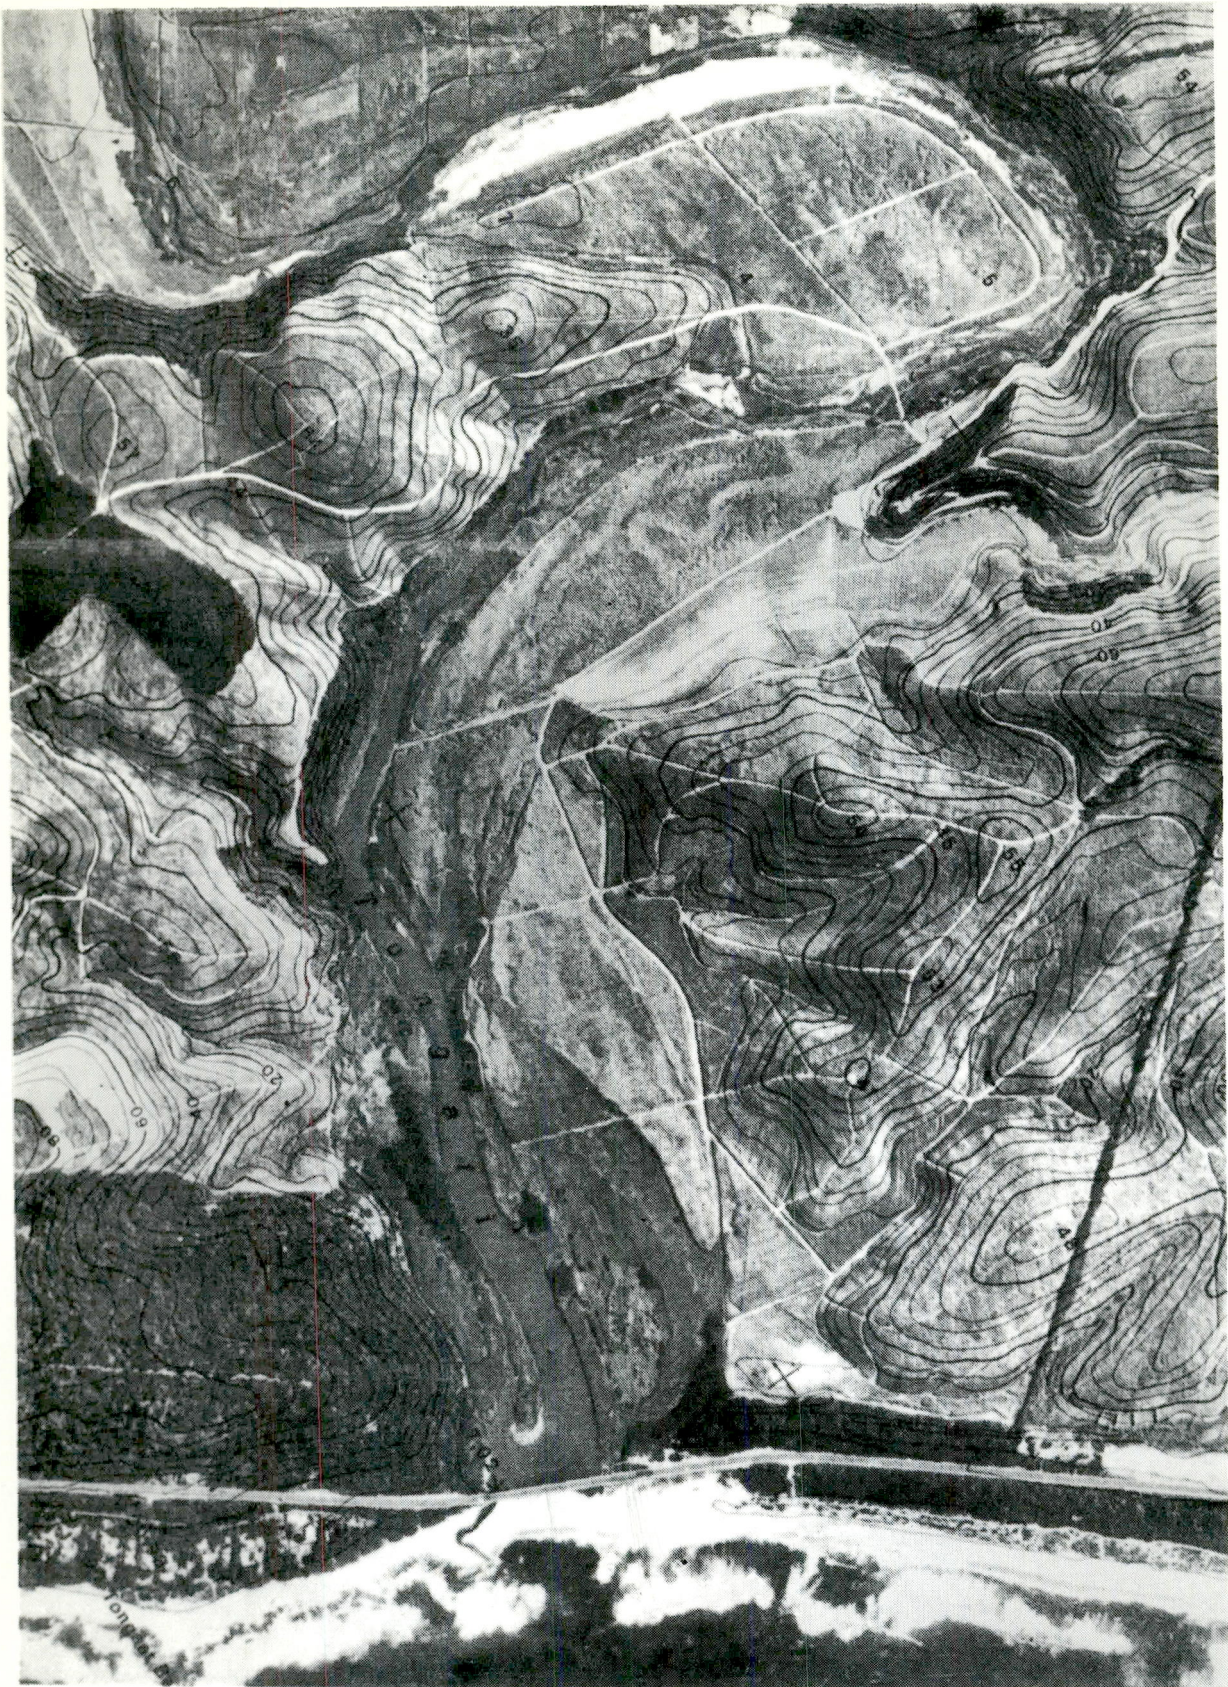
NN 4/6

23-6-77 (ORTHOPHOTO)
