Author BRACHER P R KOVACS Z P

Title CROSS-SECTION CHANGES IN THE MFOLOZI RIVERS: EROSION
AND SEDIMENTATION

Source 1985 UNPUBLISHED REPORT. DEPT. OF WATER AFFAIRS

P.R. Bracher and Z.P. Kovács
Department of Water Affairs 1985.

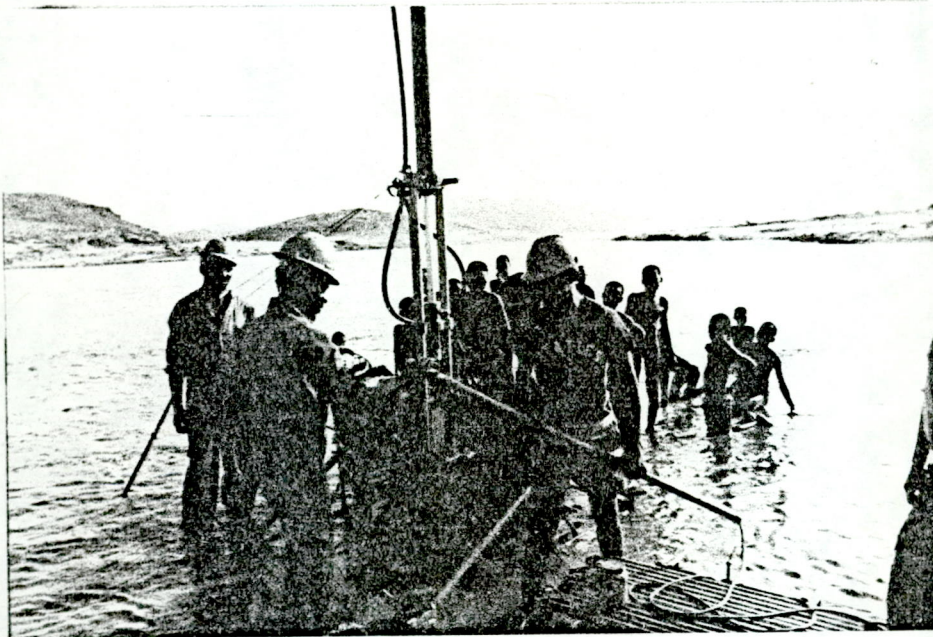
14. CUPT PROBE

This is the deepest profile which was scoured during the Domoina flood. It was determined only in the Mfolozi River, in sections 3 and 4 at Site 3. The method employed was the Piezometer Cone Penetration Testing (CUPT) developed by Jones and Rust (2). The piezometer used in the CUPT testing is similar to the standard 35 mm diameter electrical cone but in addition has a pore pressure sensor. This allows simultaneous measurement of penetration resistance and excess pore pressure generated during penetration.

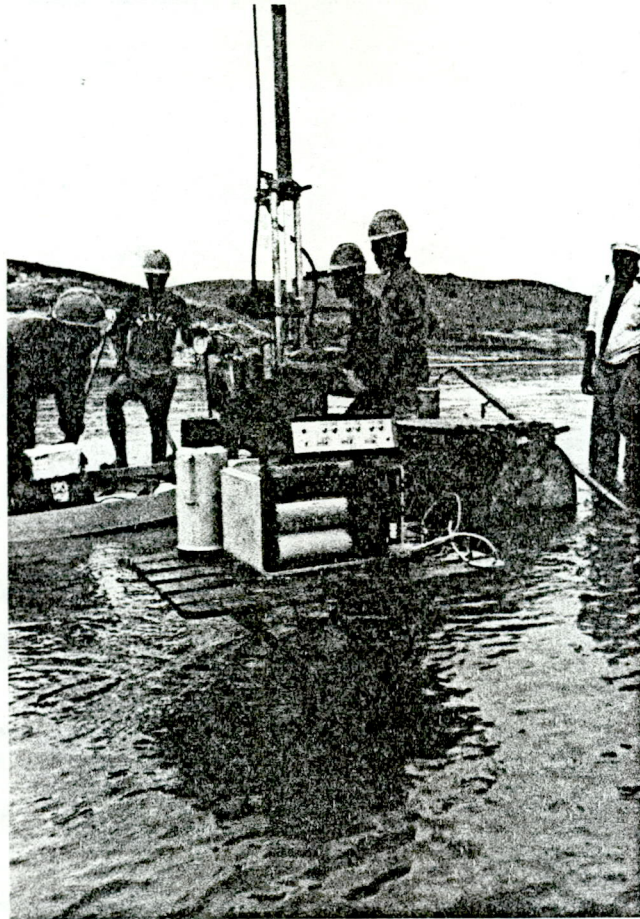
15. CUPT PROBE: VIEW OF RECORDING EQUIPMENT
