**HYDROLOGICAL/HYDRAULIC STUDY  
OF NATAL ESTUARIES**

**DATA REPORT NO. 17  
MBIZANA NS 10**

NRIO DATA REPORT 8402

Stellenbosch, South Africa  
April 1984

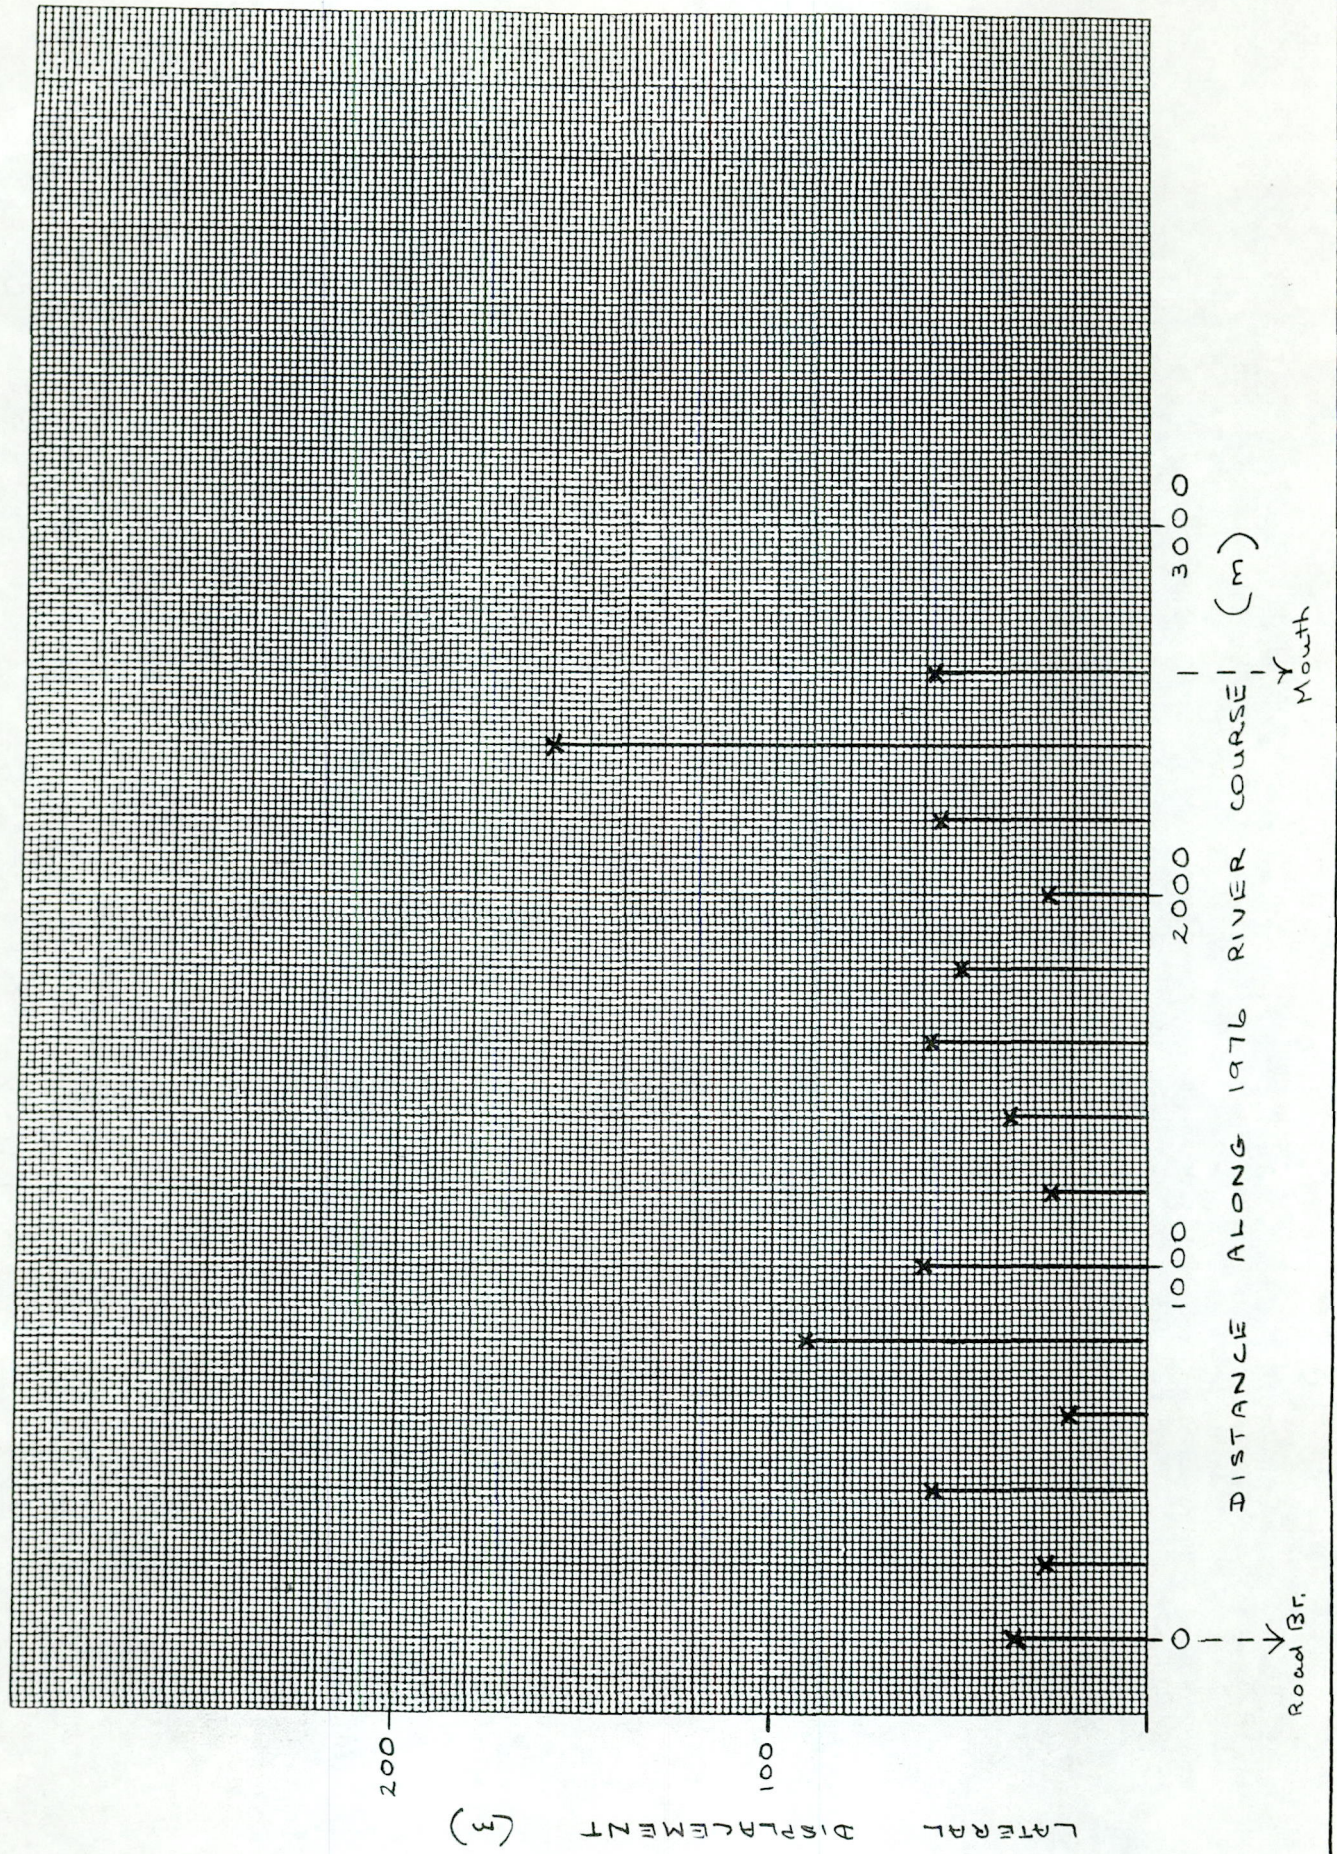
FIGURE  
 NS 10/1

NATAL ESTUARIES: MBIZANA  
**THALWEG DISPLACEMENT**  
 (1937 - 1976)

There is some geomorphological control over the river course and the flood plain is fairly narrow. Nevertheless, the course of the river shifted considerably during the period 1937 to 1976. The average lateral displacement of 54,5 m and average coefficient of variation of 37 per cent indicate unstable conditions.

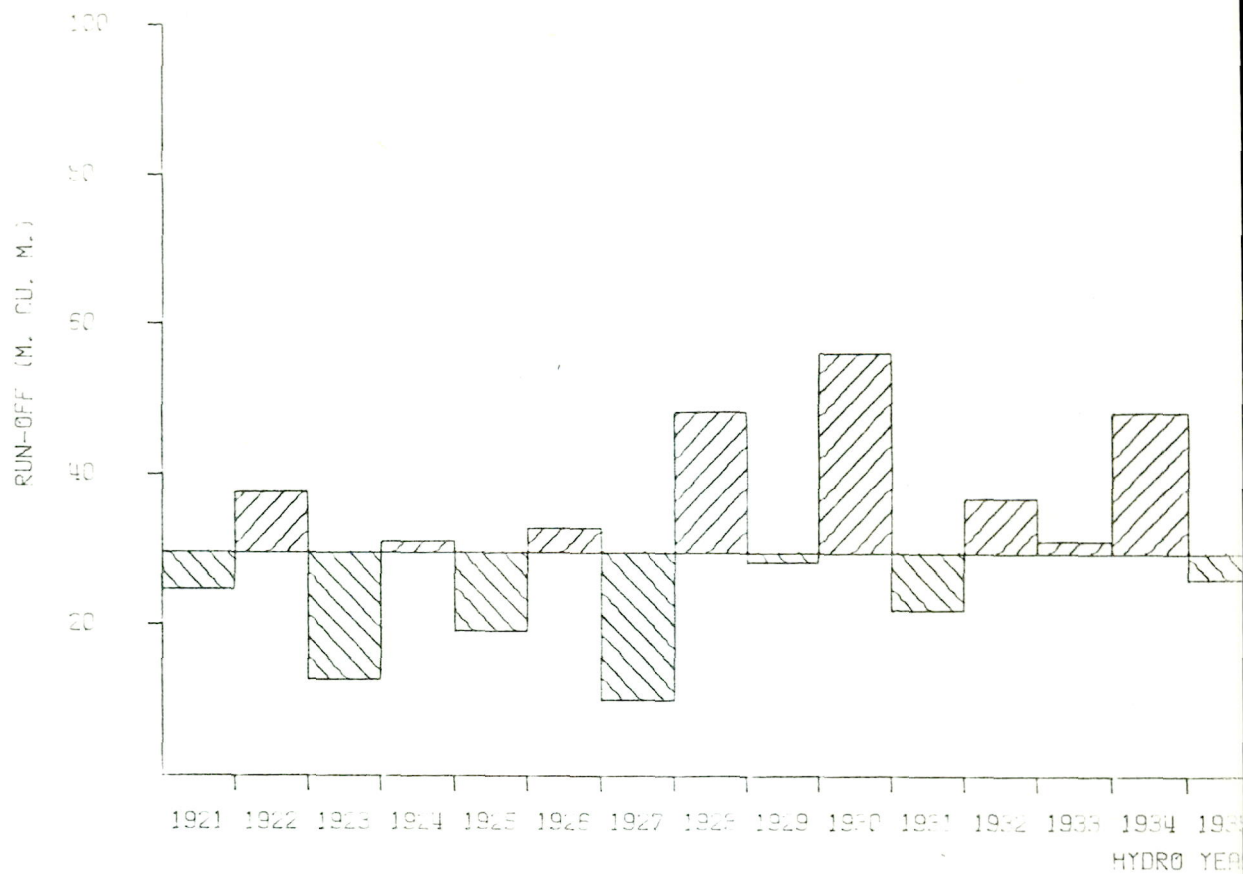
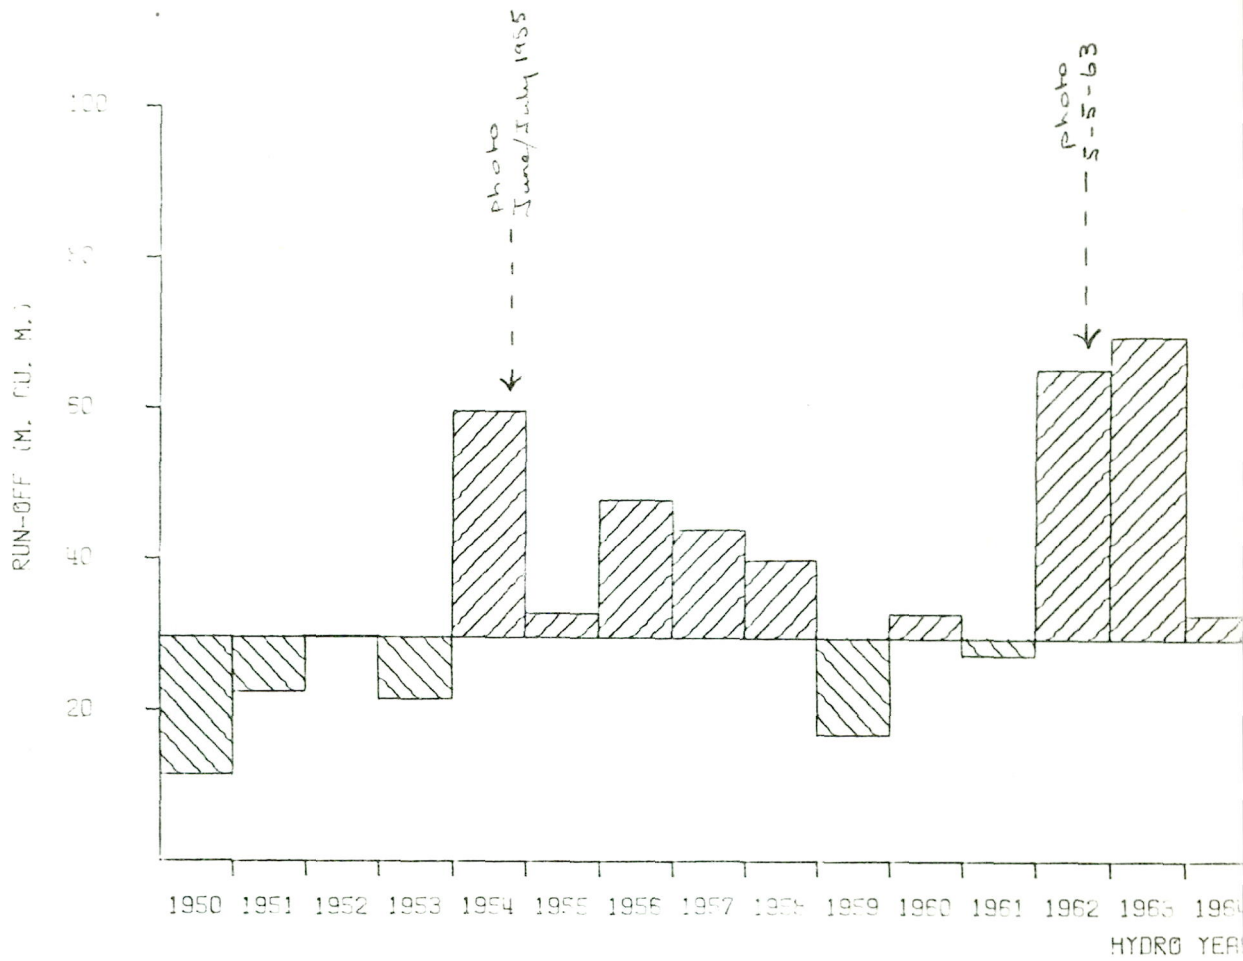
FIGURE  
 NS 10/2

NATAL ESTUARIES : MBIZANA  
 SIMULATED ANNUAL RUN-OFF  
 1921-1976

The M.A.R. from a catchment of 145 km<sup>2</sup> is 29,56 x 10<sup>6</sup> m<sup>3</sup>. Of particular interest to this study is the nature of the run-off which is very erratic; the Mbizana is subject to severe flash floods. This is quantified by the very high coefficients of variation (V%) for the monthly run-off (Table NS10/X) and the wide spectrum of annual and monthly run-off values shown in Figures NS10/2 and 3. Figure NS10/4 shows the trends in the annual run-off for the period 1921-1976. The aforementioned Table and Figures are based upon simulated run-off data for tertiary catchments (Pitman *et al.*, 1981) and although major widespread floods show up well, more localised floods may be masked. An example of this was the severe flood of February 1977 referred to by Begg (1978). For classification purposes, current and antecedent run-off conditions must be considered for each of the time slices covered by the aerial photographs. The following important facts emerge regarding the six relevant photographs:

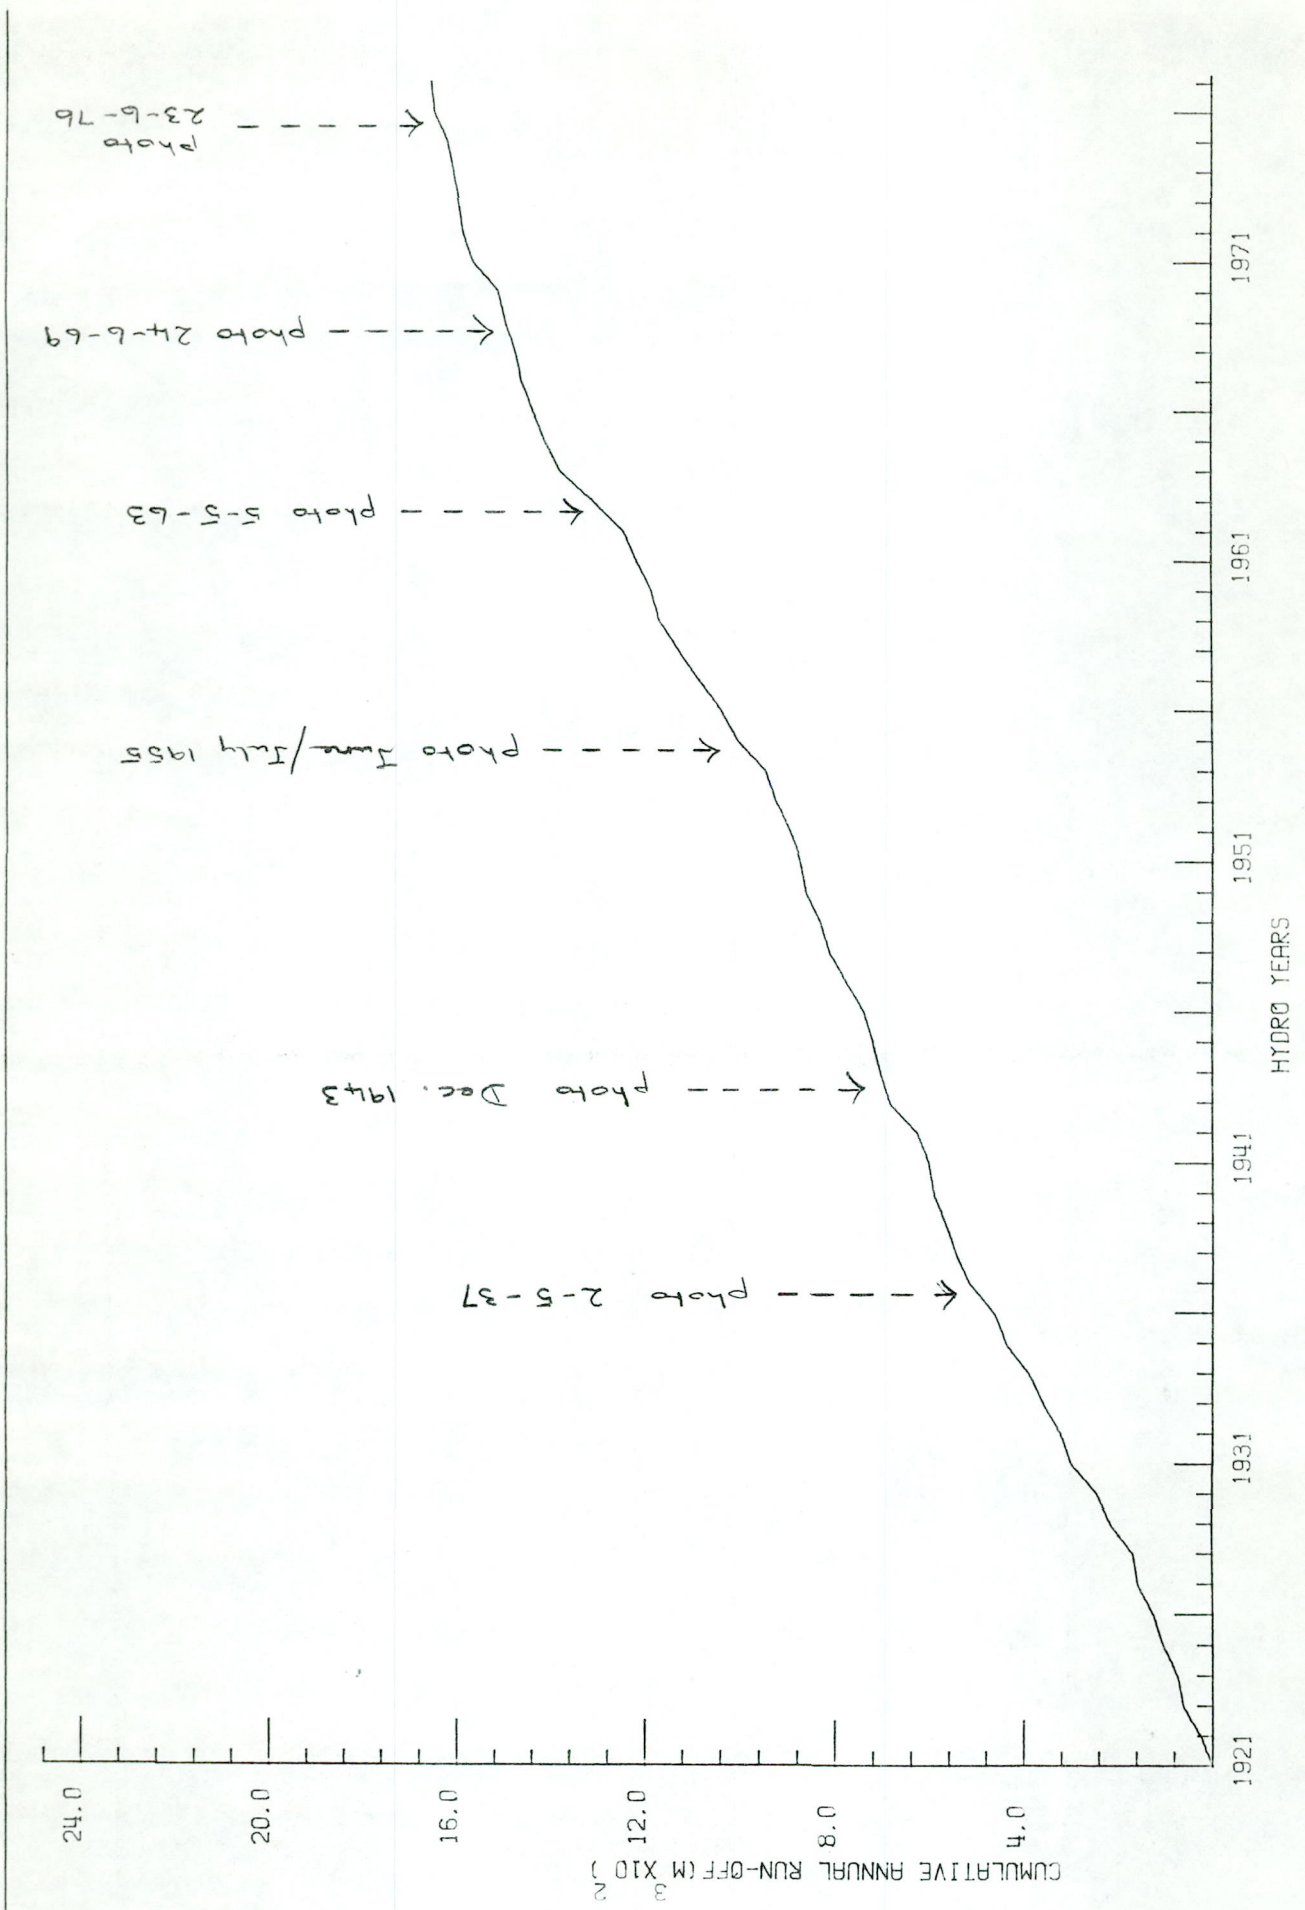
FIGURE  
**NS 10/4**

NATAL ESTUARIES : MBIZANA  
**CUMULATIVE ANNUAL RUN-OFF**

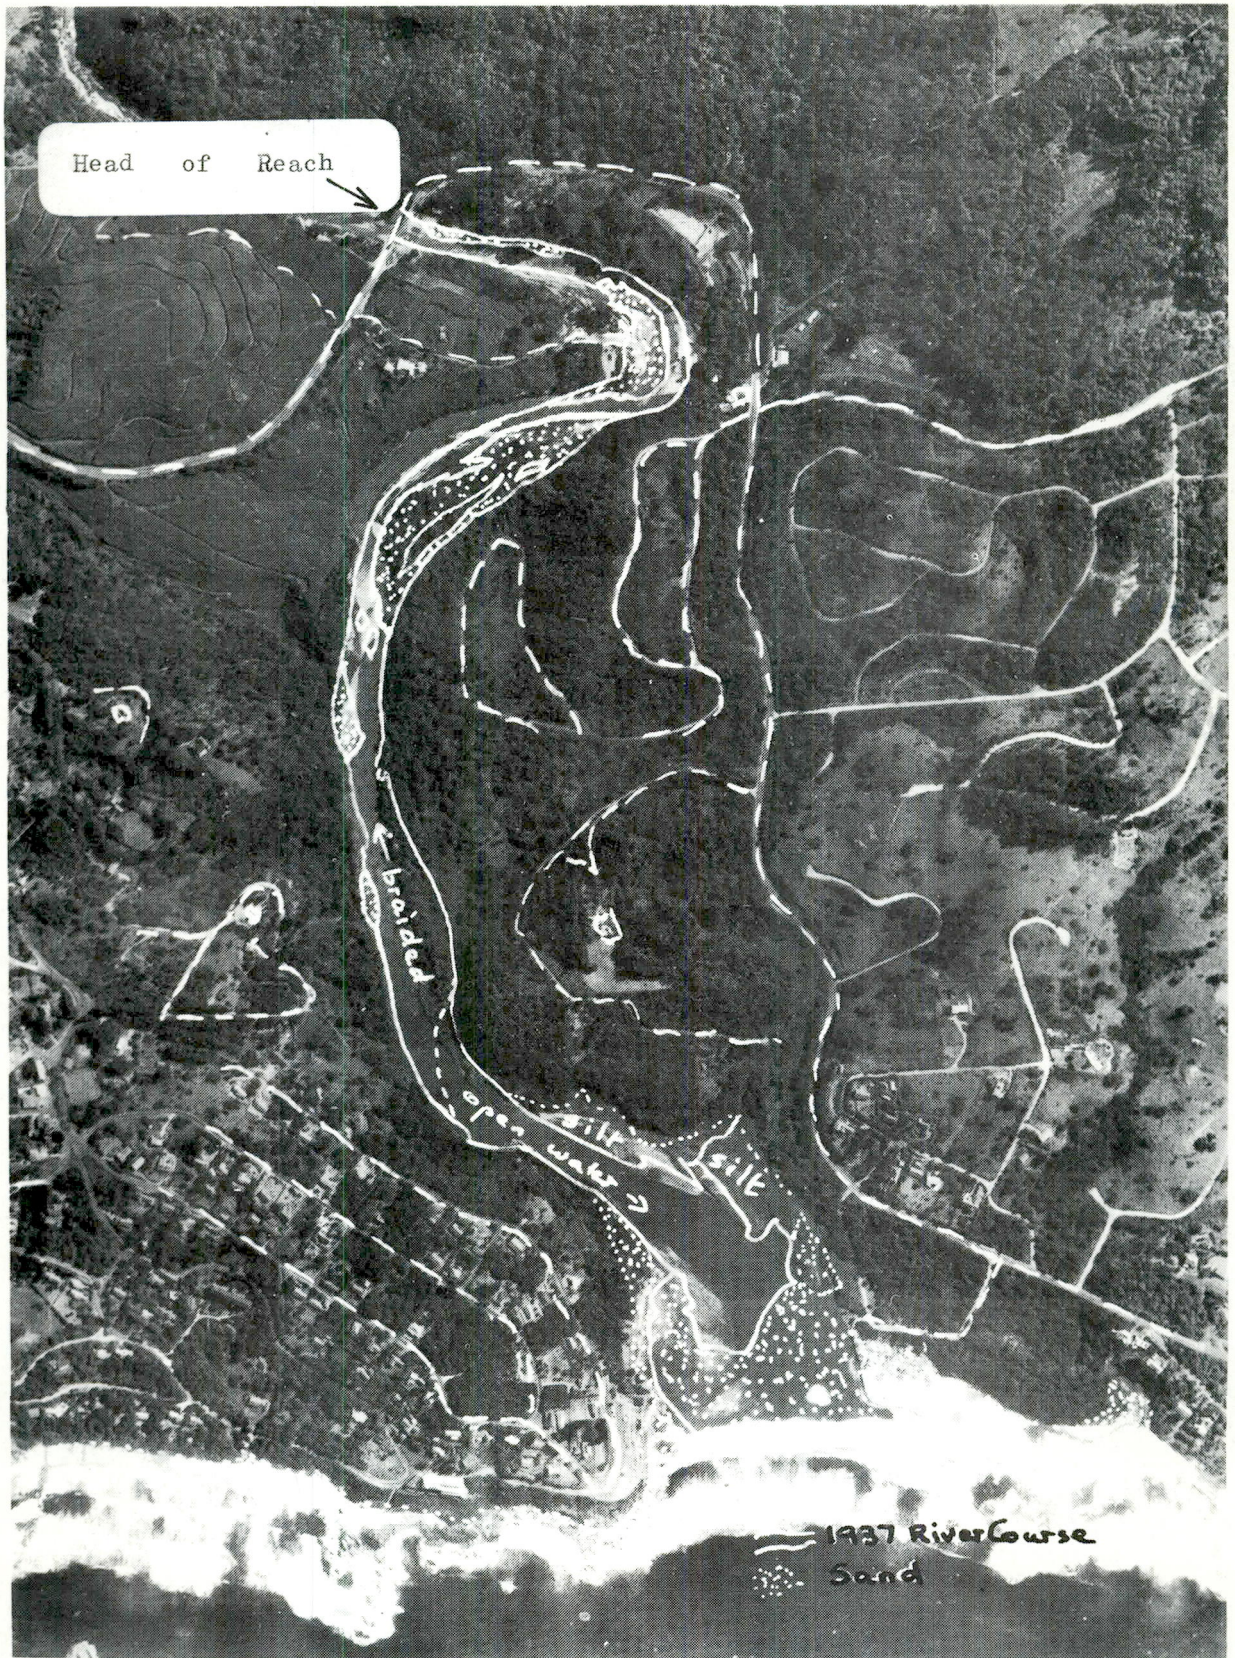
NS 10/1

SCALE : 1:10 000 approx.

The Mbizana River discharges into the Indian Ocean on the Natal South coast at 30° 55'S, 30° 20'E. The head of the reach under review is the national road bridge 2,6 km from the mouth (Photograph NS10/1).

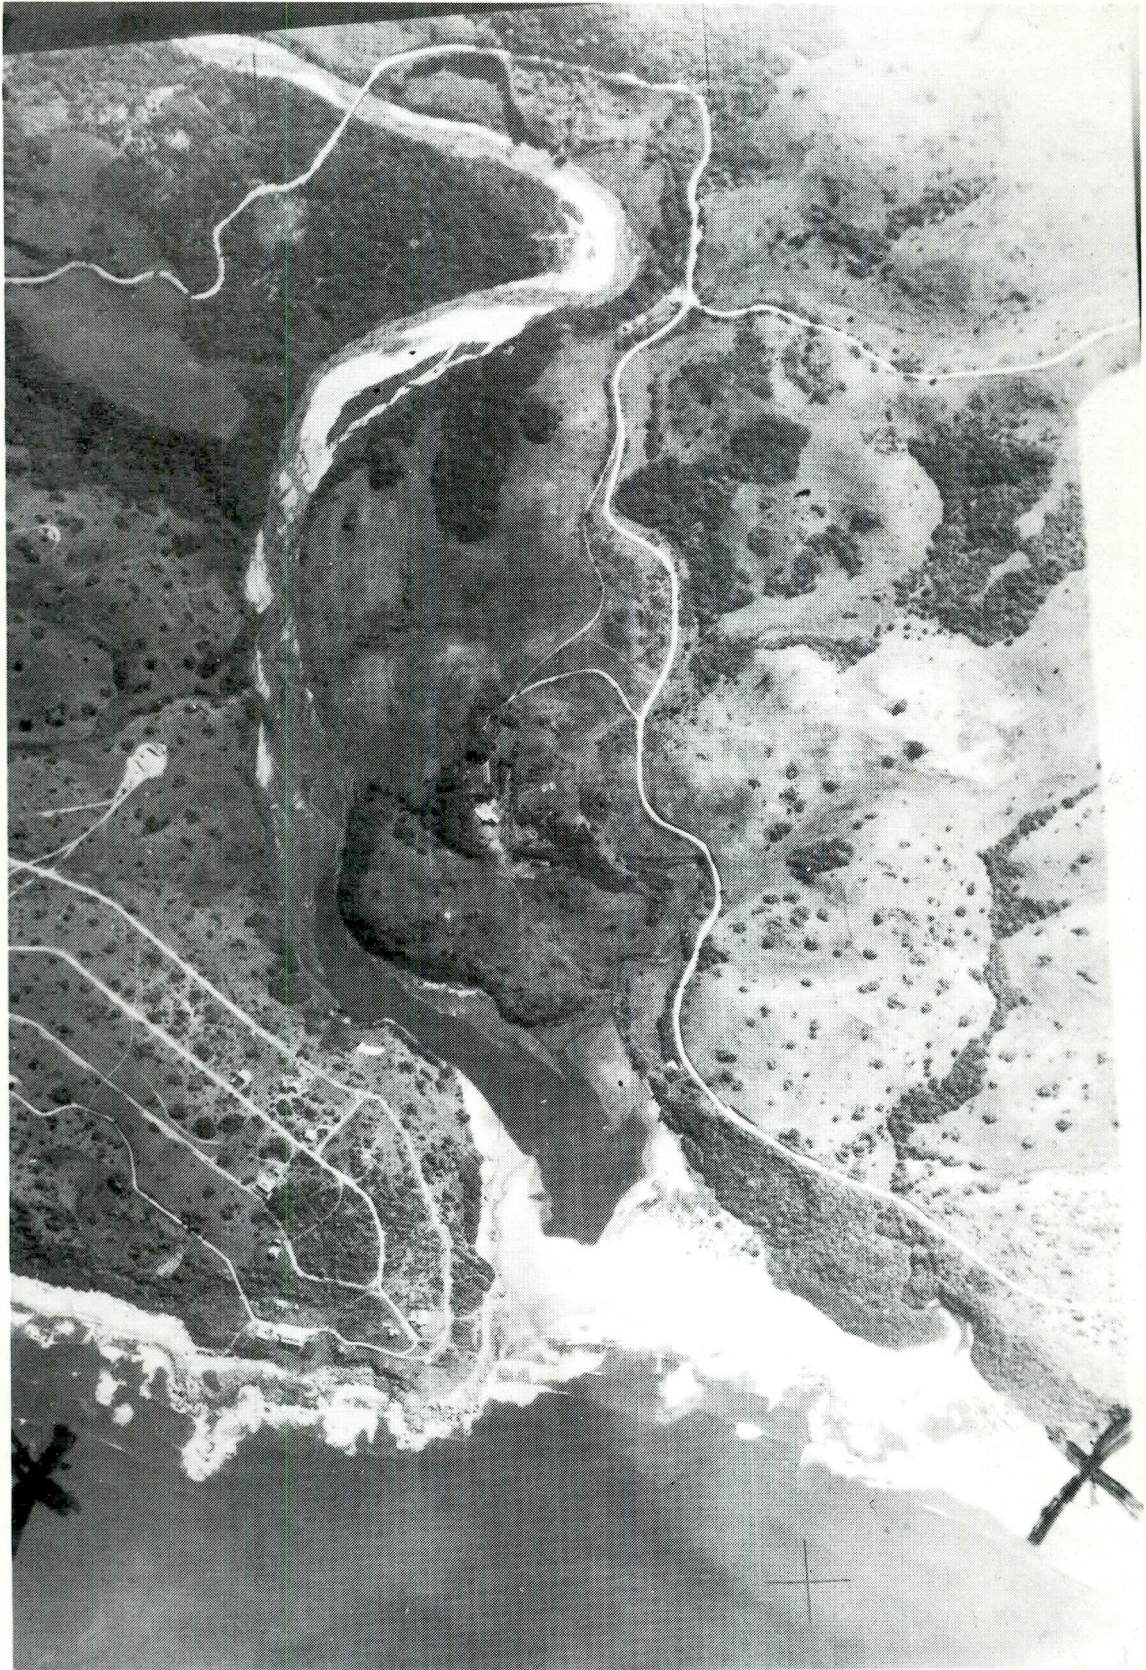
NATAL ESTUARIES : MBIZANA

2.5.37 (10 h 50)

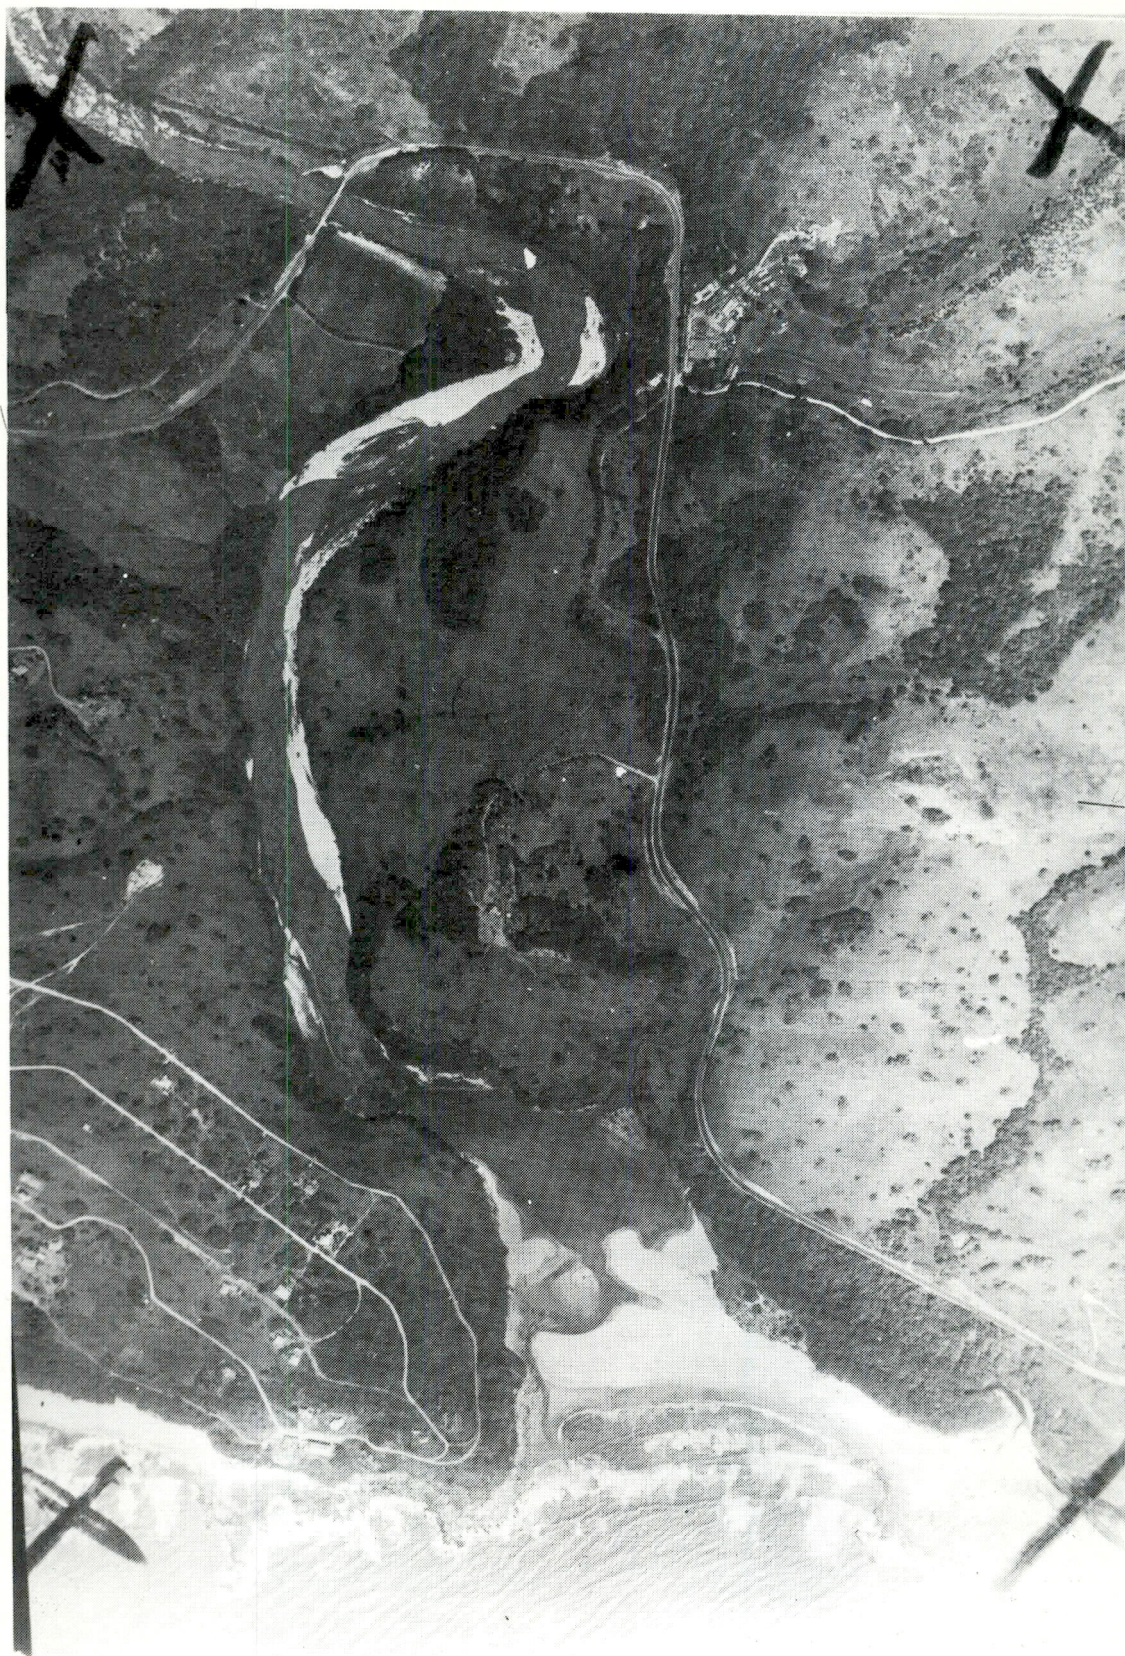
NS 10/2

NATAL ESTUARIES : MBIZANA  
DECEMBER 1943 (10 h 14)

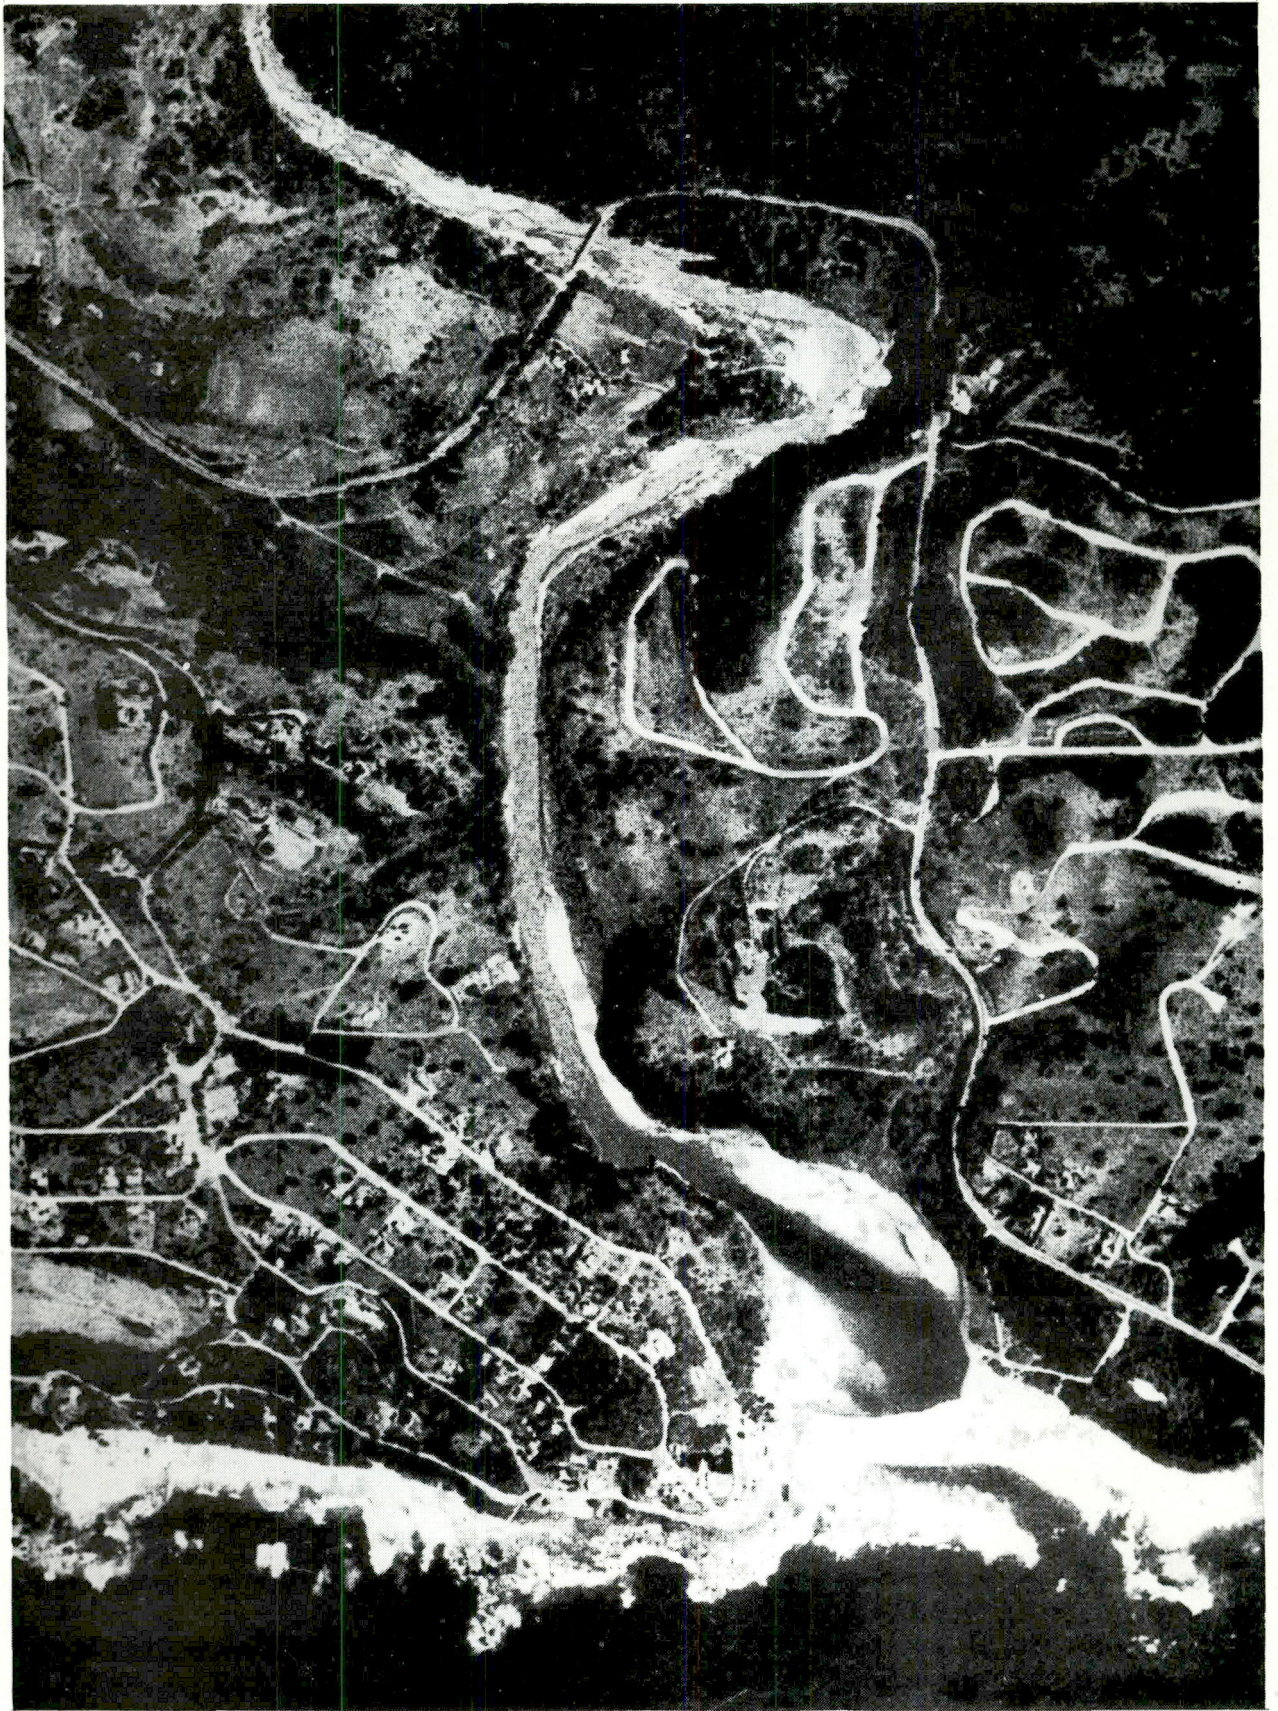
NS 10/4

SCALE : 1:10 000 approx.

Begg (1983) estimates the mouth to be closed for 68 per cent of the year. The six aerial photographs are representative of such conditions; three of them show the mouth completely blocked by a sandbar (Photographs NS10/4, 6 & 7). There are no aerial photographs available for the period during or immediately after severe floods showing the whole bar swept away. Soon after such an event, a sand-spit forms from the right bank and migrates northwards until the flood channel is closed. The lagoon then fills and eventually breaches the bar in its normal position against rocks on the right bank (Begg 1978). Photographs NS10/3 & 5 depict this normal open-mouth situation. The six time slices of photography under review show that the landward side of the spit/bar has migrated seawards since 1955. This is probably the result of the marked increase in bed levels (see paragraph below on "siltation").
