**HYDROLOGICAL / HYDRAULIC STUDY
OF NATAL ESTUARIES**

DATA REPORT No. 12
MVOTI NN7

NRIO DATA REPORT D8301

Stellenbosch, South Africa
June 1983

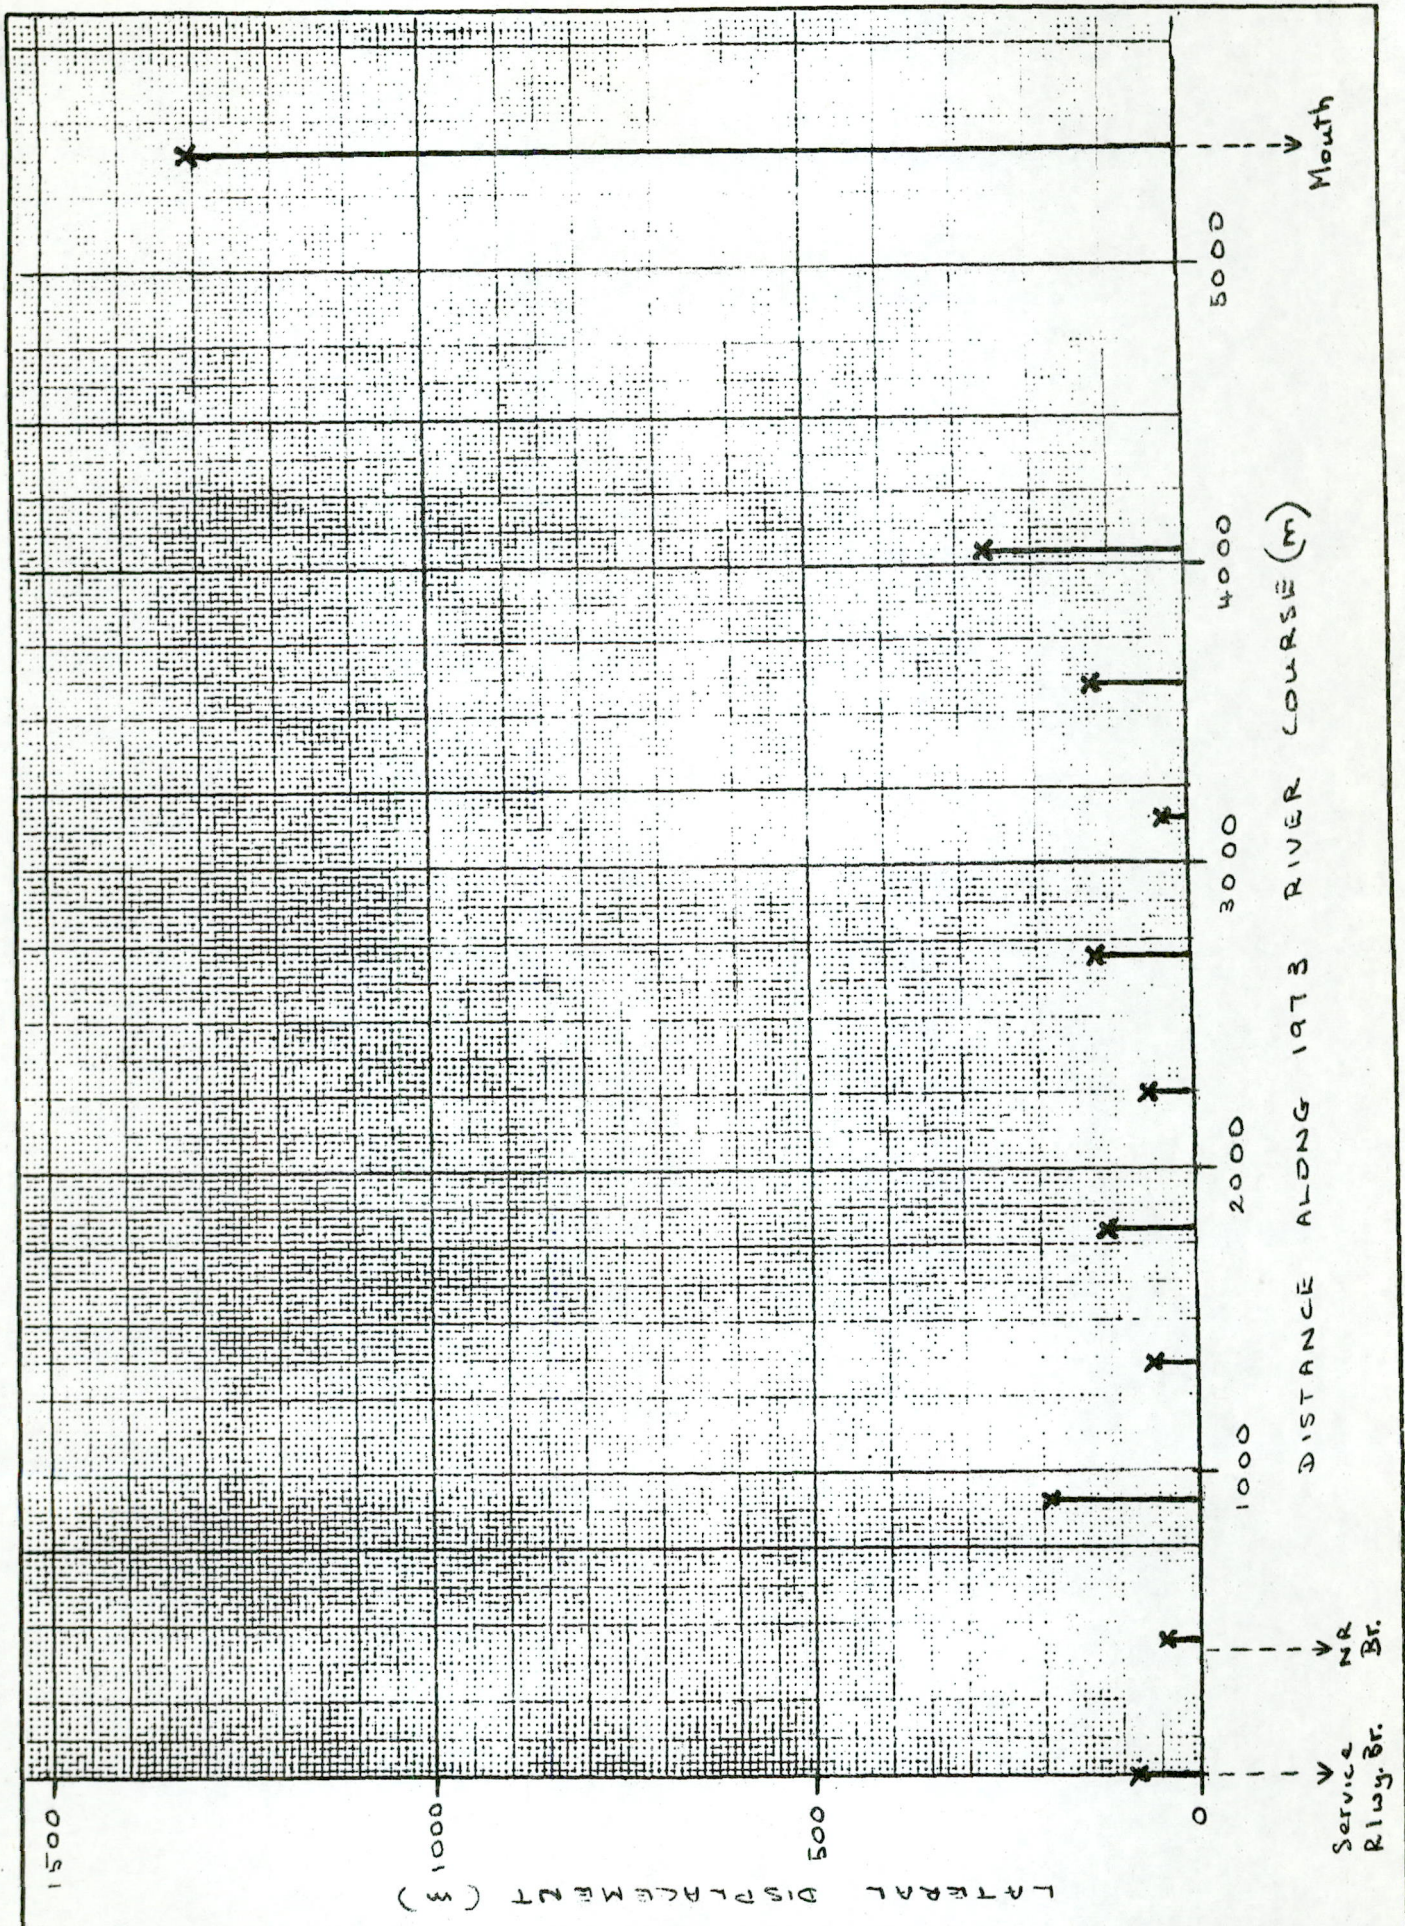
FIGURE
 NN 7/1

THALWEG DISPLACEMENT
 1937 - 1976

The Mvoti has shifted its course laterally to a marked degree during the period under review (and for previous decades, from photographic evidence). This is partly a result of the changing mouth position in response to wet and dry phases already discussed and is quantified by the high average lateral displacement of 218,9 m and high average coefficient of variation of 53,7% (Table NN7/VII). However, it should be noted that during the "normal" conditions of lower to average flow, with the mouth in its southerly position, the trend has been for thalweg lengths and sinuosity to increase. This is typical of aggrading conditions.

Average lateral displacement 1937-76 = 218,9 m

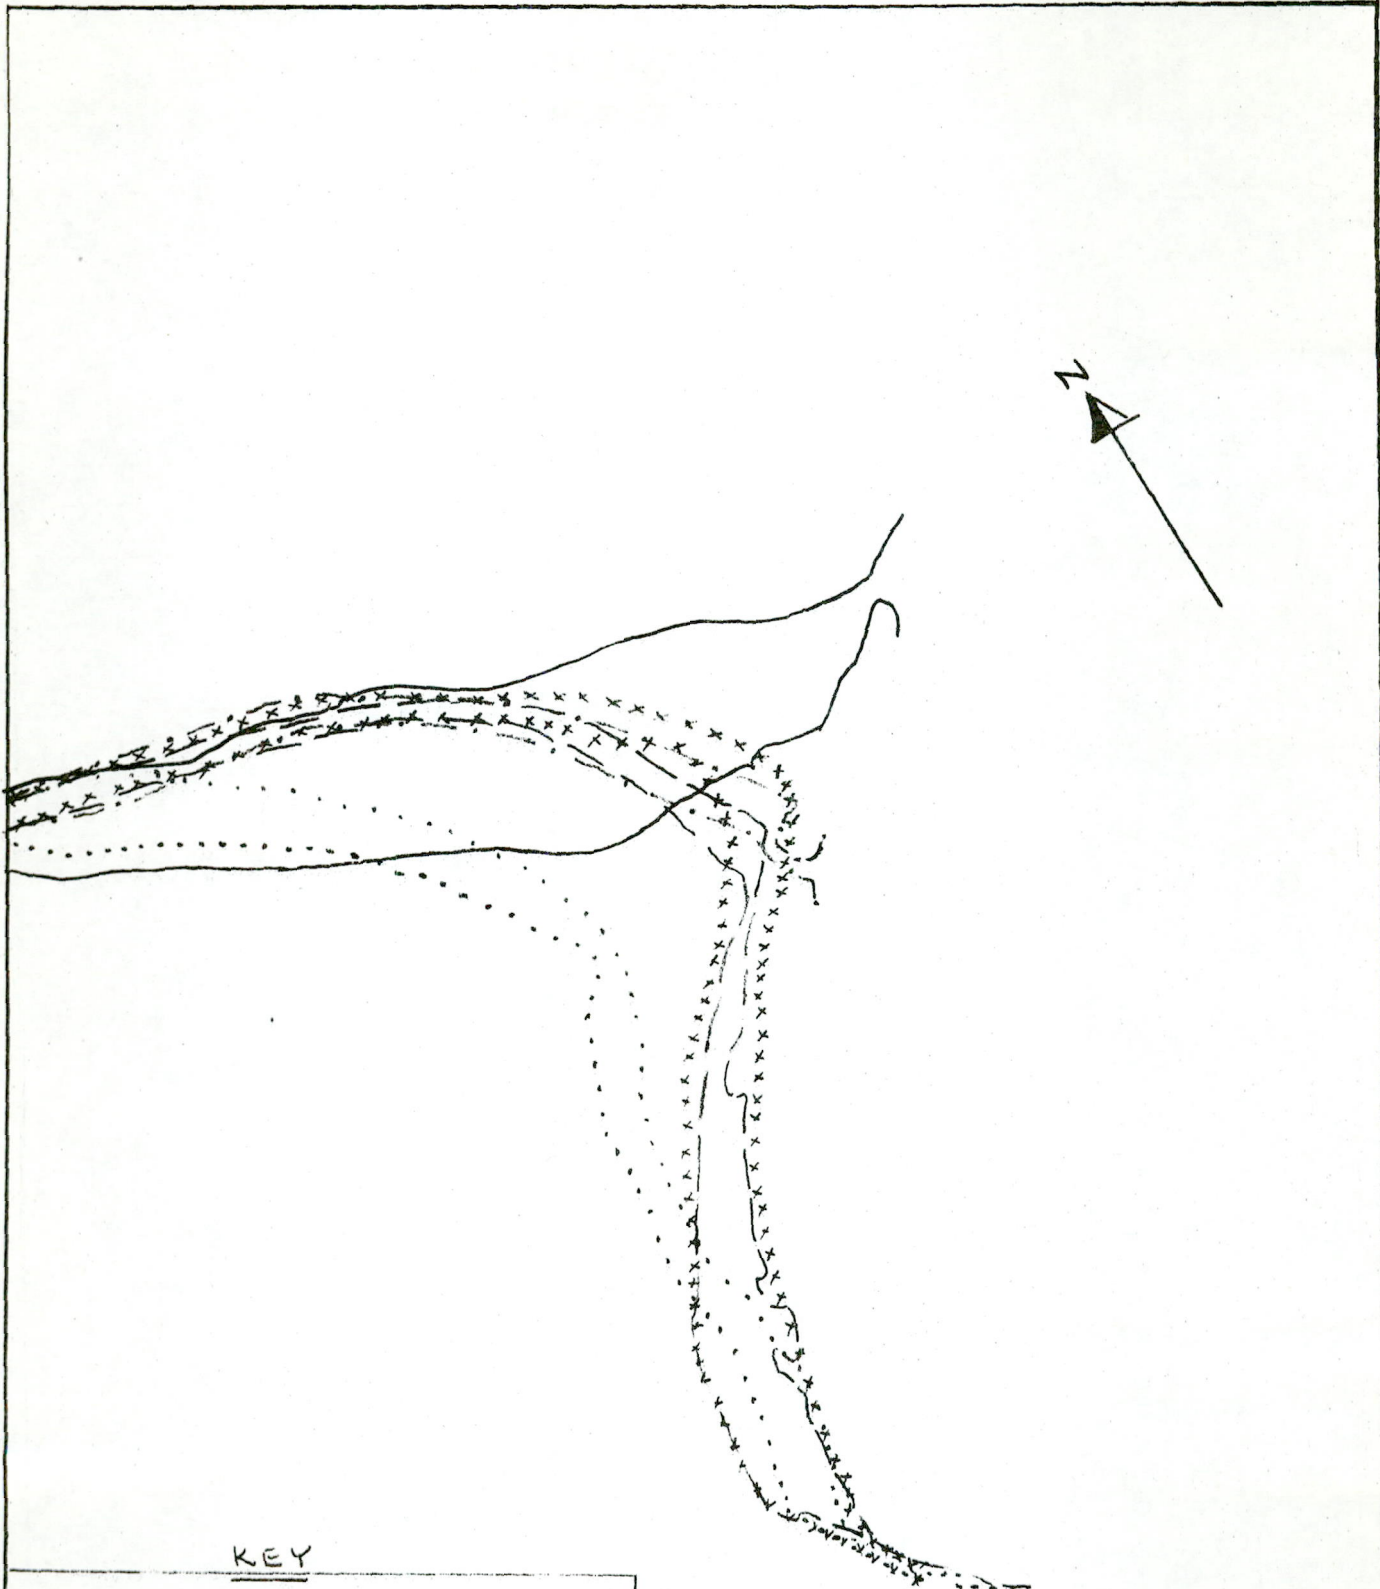
FIGURE
NN 7/2

KEY

1-5-37 river course

6-6-59 river course

2-8-67 river course

3-6-73 river course

14-5-76 river course

NATAL ESTUARIES: MVOTI
MOUTH POSITIONS
1937 - 1976

The Mvoti is often diverted at its mouth by a long, southerly-extending spit and discharges into the ocean alongside rocks on its right bank. The mouth position is, however, variable (Figure NN7/2). Under flood conditions, the river takes a straighter course to the ocean and breaks through the spit in a more northerly position. This is a natural functioning of the estuary. The mouth usually remains open but occasionally, if it closes, the bar is breached mechanically to ensure that sugar cane does not become flooded (Begg 1978).

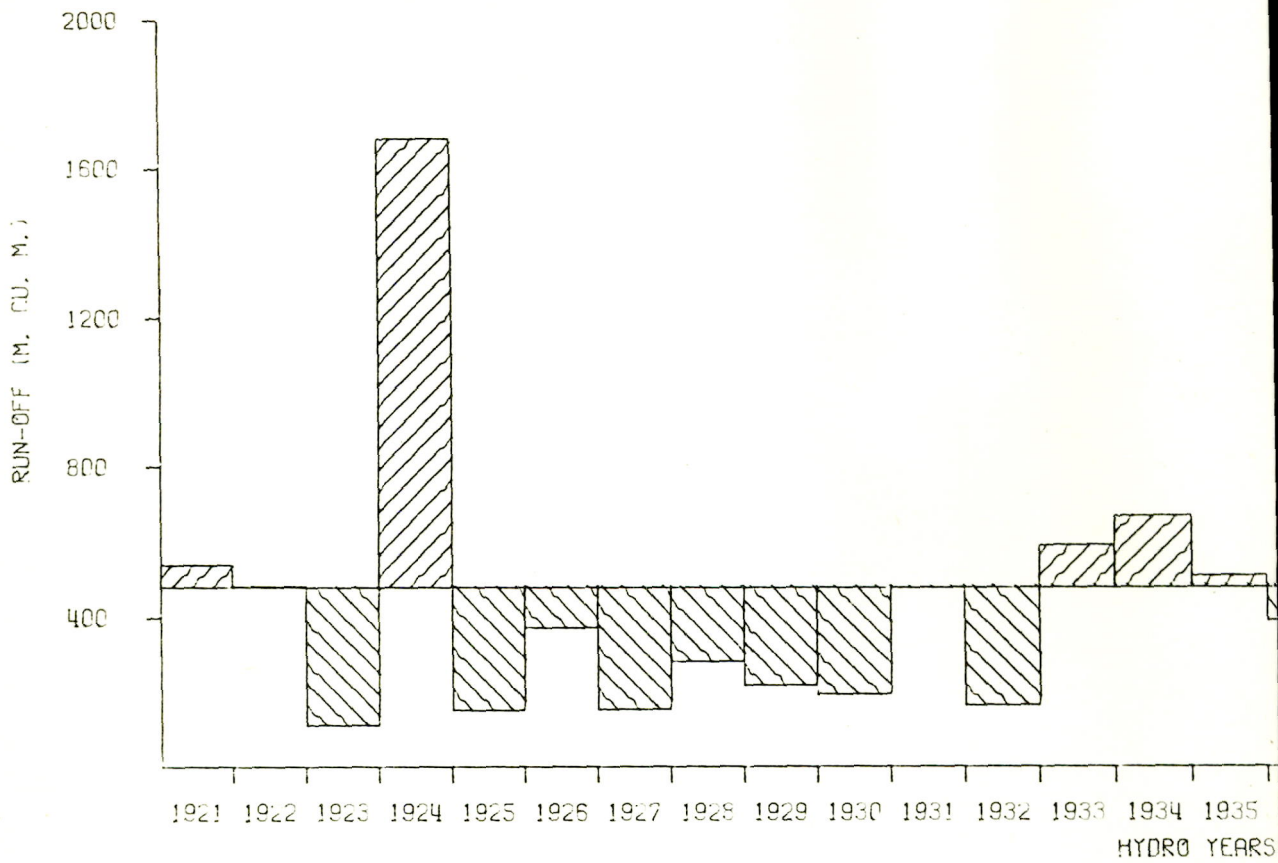
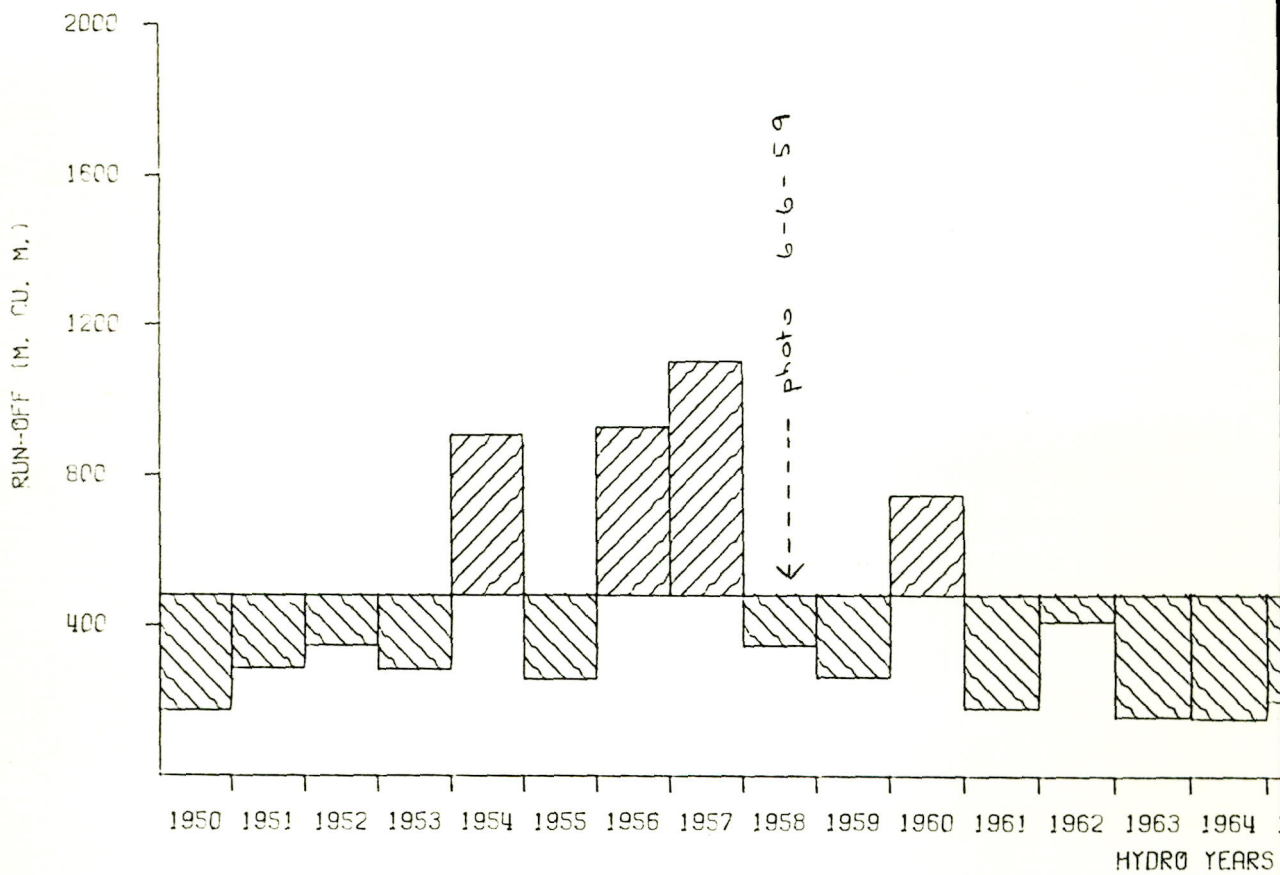
FIGURE
 NN7/3

NATAL ESTUARIES (MVOTI)
 SIMULATED ANNUAL RUN-OFF
 1921-1975

The M.A.R. from a catchment area of 2829 km² is 481,71 x 10⁶ m³. (Table NN7/VIII). Of particular interest to this study is the nature of the run-off: it is very erratic. The mean run-off is far higher than the median run-off during the summer rainy season, the higher averages being the result of the occasional major floods to which the Mvoti is subject. Long dry phases broken by short wet phases are clearly shown in Figure NN7/3 and more detailed, erratic nature of the monthly run-off in Figure NN7/4. For classification purposes, consideration must be given as to when the photographs were taken with regard to run-off. The following important facts emerge regarding the five photographs studied and antecedent run-off conditions:

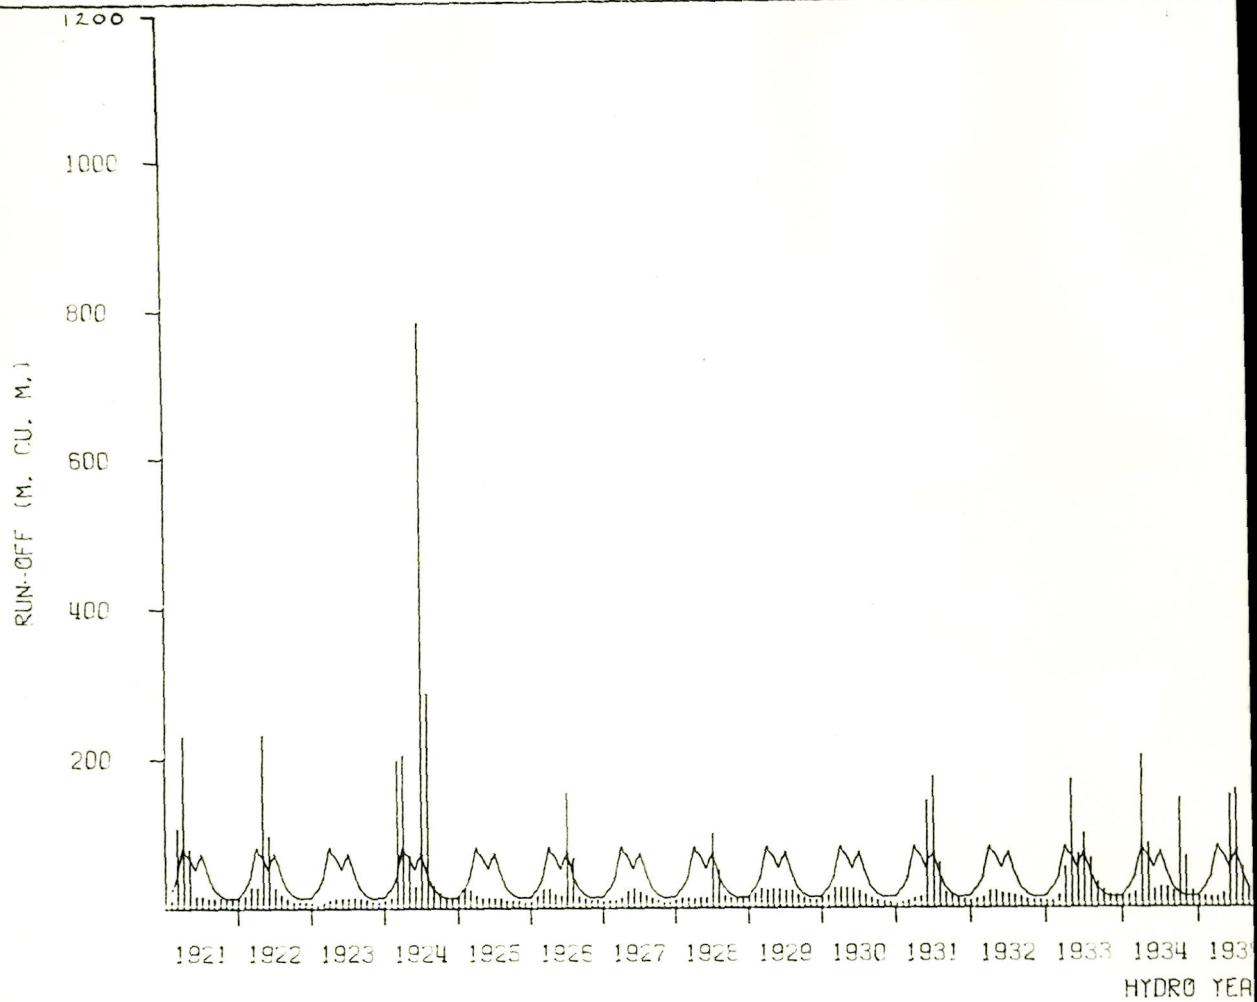
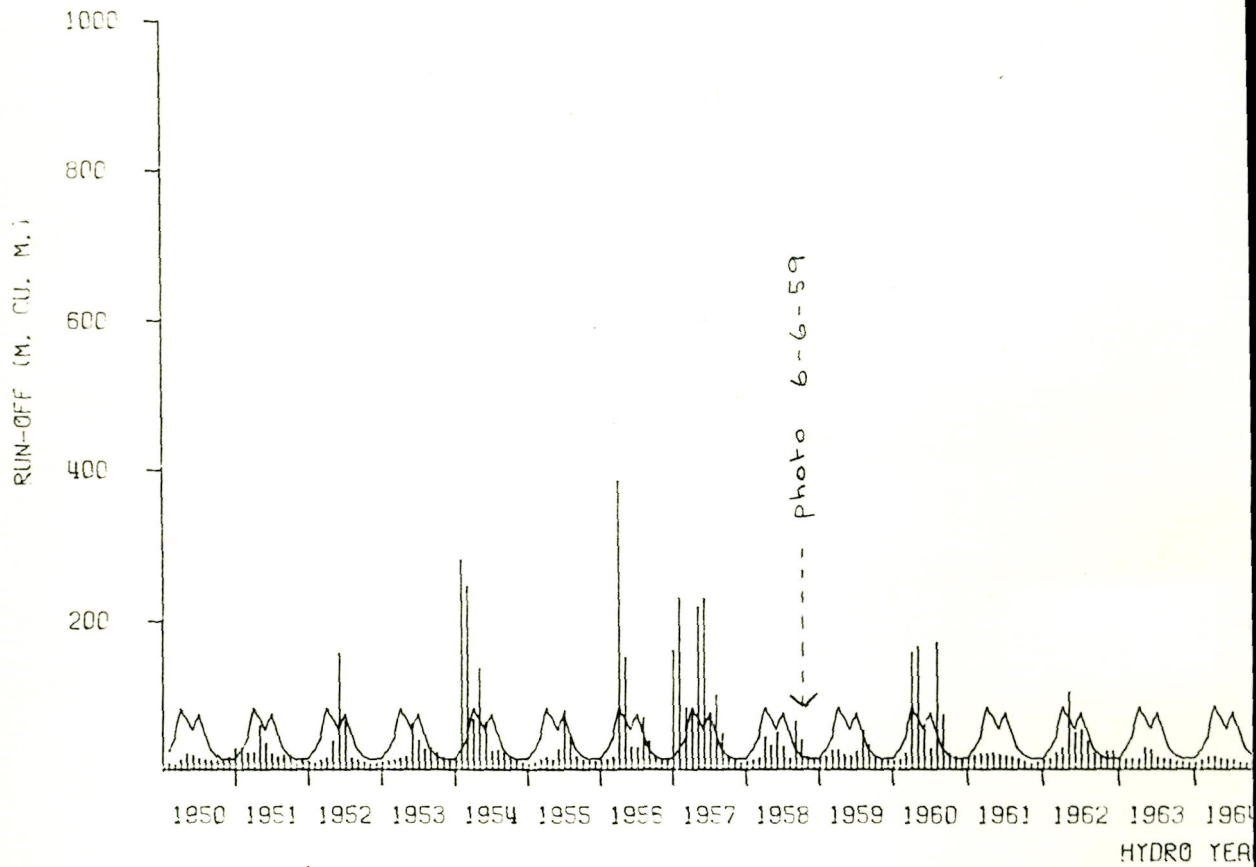
FIGURE
 NN 7/4

NATAL ESTUARIES : MV071
 SIMULATED MONTHLY RUN-OFF
 1921-1975

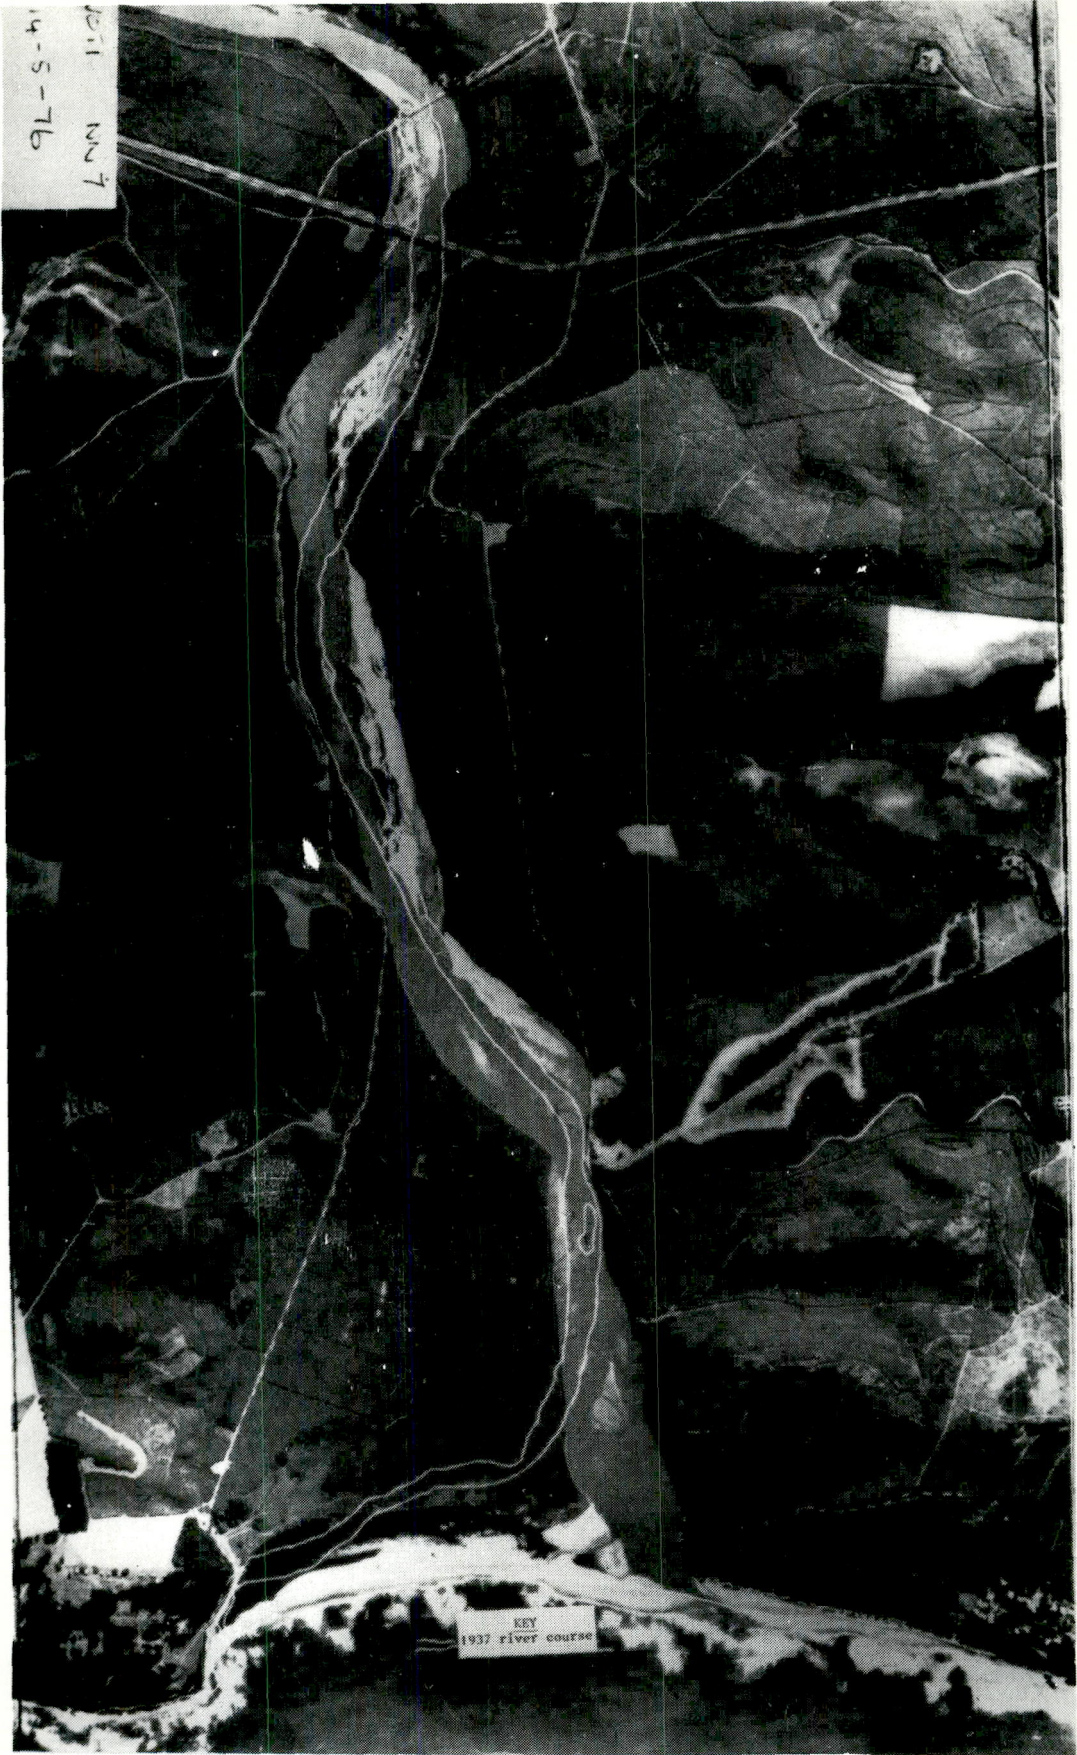
TRACED : JGAN CHECKED : DATE : REF :	NATAL ESTUARIES : MVOTI 14-5-76 (1-5-37 RIVER COURSE SUPERIMPOSED)	PHOTOGRAPH NN 7/1
NATIONAL RESEARCH INSTITUTE FOR OCEANOLOGY

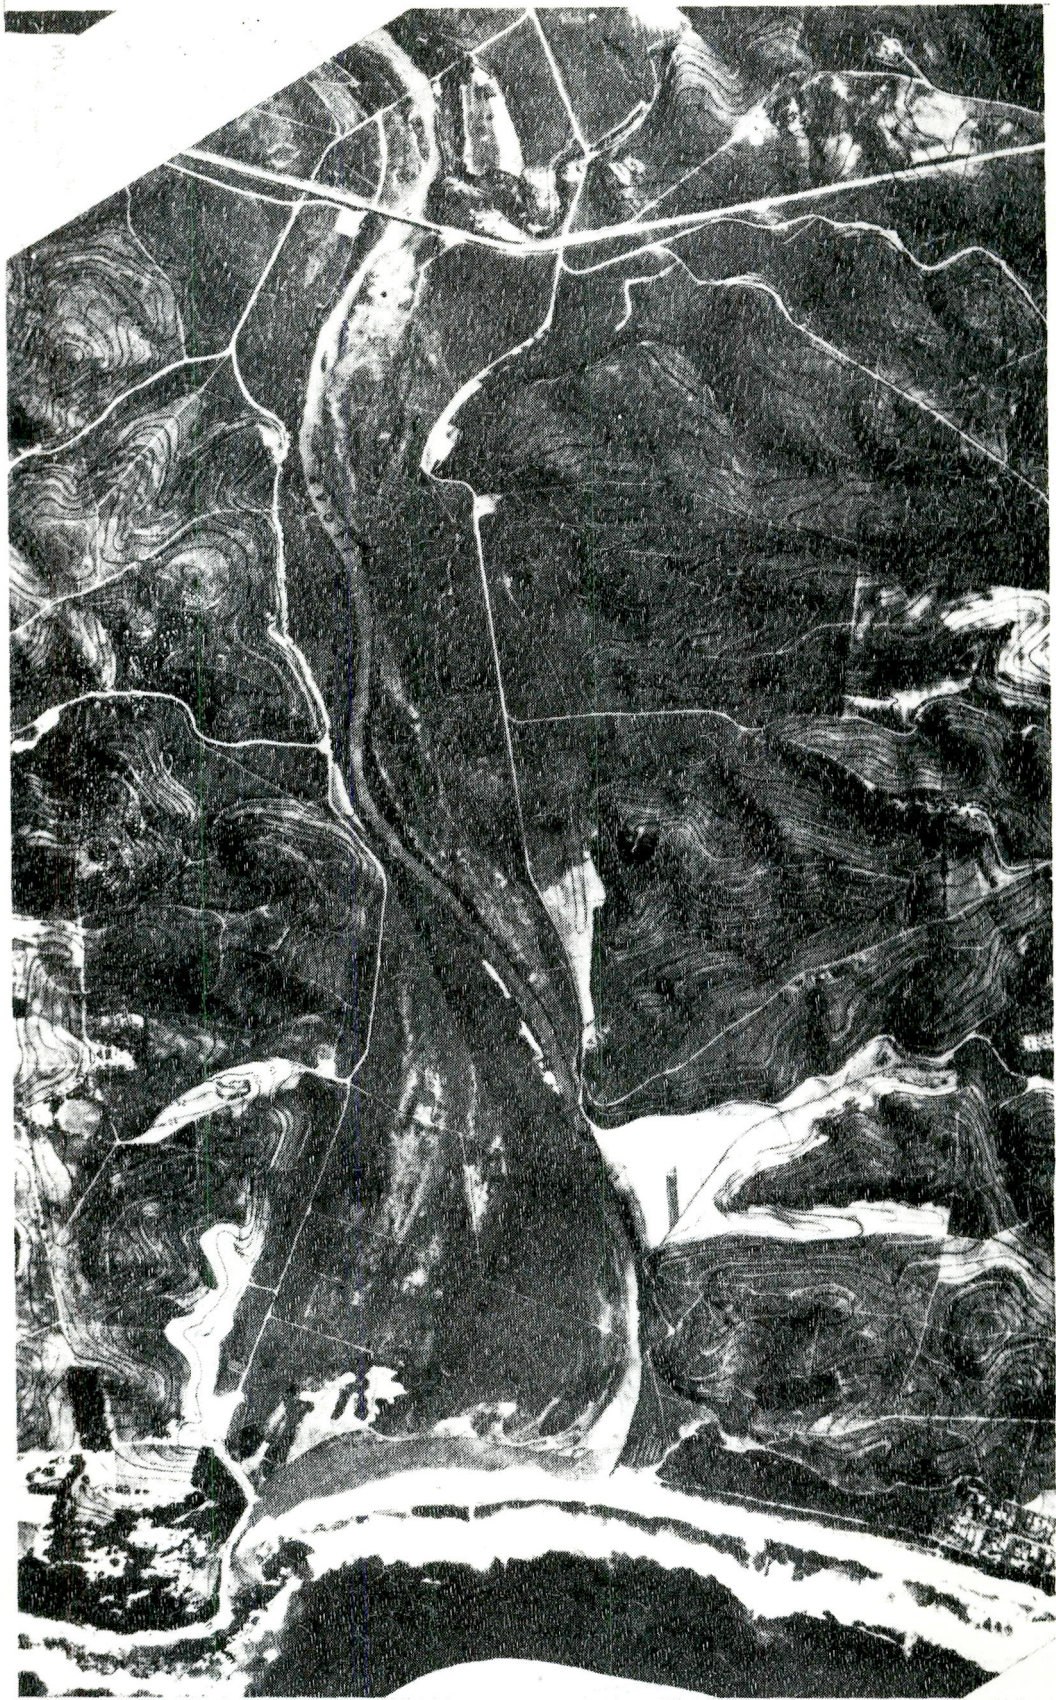
NN 7/7

3-6-73 (ORTHO PHOTO)

Details of the classification of the lower reaches of the Mvoti for 1937, 1959, 1967, 1973 and 1976 are given in Tables NN7/I-V. River widths and details of lateral stability appear in Tables NN7/VI and VII. Simulated run-off for the period 1921-1975 is given in Table NN7/VIII and an abstract of results in Table NN7/IX. Thalweg displacement from 1937-1976 and a sketch map illustrating various mouth positions are shown in Figures NN7/1 and 2. Graphs of simulated annual and monthly run-off are given in Figures NN7/3 and 4. Photograph NN7/1 shows the 1937 river course superimposed on a 1976 photograph. Photographs used for classification purposes are reproduced as Photographs NN7/2-6. Photograph NN7/7 shows the orthophoto compiled from the 1973 photography.
