**HYDROLOGICAL / HYDRAULIC STUDY
OF NATAL ESTUARIES**

DATA REPORT No. 11
MPAMBANYONI NS 40

NRIO DATA REPORT D8302

Stellenbosch, South Africa
June 1983

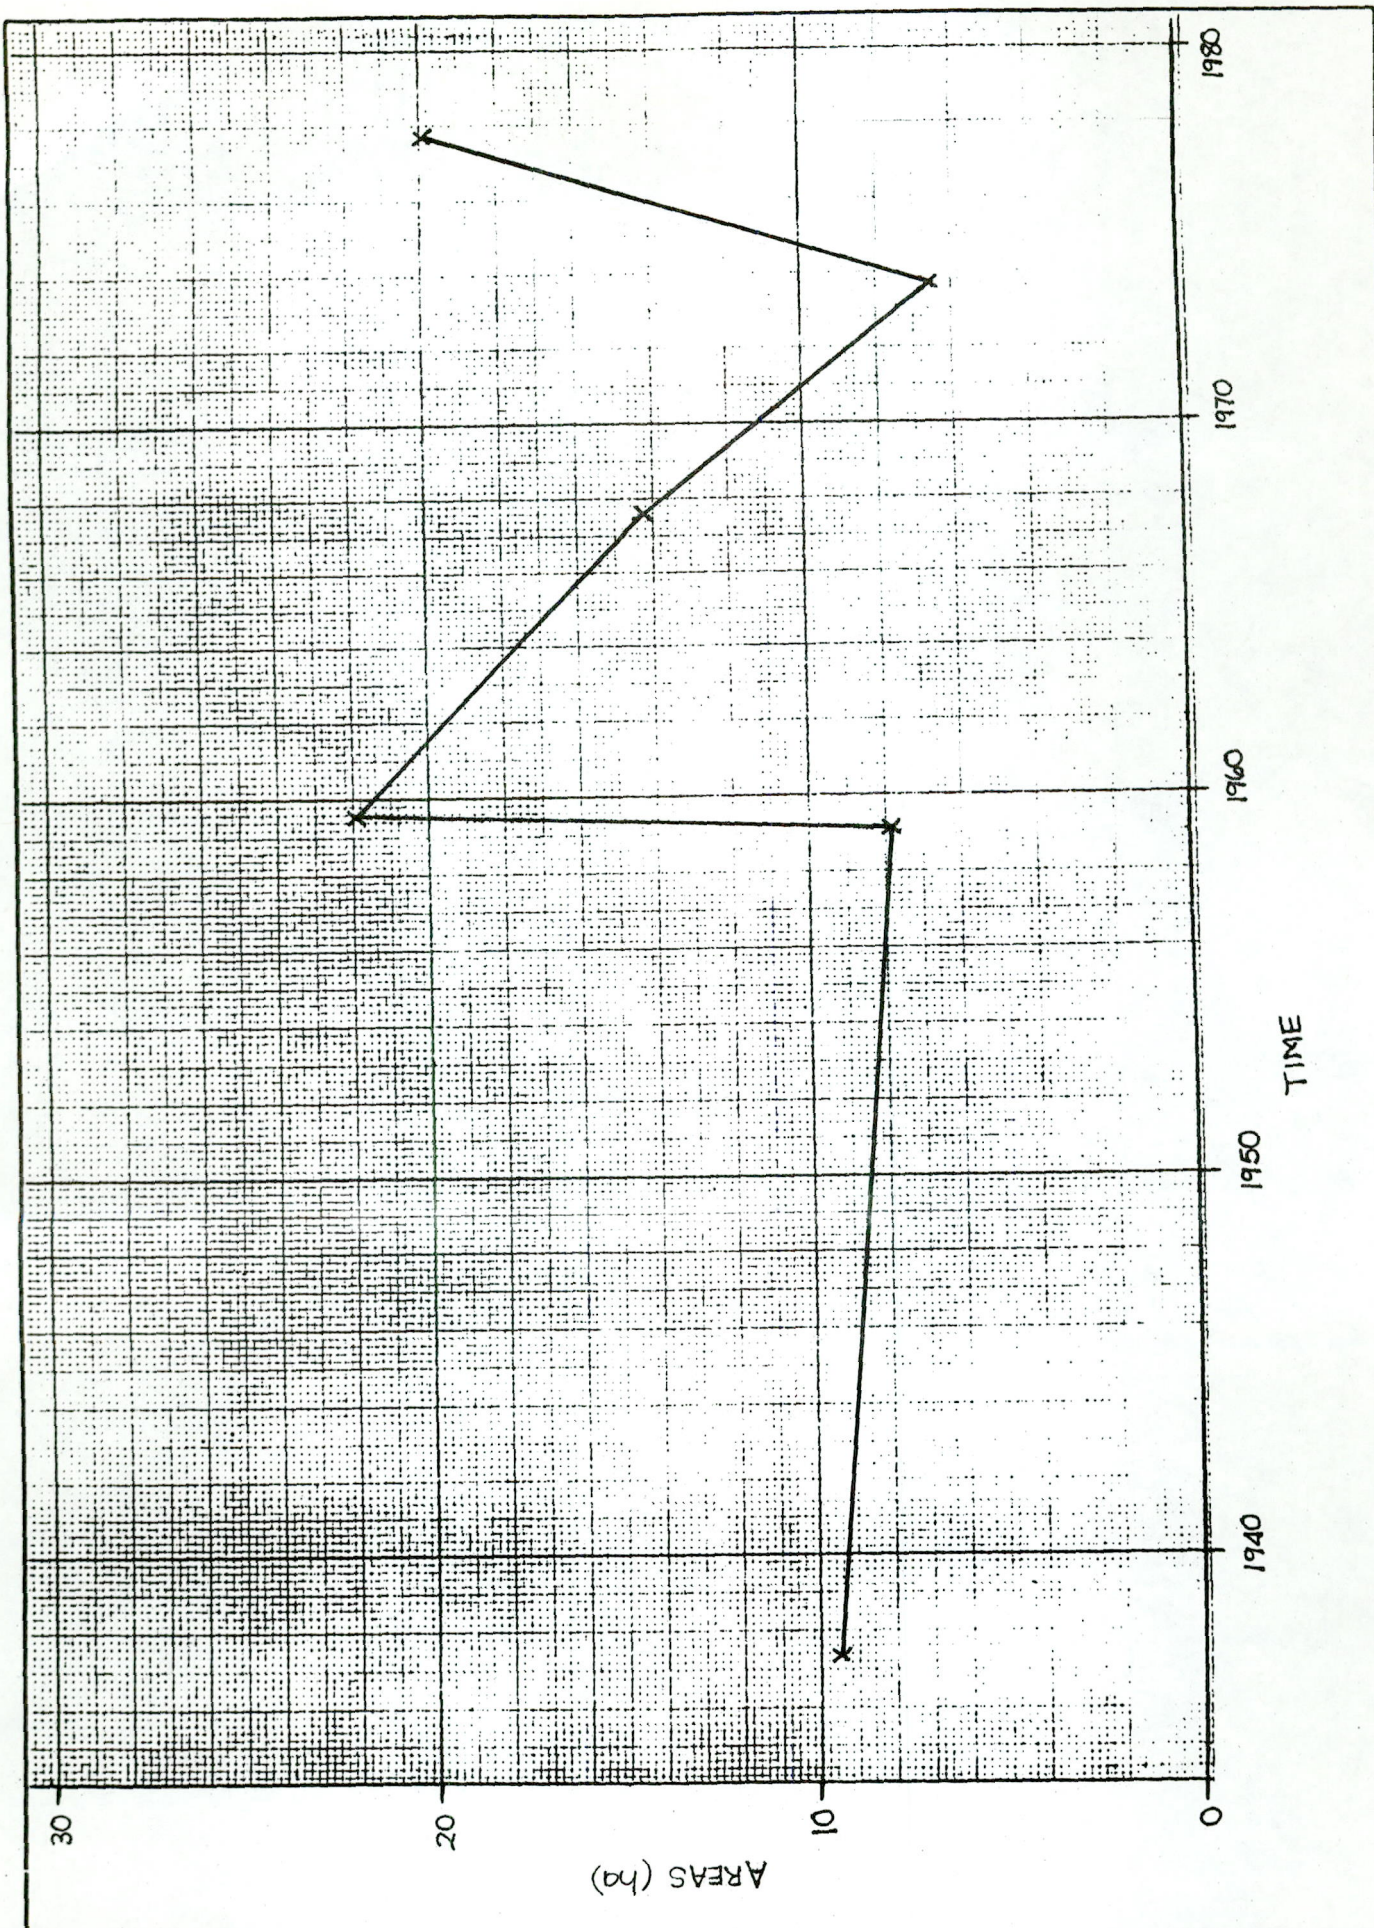
FIGURE
 NS 40/2

NATAL ESTUARIES: MPAMPANYONI
 OPEN WATER AREAS 1937-76

The longer thalweg and higher sinuosity for the 6 June 1959 is at first sight confusing. It is due to the fact that at that time three weeks after the devastating May 1959 flood, the main river flow ran round large mid-channel bars and a temporary causeway built to reach the Renishaw mill. (Photograph NS 40/4). From the same photograph the peak flood course can be deduced. The road and rail bridge embankments could not withstand the flood and the river adopted a more direct course to the ocean. It is interesting to note that the sinuosity under such conditions was reduced to 1,03. The varying average river widths (Table NS 40/VII) and open water areas (Figure NS 40/2) reflect the influence of the floods.

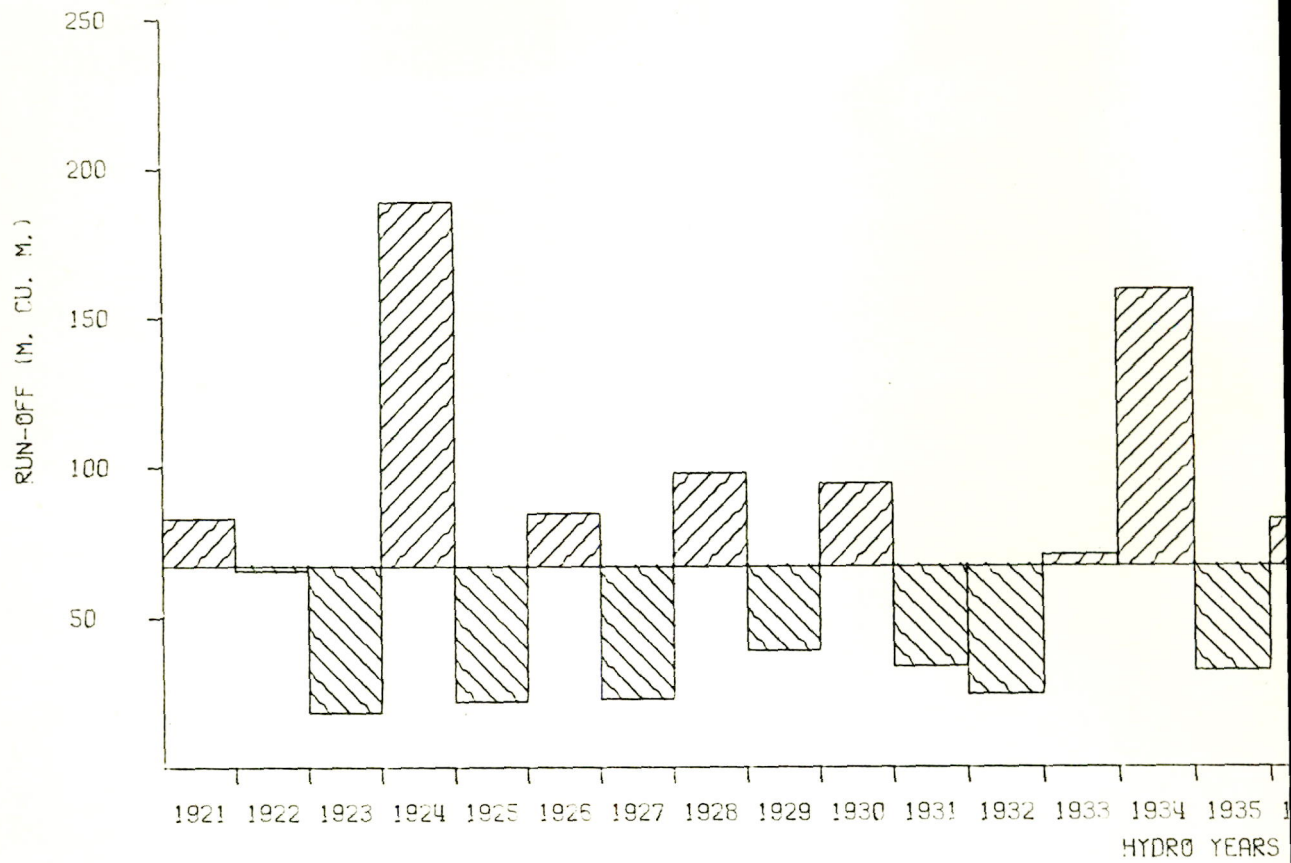
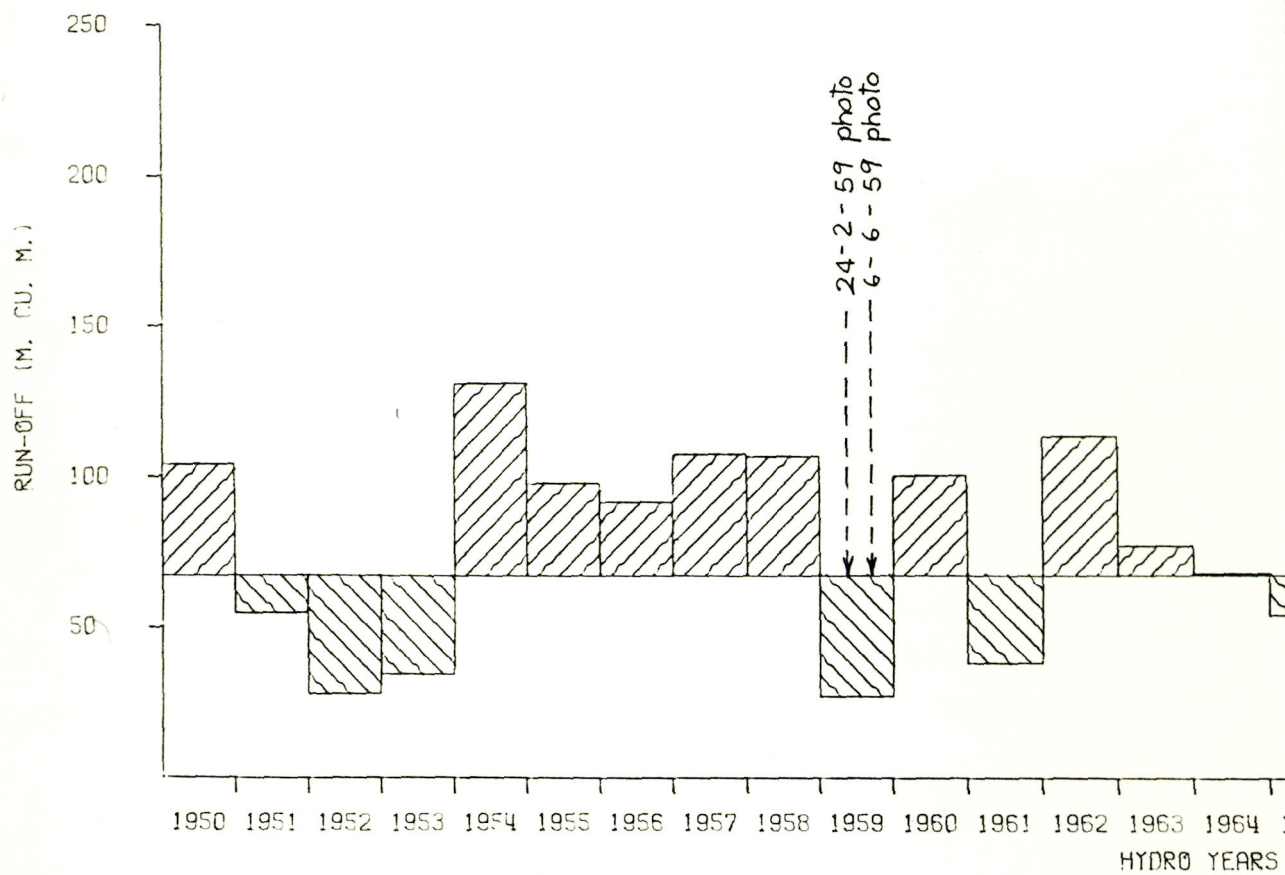
TRACED : COMPLETE CHECKED : DATE : REF. :	NATAL ESTUARIES - MPAMBANYONI SIMULATED ANNUAL RUN-OFF 1921-1975	FIGURE NS40/3
NATIONAL RESEARCH INSTITUTE FOR OCEANOLOGY

The MAR from a catchment area of 562 km² is $71,29 \times 10^6 \text{ m}^3$ (Table NS 40/IX). The run-off is very erratic. Monthly run-off may be well below the mean for long periods which are broken by violent floods (Figure NS 40/4). A major flood with an estimated peak discharge of 1 228 cumecs occurred on the 17th/18th May 1959 : the northern approach embankments of both the rail and road bridges near the mouth were swept away and buildings were damaged at the Renishaw sugar mill. (Meineke 1960). Flooding of a similar magnitude was again experienced in March 1976.

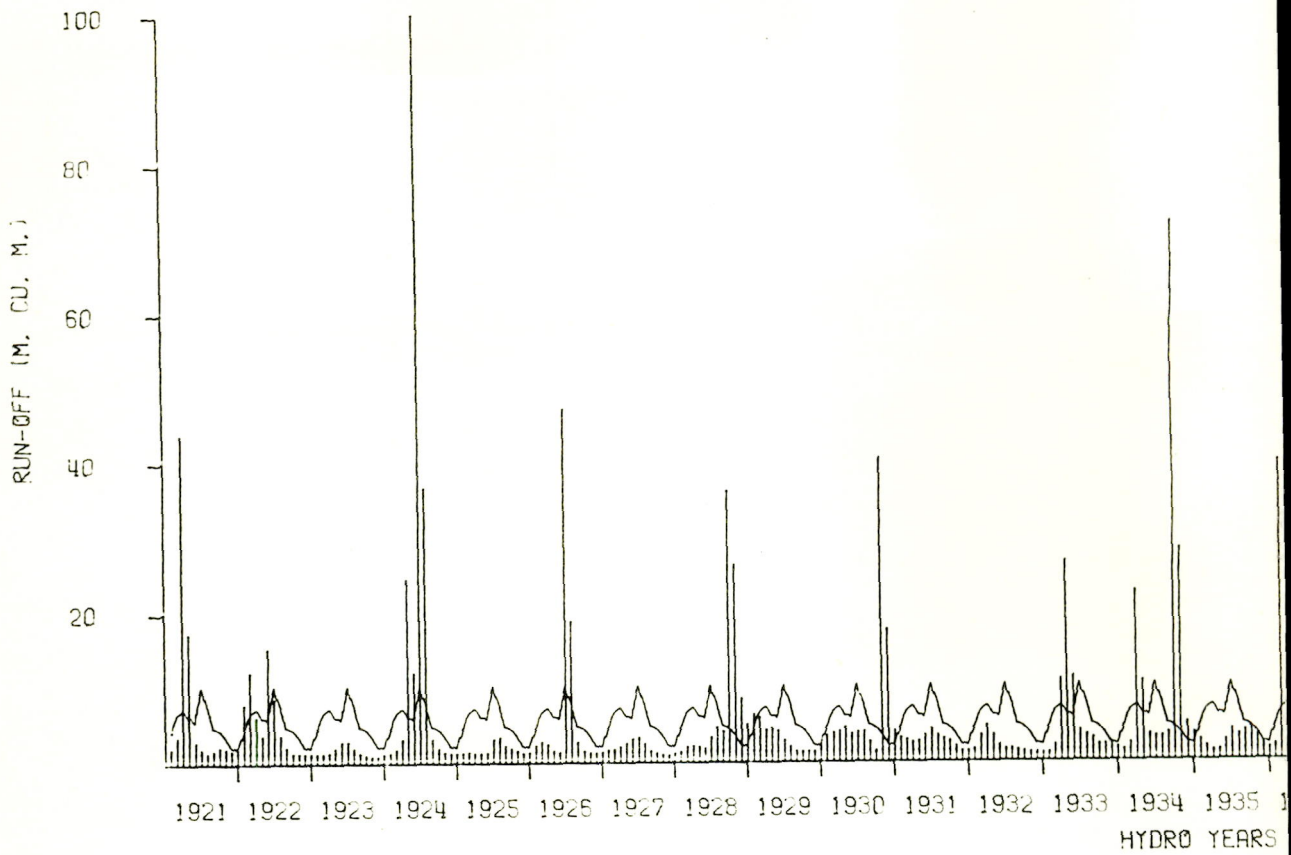
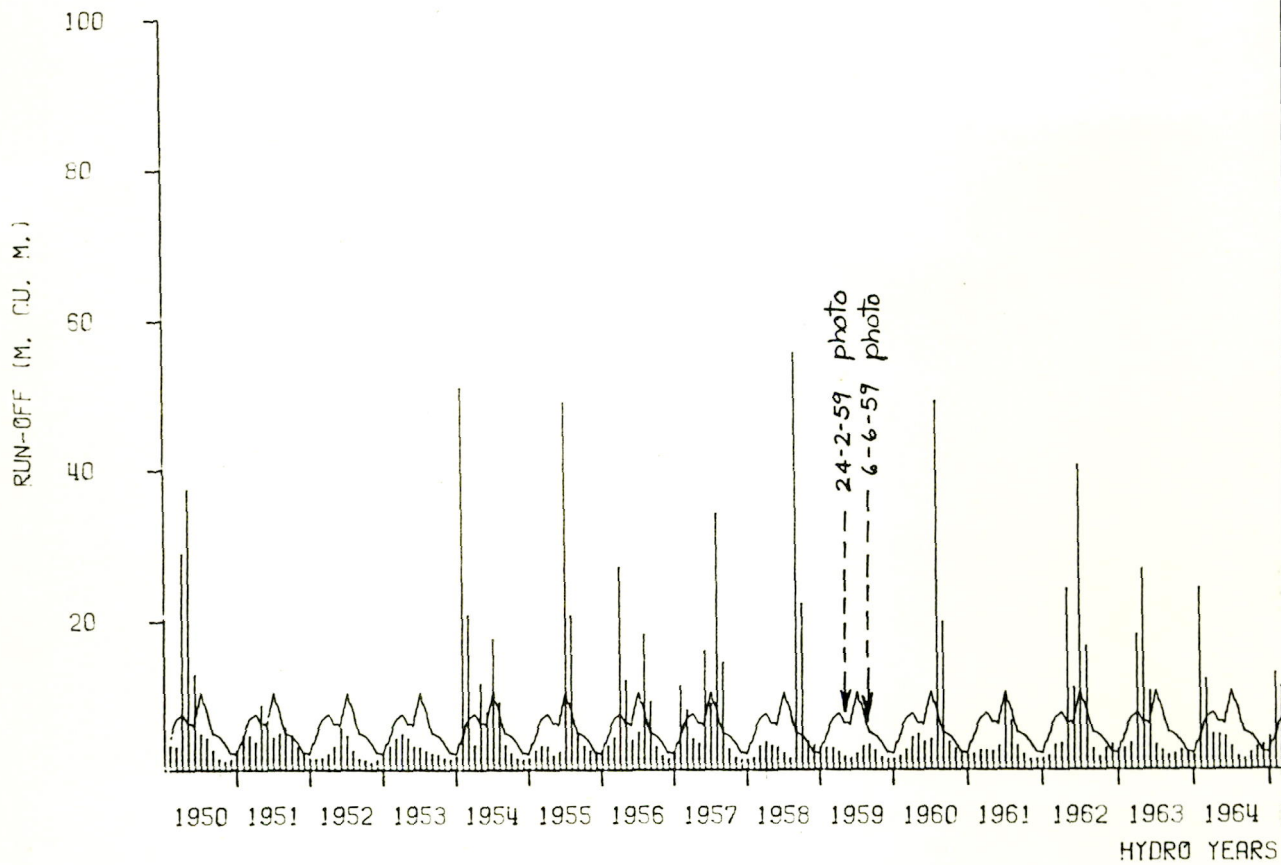
FIGURE
 NS 40/4

NATAL ESTUARIES : MPAMBANYONI
 SIMULATED MONTHLY RUN-OFF
 1921-1975

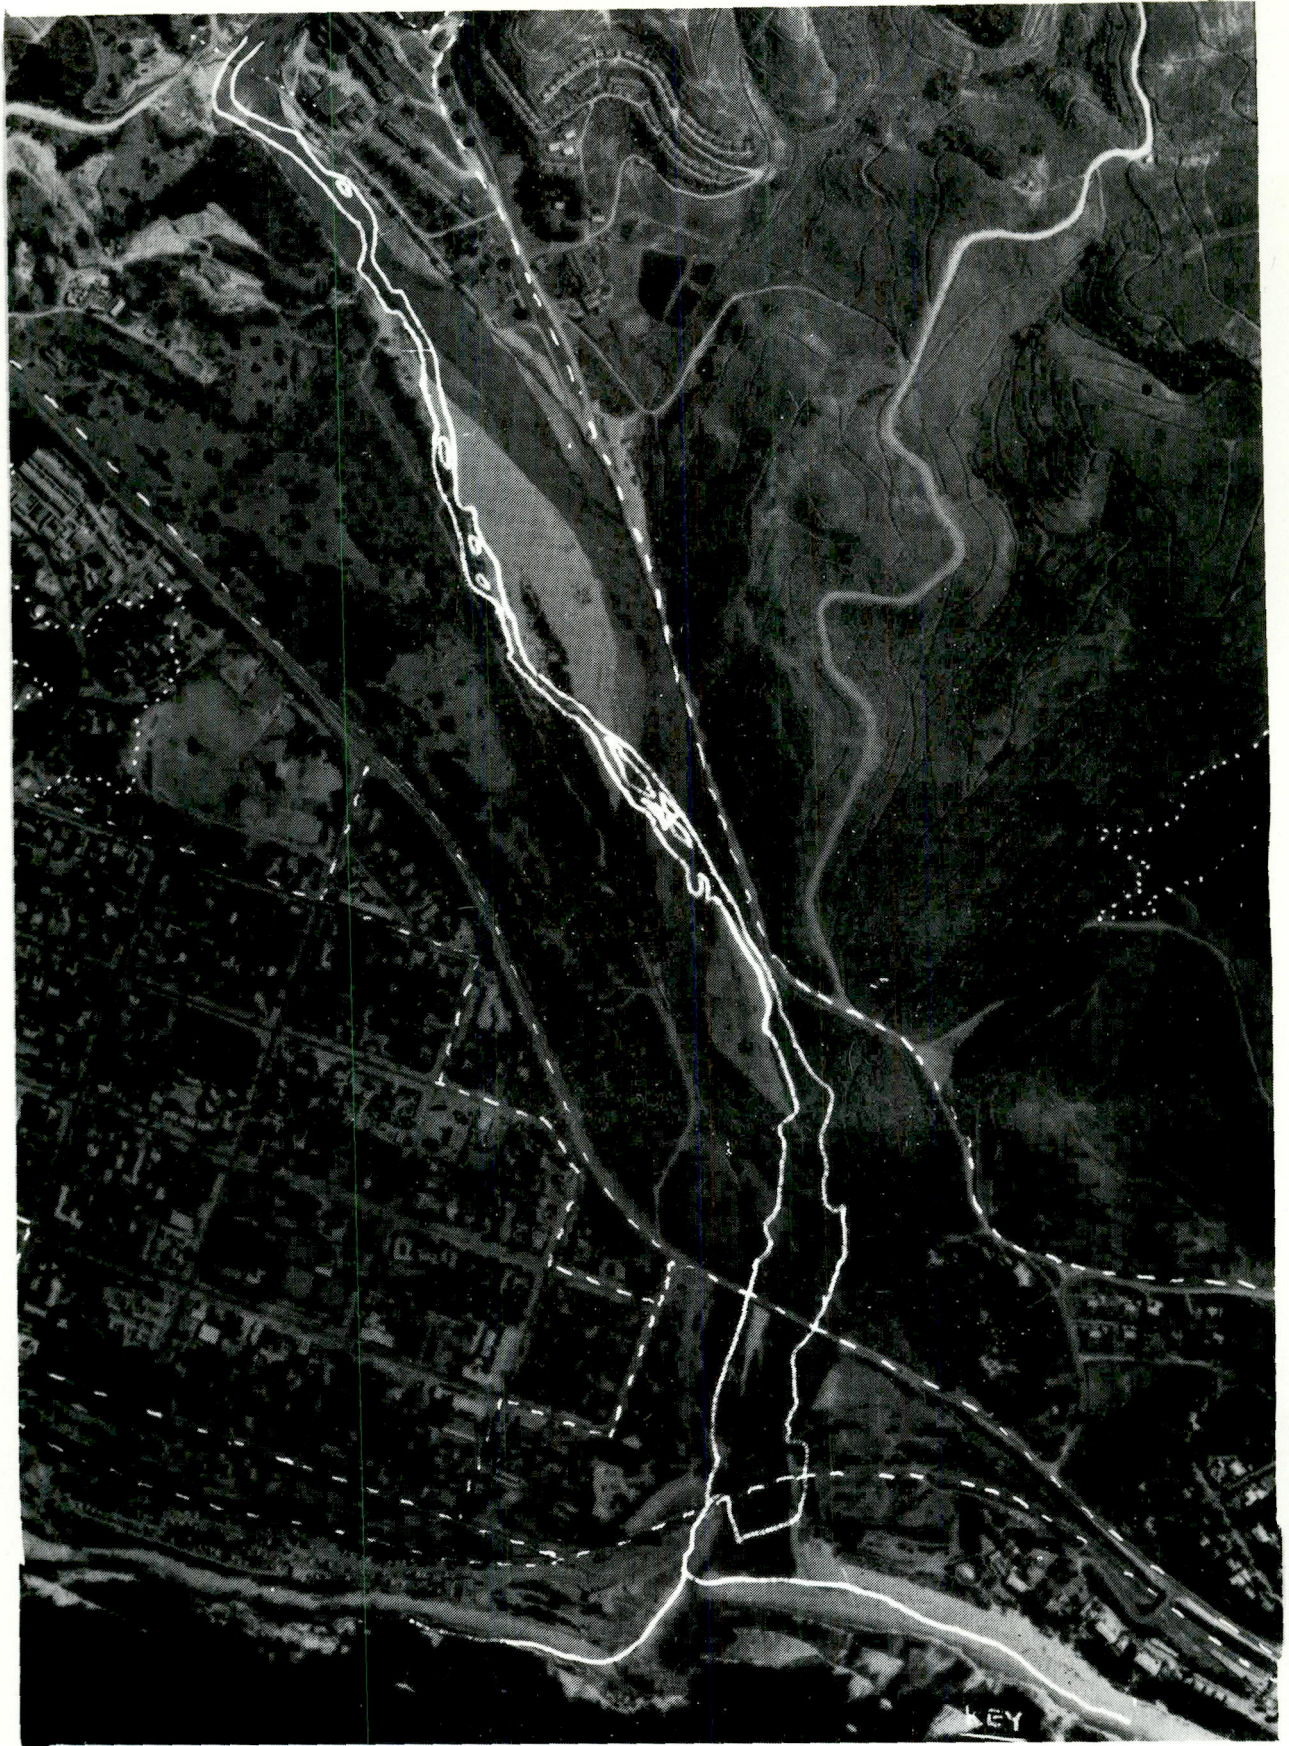
PHOTOGRAPH
NS 40/1

SCALE: 1 : 10 000 approx

NS 40/1	6-7-76 at 12h52 (30-4-37 river course superimposed)
NS 40/2	30-4-37 at 12h30
NS 40/3	24-2-59 at 11h07
NS 40/4	6-6-59 at 13h00
NS 40/5	18-6-67 at 11h31
NS 40/6	12-8-73 at 14h26
NS 40/7	6-7-76 (orthophoto)

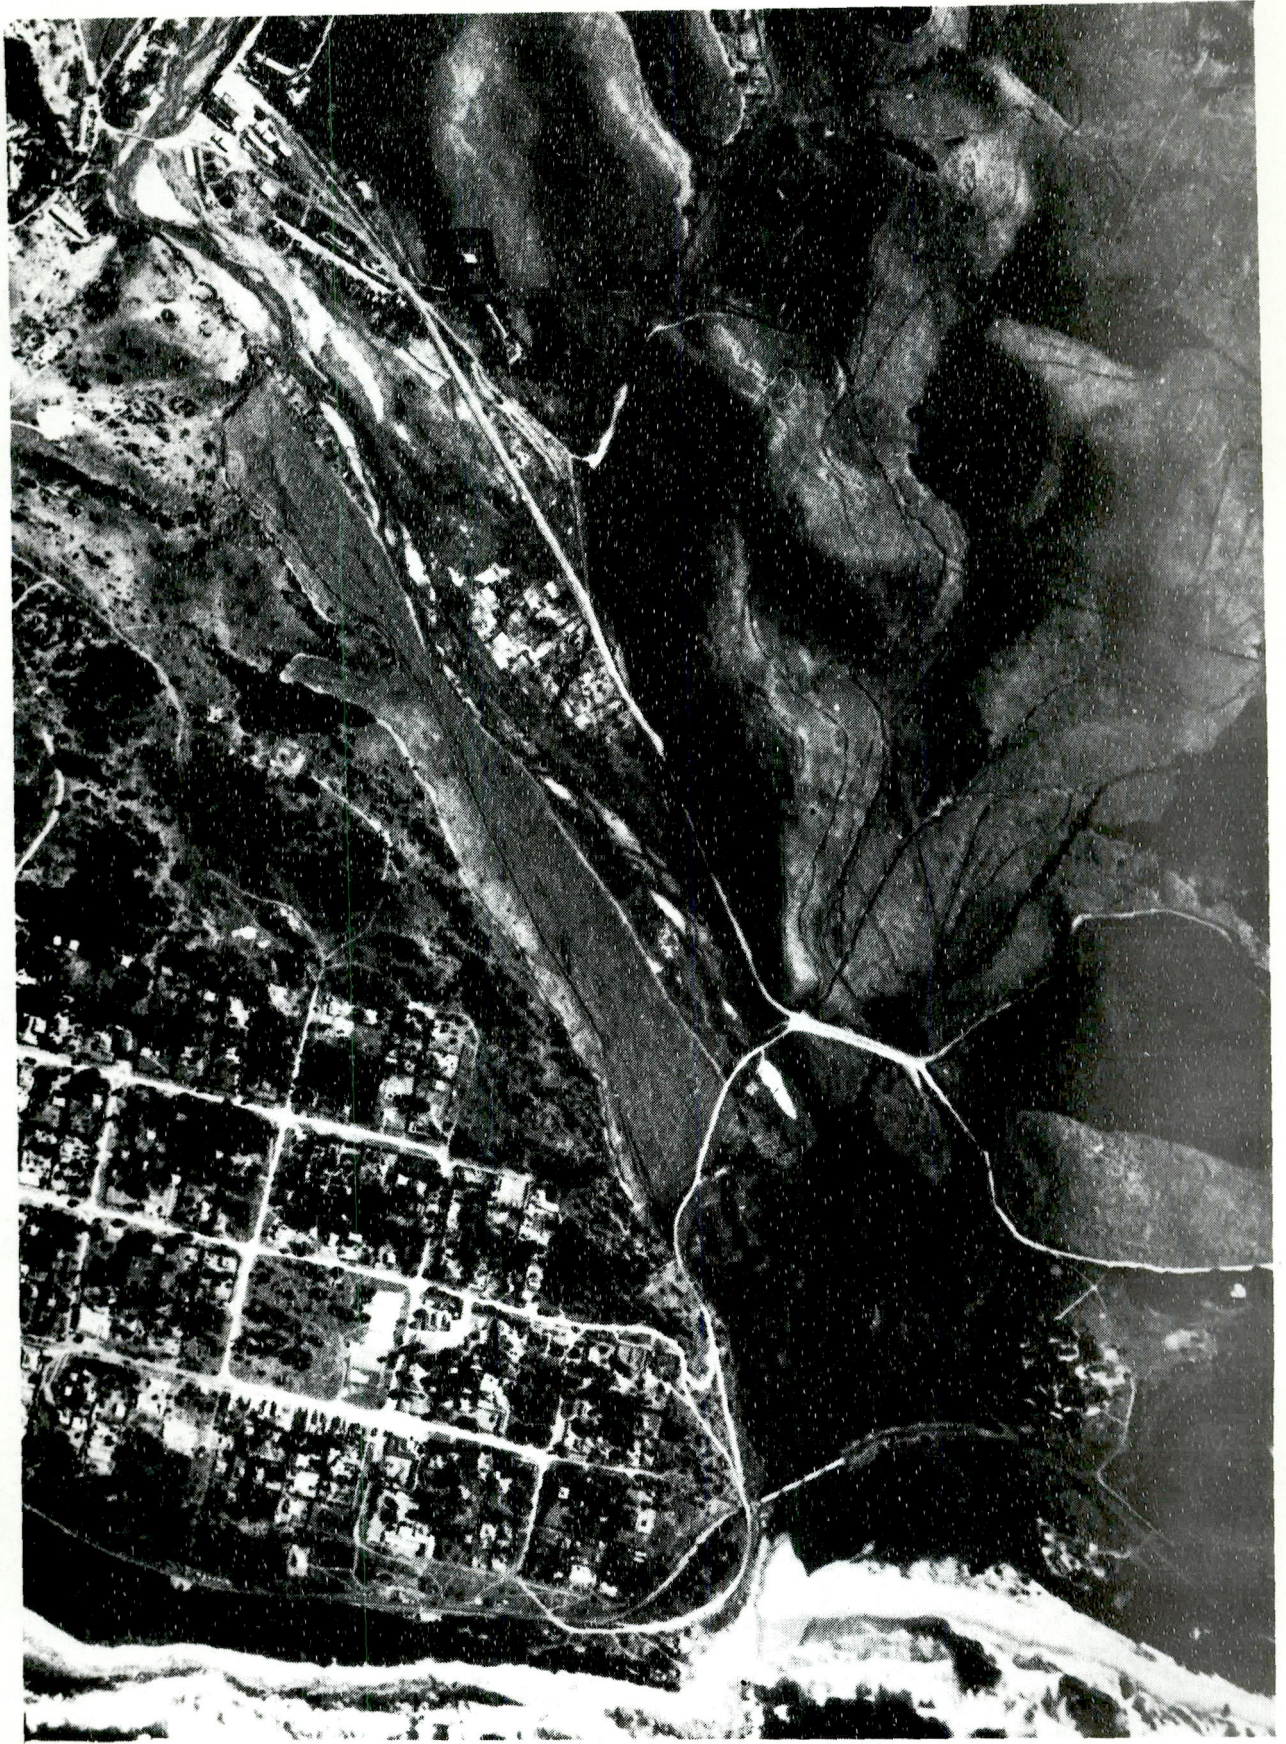
PHOTOGRAPH
NS 40/2

SCALE 1:10 000 approx

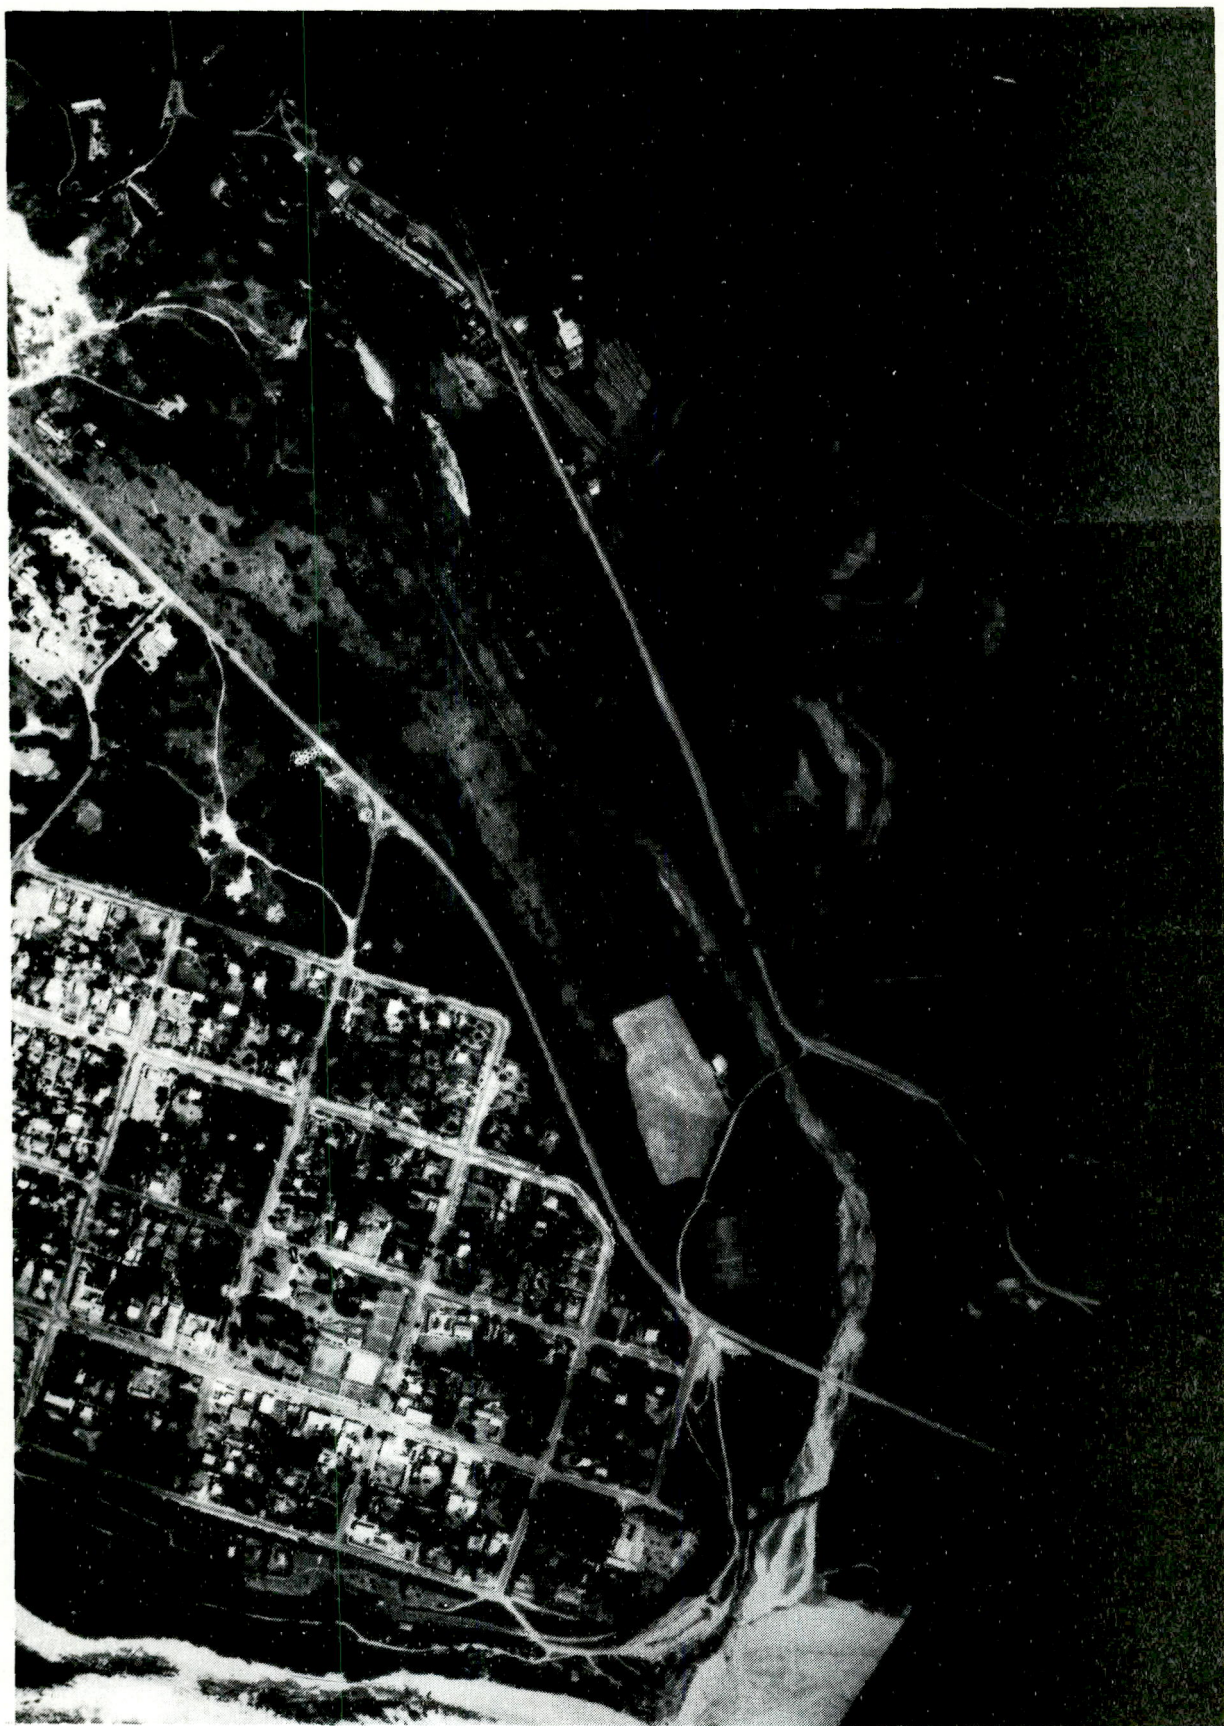
NS 40/3

SCALE 1:10 000 approx.

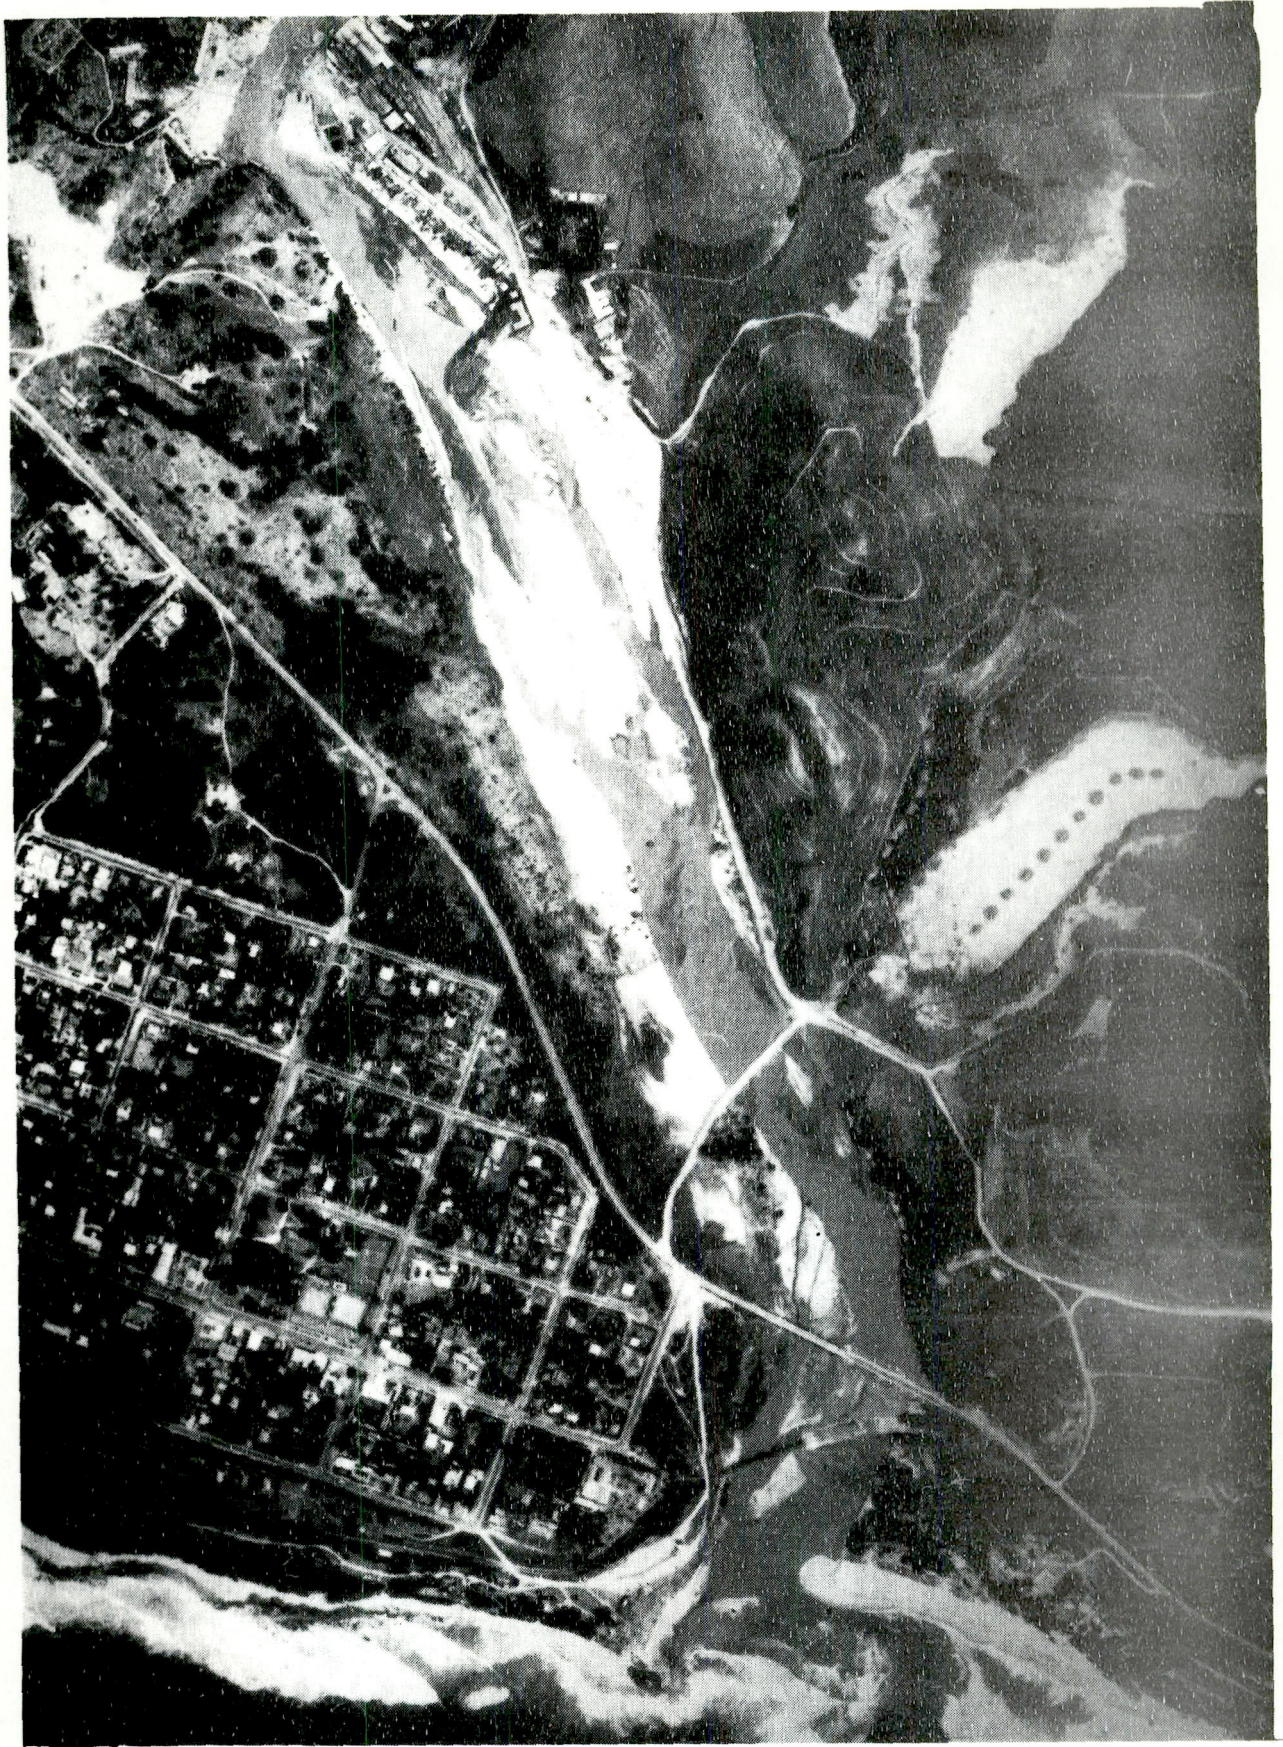
NS 40/4

SCALE: 1:10 000 approx

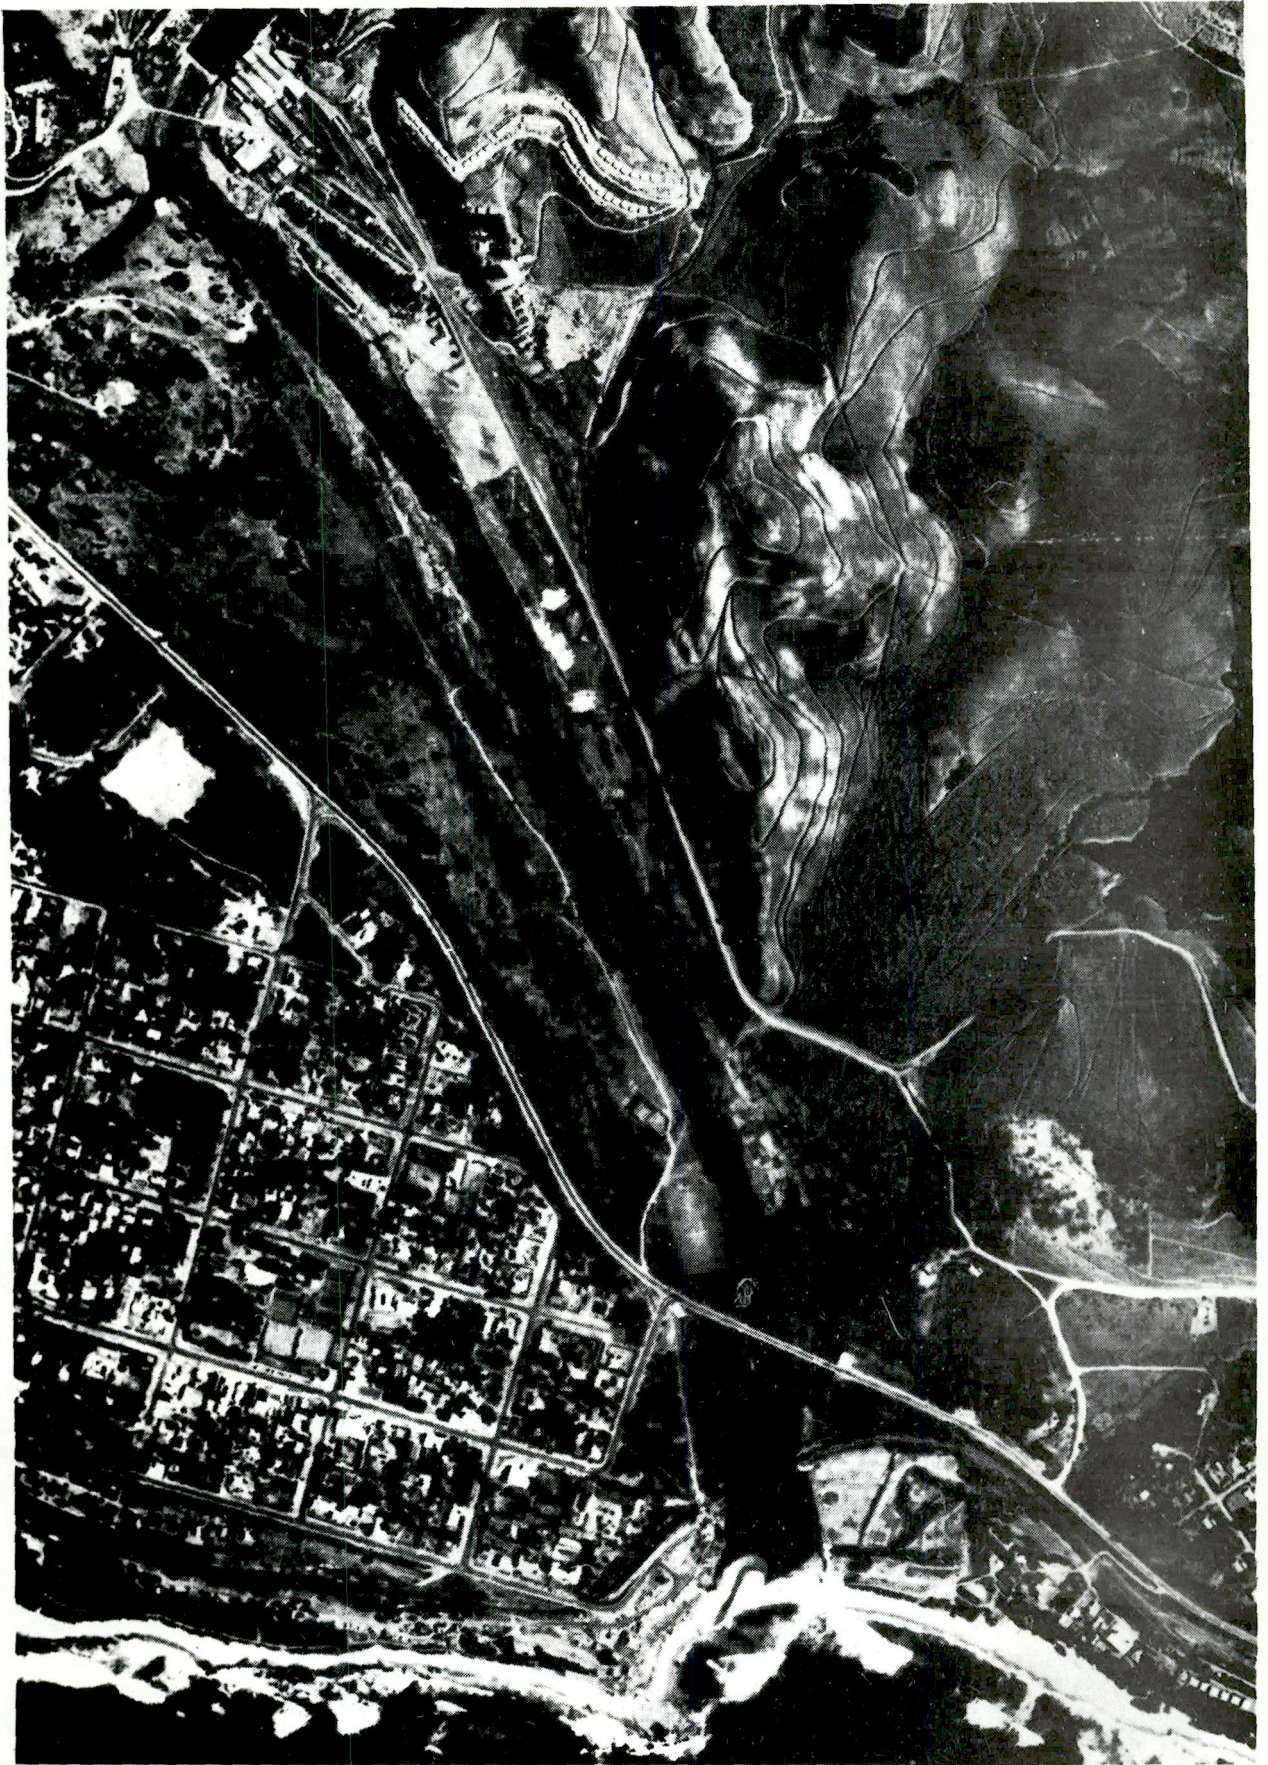
PHOTOGRAPH
NS 40/5

SCALE: 1:10 000 approx.

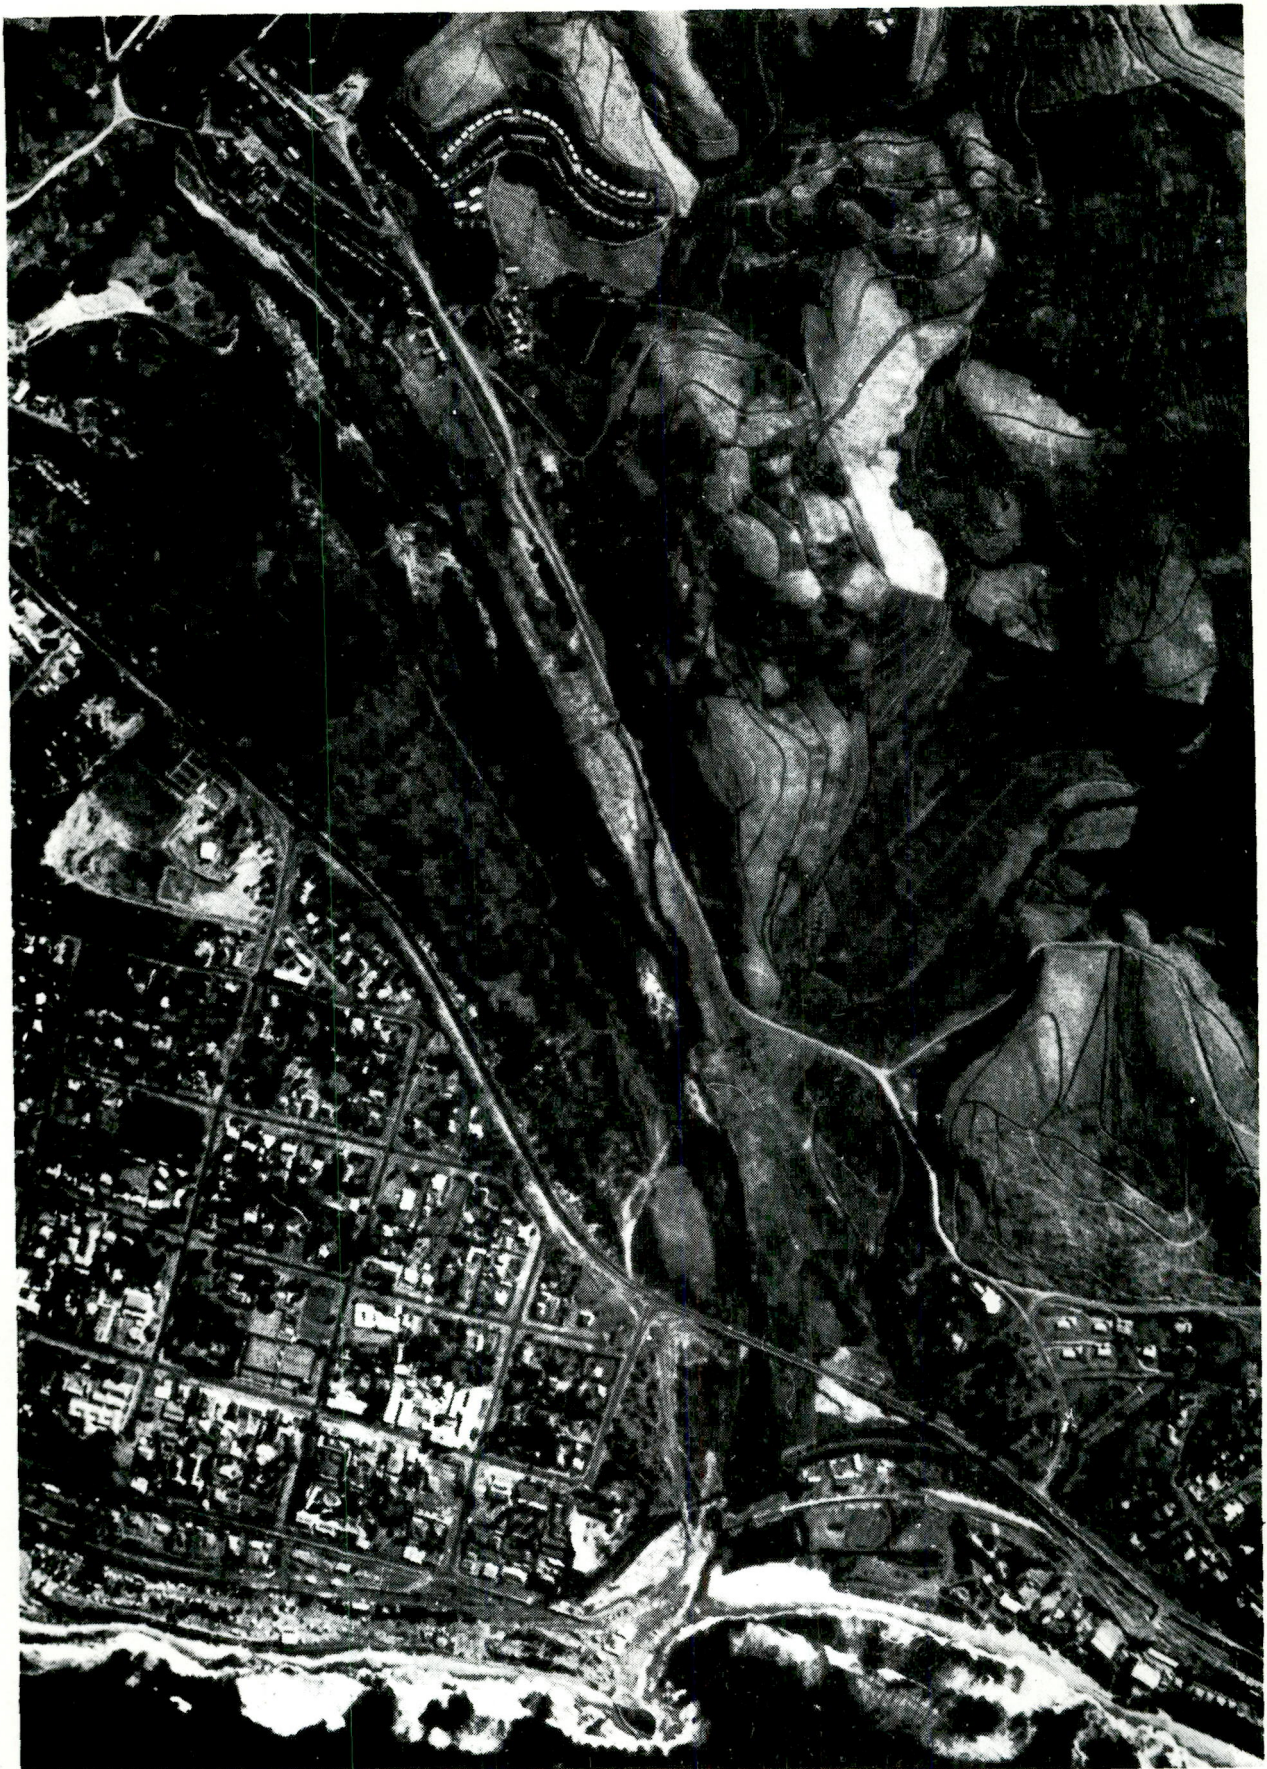
NS 40/6

SCALE 1 : 10 000 approx.

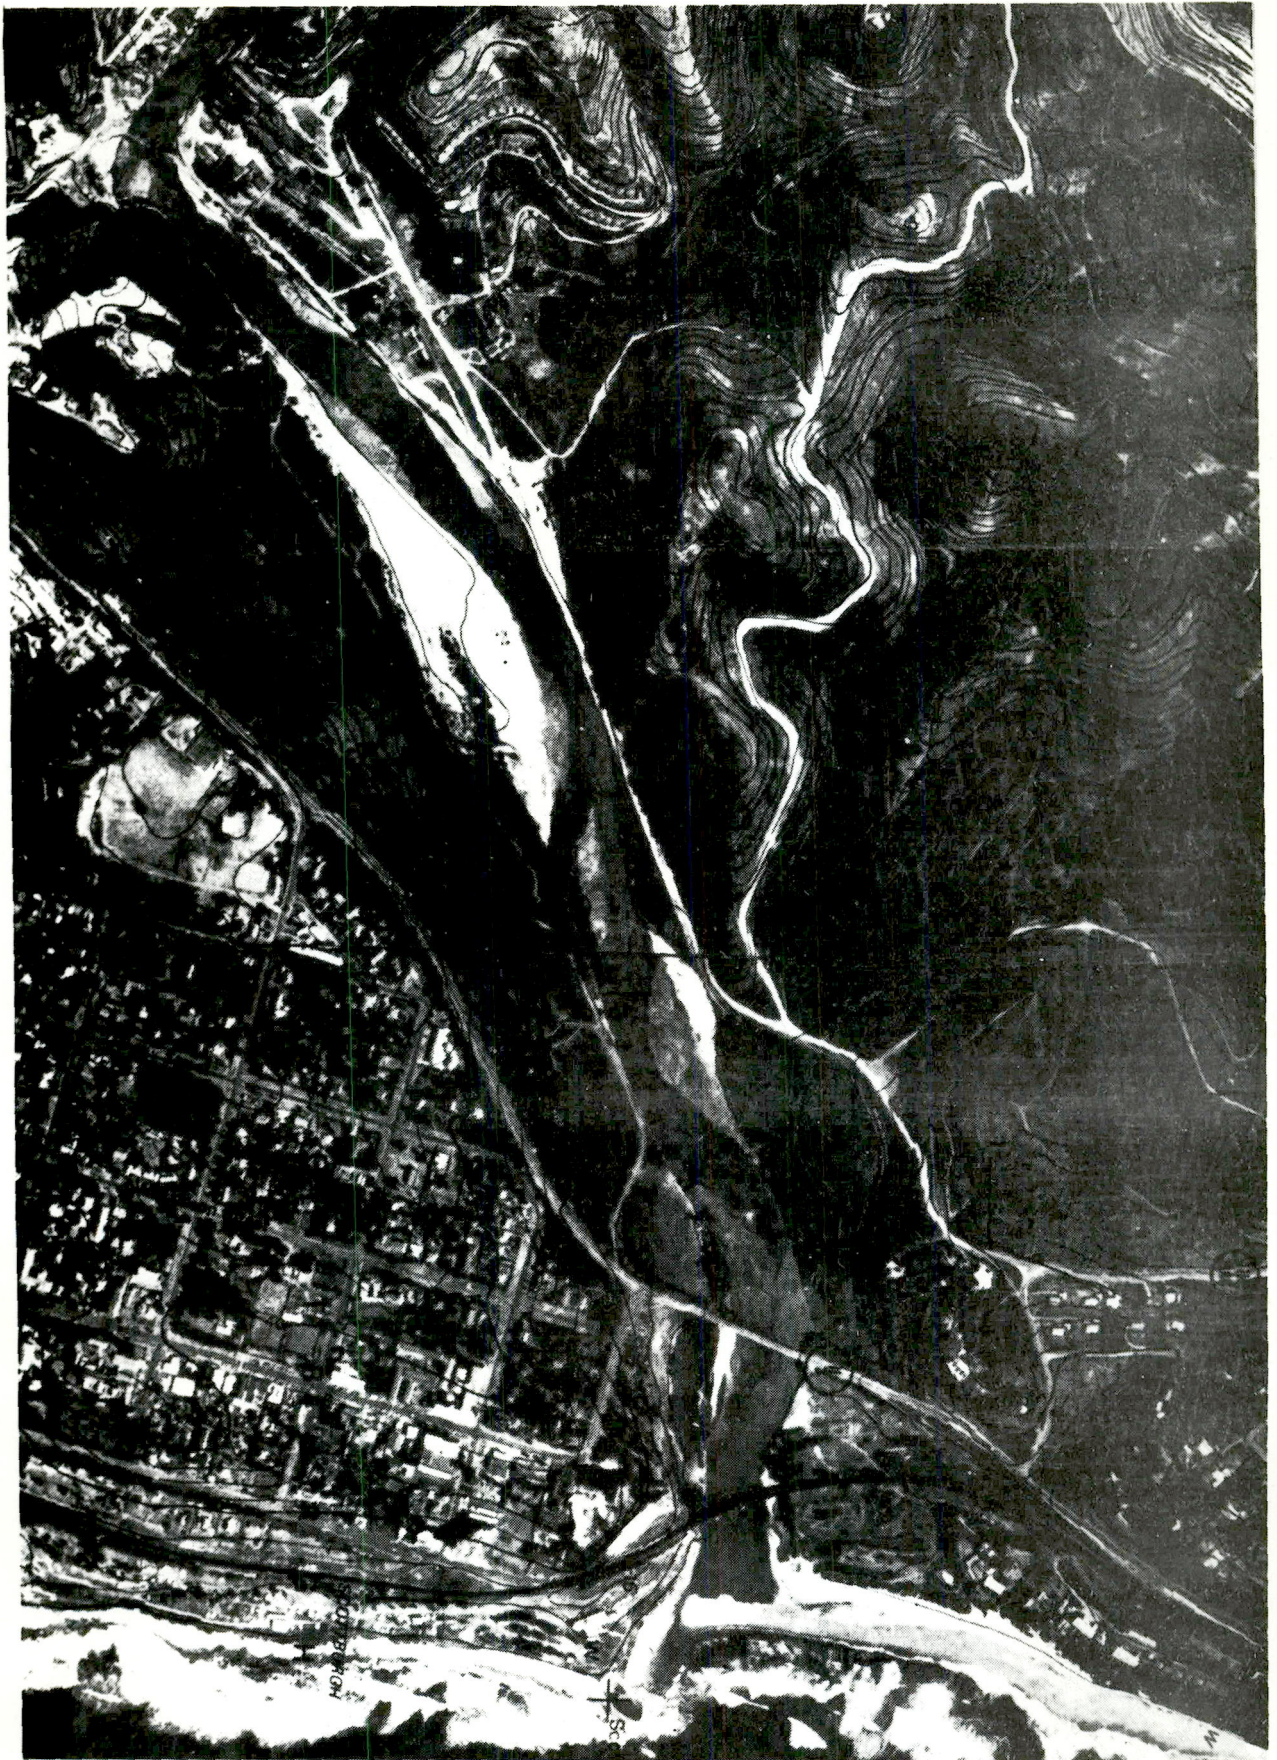
SCALE: 1:10 000 approx
