**HYDROLOGICAL / HYDRAULIC STUDY  
OF NATAL ESTUARIES**

**DATA REPORT No. 13**  
**MHLALI NN5**

NRIO DATA REPORT D8303

Stellenbosch, South Africa  
August 1983

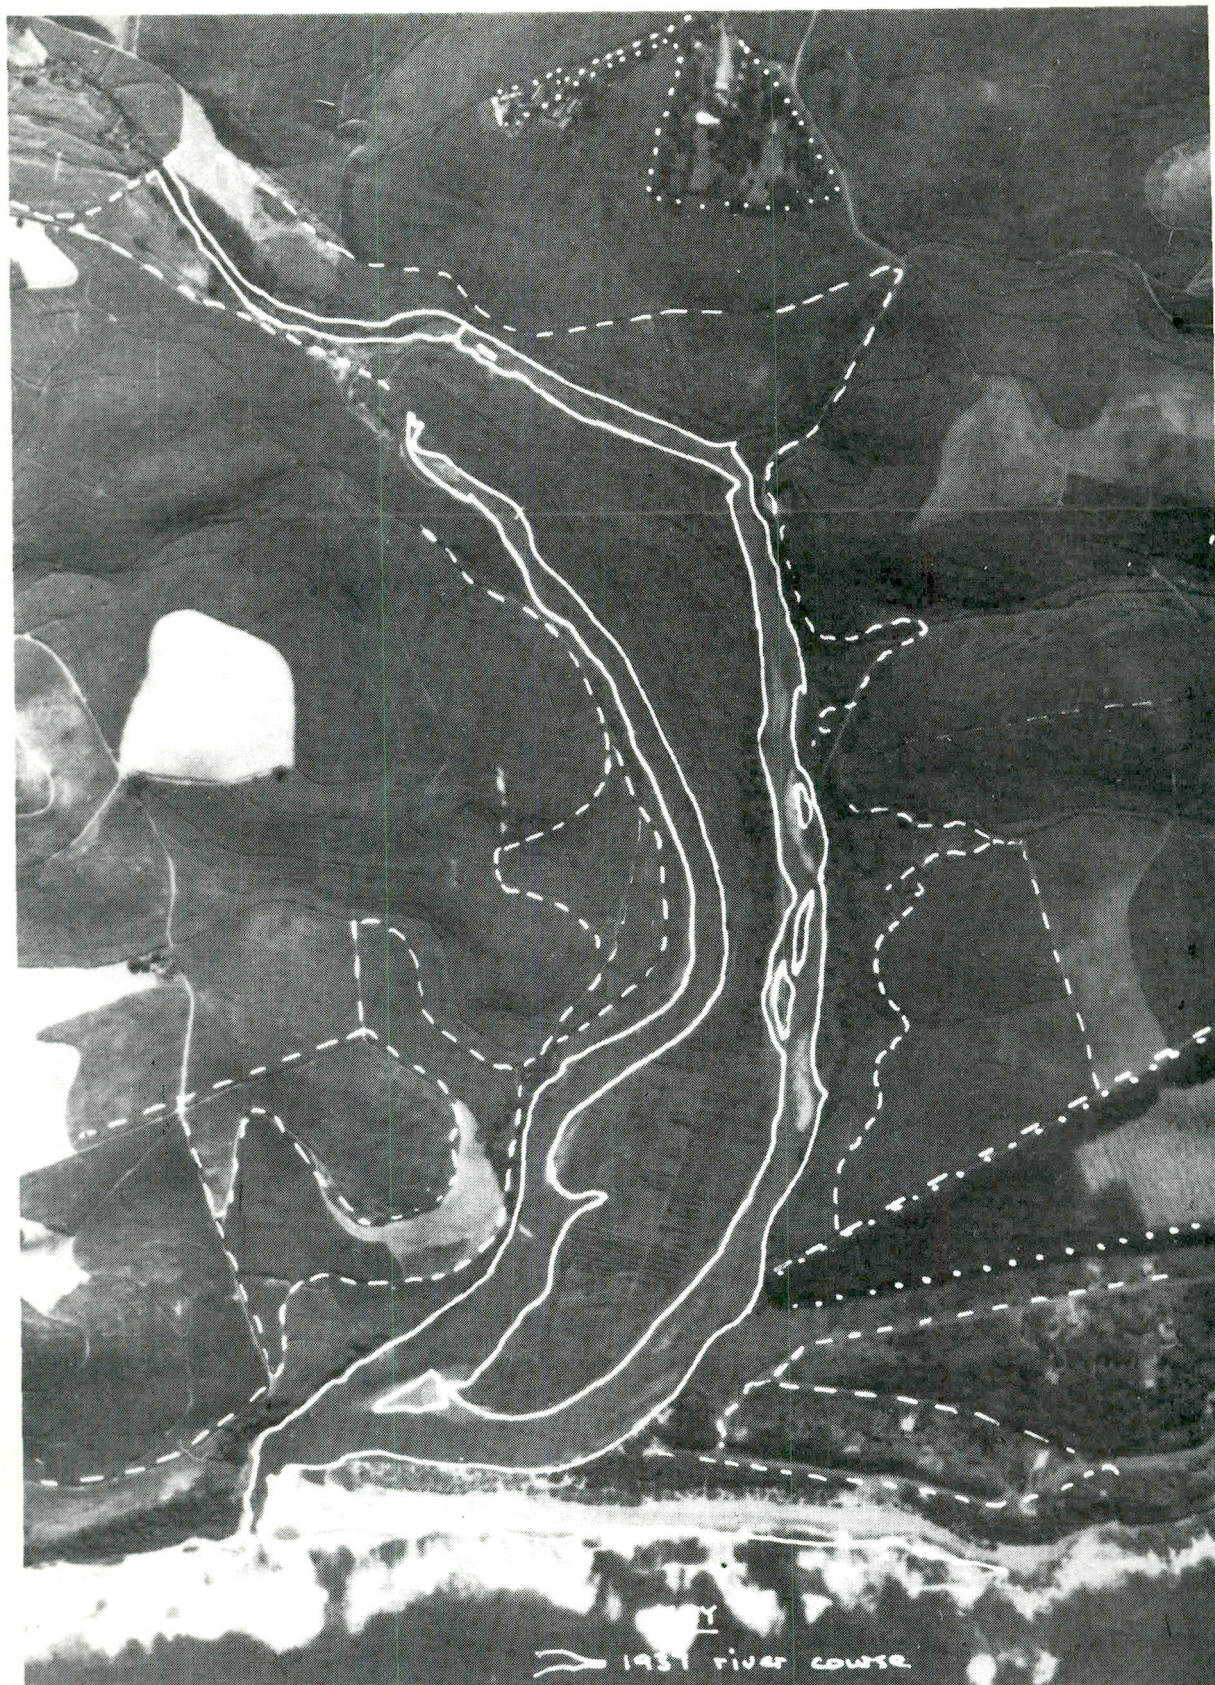
| <p>TRACED JGAN<br/>CHECKED<br/>DATE:<br/>REF</p> | <p>NATAL ESTUARIES MHLALI<br/>14-5-76<br/>(1-5-37 RIVER COURSE SUPERIMPOSED)</p> | <p>PHOTOGRAPH<br/>NN5/1</p> |

Most of the valley sides are under sugar cane. The percentage of the flood plain under sugar cane increased from 32,5% to 48,8% during the period under review and there was some cultivation to the channel edge. There is a weir across the main channel, 500 m from the head of the reach. The 1976 aerial photograph shows sand being excavated from the spit.

(a) Weir across main channel, 500m from head of reach  
(b) Sand extraction from bar (1976 photo)

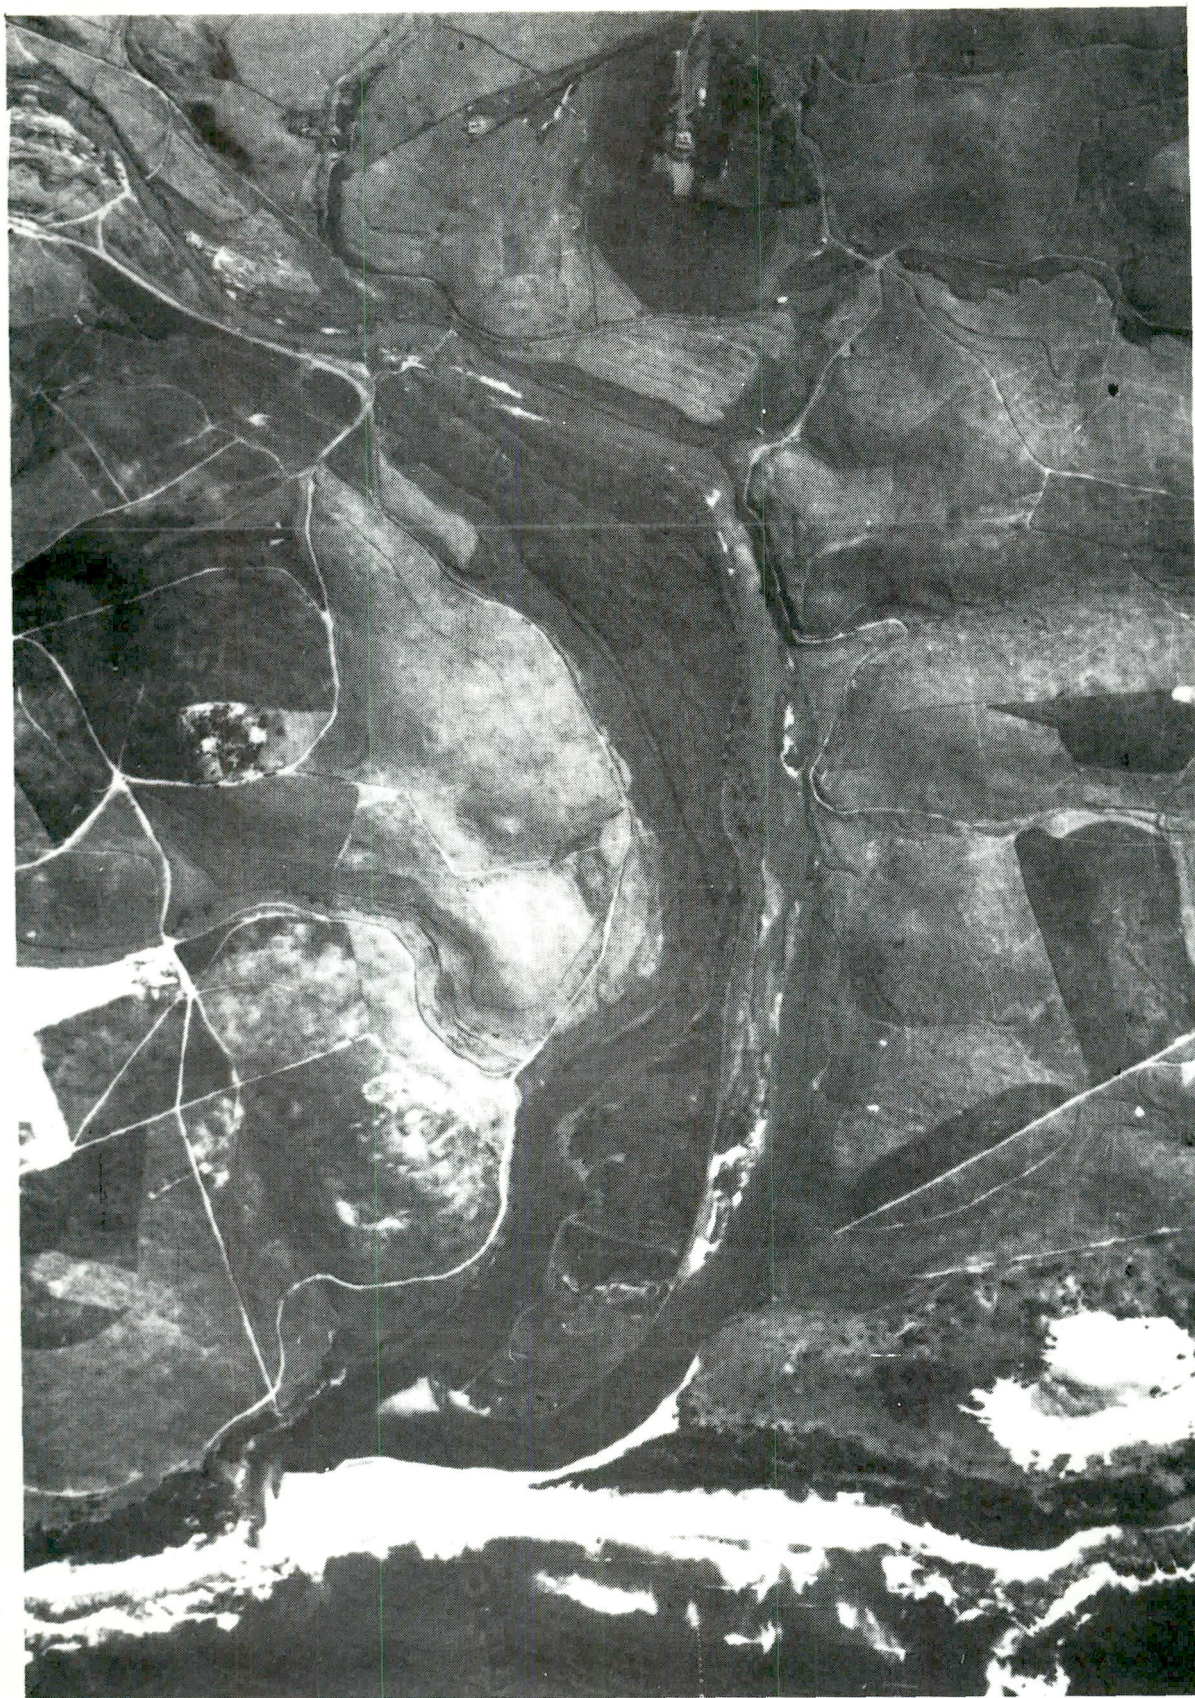
PHOTOGRAPH  
NN5/2

| NN5/2 | 1-5-37 (12h15) |

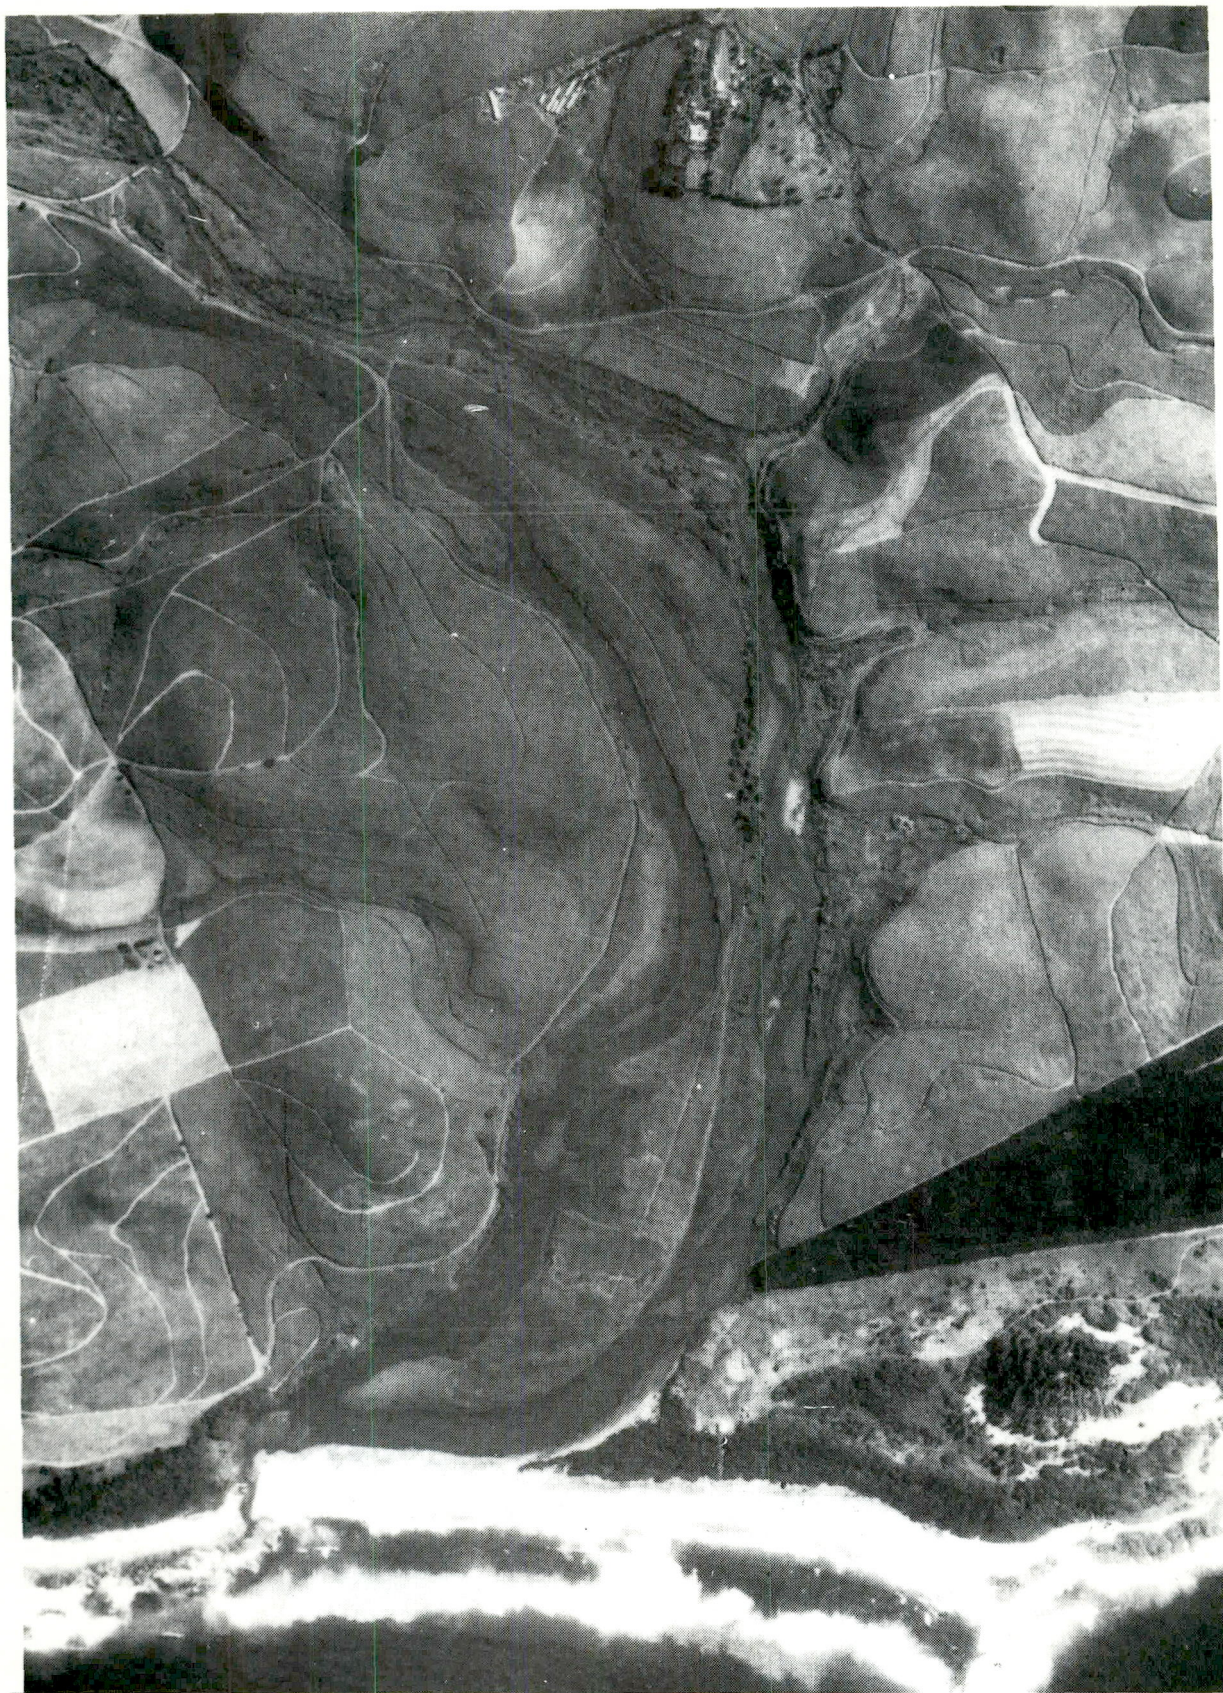
| NN5/3 | 6-6-59 (11h27) |

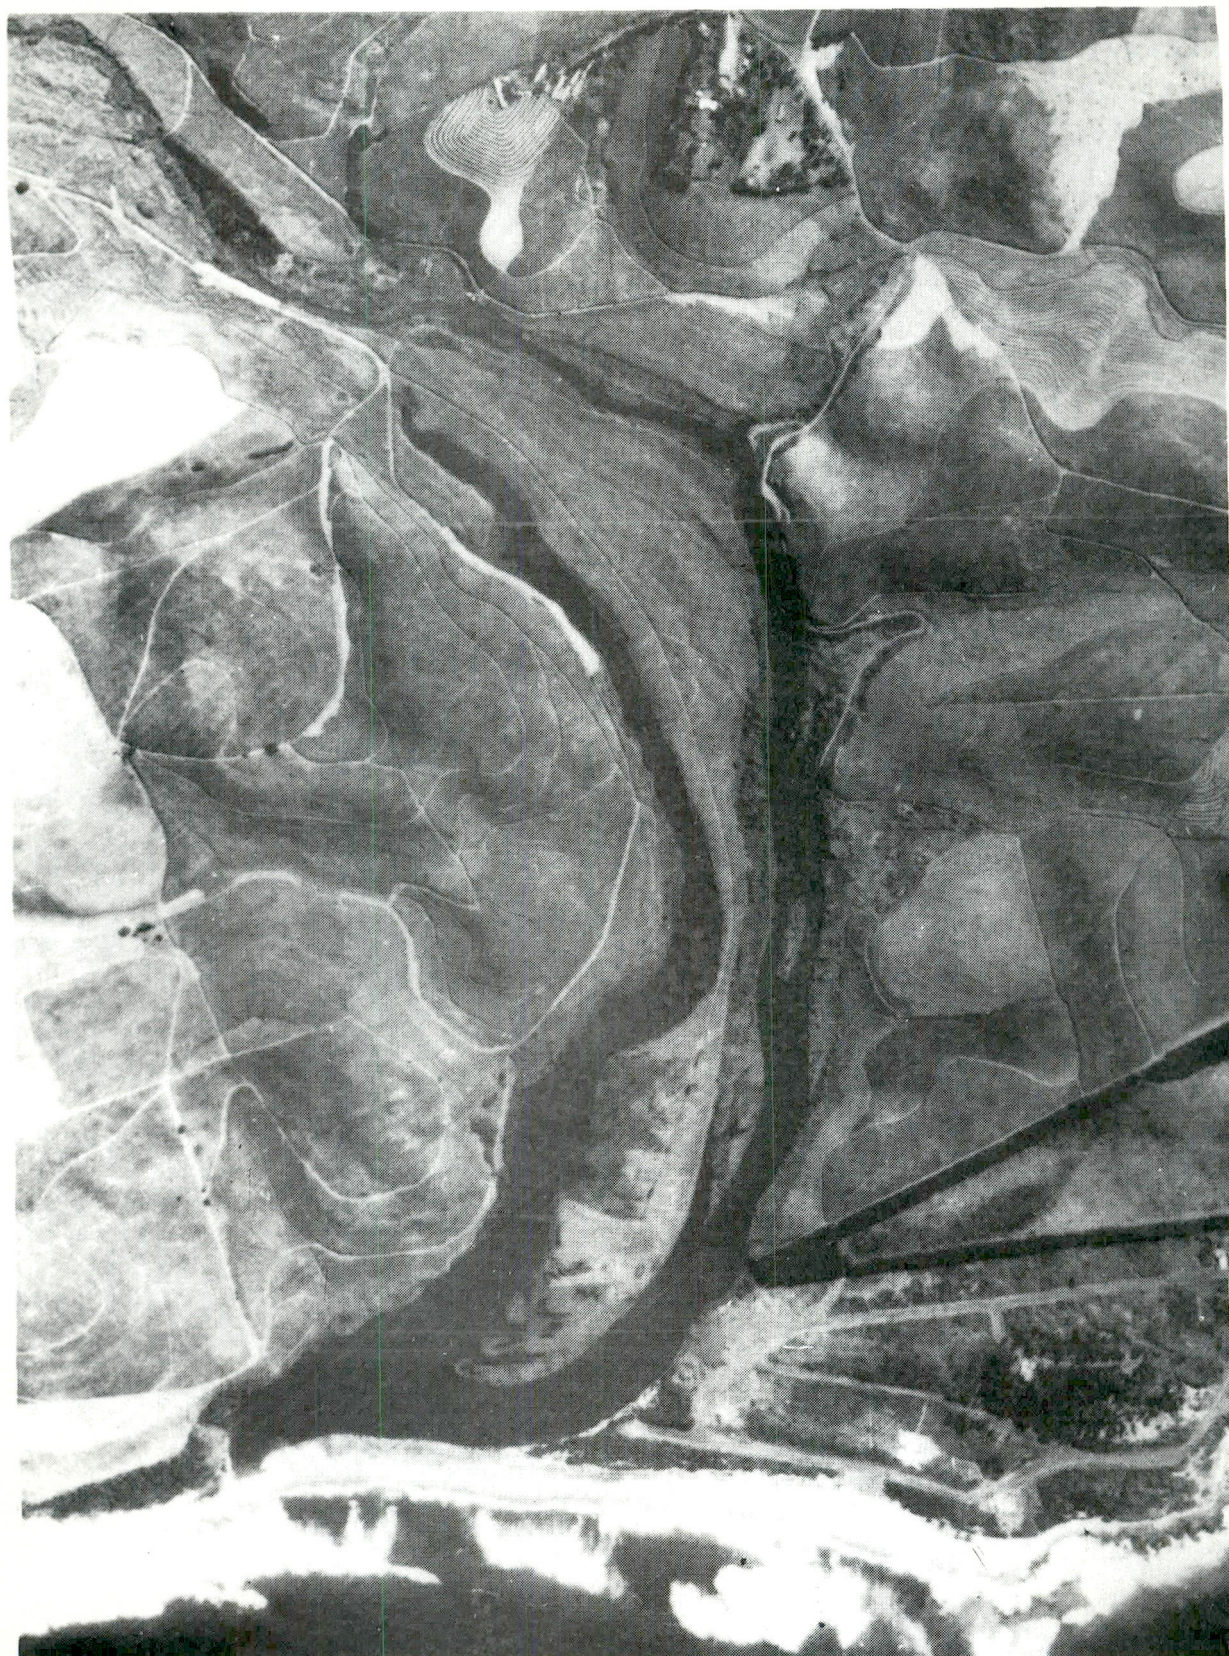
| NN5/4 | 2-8-67 (12h42) |

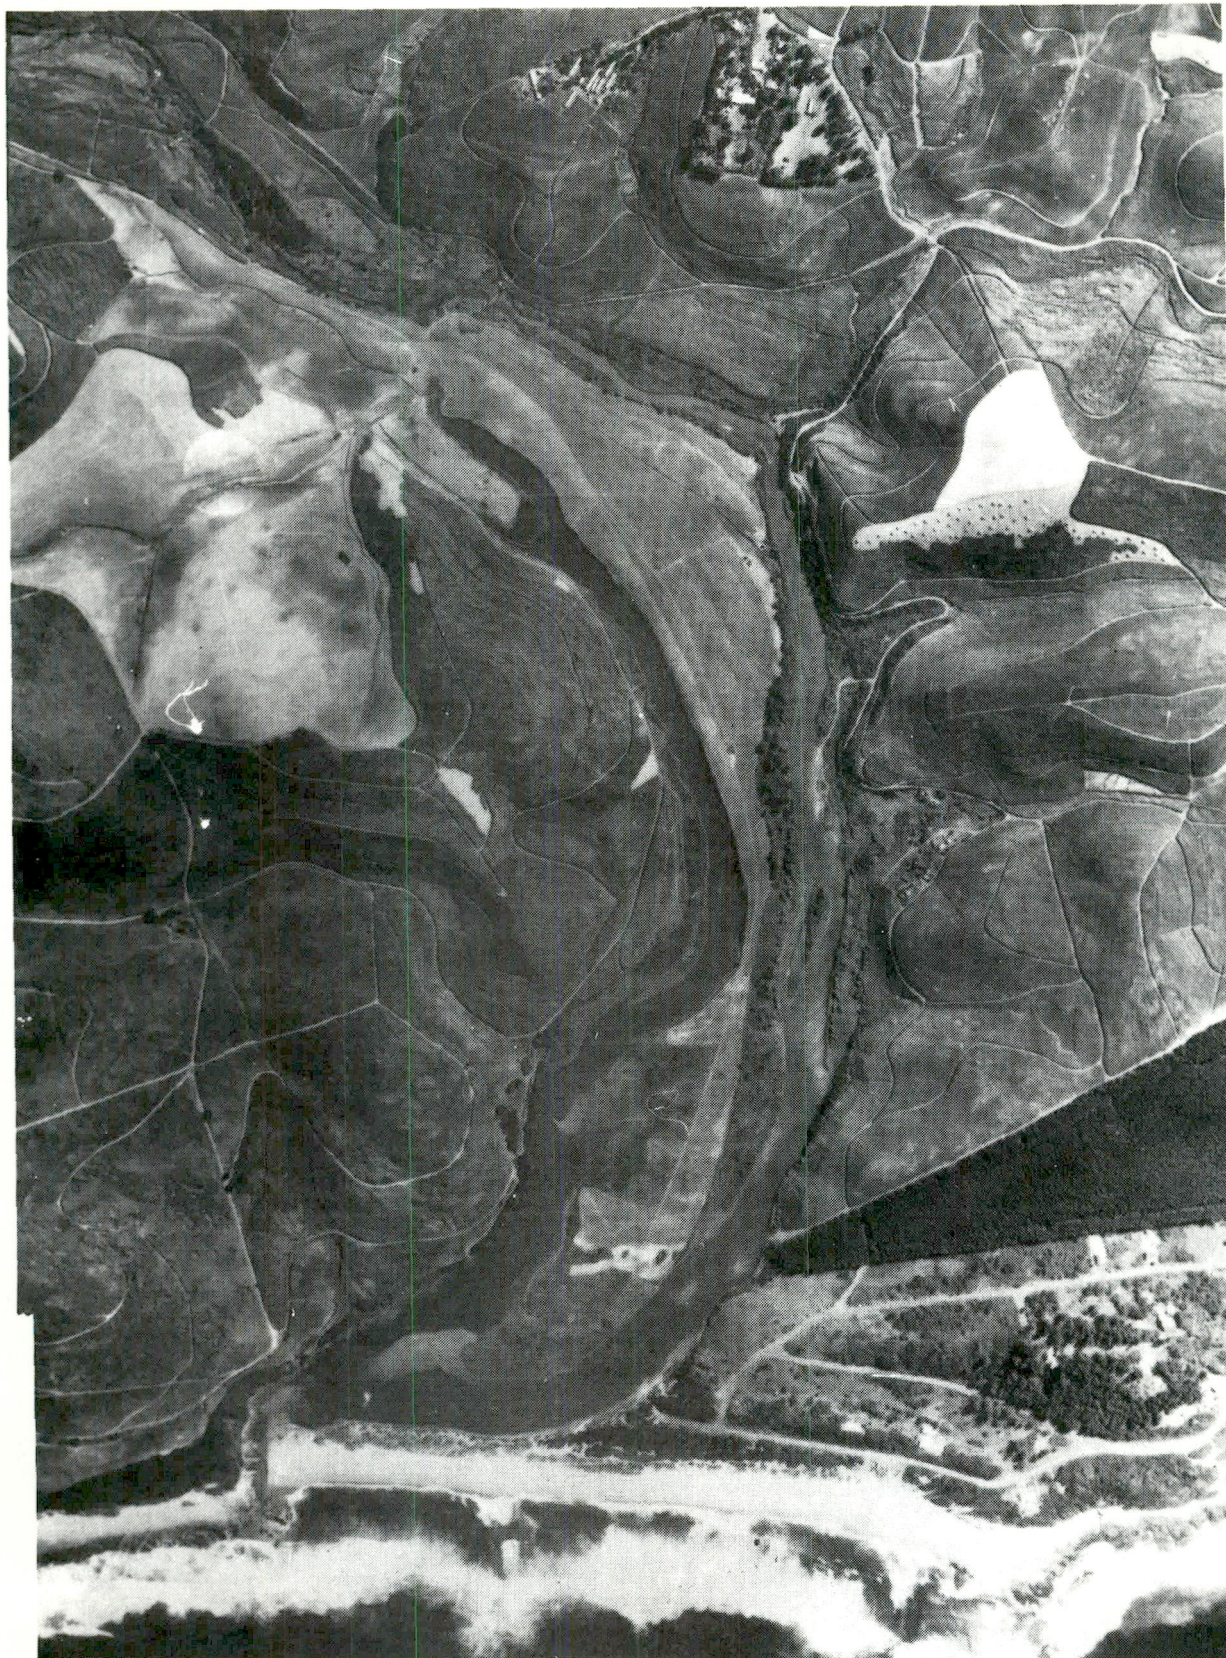
| NN5/5 | 3-6-73 (12h00) |

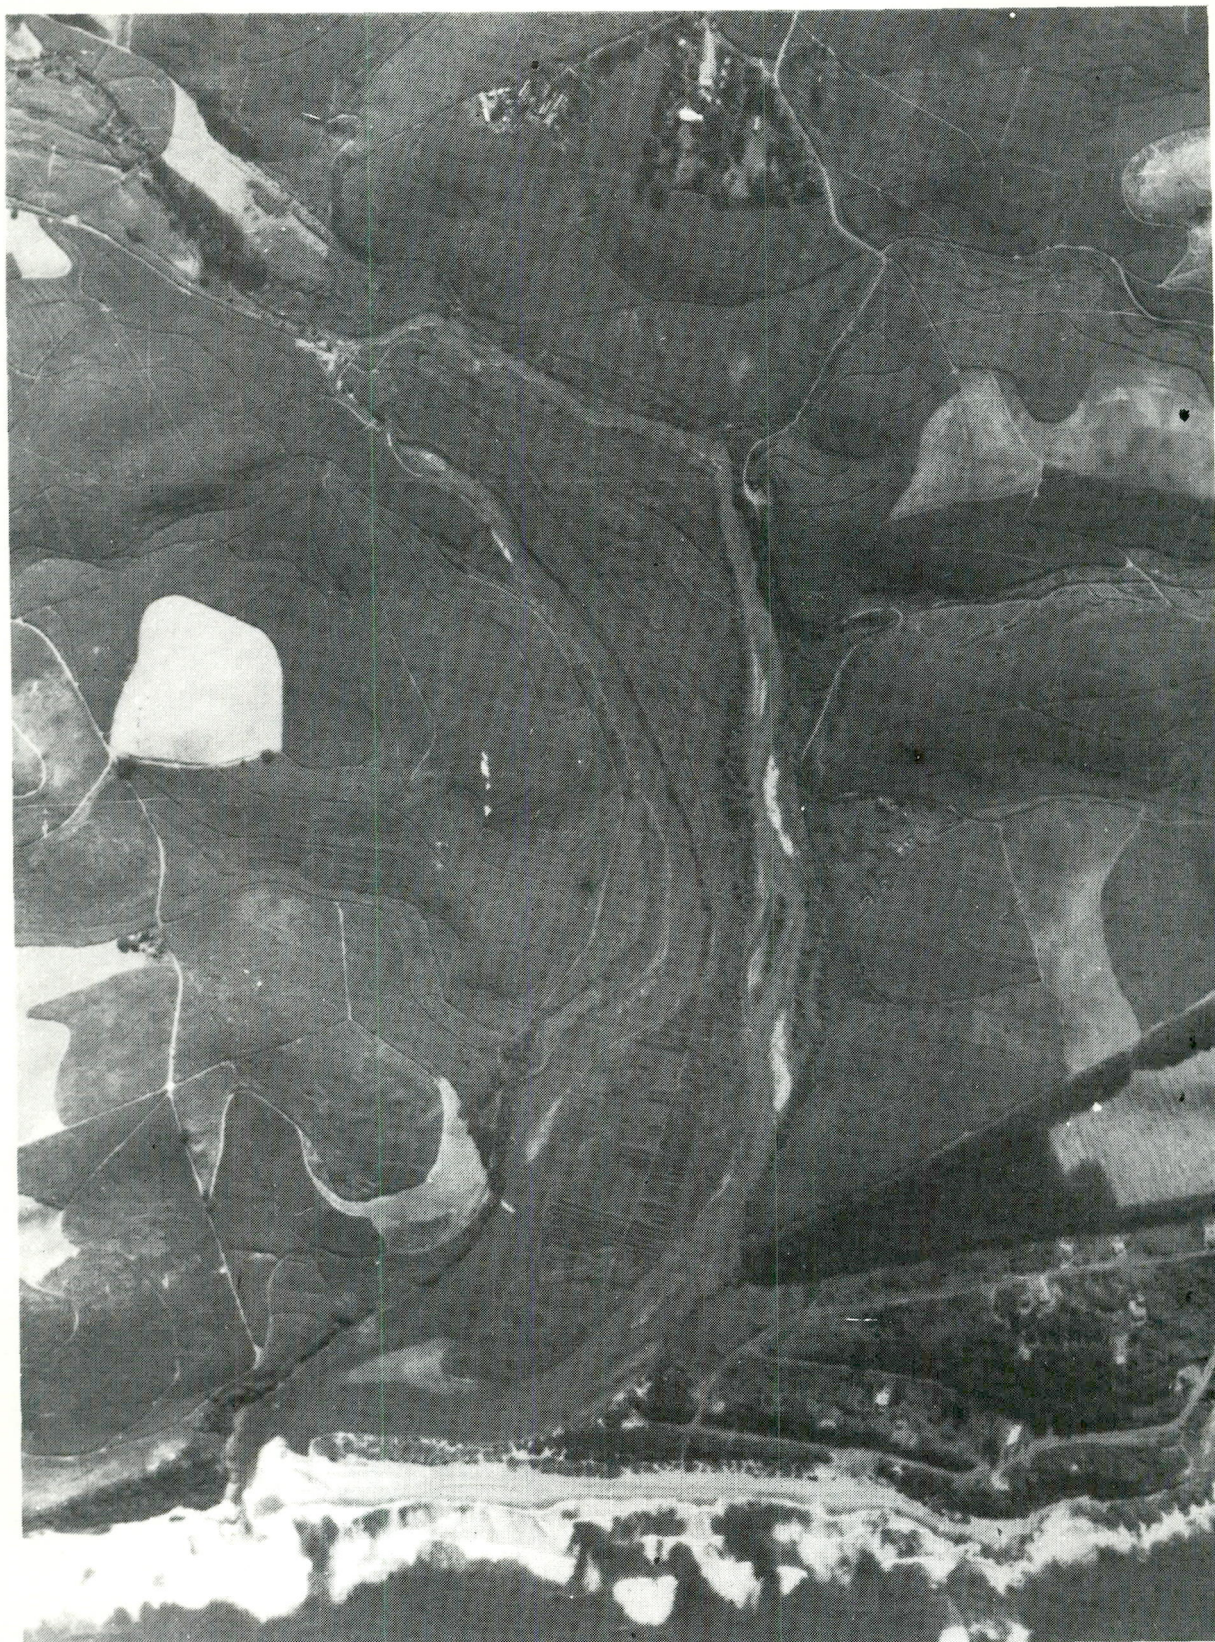
| NN5/6 | 14-5-76 (14h29) |
