**HYDROLOGICAL / HYDRAULIC STUDY  
OF NATAL ESTUARIES**

**DATA REPORT NO. 14  
MTWALUME NS 32**

NRIO DATA REPORT D 8304

Stellenbosch, South Africa  
August 1983

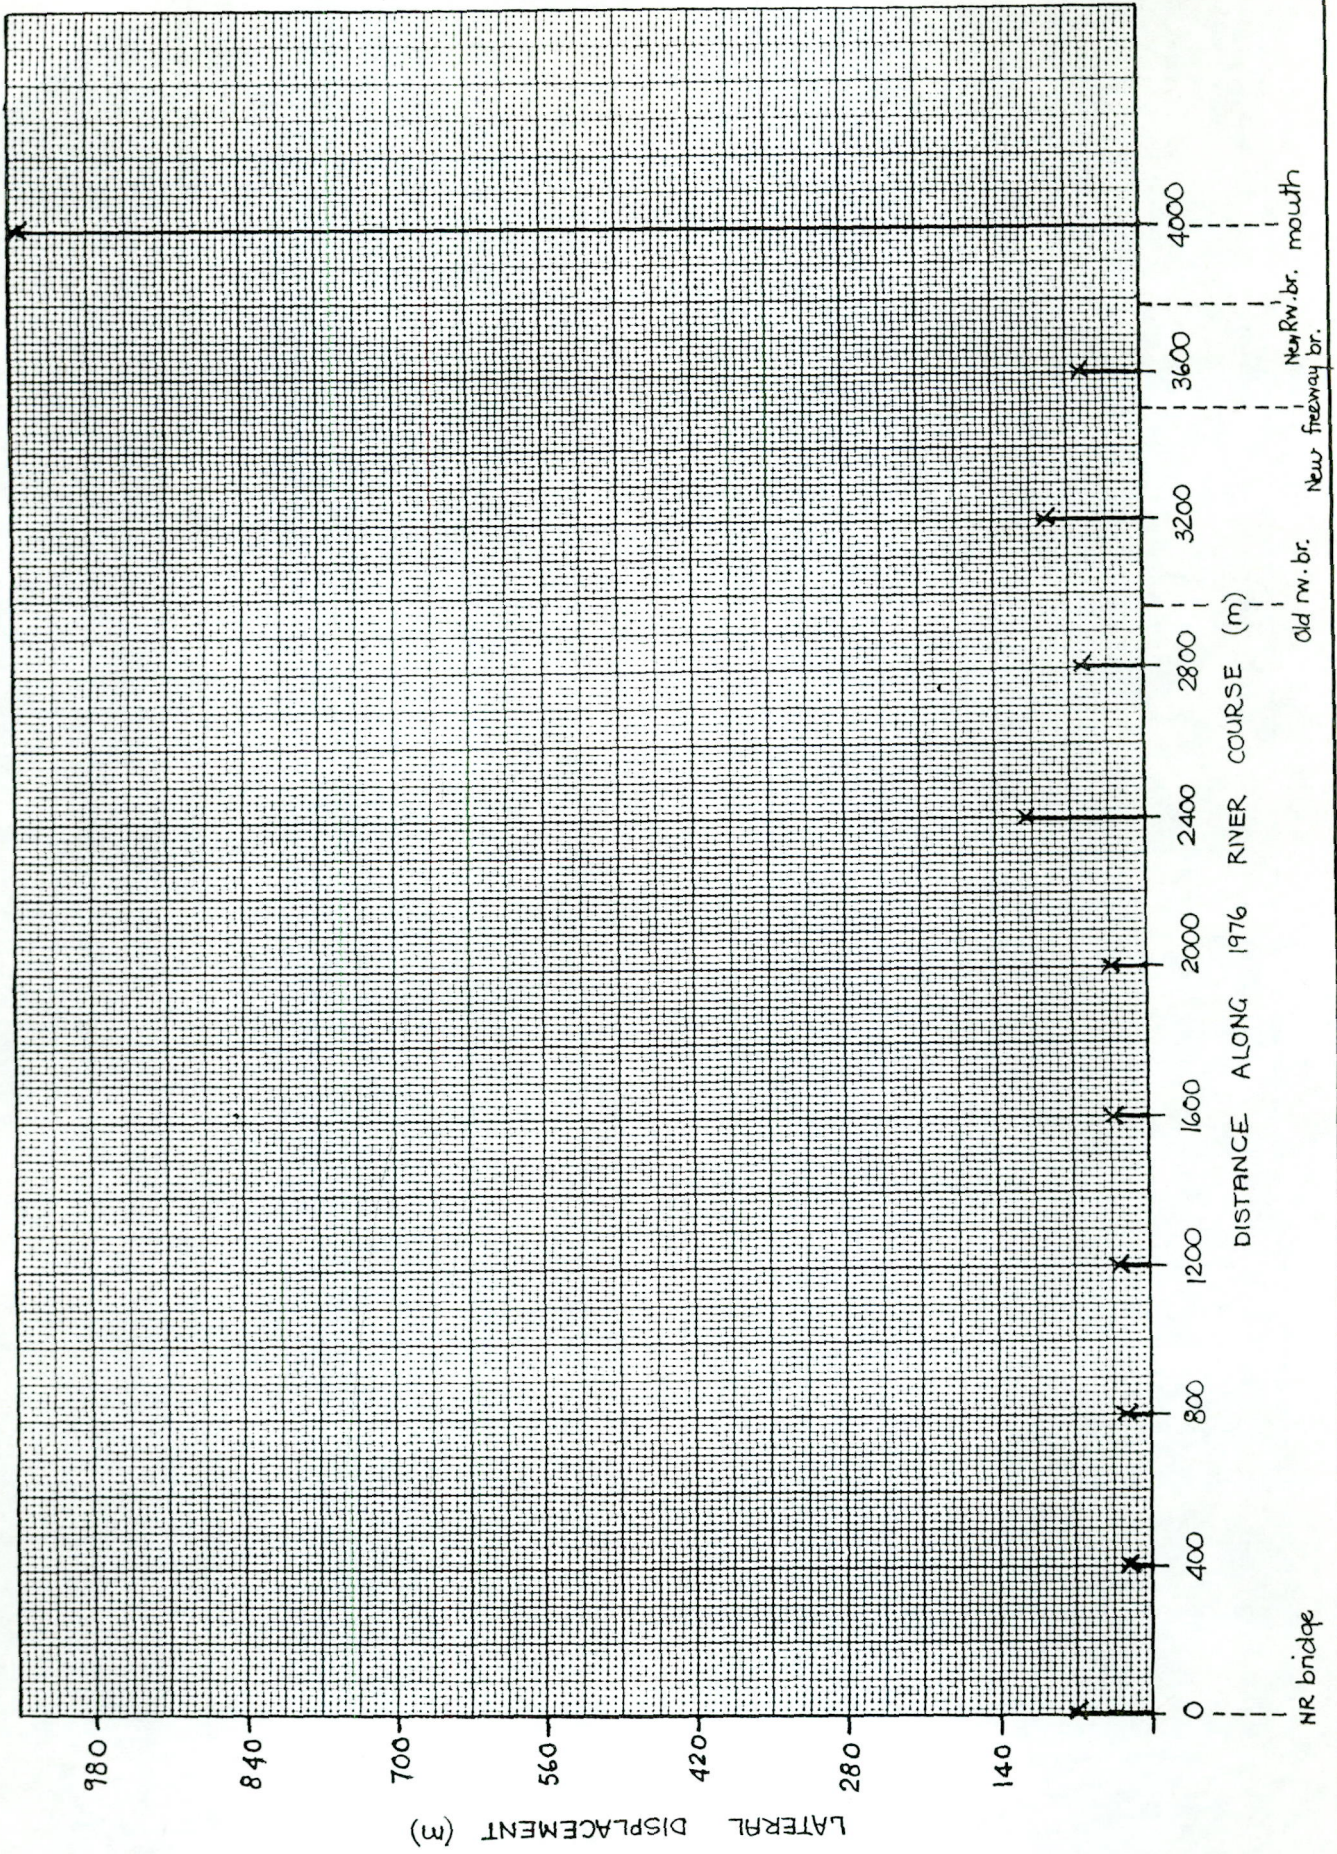
FIGURE  
 NS 32/1

NATAL ESTUARIES: MTWALUME  
 THALWEG DISPLACEMENT: 1937-1976

of 138,5 m with a high average coefficient of variation of 38% (Table NS 32/IX) Thalweg displacement is shown in Figure NS32/1 and even allowing for the marked influence of the migration of the mouth, the lateral displacement is considerable. Changes in river widths and open water areas chiefly reflect the influence of major floods, and changes in sinuosity are largely a result of varying mouth conditions and positions. The reduction in estuarine length shows aggradation (vertical instability).

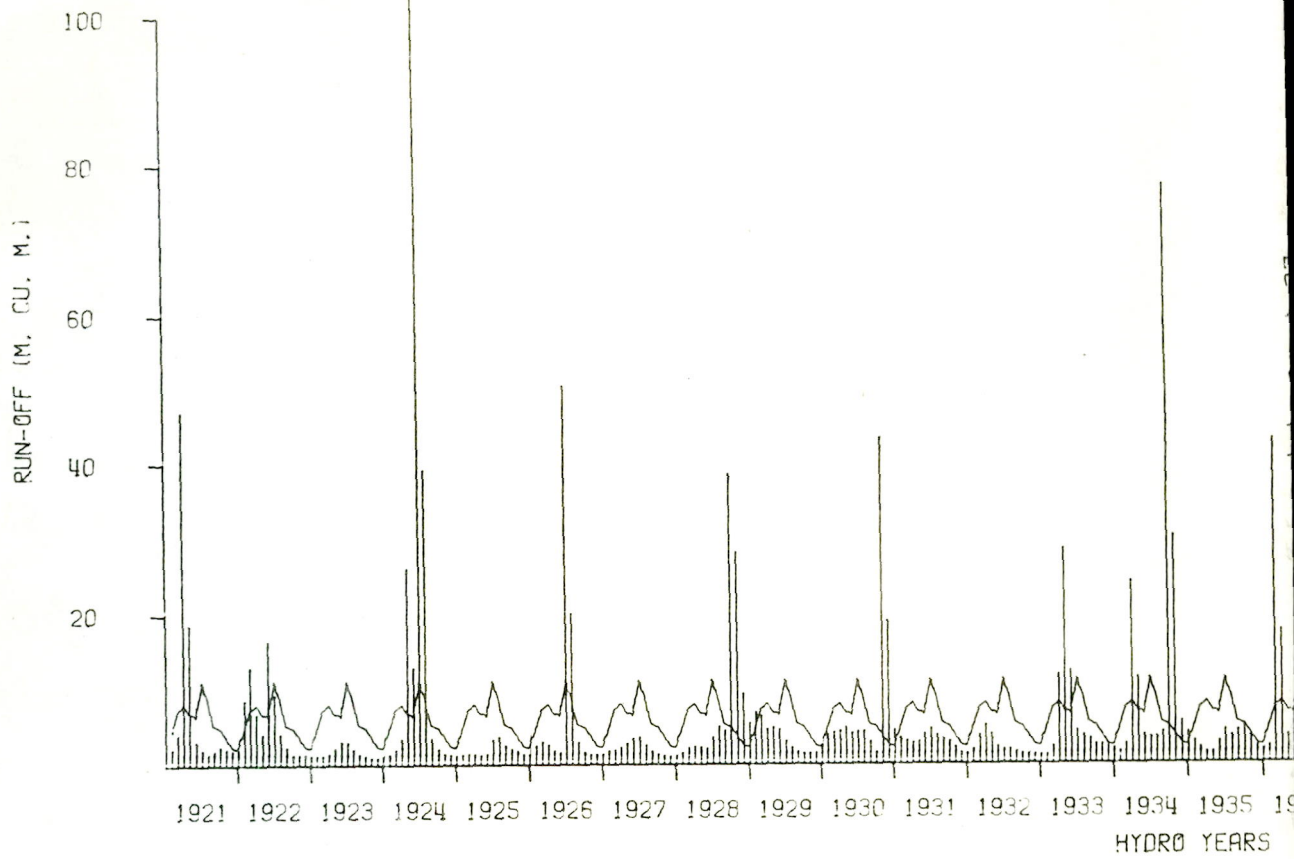
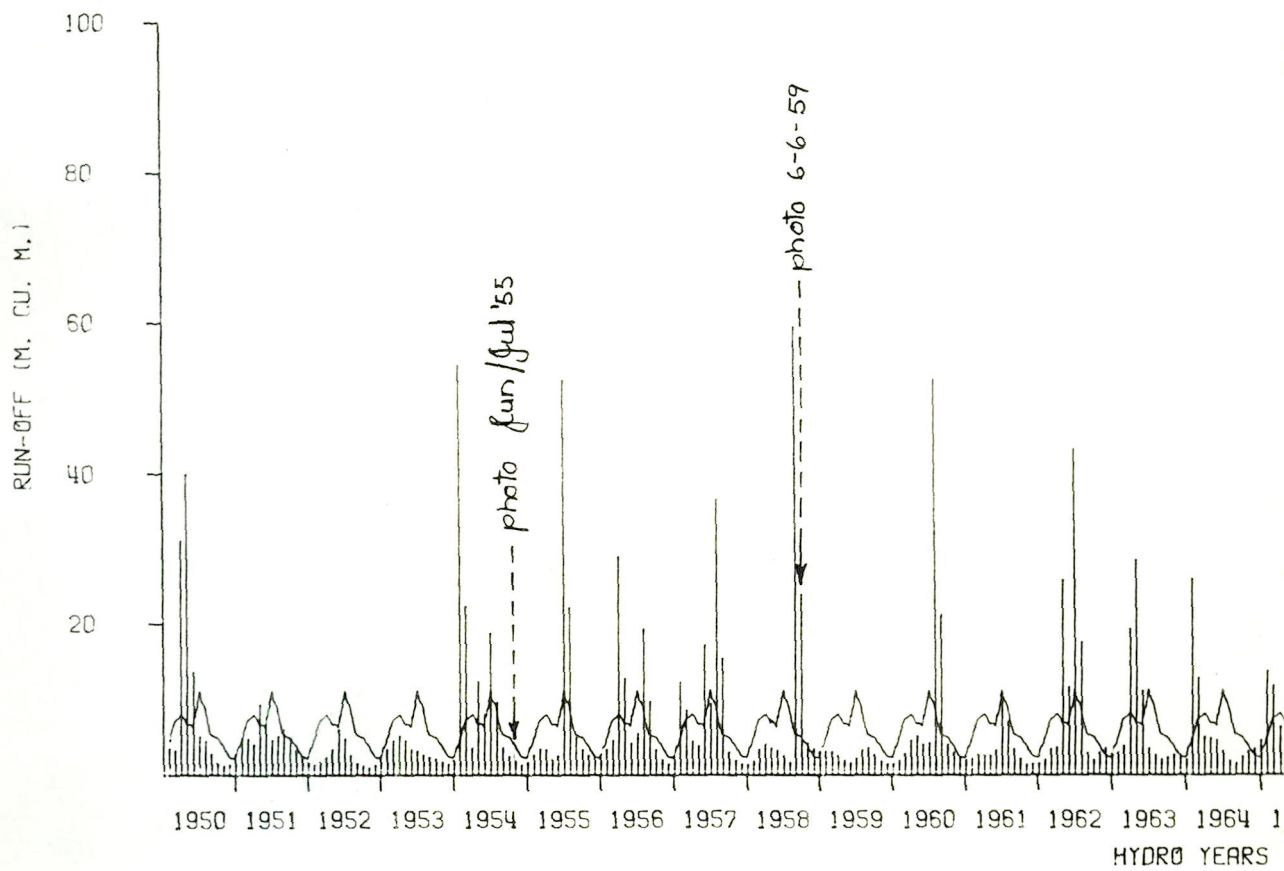
FIGURE  
 NS 32/4

NATAL ESTUARIES : MTHALUME  
 SIMULATED MONTHLY RUN-OFF  
 1921-1975

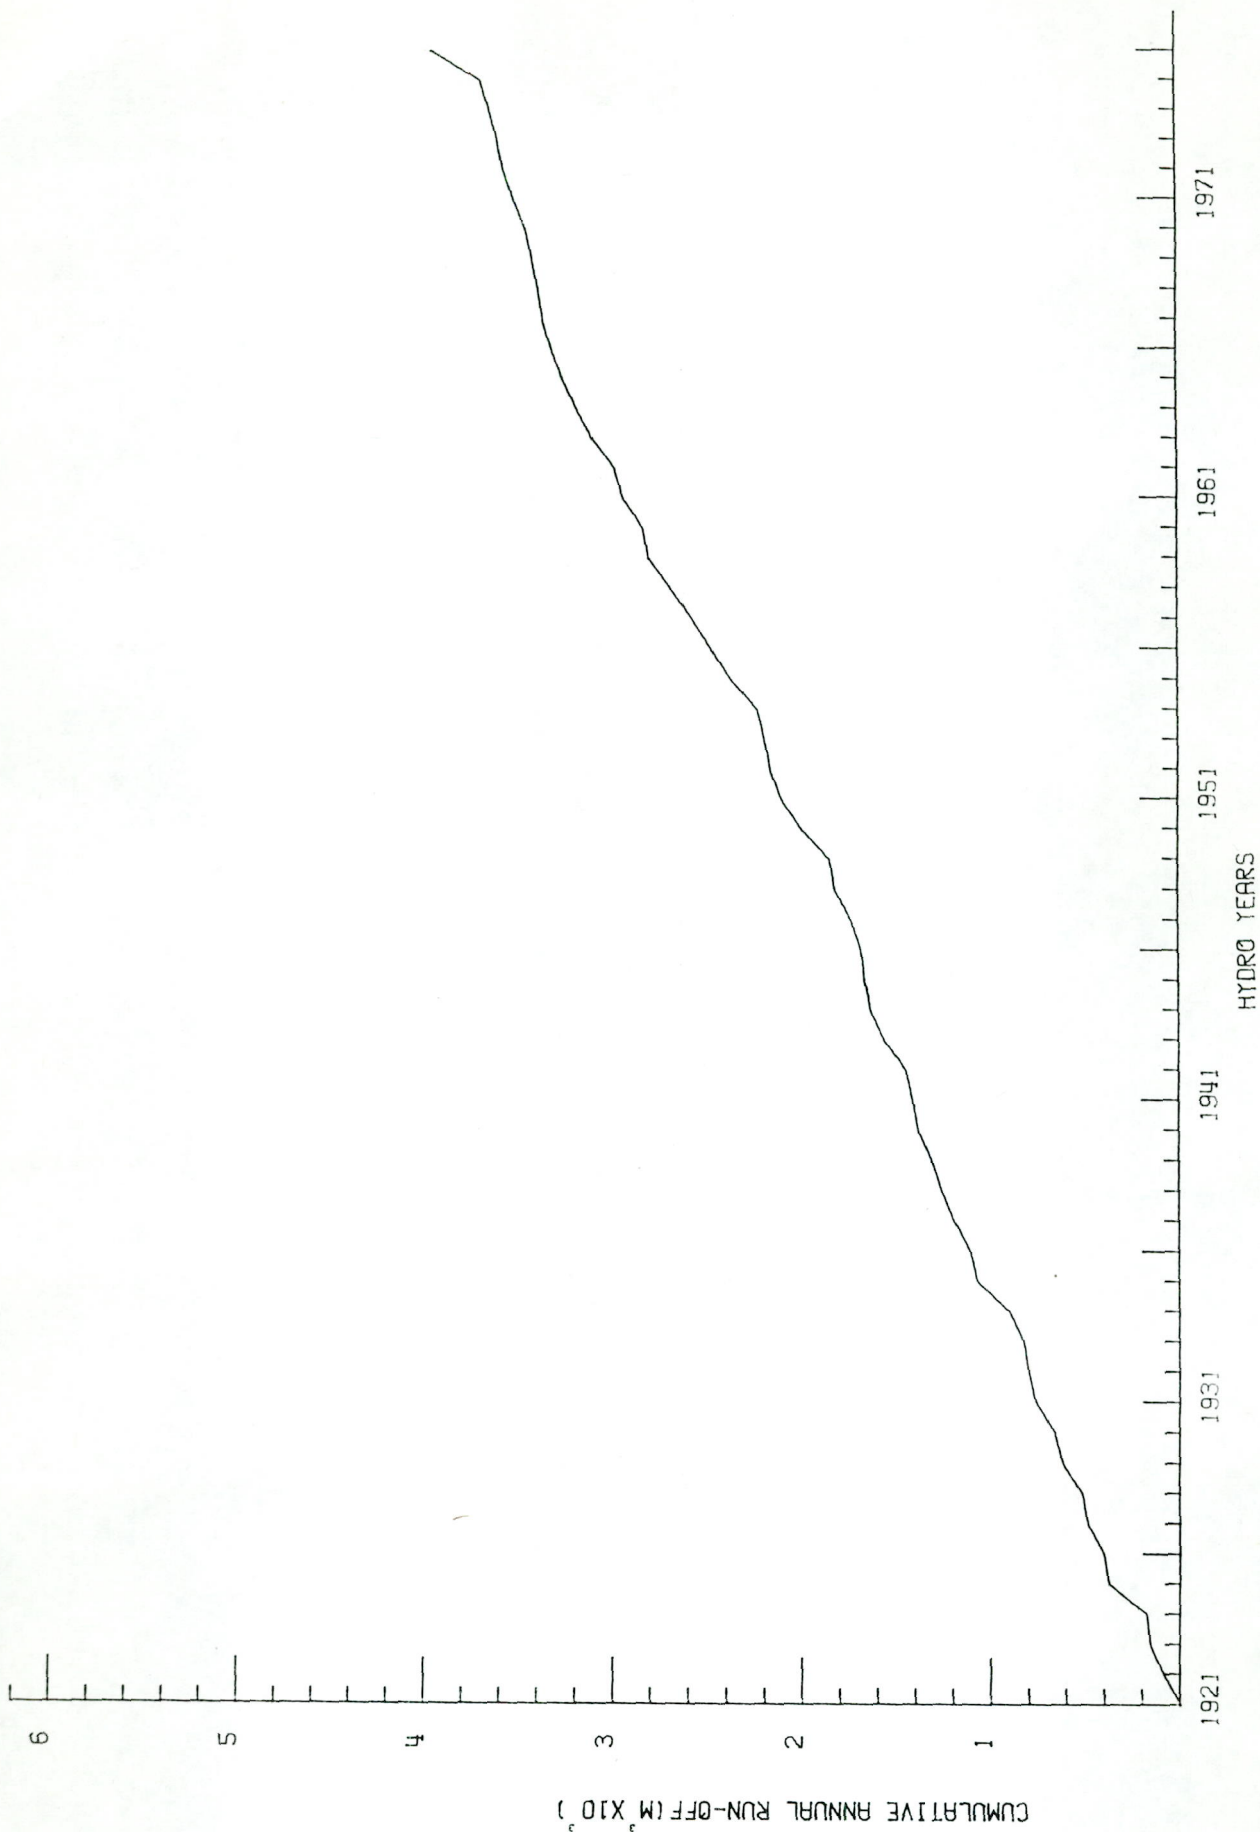
FIGURE  
 NS 32/5

NATAL ESTUARIES: MTWALUME  
 CUMULATIVE ANNUAL RUN-OFF

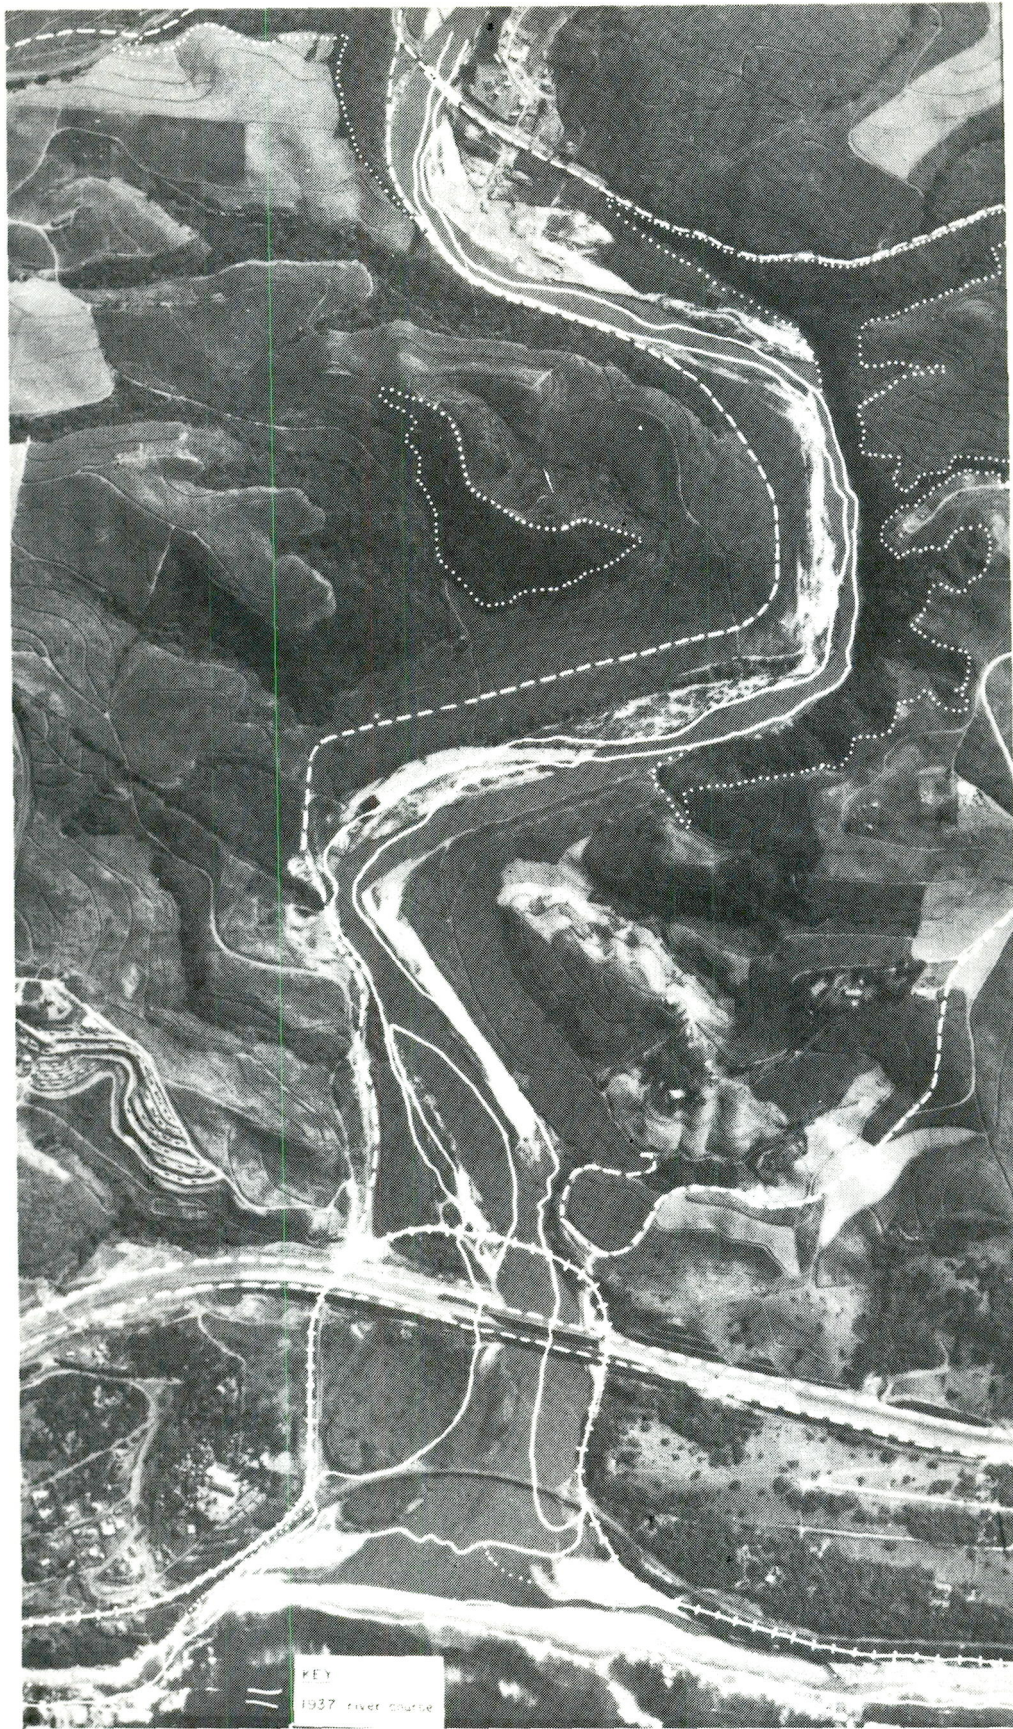
PHOTOGRAPH  
NS 32/1

NS 32/1	6-7-76 at 13h58 (30-4-37 river course superimposed)
NS 32/2	30-4-37 at 12h20
NS 32/3	Jun/Jul 1955 at 11h30
NS 32/4	6-6-59 at 13h07
NS 32/5	17-6-67 at 13h25
NS 32/6	23-6-69 at 10h18
NS 32/7	6-7-76 (Orthophoto)

The river flows along a deeply incised meander for the upper part of the reach under review and the flood plain is fairly narrow. The upper part of the reach has been fairly stable but the lower part (from section 7) has shifted laterally to a marked degree during the period 1937 - 1976 (Photo NS32/1). There is a high average displacement
