**HYDROLOGICAL / HYDRAULIC STUDY
OF NATAL ESTUARIES**

DATA REPORT NO. 16

MDLOTANE NN 8

NRIO DATA REPORT D 8307

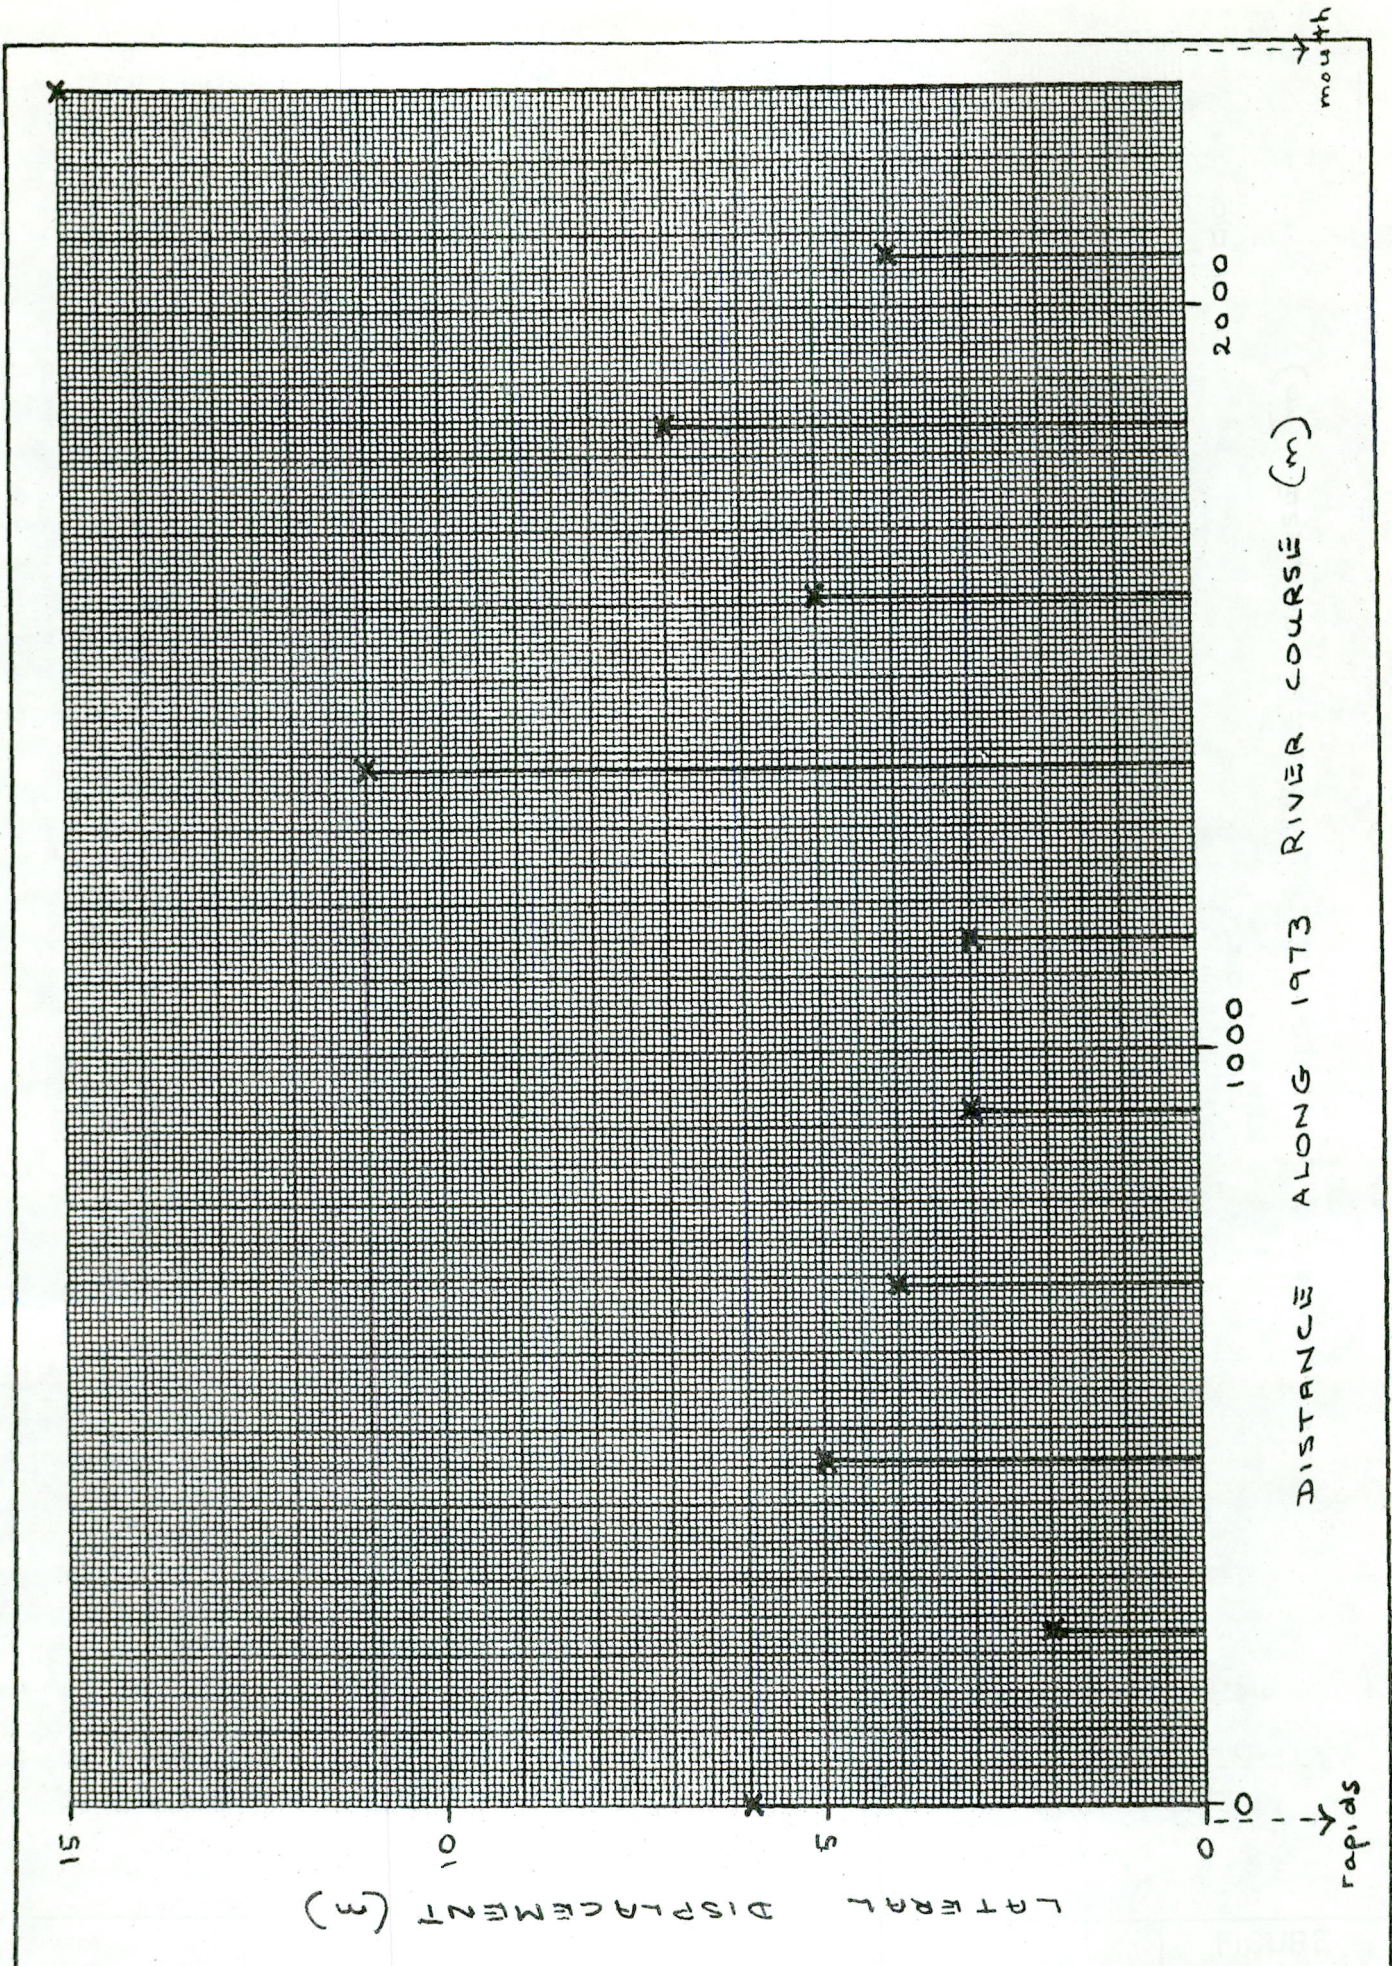
FIGURE
 NN8/1

NATAL ESTUARIES: MOLOTANE
 THALWEG DISPLACEMENT
 (1937-1976)

The meanders of the estuary are incised and even where there is some room for lateral shift, the river has remained stable for the period under review (Photograph NN8/1). This is quantified by the low average lateral displacement of 6,1 m and average coefficient of variation of 10,9 per cent (Table NN8/IX). Furthermore, the sinuosity remains constant; the only small change is caused by the extent to which the sandbar blocks the mouth.

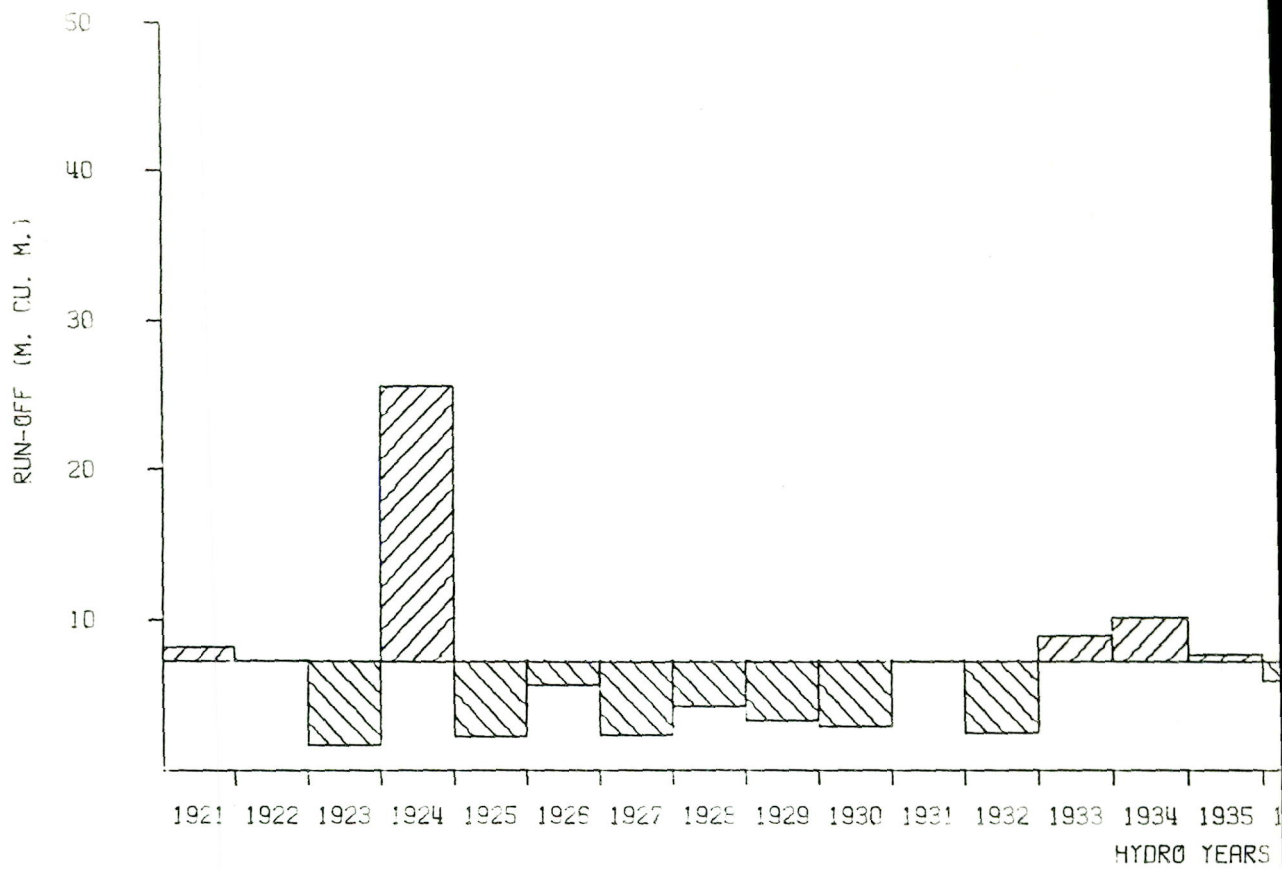
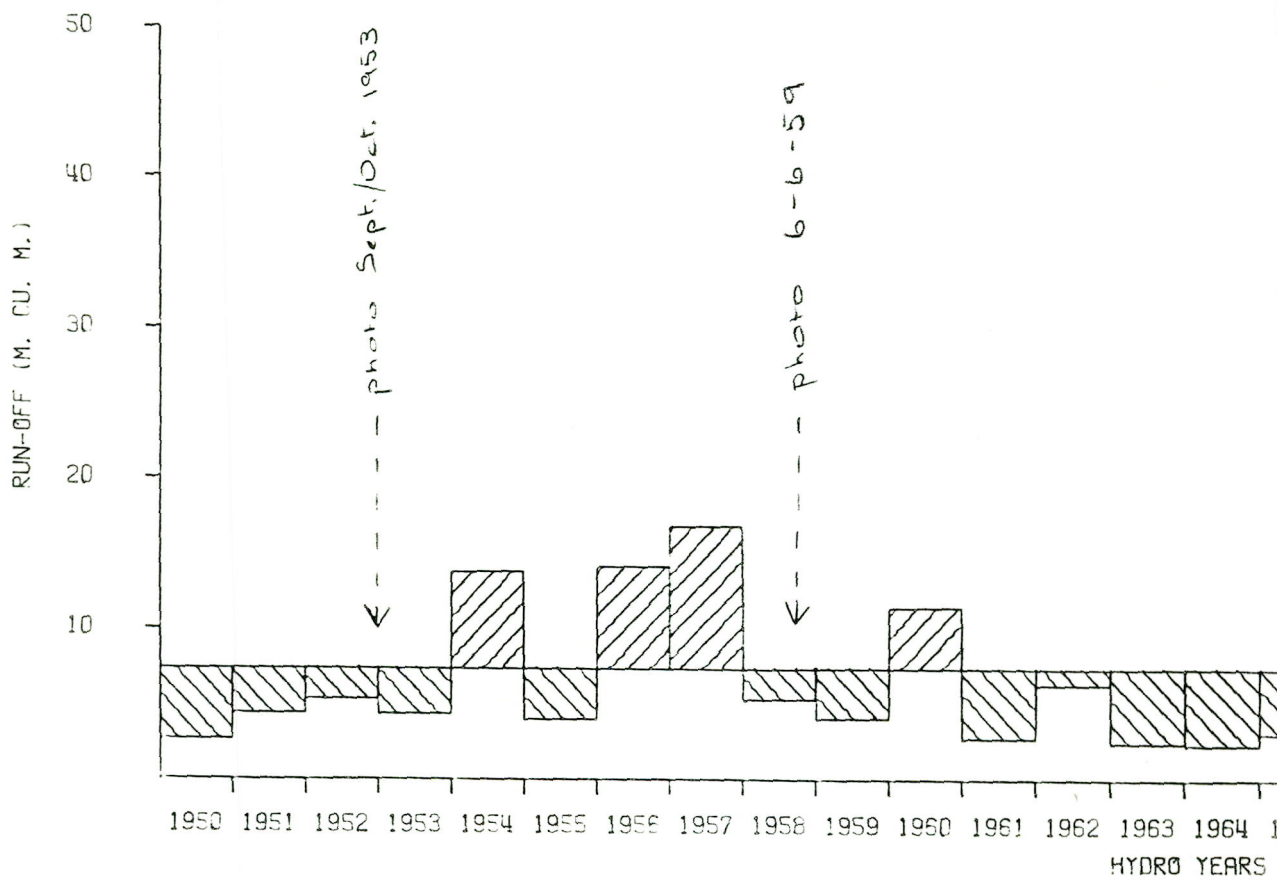
TRACED : COMPLETE CHECKED : DATE : REF. :	NATAL ESTUARIES MDLOTANE SIMULATED ANNUAL RUN-OFF 1921-1975	FIGURE NN8/2
NATIONAL RESEARCH INSTITUTE FOR OCEANOLOGY

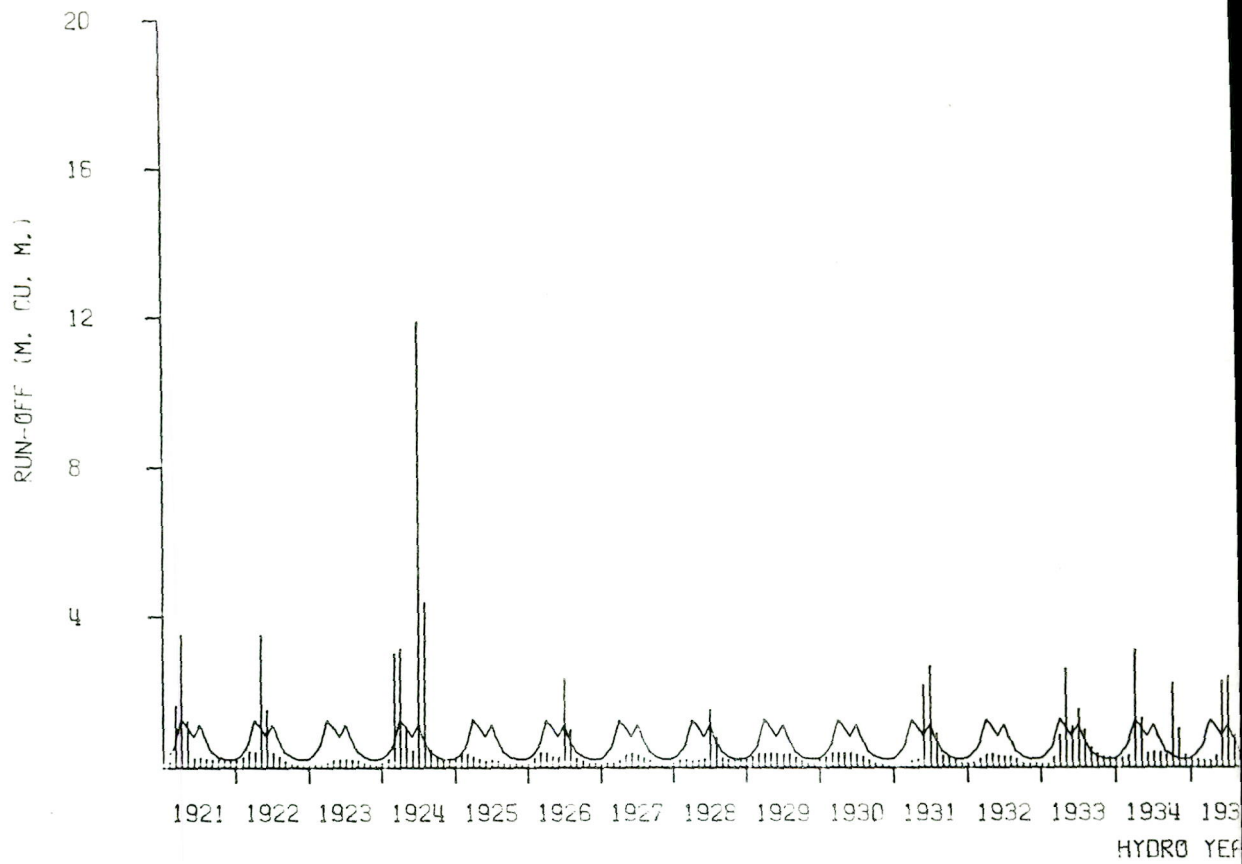
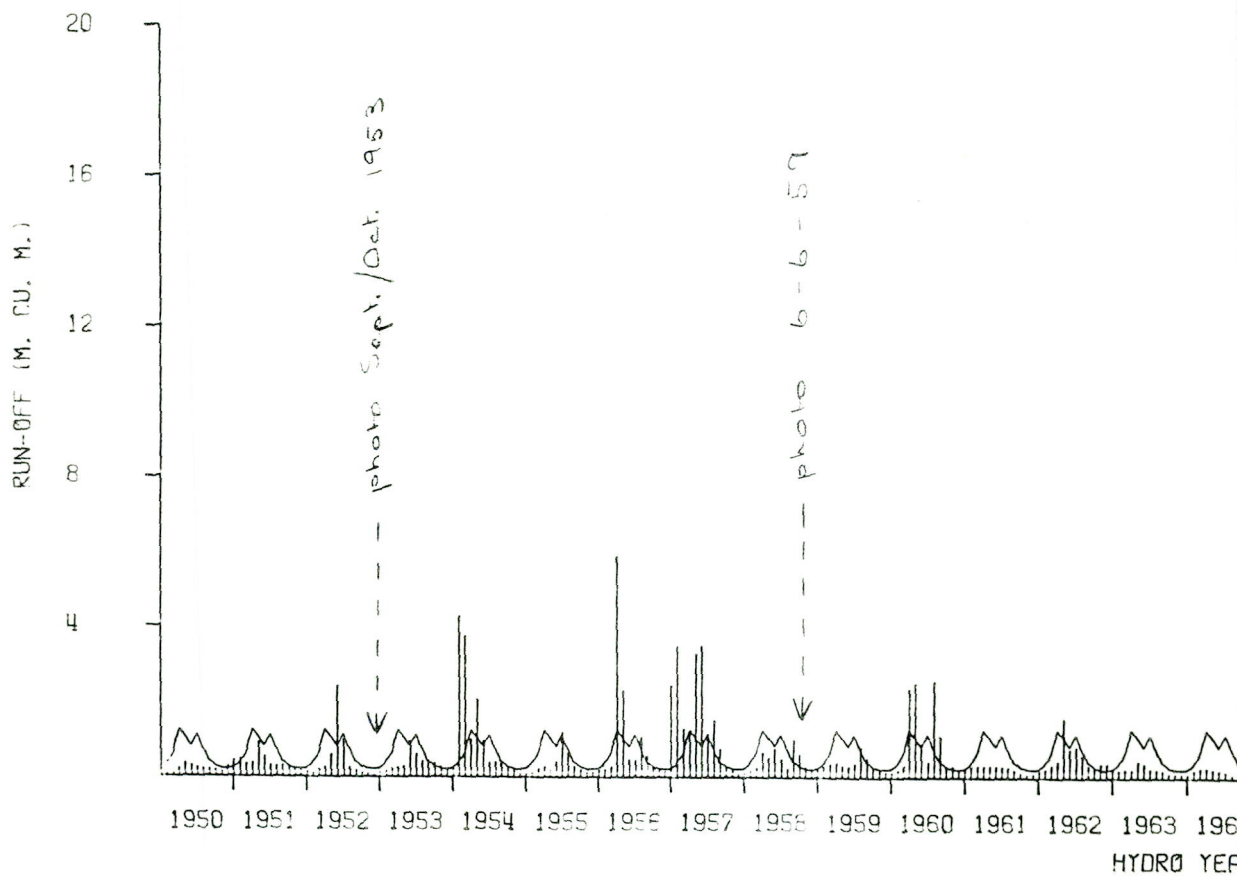
FIGURE
 NN8/3

NATAL ESTUARIES - MDLOTANE
 SIMULATED MONTHLY RUN-OFF
 1921-1977

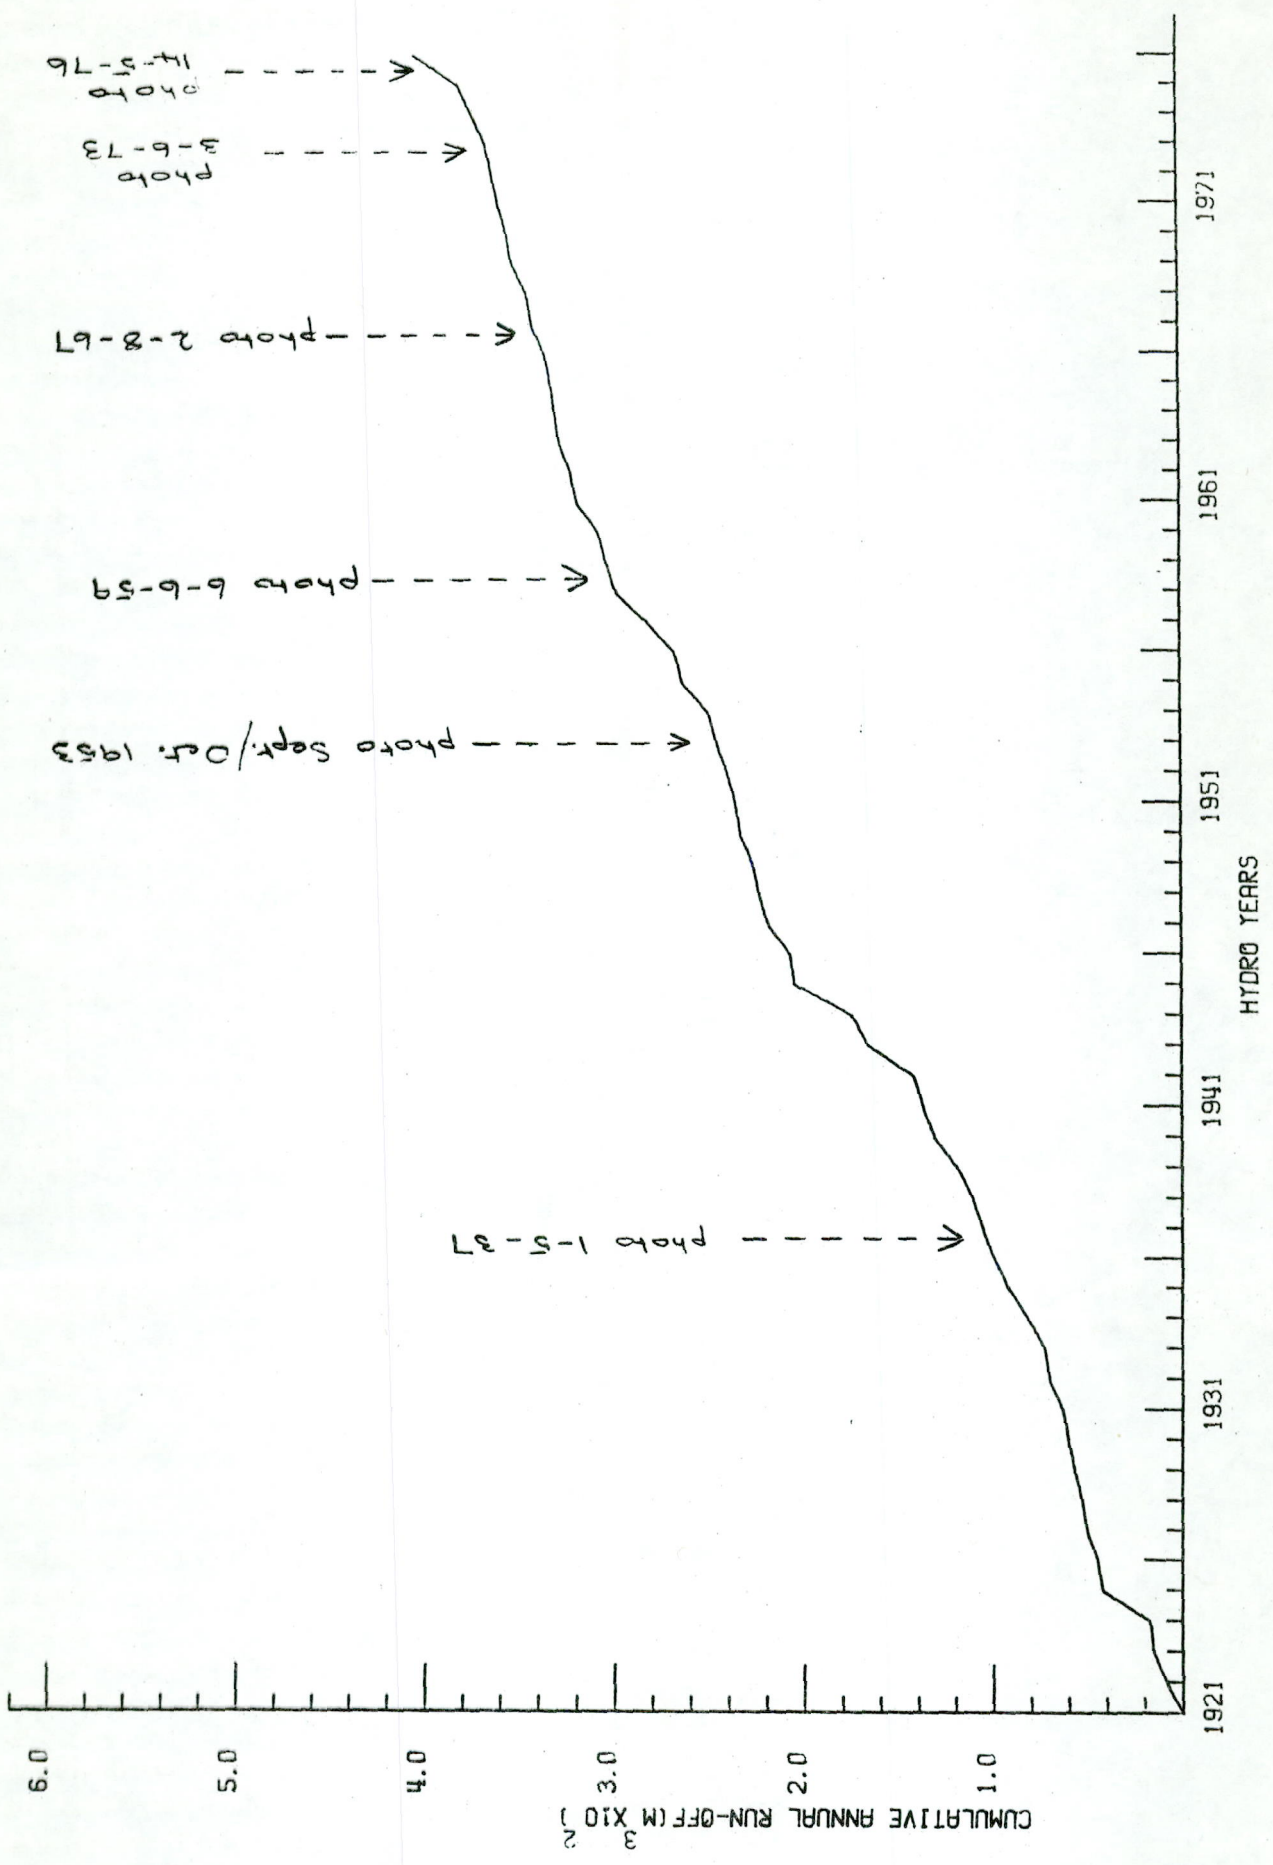
FIGURE
 NN8/4

NATAL ESTUARIES: MDLOTANE
CUMULATIVE ANNUAL RUN-OFF

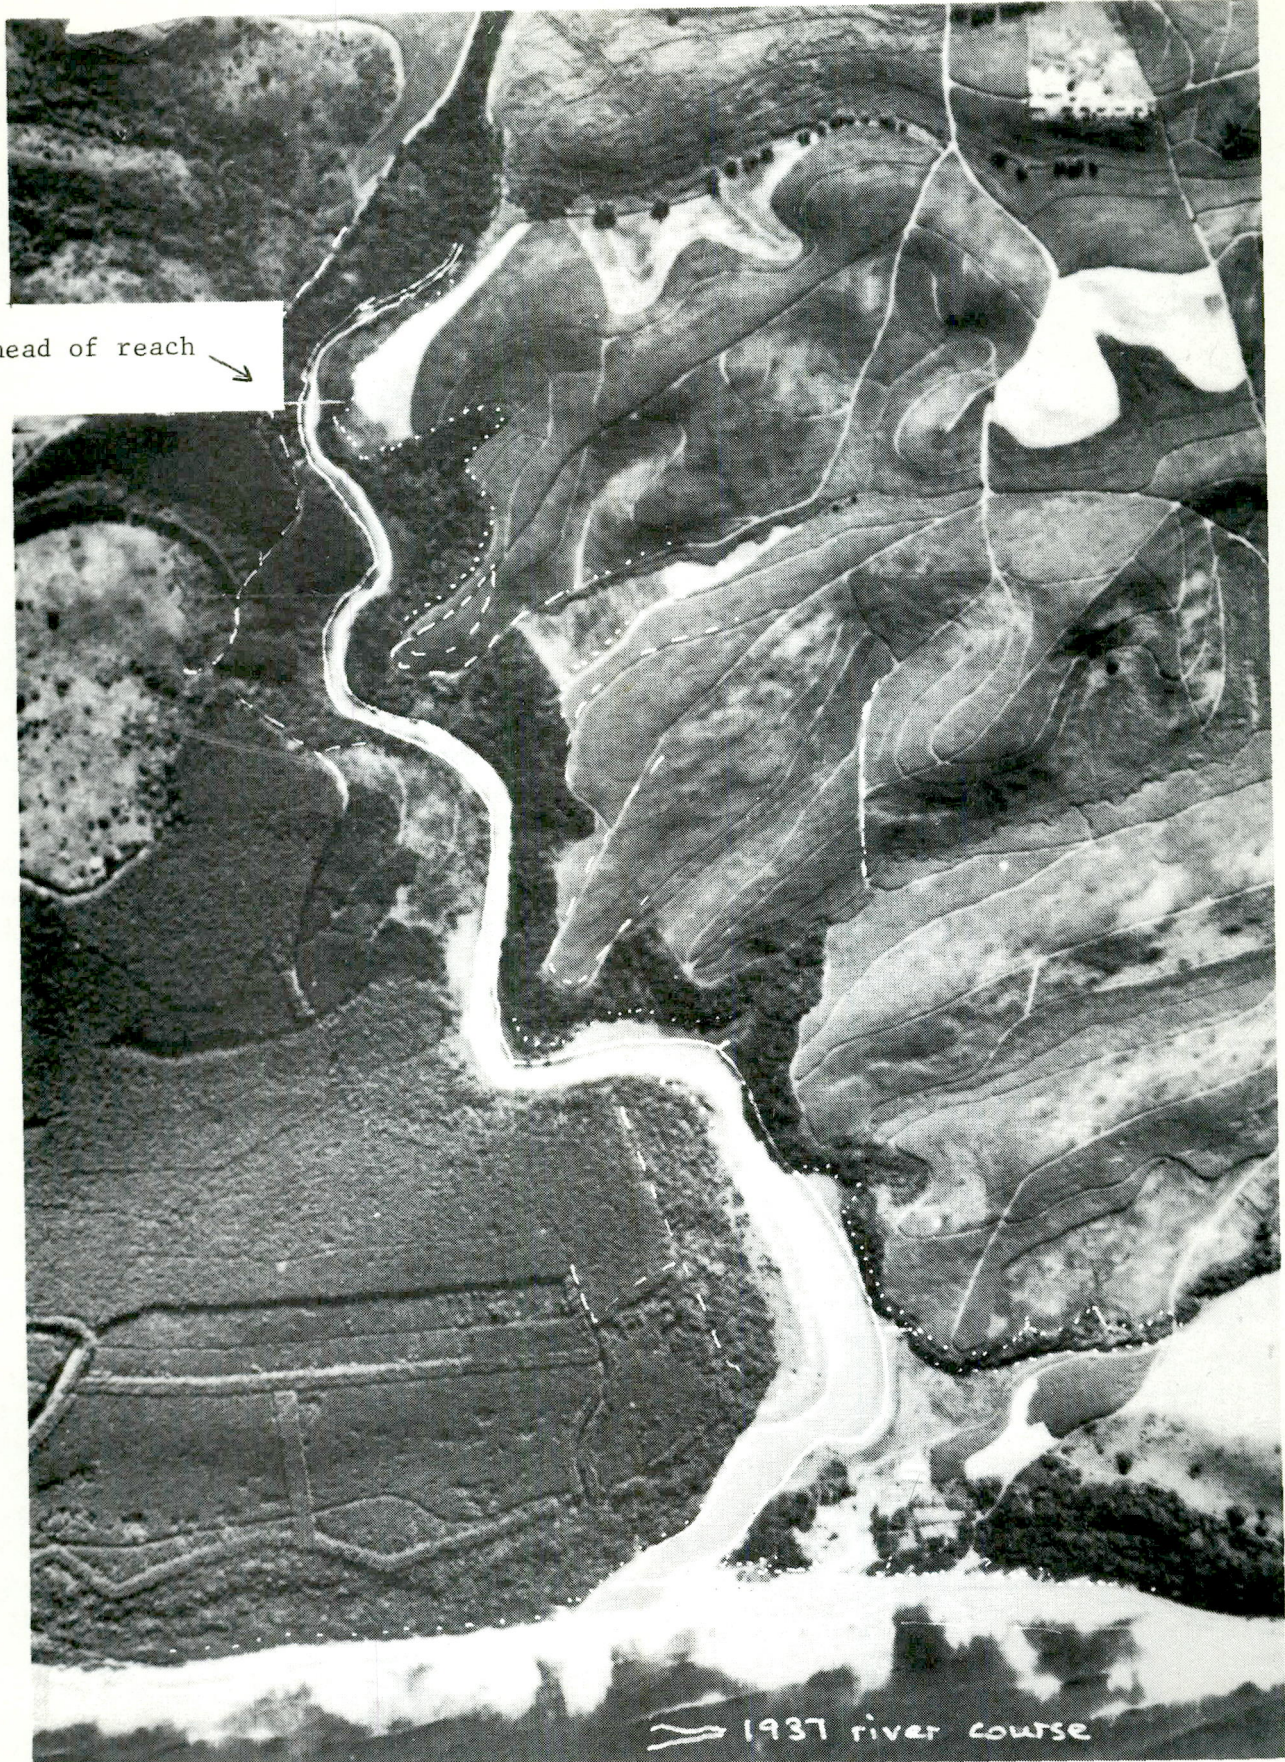
NN8/1

head of reach

1937 river course

14-5-76
