**HYDROLOGICAL/HYDRAULIC STUDY
OF NATAL ESTUARIES**

**DATA REPORT NO. 9
(REVISED)**

MDLOTI NN 3

NRIO DATA REPORT D8606

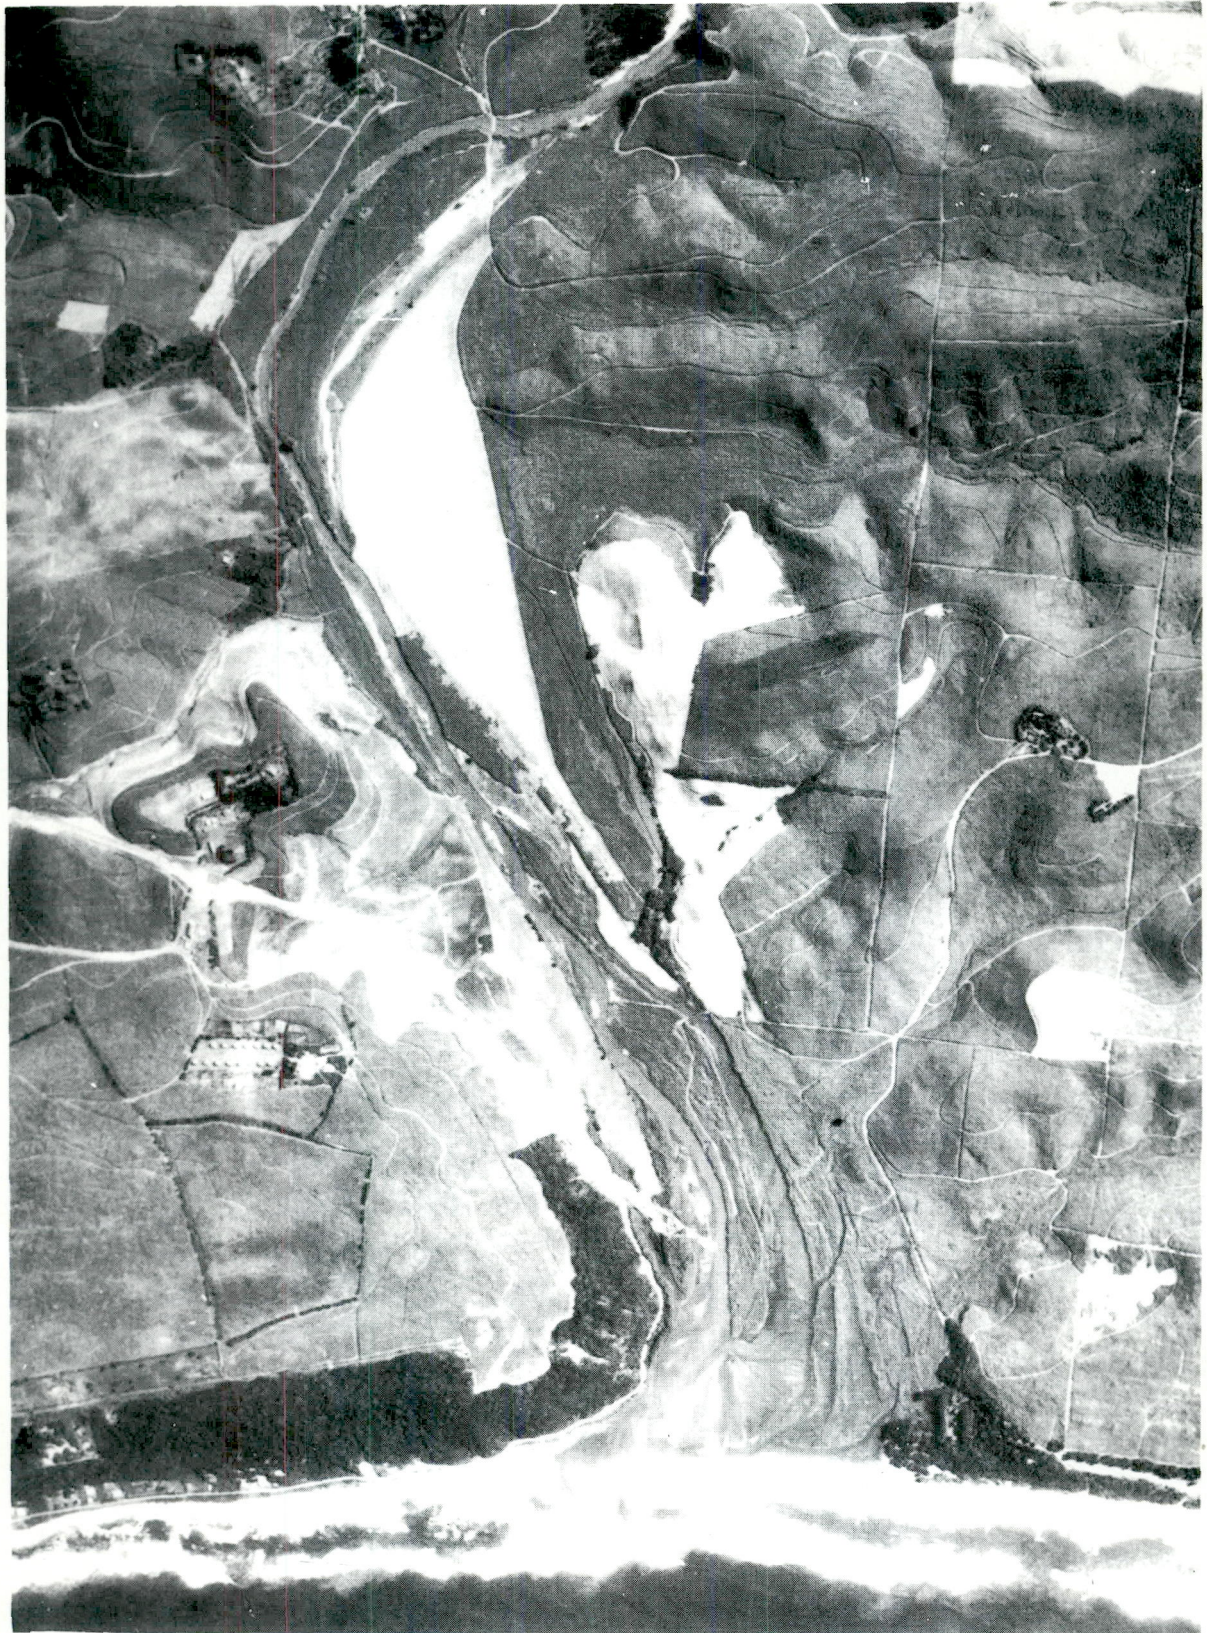
TRACED JGAN CHECKED DATE REF	NATAL ESTUARIES: MDLOTI 6-6-59 (11h53)	PHOTOGRAPH NN3 /4
---------------------------------------	---	--------------------------

reduction in open water areas. Photographs NN3/2-6, from 1937 to 1977 show that 21 per cent of the flood plain is occupied by fluvial silt deposits and swamps (Table NN3/I) and that avulsion occurs, these factors being indicative of siltation.

Photographs NN3/2-6 show changes in siltation areas from 1937 to 1977, and areal measurements of the flood plain quantify these changes (Table NN3/I). Care must be taken in studying these changes in composition of the flood plain - river stage must be comparable and one must examine carefully which changes in cultivated and bush areas have been at the expense of the base line (1937) recent siltation areas. For the five time slices under review, the run-off was below average and in the one case

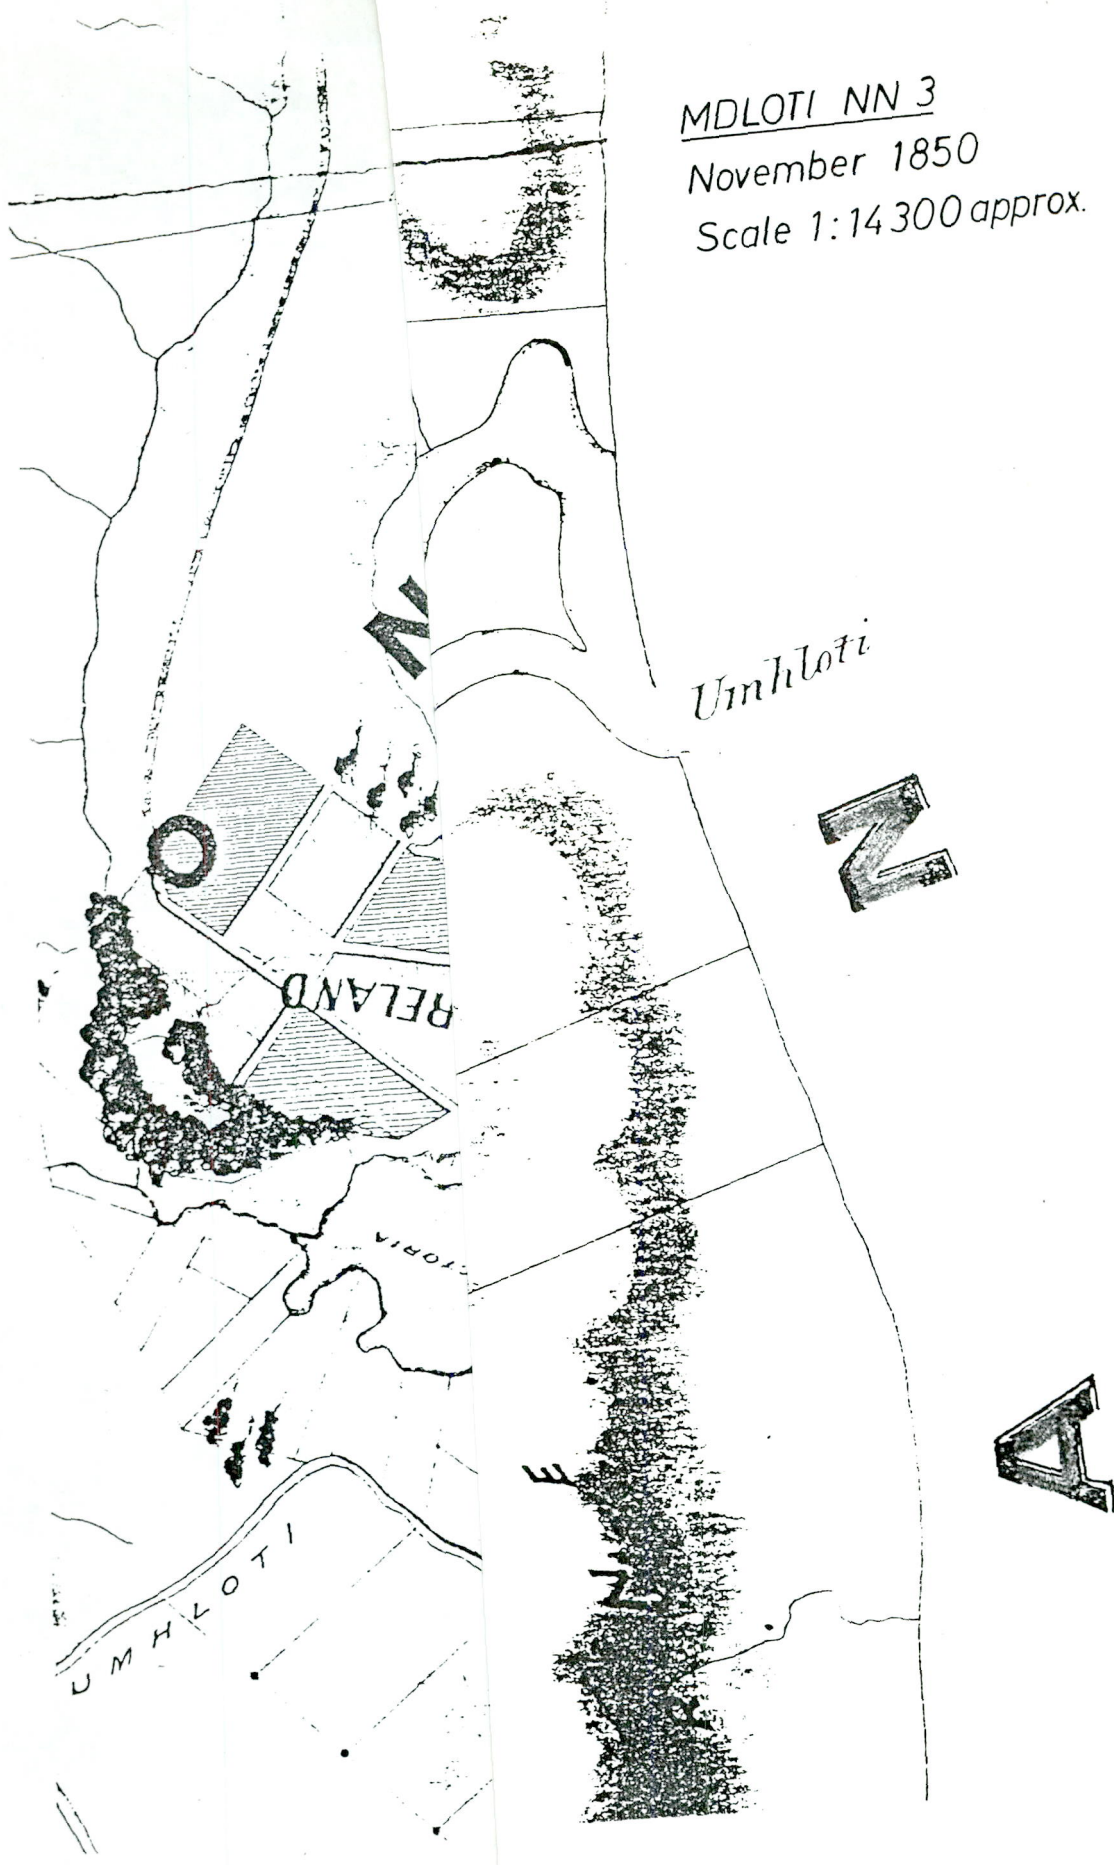
MDLOTI NN 3
November 1850
Scale 1:14300 approx.

The lowest 3,4 km of the Mdloti show severe siltation. On a November 1850 map in the Natal Archives, Pietermaritzburg (photo-copy inside back cover), a greater expanse of open water is depicted near the mouth compared with the available aerial photographs from 1937 onwards. The latter, in particular Photographs NN3/2-4, give evidence of the earlier larger water body on the left bank which by 1937 was largely infilled with silt and swamps. The turn of the century falls outside our detailed study period but the early map allows us to set the stage for current siltation. Figure NN3/2 shows the continuing trend of

Apart from the scour and fill during major floods, there is evidence that the Mdloti is generally aggrading in its lowest reaches, although this cannot be quantified. Firstly, comparing the November 1850 map and the earliest (1937) aerial photography, former open water areas have been infilled by sediment and/or swamps. This pattern has continued from 1937-1977 (N.B. the increase of reedswamp areas which colonize deposits emerging above mean water level from 1937-1977). Secondly, channel avulsion itself is indicative of aggrading conditions.
