**HYDROLOGICAL / HYDRAULIC STUDY
OF NATAL ESTUARIES**

**DATA REPORT NO.24
DAMBA NS 23**

NRIO DATA REPORT D 8608

**Stellenbosch, South Africa
December 1986**

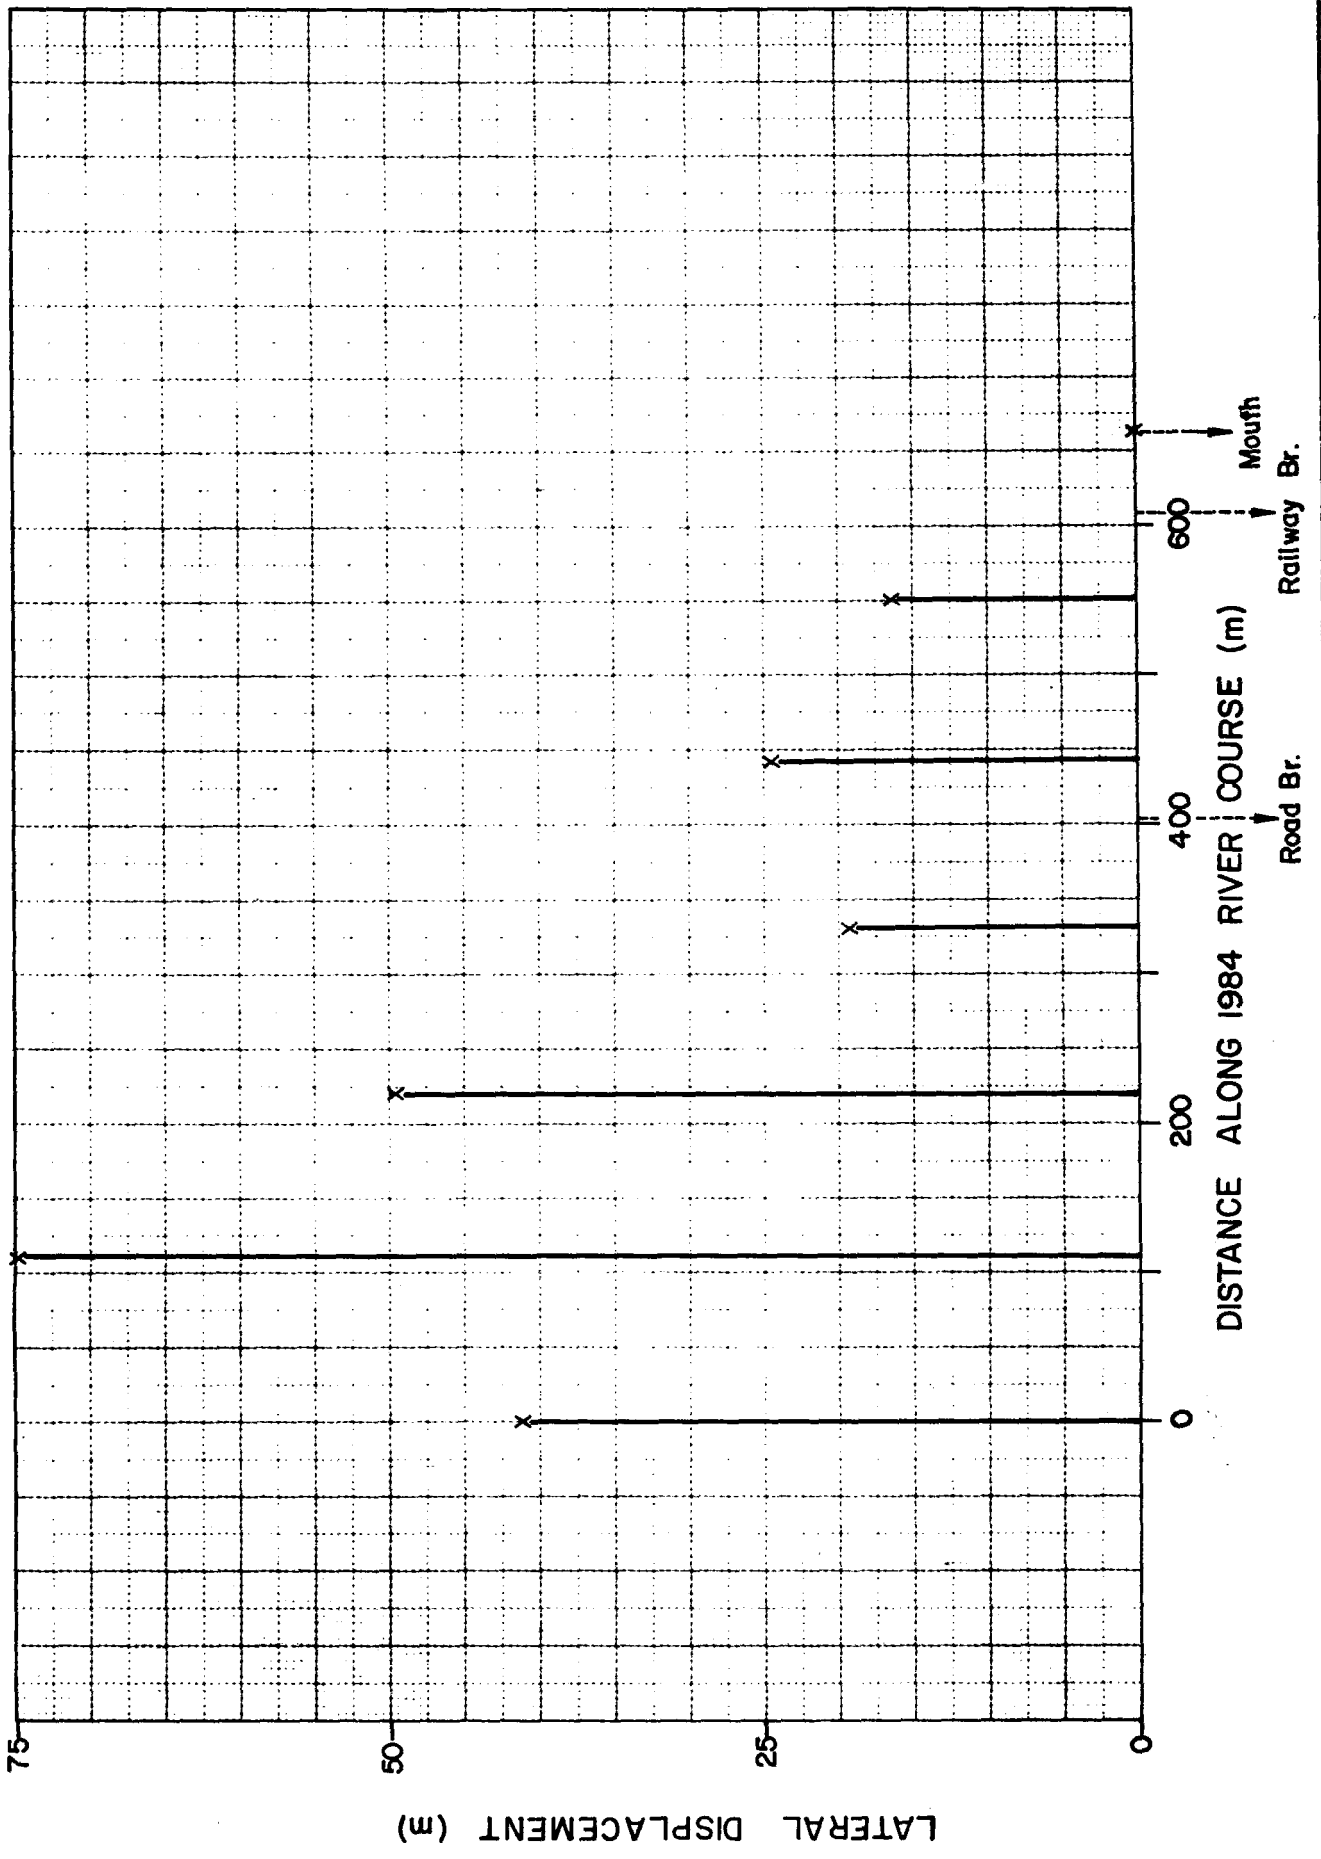
FIGURE
 NS 23 / 1

NATAL ESTUARIES: DAMBA
THALWEG DISPLACEMENT
 (1937 - 1985)

Lateral shift is greatest at sections 1, 2 and 3 where the river has adopted various courses through the swampy conditions created on its own alluvial deposits (Figure NS23/1 and Table NS23/XI). In general, upstream of the NR bridge, the river has shifted towards the left valley side in the period 1937-1985 (Photograph NS23/10). Photograph NS23/5, taken in June 1969, shows a very straight channel between sections 1 and 2 directing the river towards the left valley side. It looks man-made but no evidence can be found to corroborate this photo interpretation. The sinuosity for the whole reach has varied during the period under review while showing a general tendency to increase, slightly.

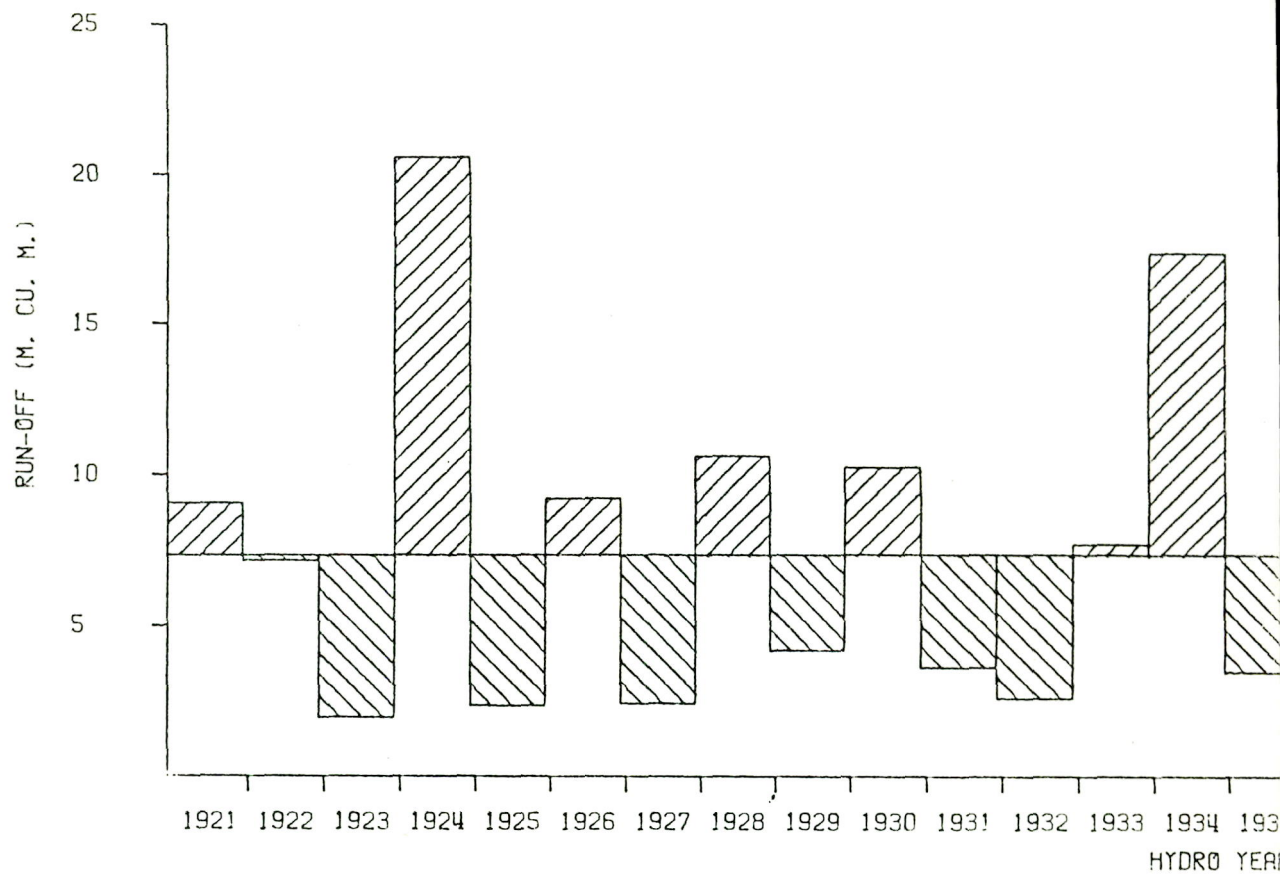
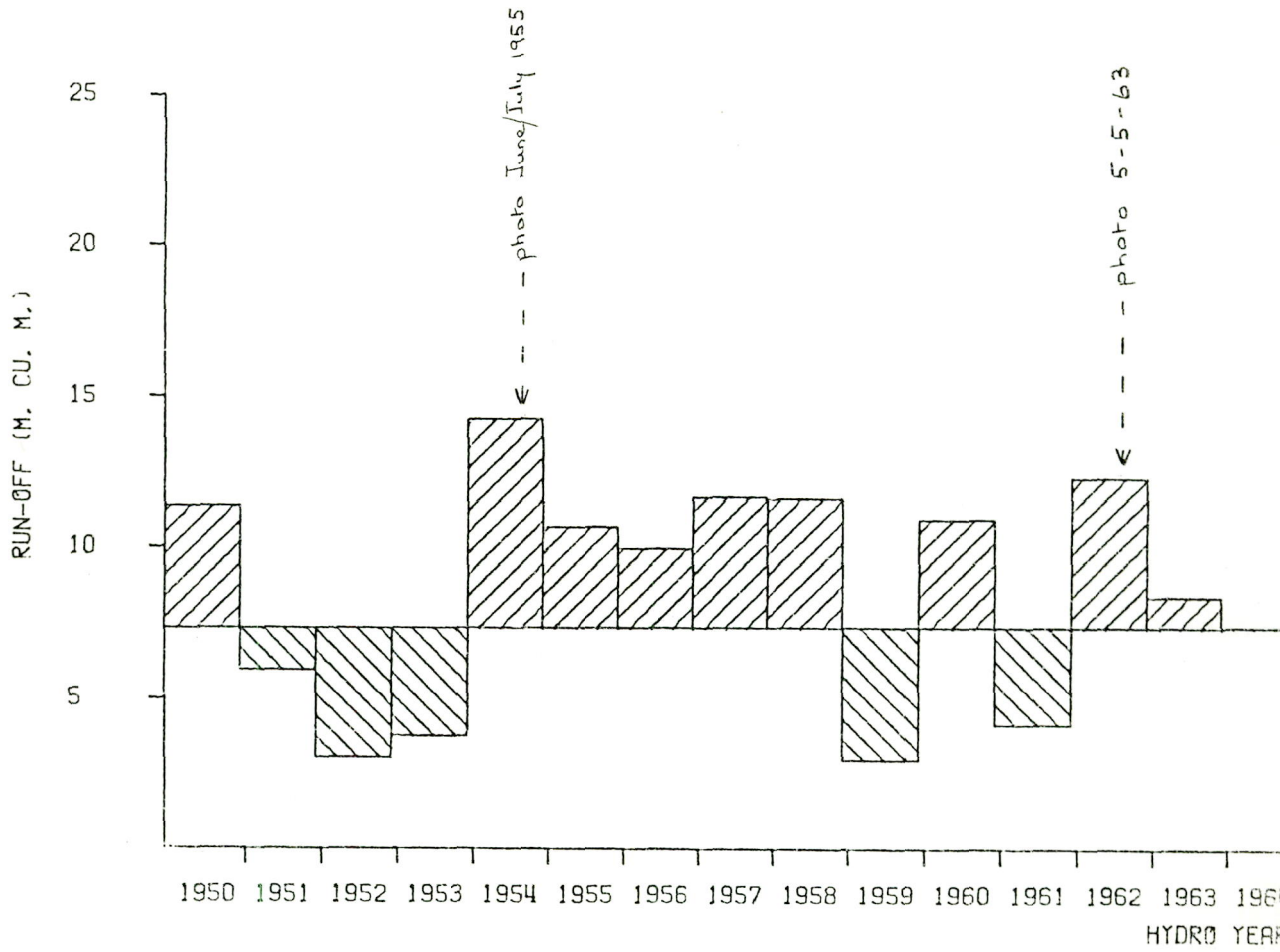
FIGURE
 NS 23/2

NATAL ESTUARIES : DAMBA
 SIMULATED ANNUAL RUN-OFF
 1921-1975

- (a) the high coefficients of variation for monthly run-off (Table NS23/XII) ranging from 53,3 to 230,7 per cent ($\bar{V} = 149,3\%$)
- (b) the wide spectrum of annual and monthly run-off shown in Figures NS23/2 and 3 and
- (c) median run-off values well below the mean (Table NS23/XII).

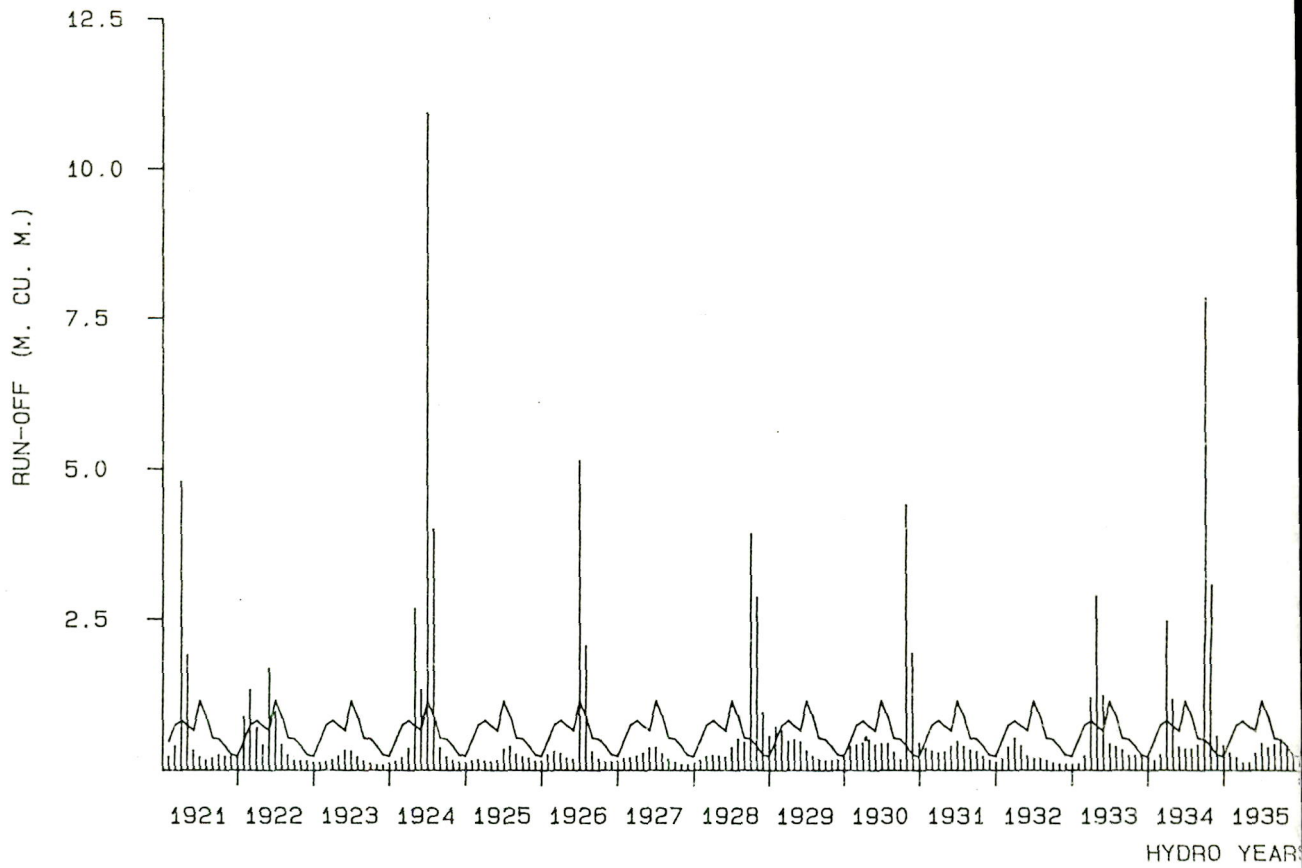
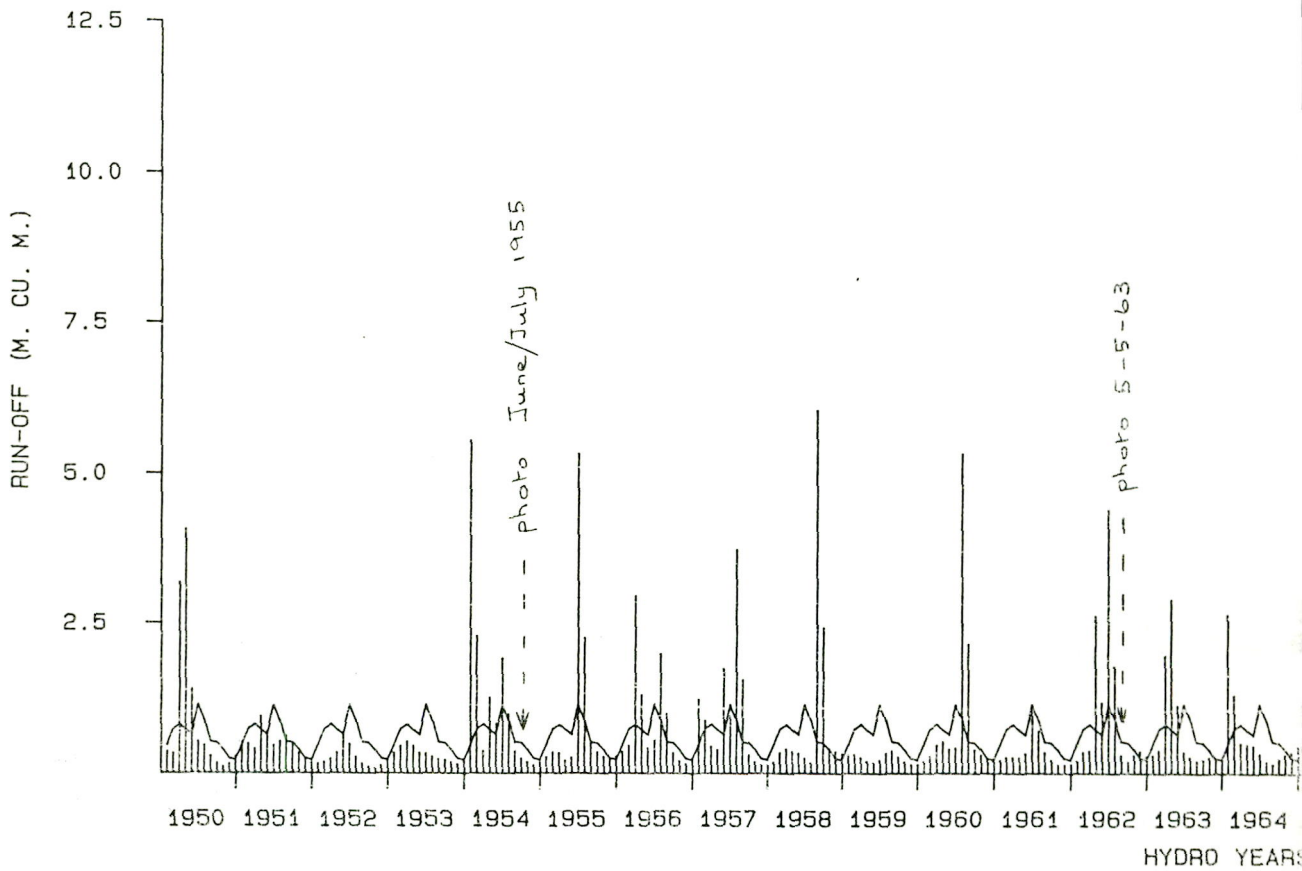
FIGURE
 NS 23/3

NATAL ESTUARIES : DAMBA
 SIMULATED MONTHLY RUN-OFF
 1921-1975

The aforementioned Table and Figures are based upon simulated run-off data for tertiary catchments (Pitman et al., 1981). These data also reveal high monthly run-off periods, with major flood flows occurring in March 1925, June 1935, November 1949 and March 1976, and lesser floods occurring in March 1927, October 1954, March 1955, April 1961 and April 1976 (Table NS23/XII and Figure NS23/3).

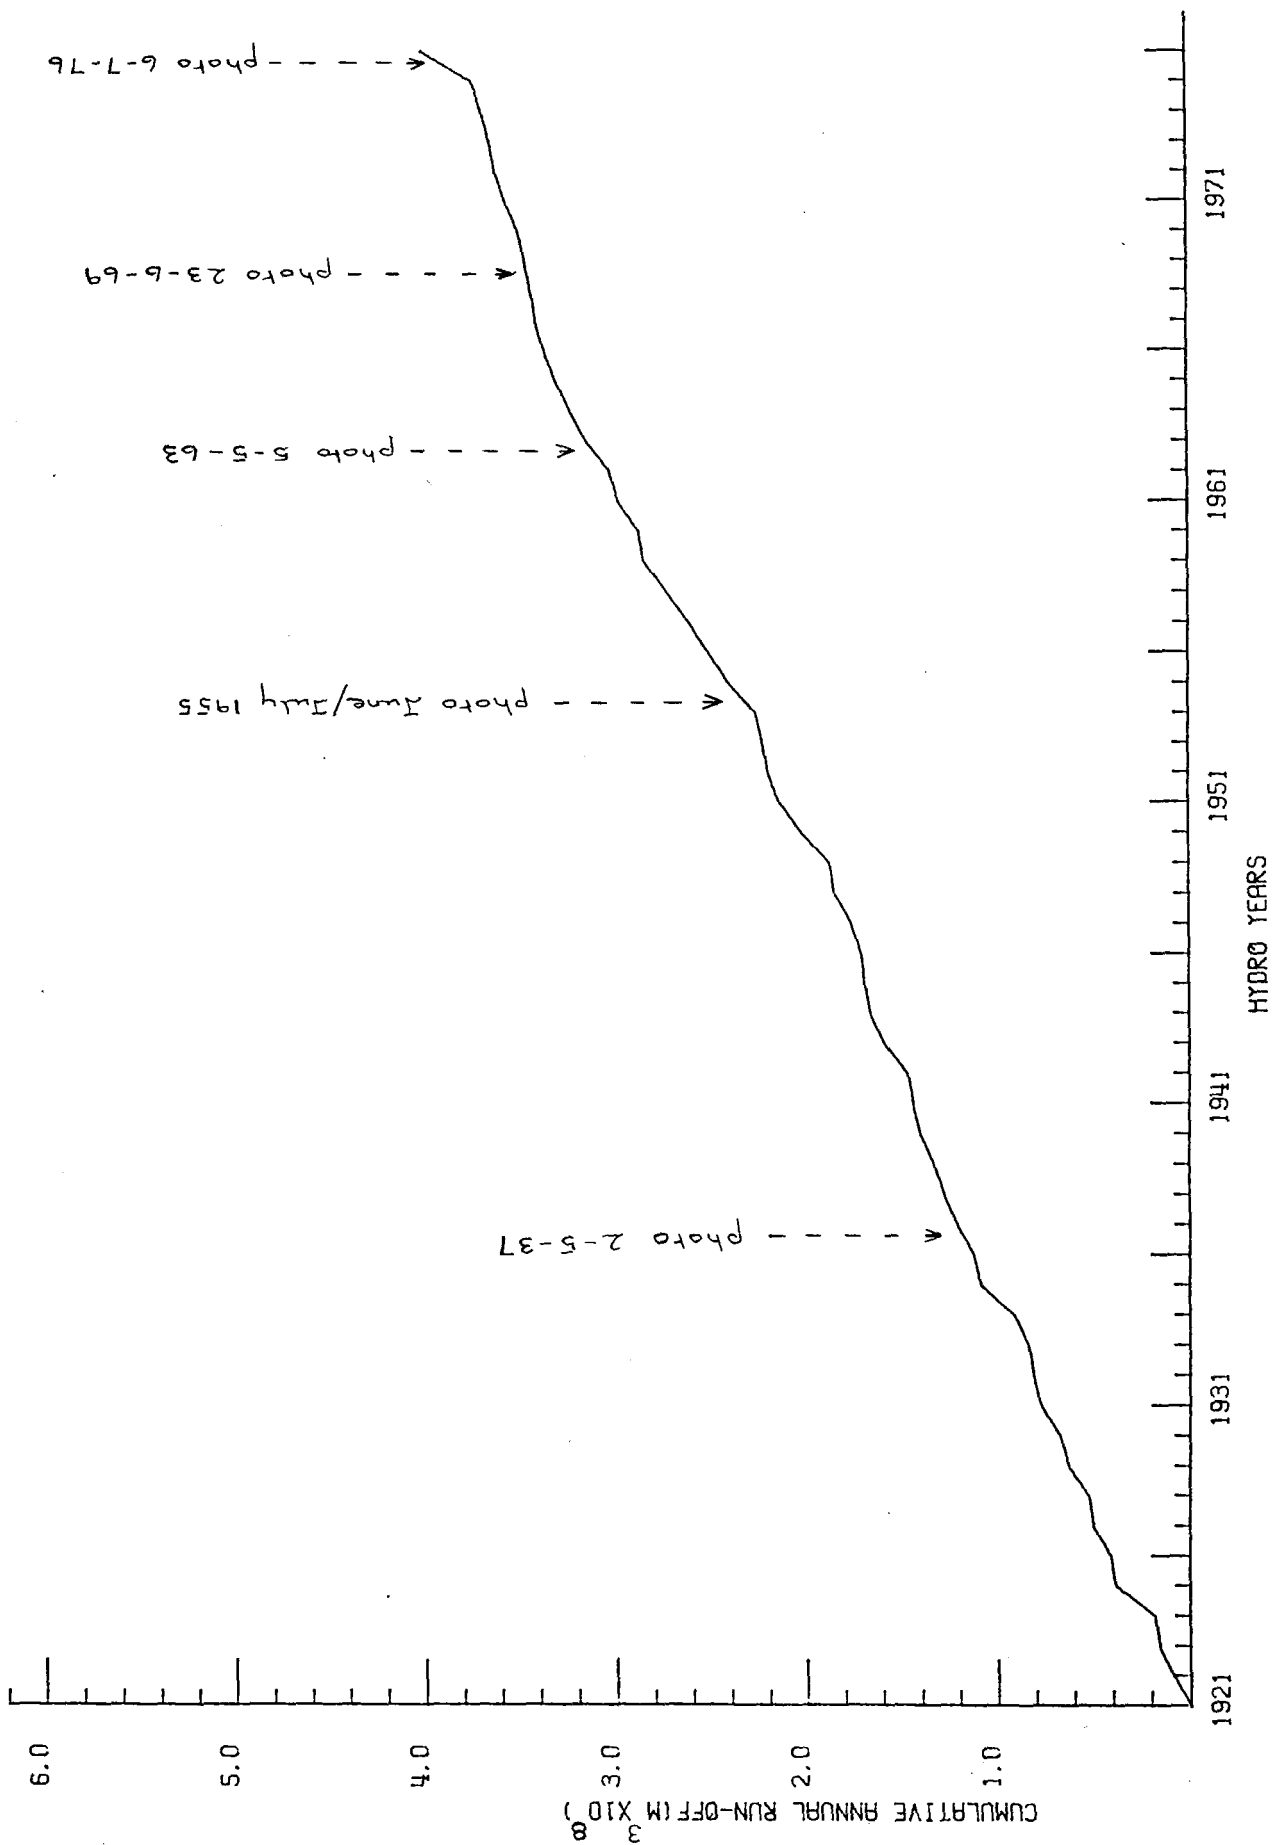
FIGURE
 NS 23/4

NATAL ESTUARIES: DAMBA
 CUMULATIVE ANNUAL RUN-OFF

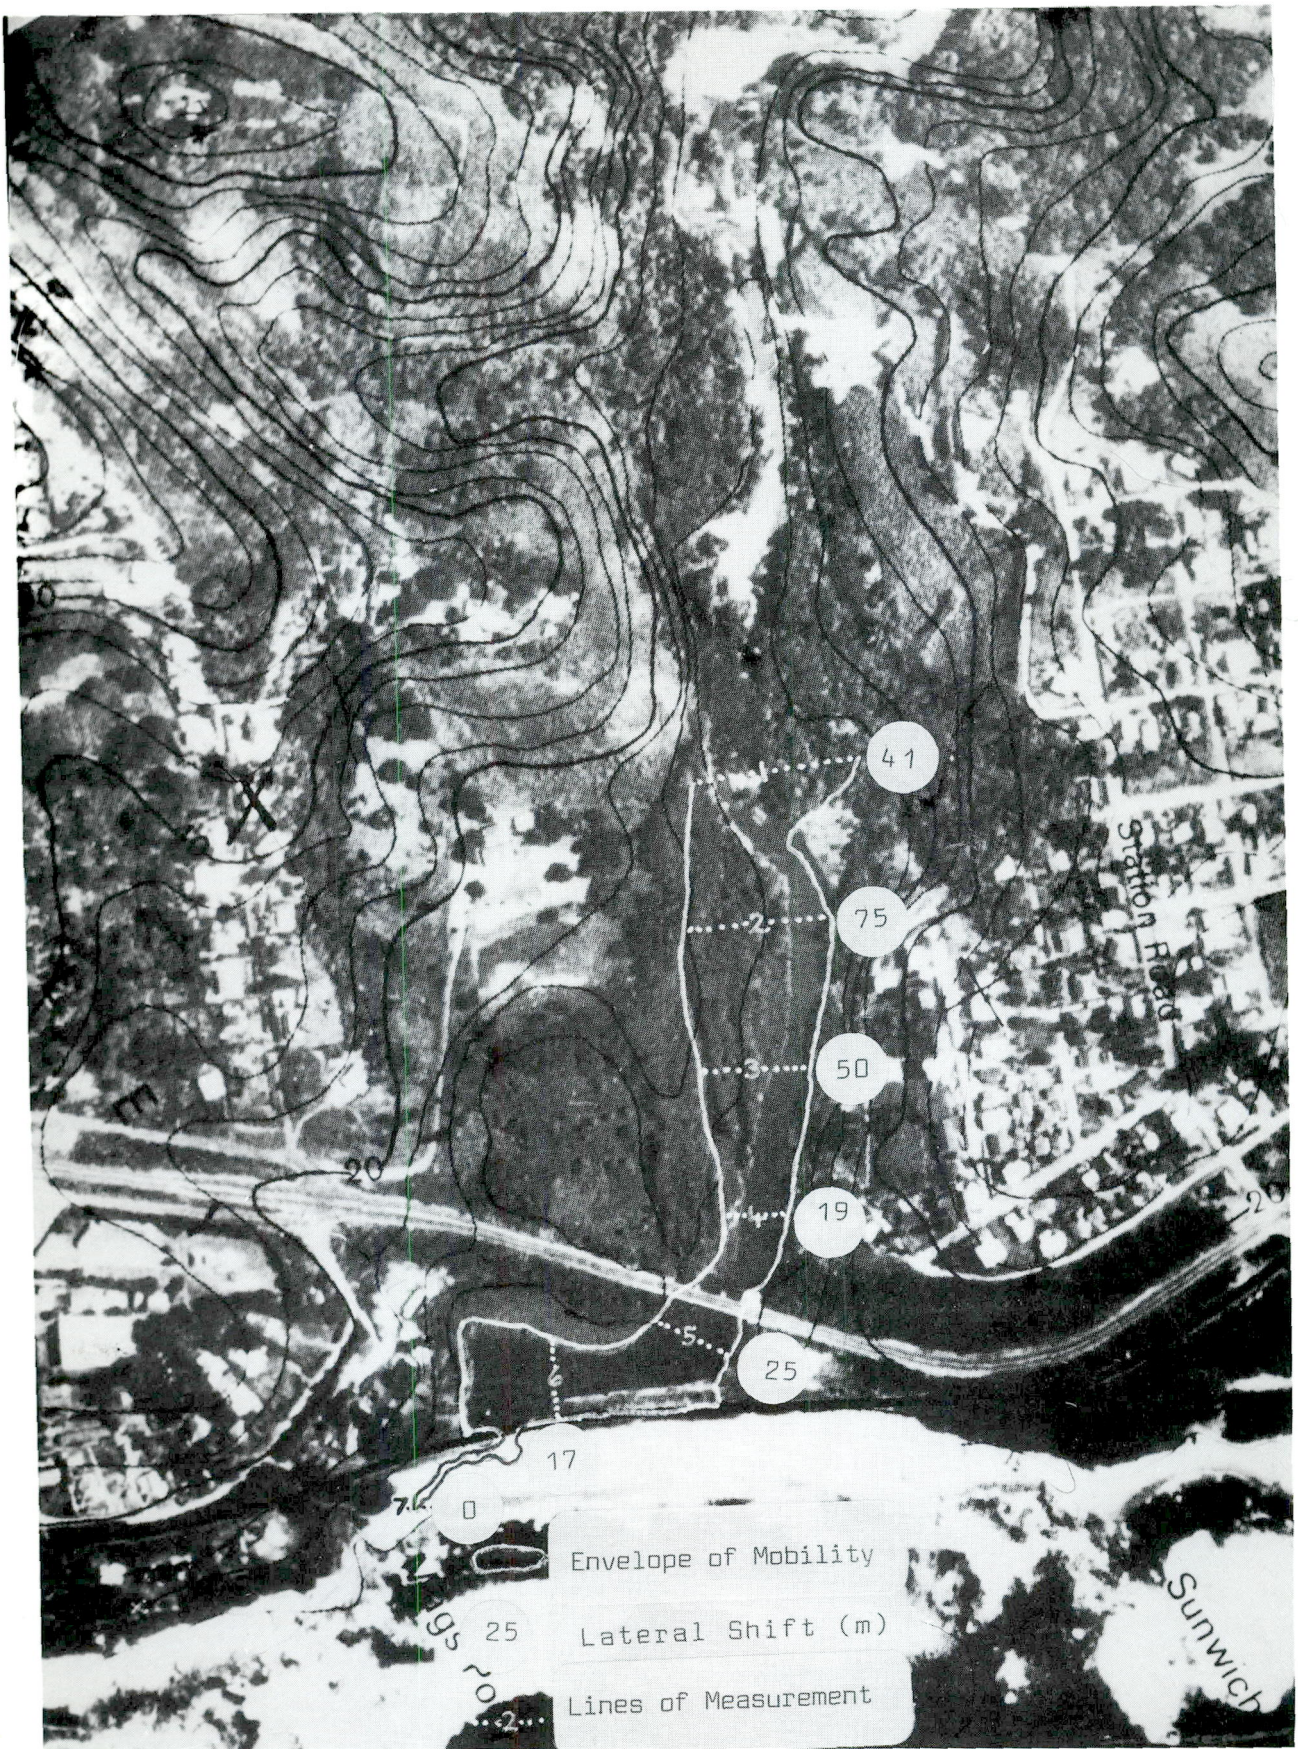
TRACED CHECKED DATE REF	NATAL ESTUARIES: DAMBA ORTHOPHOTO (ENVELOPE OF MOBILITY, LINES OF MEASUREMENT AND LATERAL SHIFT SUPERIMPOSED)	PHOTOGRAPH NS 23/11
NATIONAL RESEARCH INSTITUTE FOR OCEANOLOGY

For easy visual reference, an envelope of mobility, lines of measurement and lateral shift are superimposed on an orthophoto (Photograph NS23/11).
