**HYDROLOGICAL/HYDRAULIC STUDY OF NATAL  
ESTUARIES**

**DATA REPORT NO 28  
UMHLANGANKULU NS 8**

Town & Regional Planning Commission, Natal

January 1990

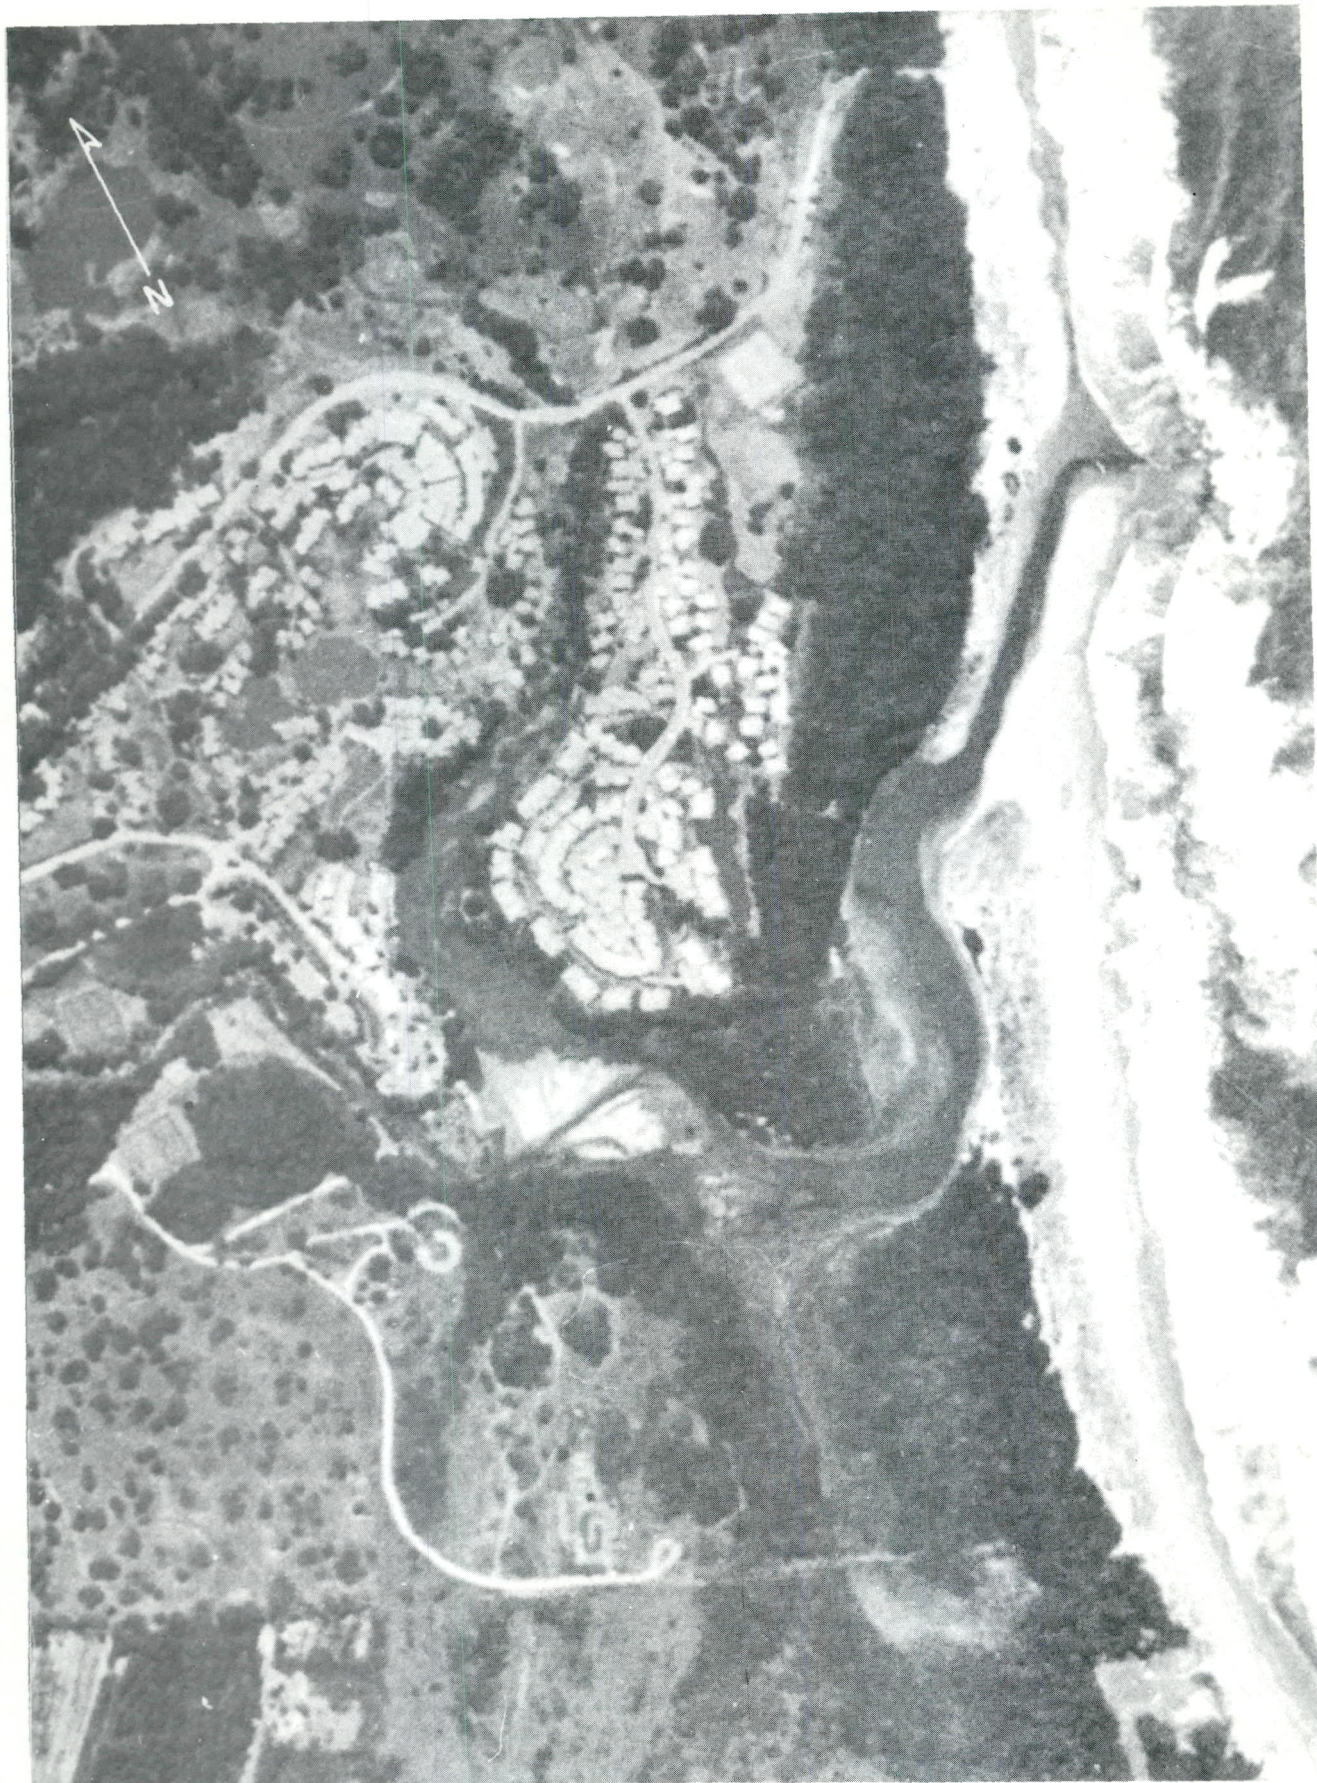
NS 8 / 9

| **NS8/9 | 02-10-87 (11h50) |

Widespread soaking rains over the catchment for five days in September 1987 resulted in major floods on the 29th September. Peak flood flow levels reached +4 m. These high discharges occurred at the end of the dry season when the mouth had been closed for a long period and the water level in the lagoon behind the sandbar was already high. Under such circumstances the flood path follows the direction of the river course in its lowest downstream bend, over the rocks on the left bank (elevation +3,2 m) discharging into the ocean to the north of the Centre

Rocks (Photograph NS8/9). At such times the dunes and dune vegetation on the left bank are eroded (see photographs inside back cover). From supplementary vertical or oblique photos and ground observations, the Umhlangankulu is known to have flowed out to sea north of Centre Rocks in January and March 1978, February 1985 and January 1989.

Aerial photographs taken when the water levels are very low (mouth open conditions e.g. Photograph NS8/9) clearly show areas

These changes naturally cannot be assessed quantitatively from aerial photographs. However, from the aerial photograph NS8/9, taken when the water level was at its lowest (September 1987) aggradation can be inferred, particularly in areas showing channel junction bars. Furthermore the steps taken to dredge the lagoon (1977 and 1989) imply aggradation.

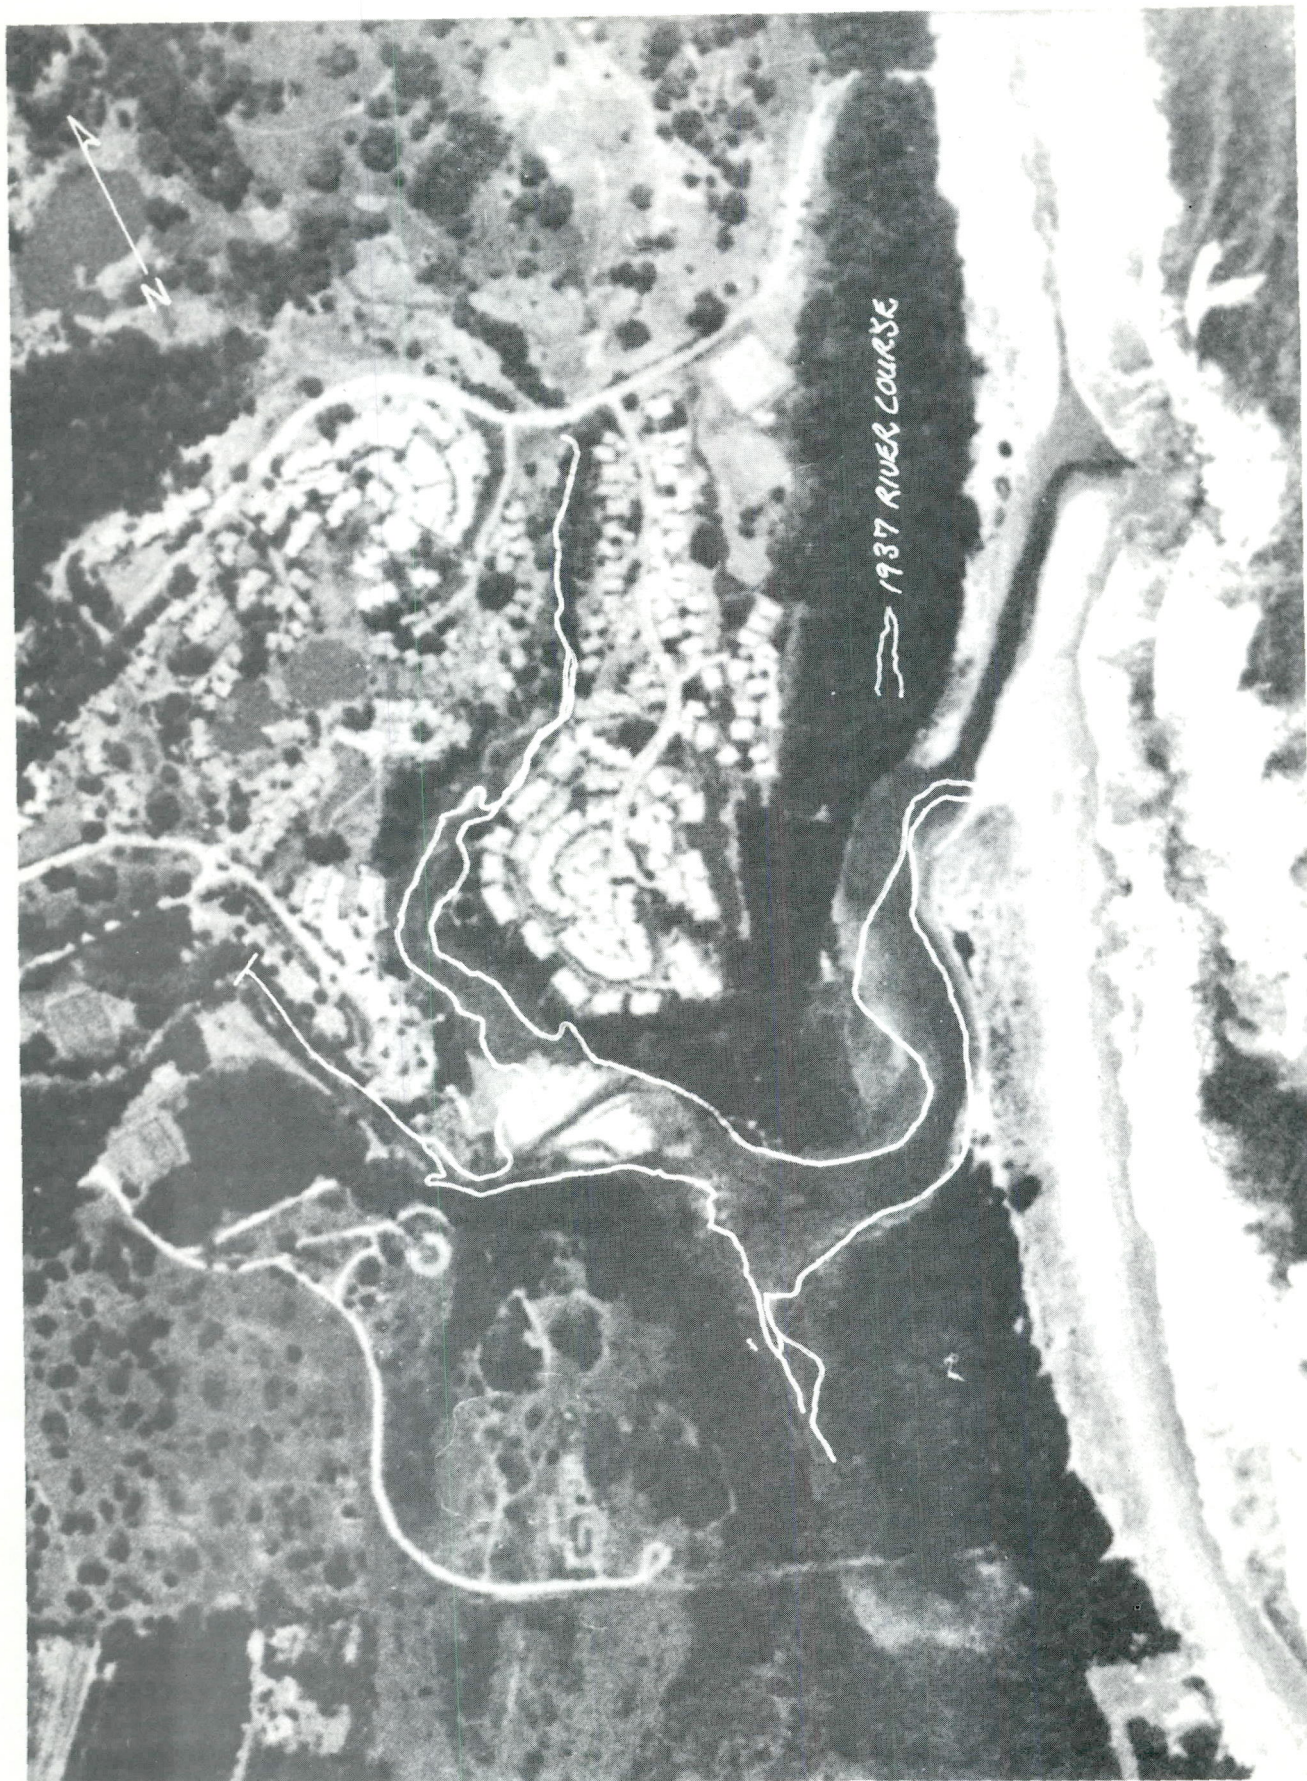
PHOTOGRAPH  
NS 8 / 10

NATAL ESTUARIES : UMHLANGANKULU  
02 - 10 - 87  
(02 - 05 - 37 RIVER COURSE SUPERIMPOSED)
