**SEDIMENTATION IN THE KROMME ESTUARY:**

**DATA REPORT**

**The Kromme River Steering Committee**

MARCH 1992

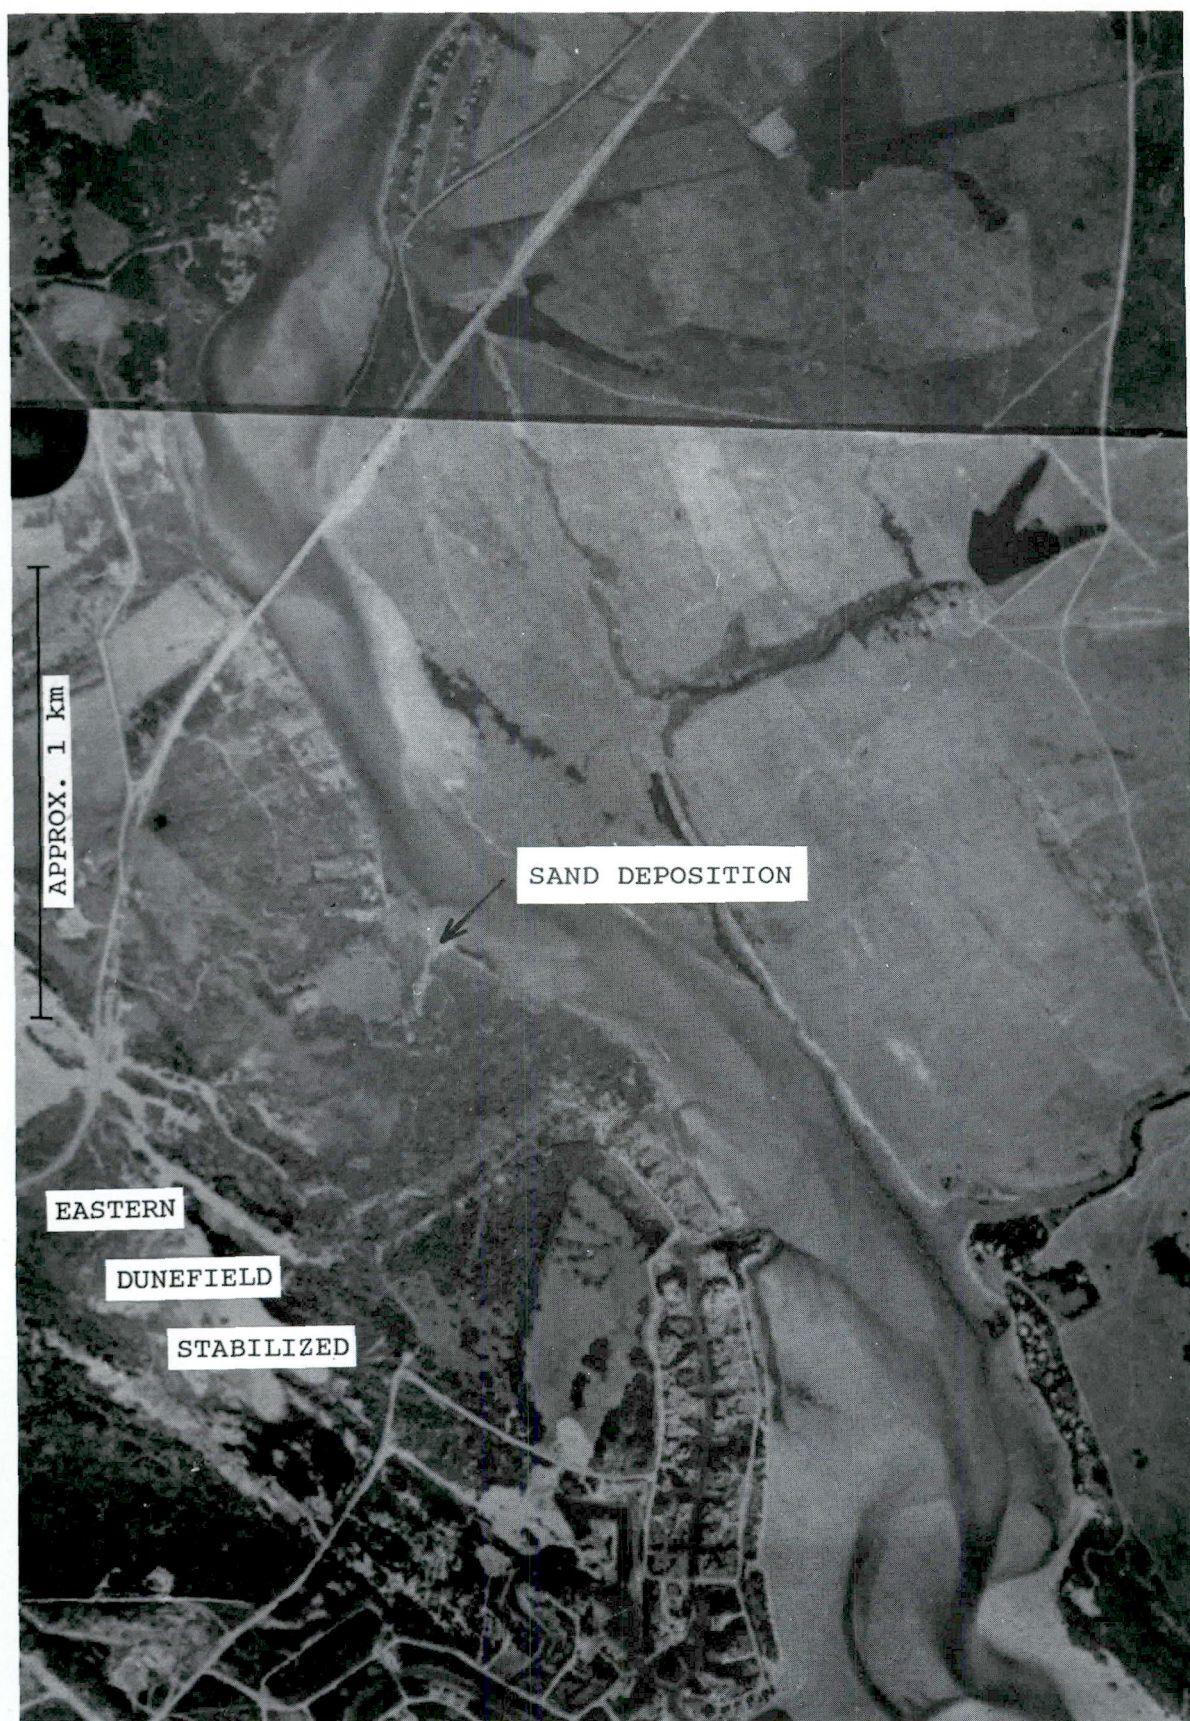
PLATE  
5

THE 1981 AERIAL PHOTOGRAPH

photographs, less deposition is evident at the confluence (Plates 4, 5, and 6) suggesting that the supply of sediment from the Sand River has decreased.

If a similar depth of the deltas is assumed, estimates of the volume of the sand at the confluence of the Sand River in 1942, 1961 or 1969 are at least 10 times larger than the 1983 value (this is particularly significant when it is considered that during these times, the river flow was not attenuated by the C W Malan Dam and large quantities of sand coming from the Sand River could have been carried out of the estuary). Thus, it appears that deposition by the Sand River decreased after 1969. This is probably because of stabilization of the eastern region of the dunefield (Plate 3) between 1969 and 1981 (Plate 5), primarily by alien vegetation.

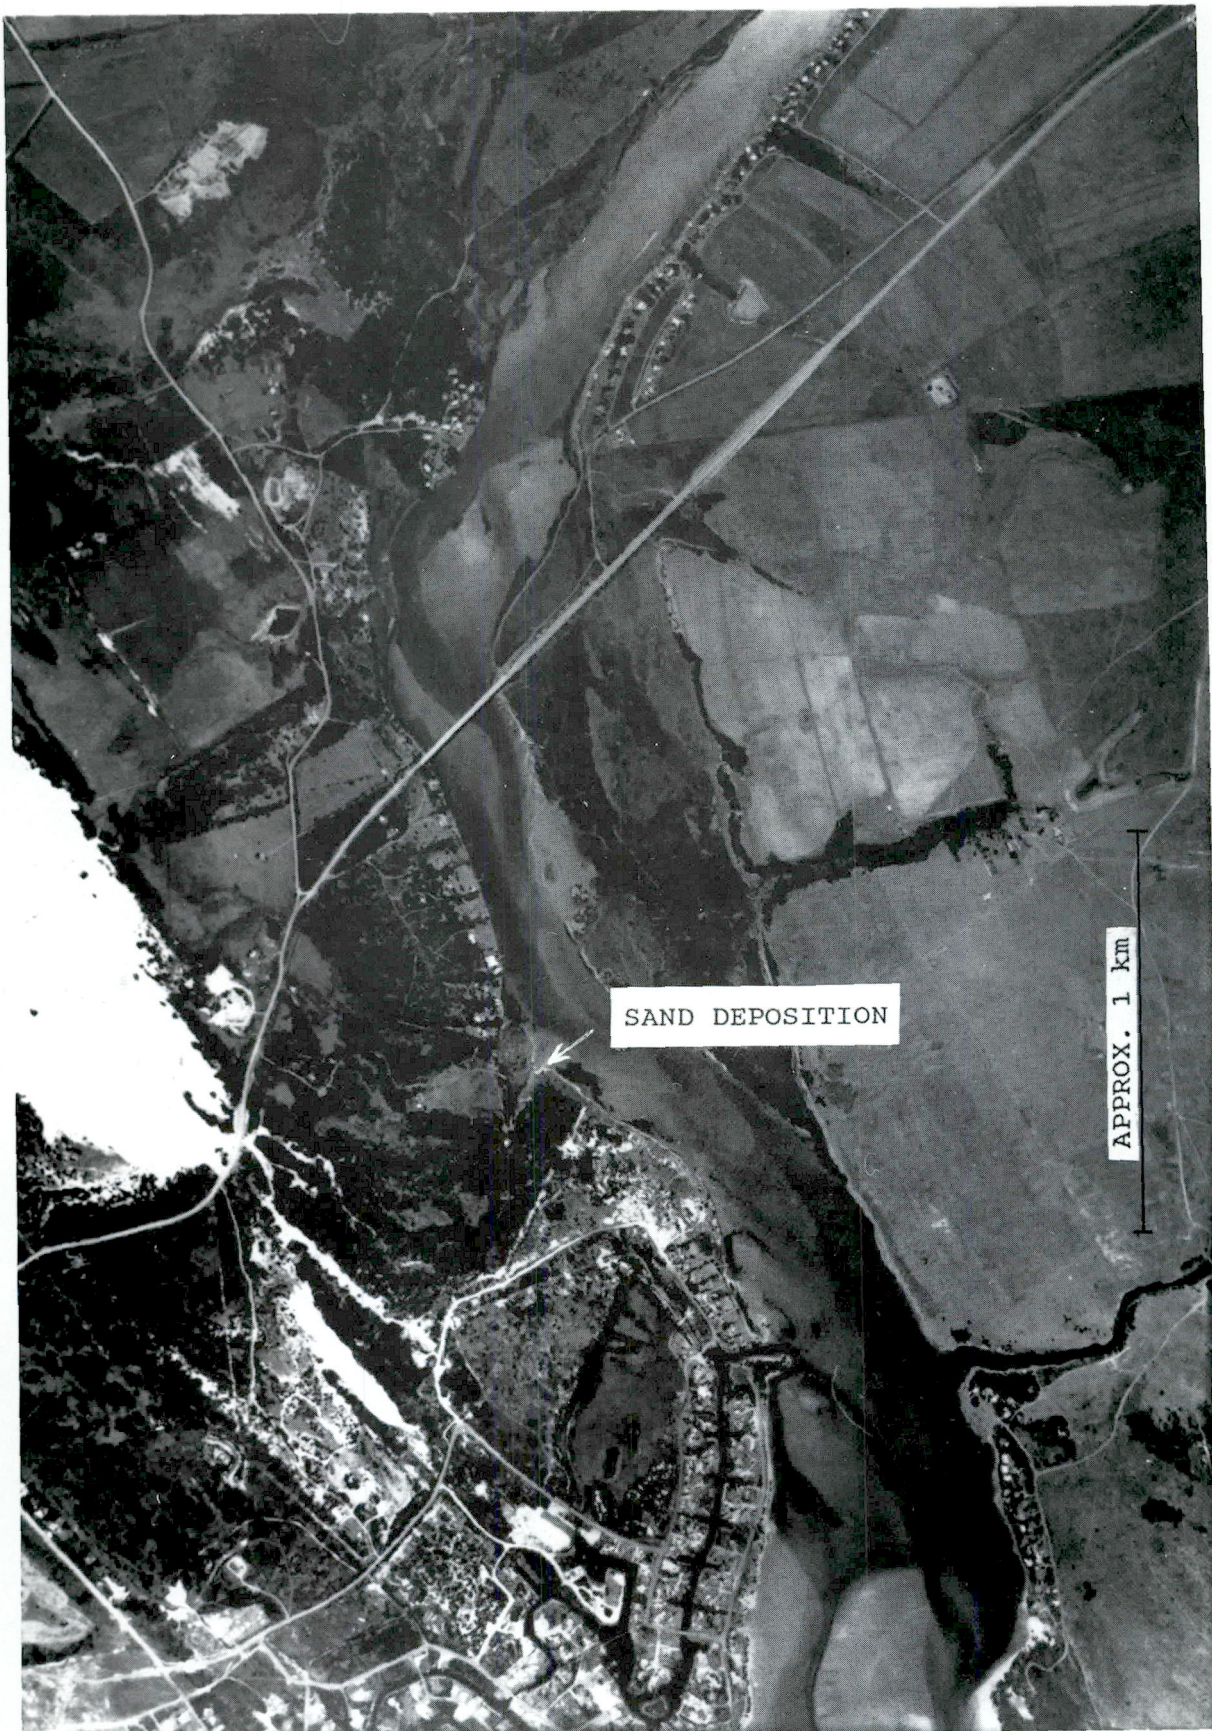
PLATE 6

THE 1987 AERIAL PHOTOGRAPH

The aerial photographs show that the Sand River deposits sand in the estuary. Its confluence with the Kromme Estuary is presently 750 m downstream of the roadbridge (Plate 6). In 1942, the confluence was 500 m further east of the present position (Plate 1). In the 1961, 1969 and 1975 photographs, two branches of the Sand River are apparent. This is because the Sand River was diverted during the construction of the marina;
