**HYDROLOGICAL/HYDRAULIC STUDY
OF NATAL ESTUARIES**

PROGRESS REPORT NO. 5

Zinkwasi estuary

NRIO MEMORANDUM 8115

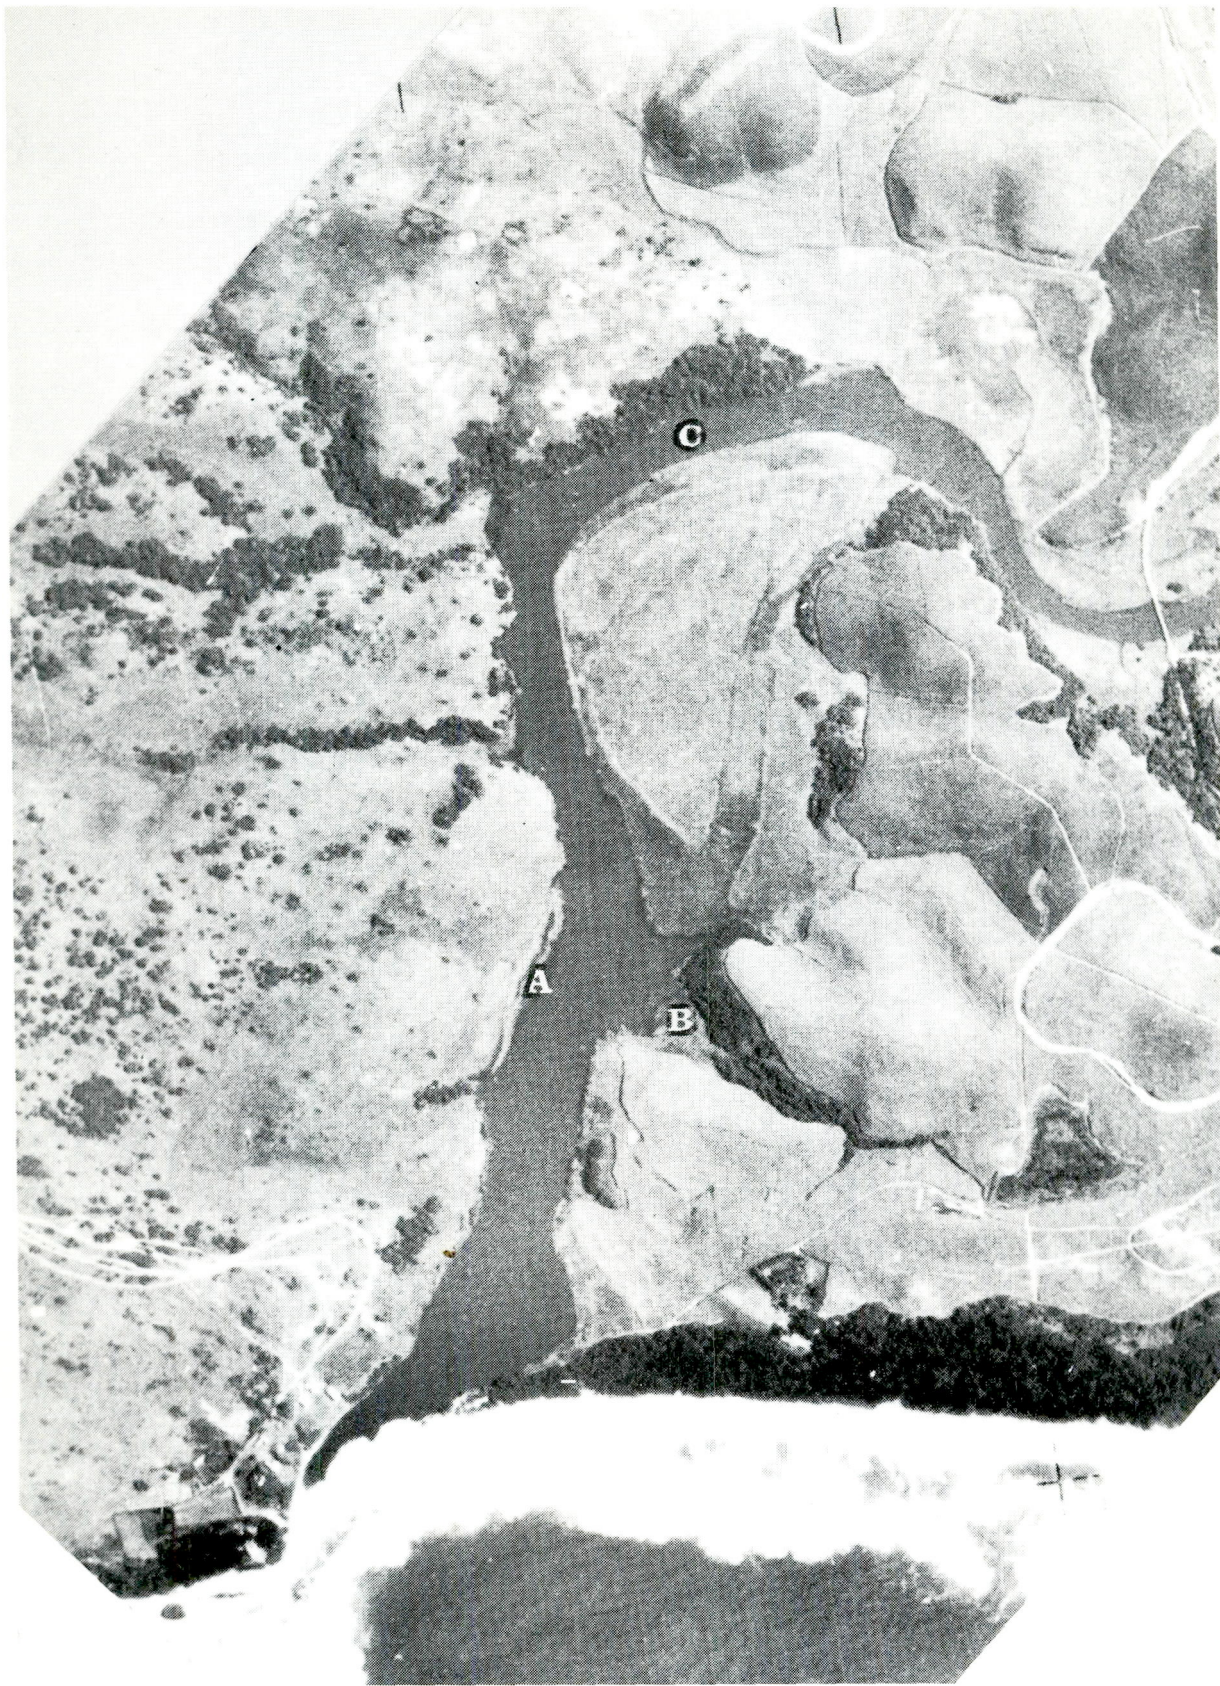
(iii) The average width of the river/lagoon has gradually decreased from 93 m to 72 m. Deposition of soil in the river bed is shown clearly in the area marked A on Photographs 1 to 3. This was largely the result of a heavy storm in May 1959 which occurred soon after the lands had been ploughed.

An example of the gradual increase in the area of channel junction bars is shown in position B on Photographs 1 to 3.

(iv) In the area marked C on Photographs 1 to 3 the water depth as noted by long-standing local residents, has decreased from approximately 6 m to less than 1 m since the early 1930's.

(v) The reasons for (iii) and (iv) above are to be found in the decrease of riverine vegetation (of photographs 1 and 2) and the increase in lands bordering the flood plain cultivated with sugar cane (see 6 and 7 of Table XI). As the total area of riverine vegetation decreased from 17 ha to 2 ha, so the percentage swamp area in the flood plain has increased from 13 to 36 per cent.

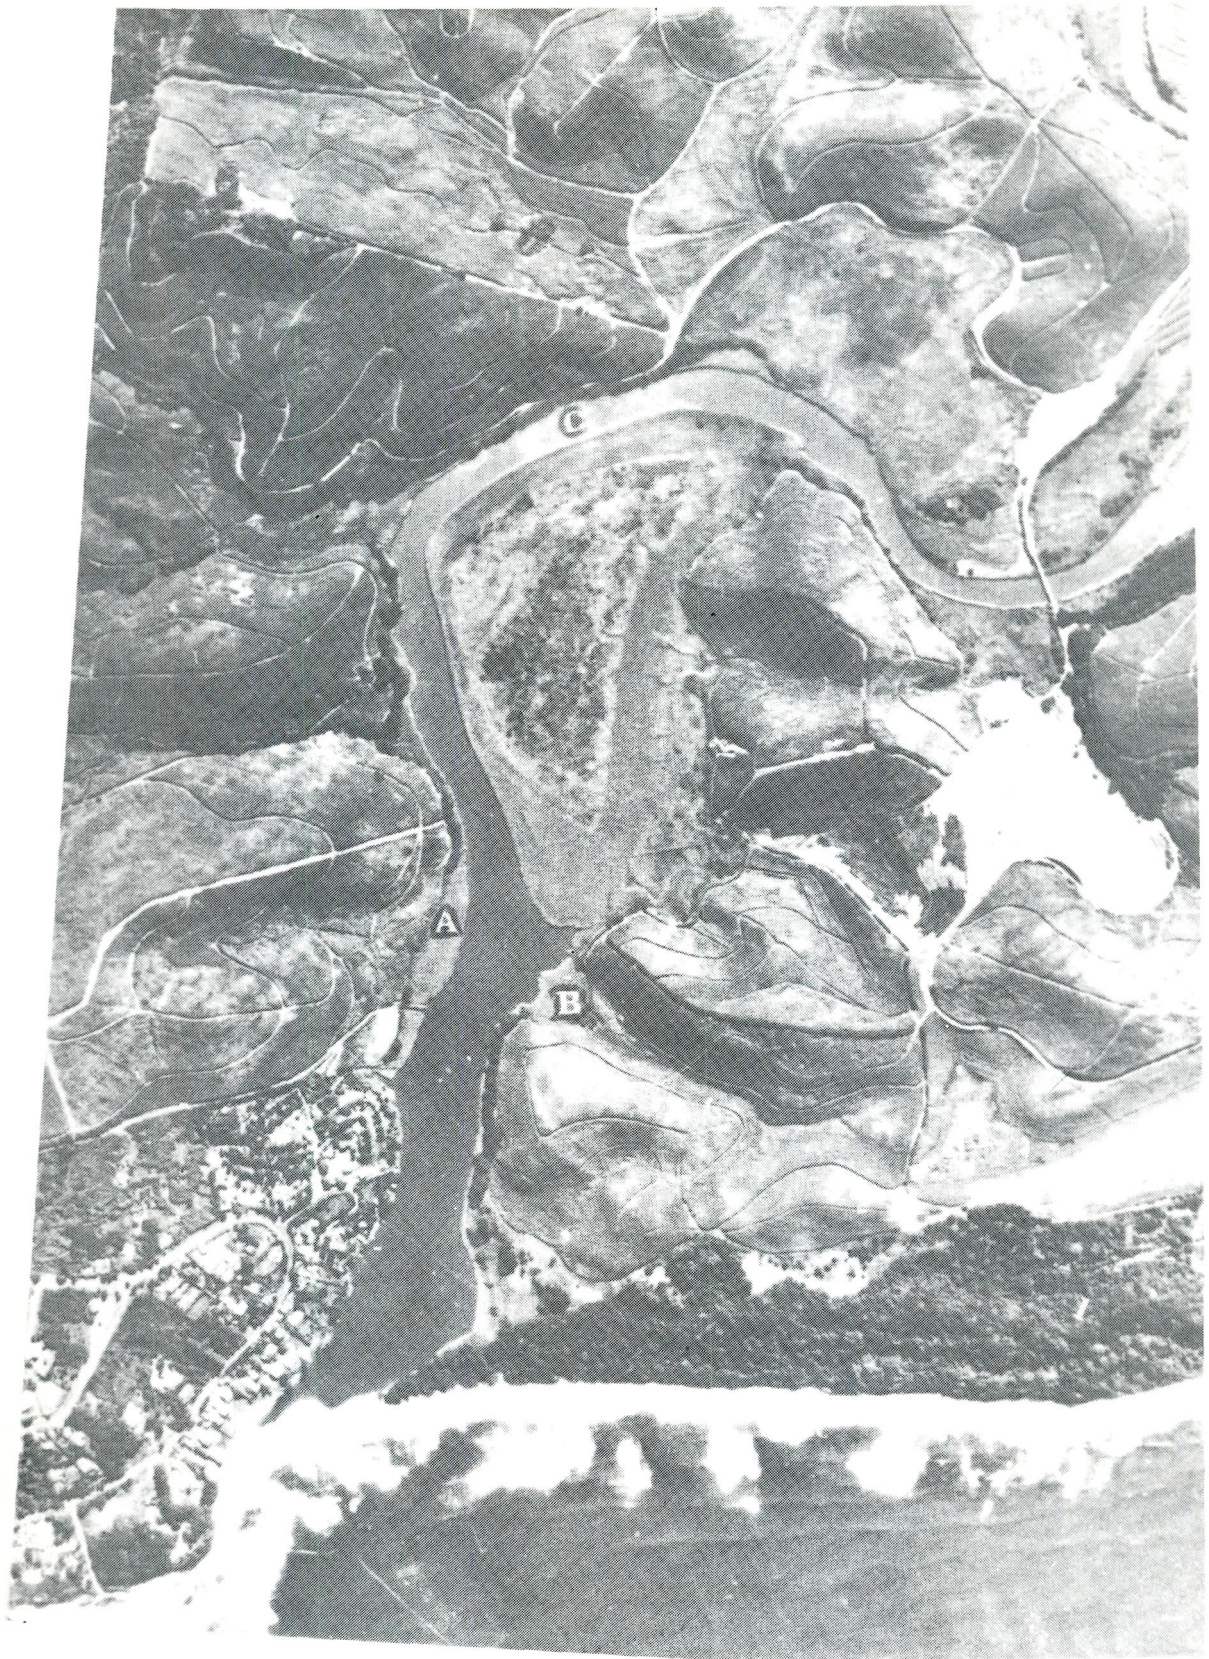
PHOTOGRAPH
3

NATAL ESTUARIES
ZINKWASI : 14-5-76
