**HEALTH OF SOUTH AFRICAN ESTUARIES,  
GROOT (Wes) - GREAT FISH**

**Executive Report**

PREPARED BY: T.D. Harrison, J.A.G. Cooper, A.E.L. Ramm, R.A. Singh  
Coastal and Catchment Environmental Programme  
CSIR  
P O Box 17001  
CONGELLA  
4013

Project No. QH102  
March 1996

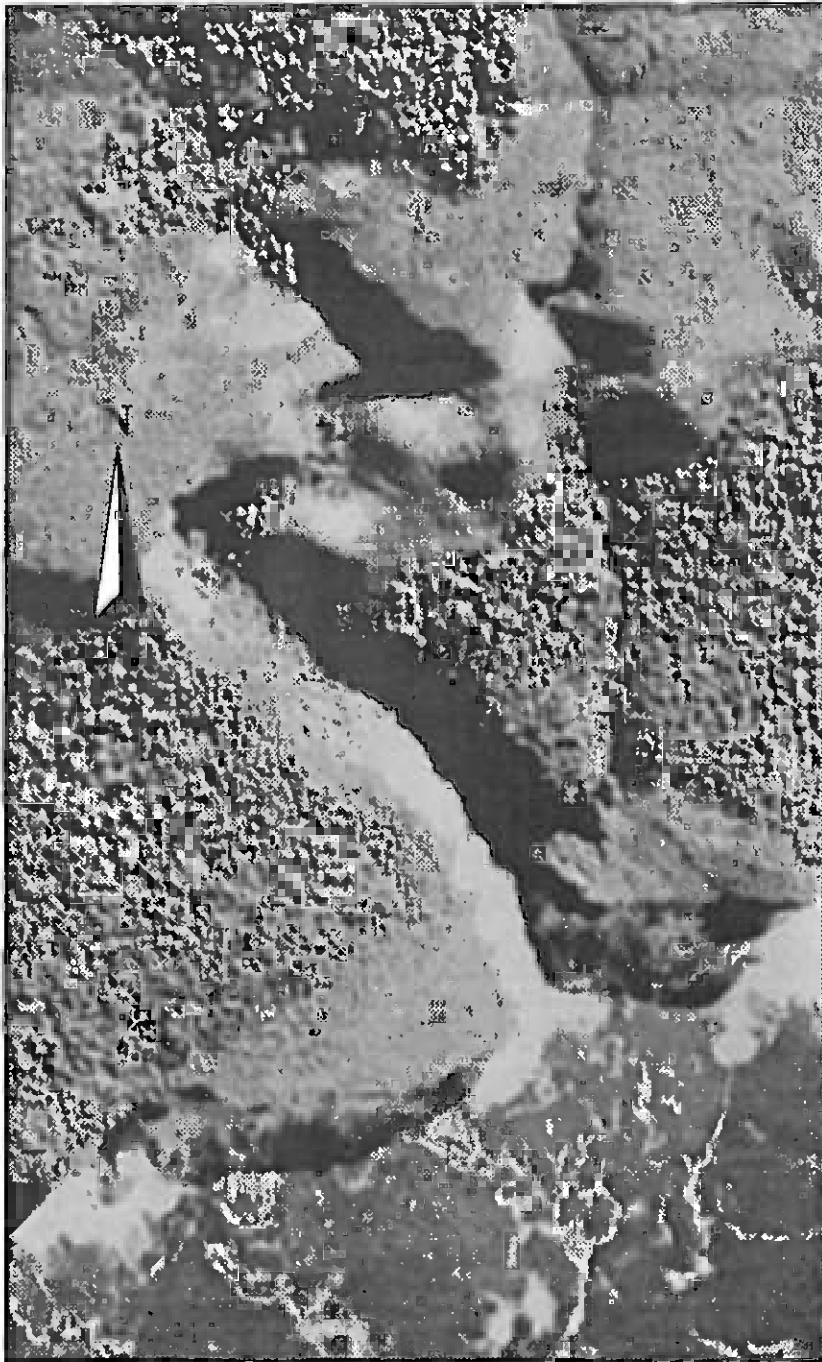
Due to its relative inaccessibility and small size, the overall health of the Helpmekaars was not assessed.

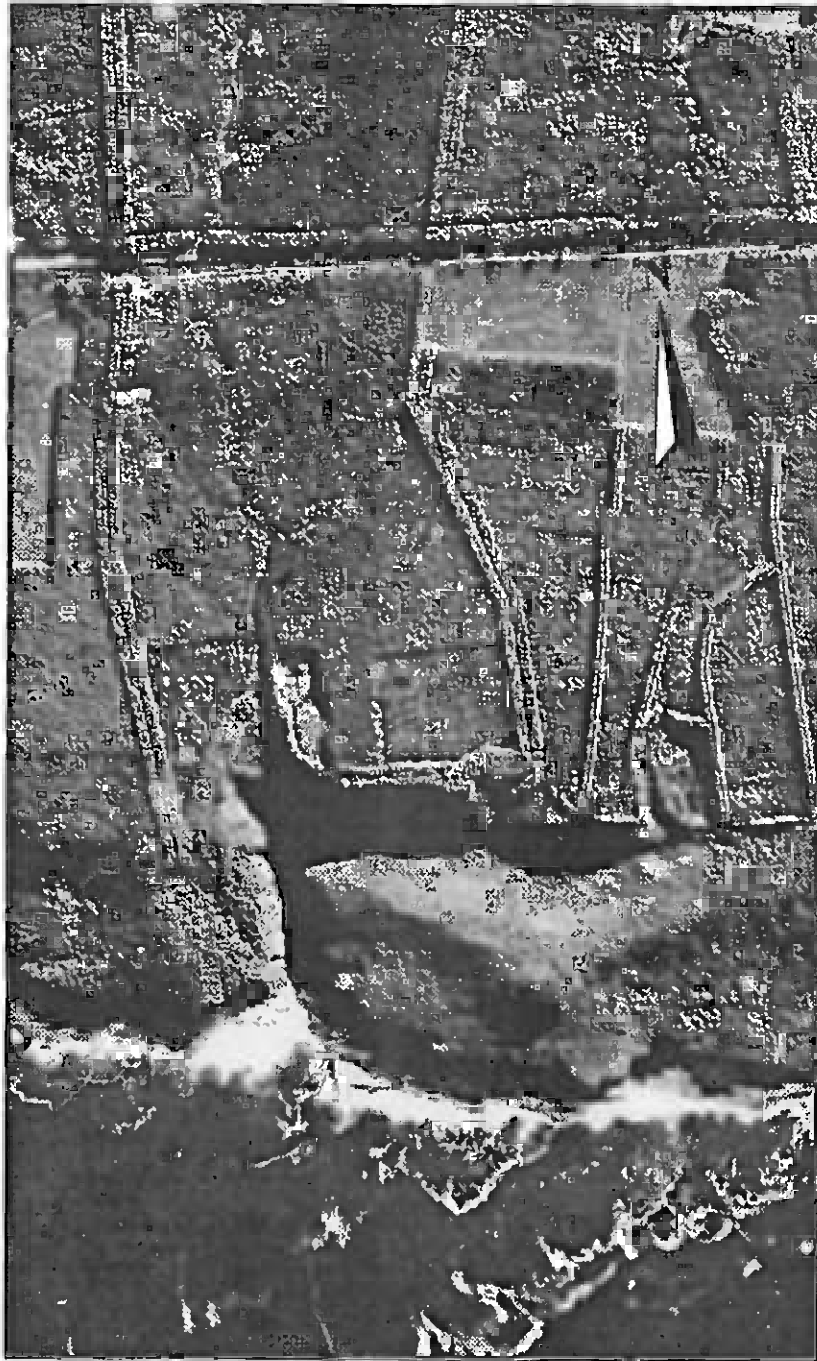
**WITELS**

Due to its relative inaccessibility and small size, the overall health of the Witels was not assessed.

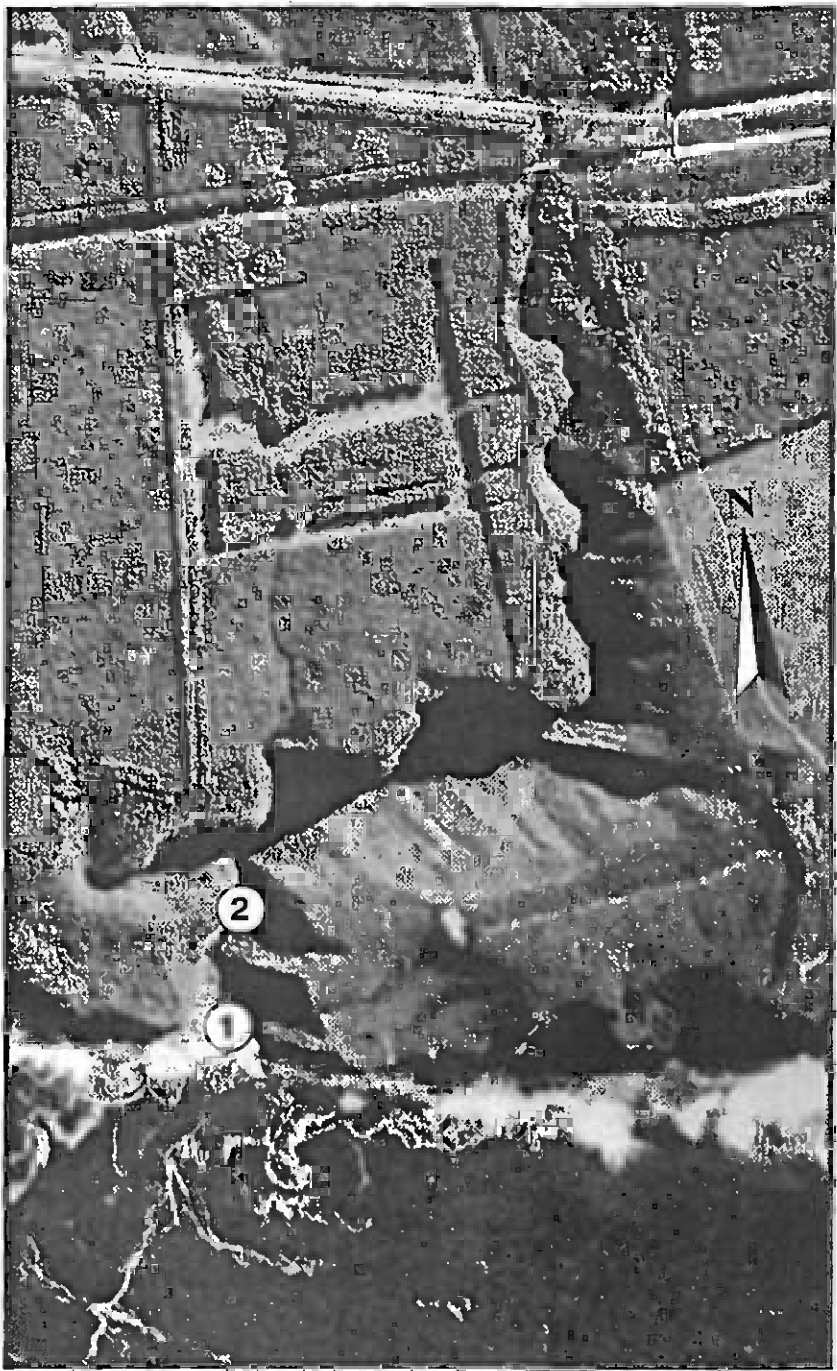
The Lottering was classed as poor biologically with a good water quality and aesthetic appearance. Overall, the system is regarded as being in a moderate condition with a composite score of 7 out of 9.

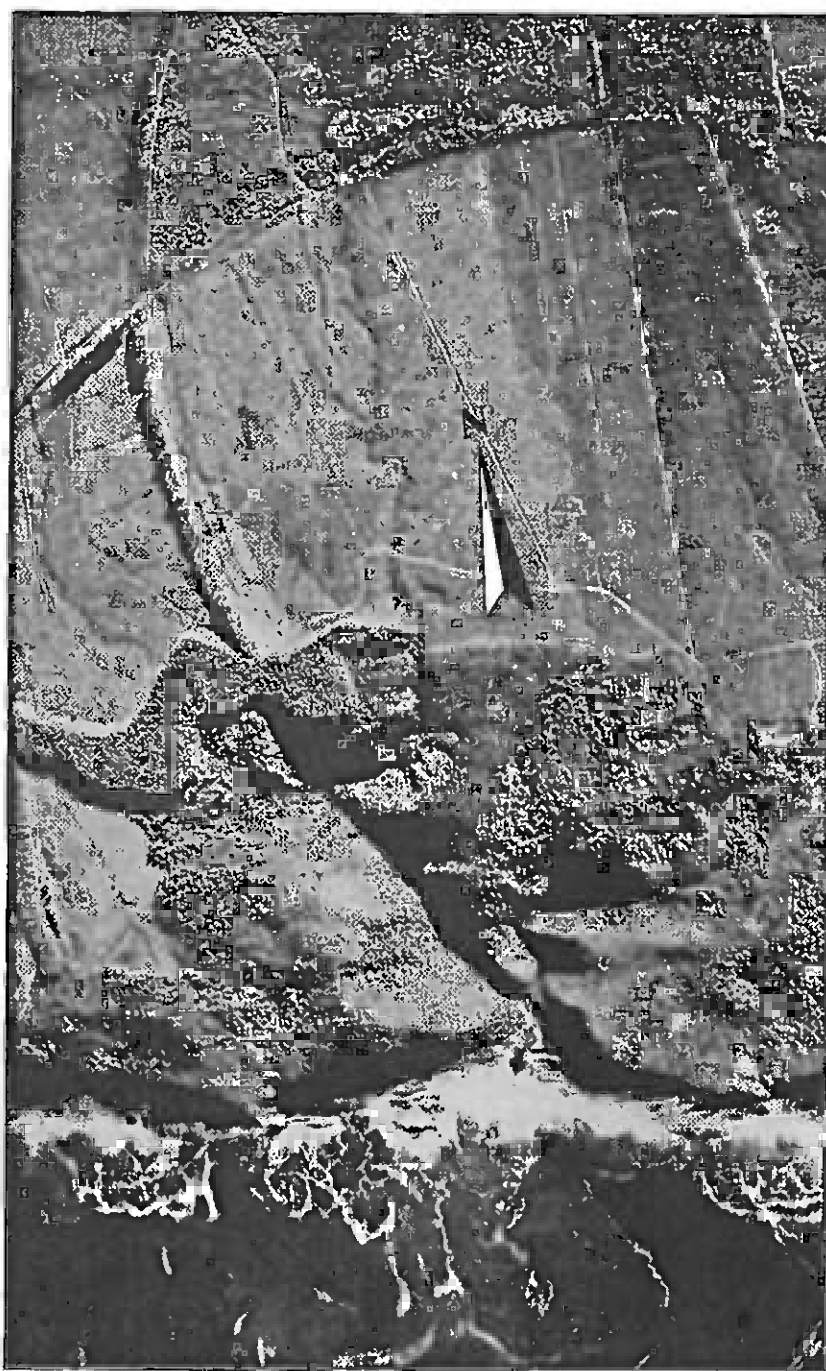
# GEELHOUTBOS

Due to its relative inaccessibility and small size, the overall health of the Geelhoutbos was not assessed.

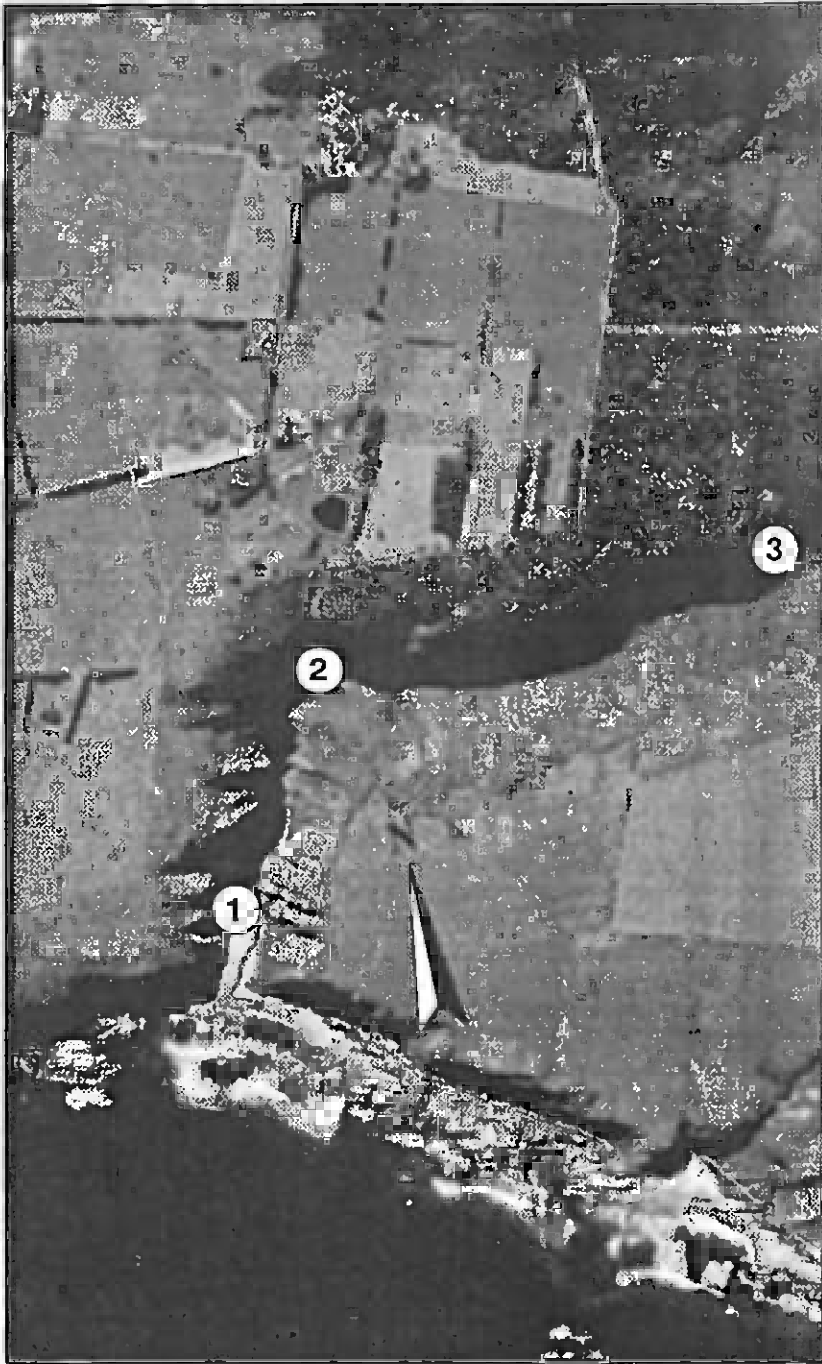
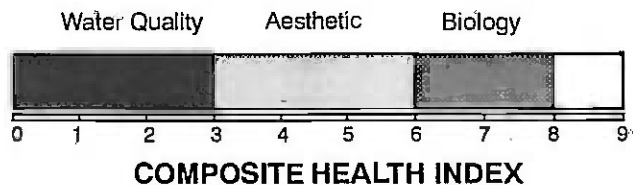
**GROOT (Oos)**

Water quality in the Groot (Oos) estuary was sampled at the positions shown opposite. The overall water quality was good with an index value of 7.4. Some impairment was observed in the suitability for human contact resulting from elevated *E. coli* counts on the day of sampling and suitability for aquatic life resulting from elevated OA concentrations and somewhat depressed dissolved oxygen levels.

The biological status of the Groot (Oos) was considered acceptable while the water quality and general aesthetic appearance of the system were both considered good. Overall, the Groot (Oos) is regarded as being in a relatively good condition with a composite score of **8 out of 9**.

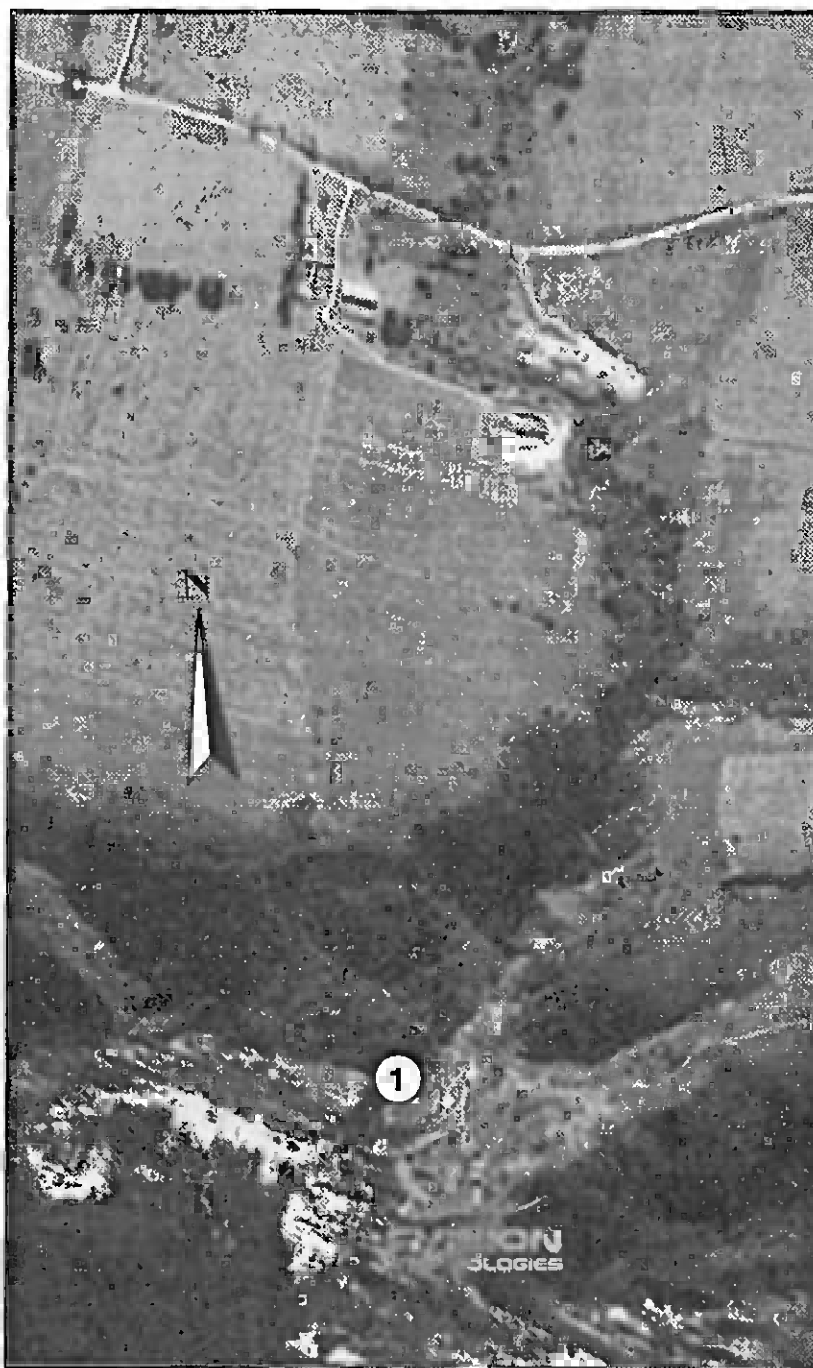
The water quality of the Klipdrif (Wes) was rated very poor while the aesthetic appearance of the system was classed as good. Based on the water quality and aesthetic state of the system, the Klipdrif (Wes) is regarded as being in a satisfactory condition with a composite score of **4 out of 6**.

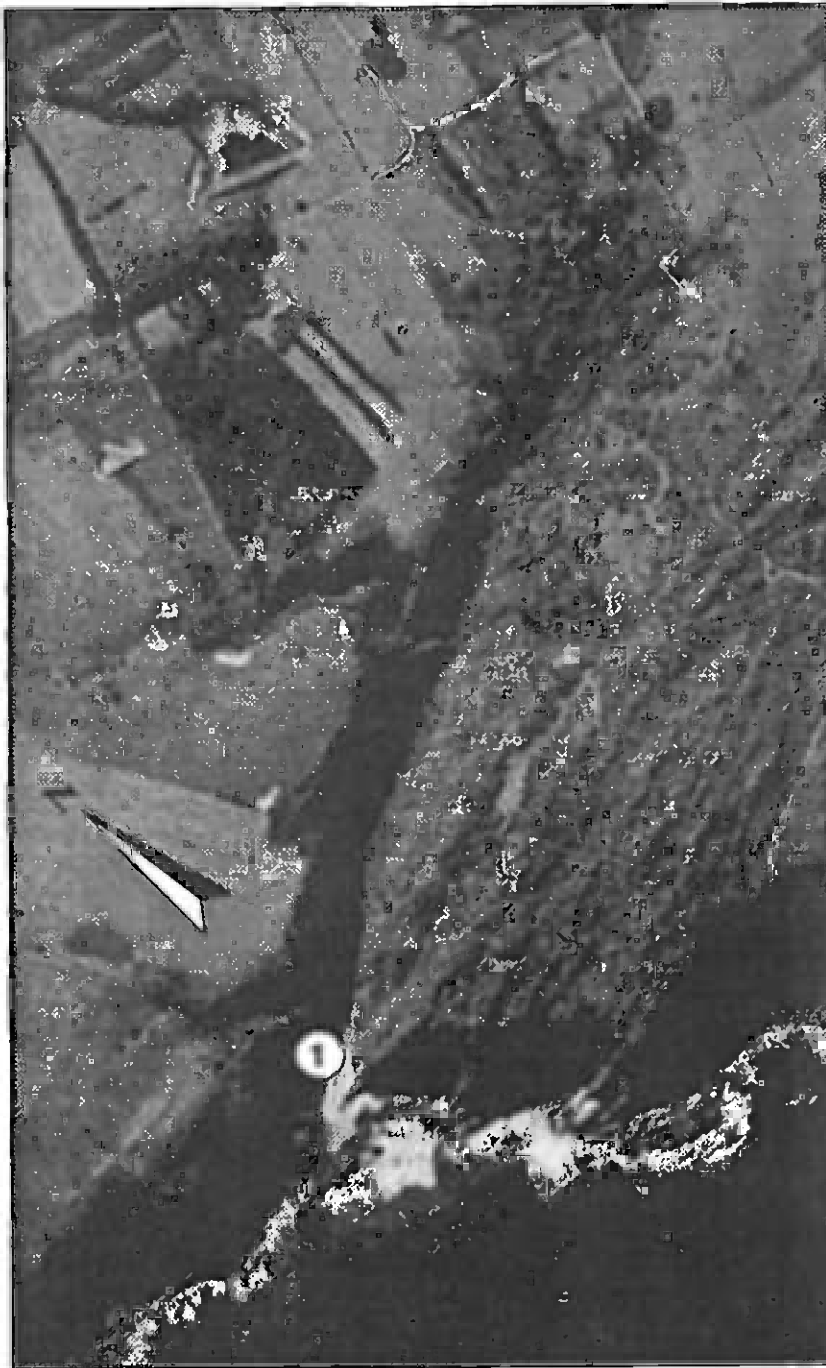
In terms of its appearance the Boskloof scored 9.6. The system falls within farmlands and the floodplain, shoreline and the surrounding area are in a near-natural condition. The only major impact on the aesthetic state of the Boskloof was the presence of flotsam washed into the system from the sea.

The water quality of the Boskloof was moderate and its aesthetic appearance was considered good. Based on these two parameters, the system is regarded as being in a moderately good condition with a composite score of 5 out of 6.

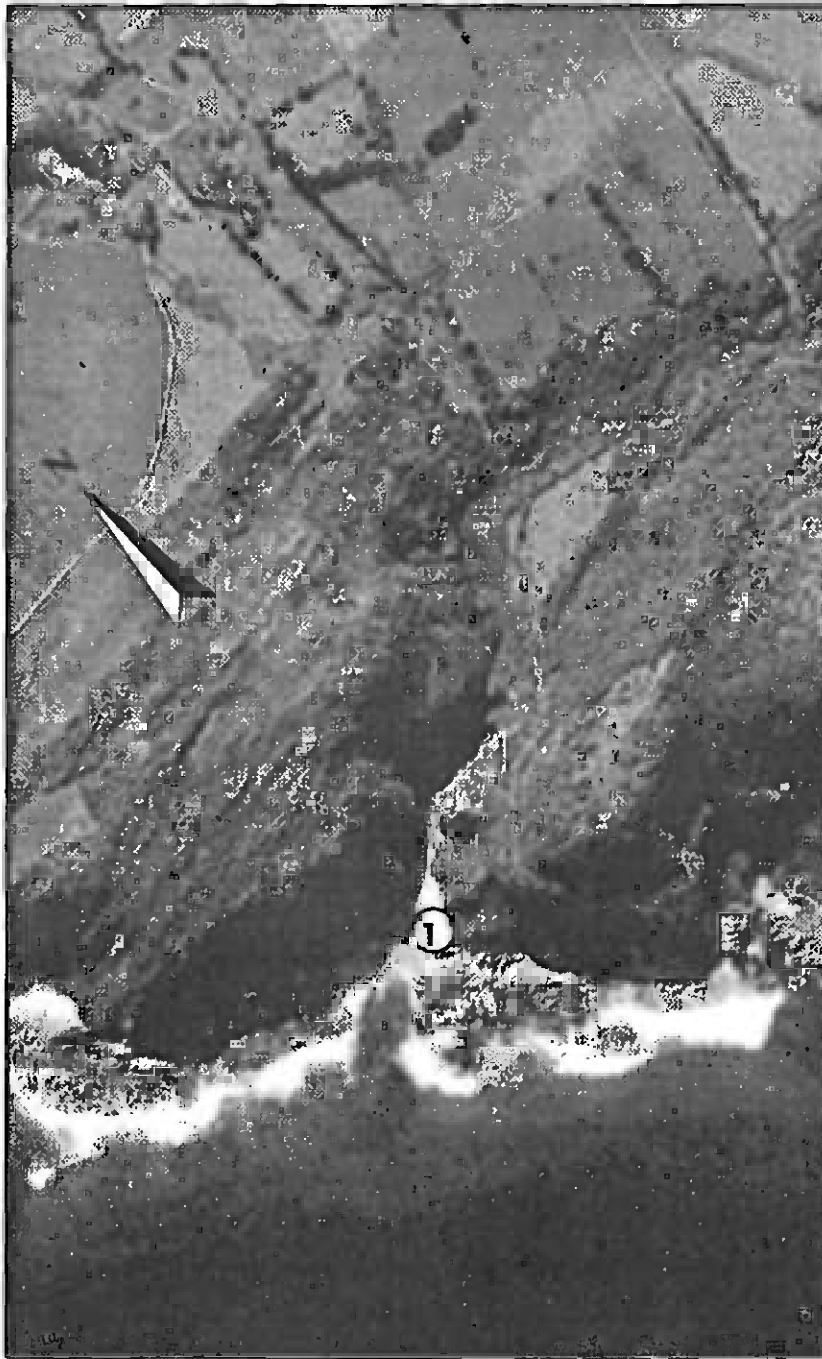
Water quality in the Kaapsedrif estuary was sampled at the positions shown opposite. The overall water quality was moderate with an index value of **4.5**. Significant impairment was observed in all three of the water quality areas. Impairment in the suitability for human contact resulting from relatively high *E. coli* counts was significant on the day of sampling.

The water quality of the Kaapsedrif was moderate and its aesthetic appearance was good. Based on these two parameters, the system is regarded as being in a moderately good condition with a composite score of **5 out of 6**.

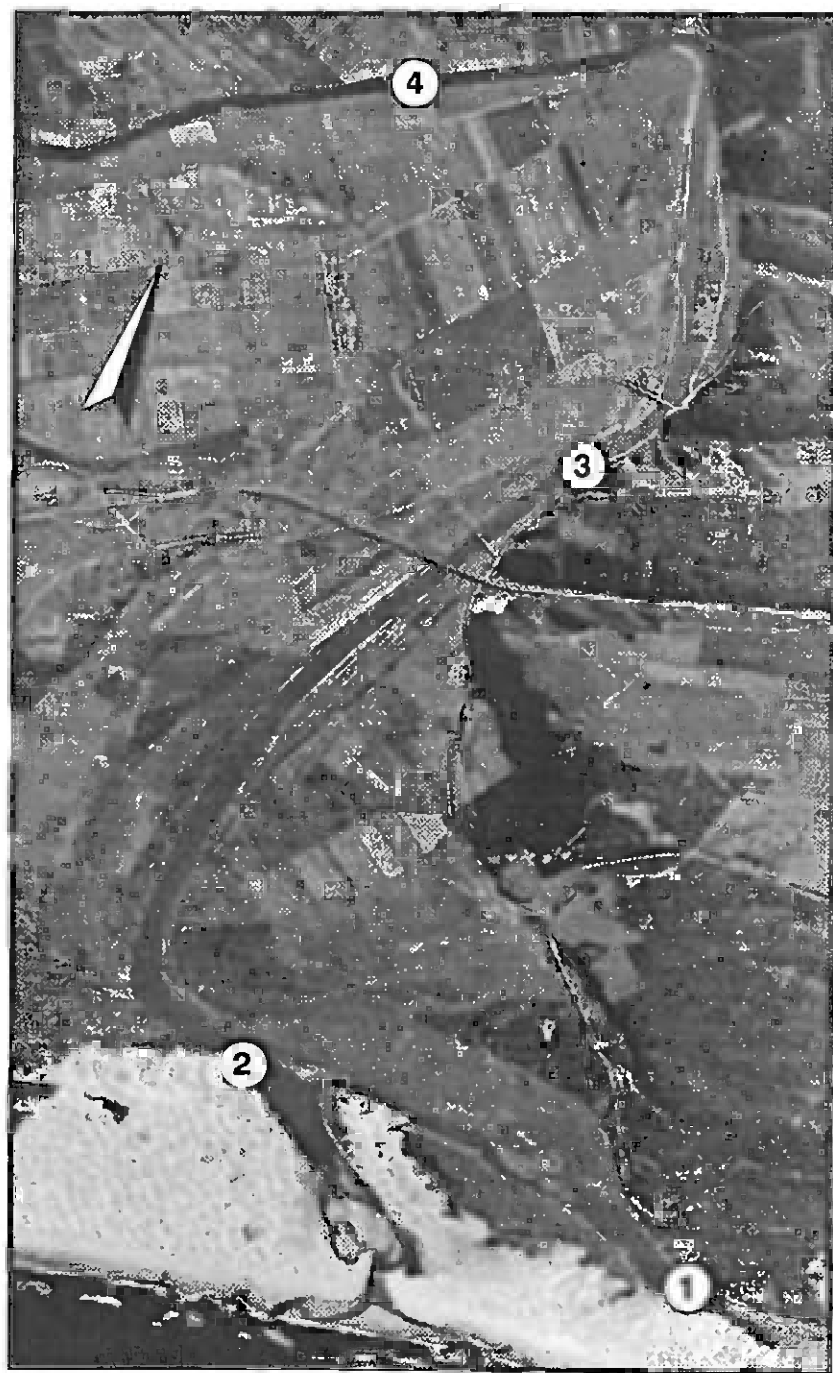
The biological status and water quality of the Gamtoos were rated as good while the aesthetic appearance of the system was satisfactory. The system is regarded as being in a moderately good condition overall with a composite score of 8 out of 9.

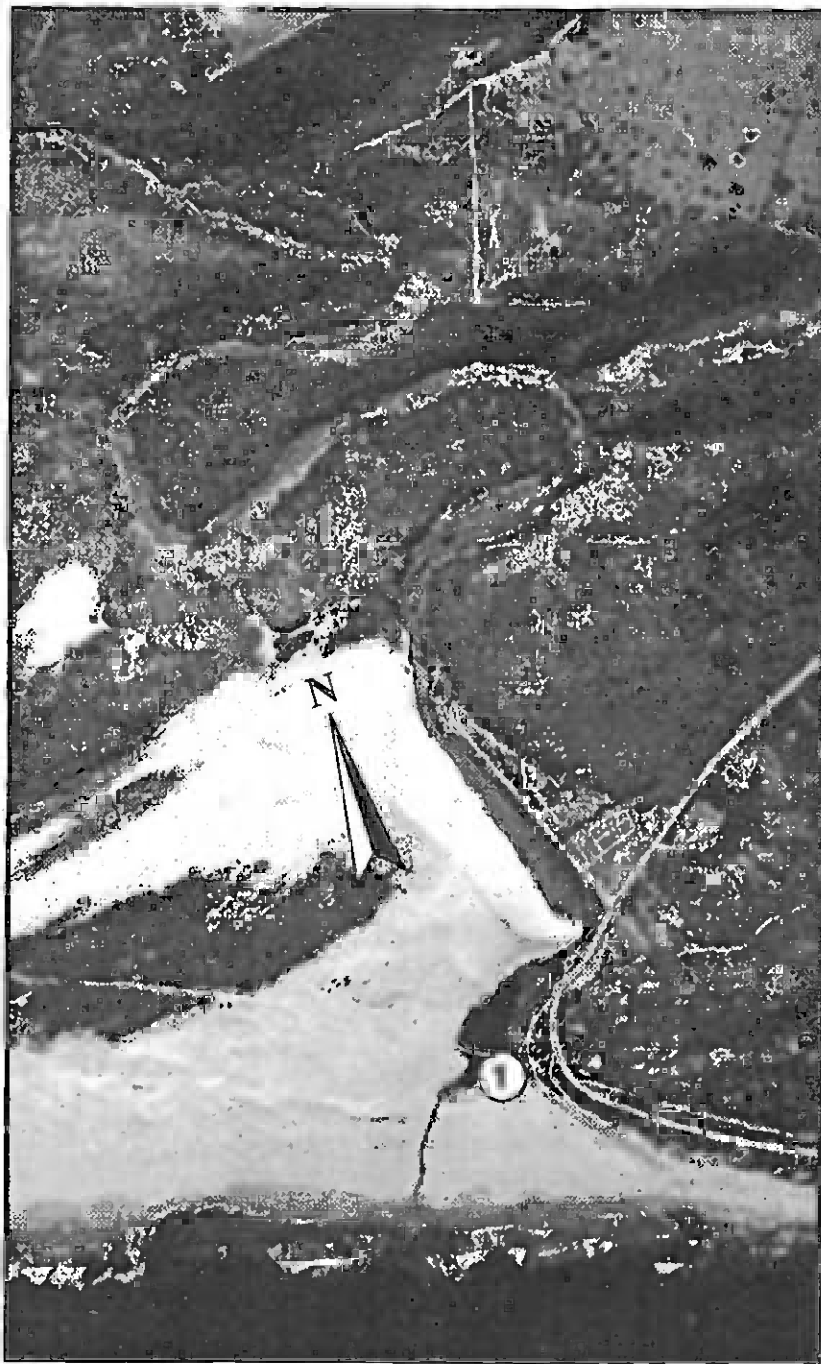
The biological status of the Maitland system was moderately poor with a satisfactory water quality. Aesthetically, the system was moderately good. Overall, the Maitland is regarded as being in a moderate condition with a composite score of 6 out of 9.

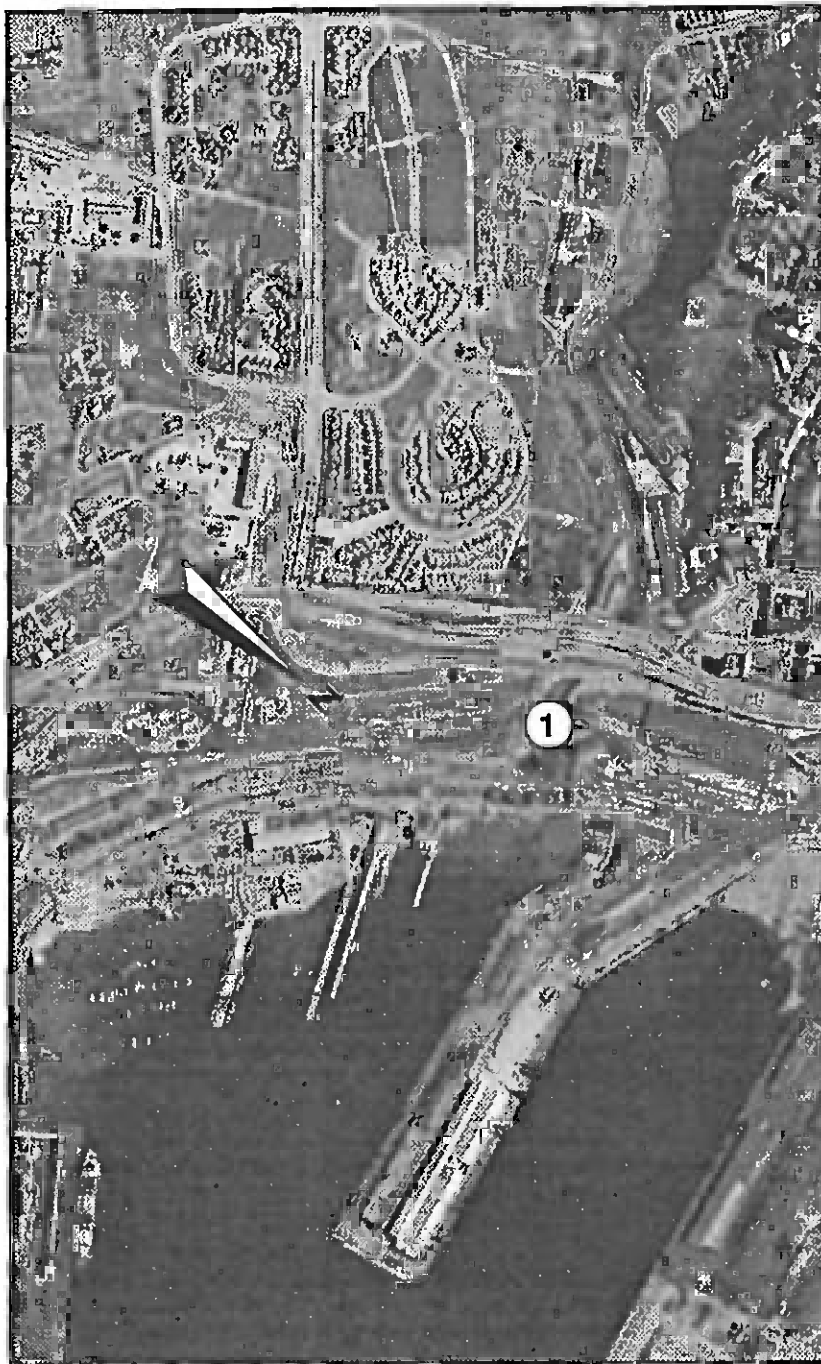
The biological status of the Bakens was moderately good with a moderate water quality. Its overall aesthetic appearance however was very poor. Overall, the system is considered to be in a moderately poor condition with a composite score of **6 out of 9**.

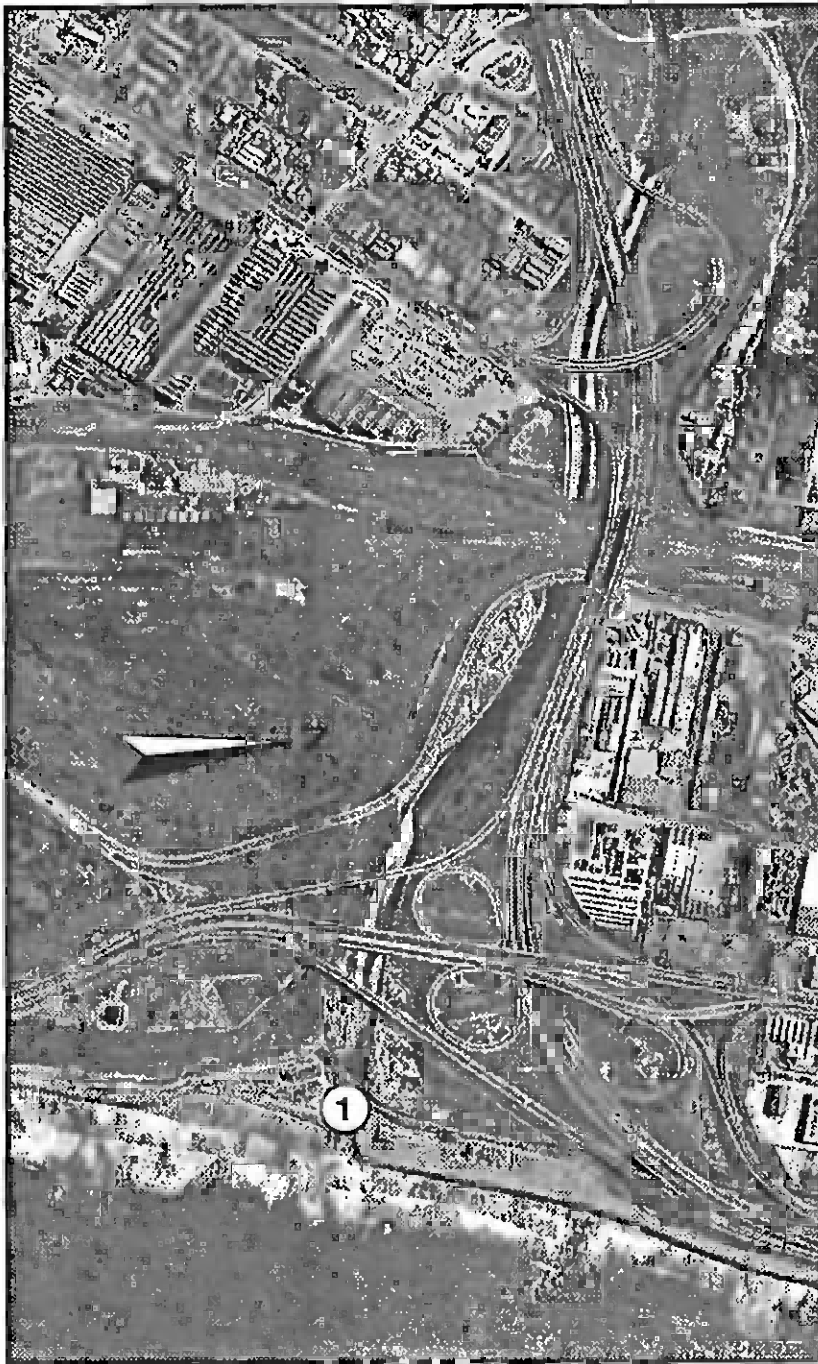
No fish species were collected in the Papkuils during this study. The system is severely degraded and had an index score of **0.0**.

The Papkuils is severely degraded in terms of its biology, water quality and aesthetic appearance. Overall, the system is in a poor condition with a composite score of **3 out of 9**.

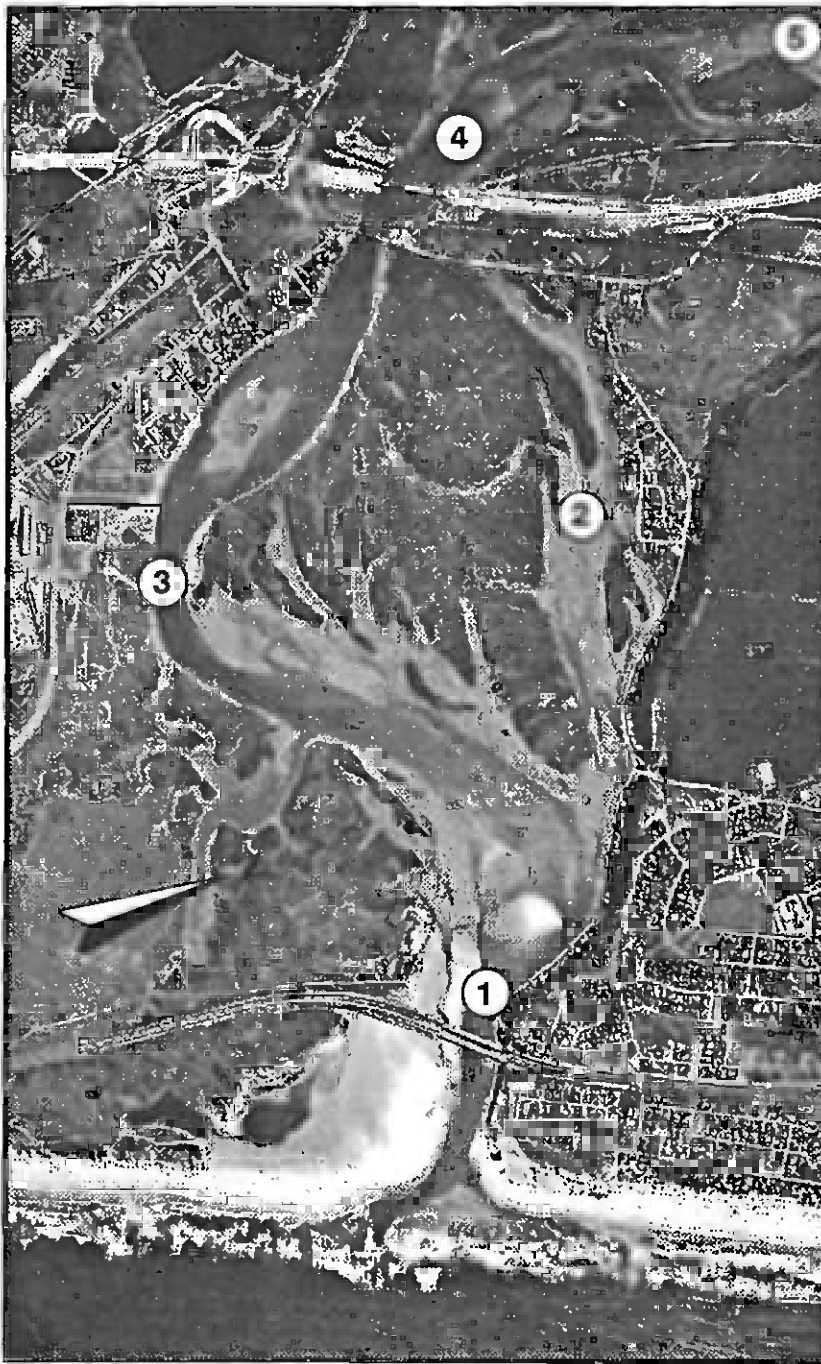
The biology and overall water quality of the Swartkops were both rated as good while its aesthetic appearance was considered moderately poor. Overall, the system is regarded as being in a moderately good condition with a composite score of 7 out of 9.

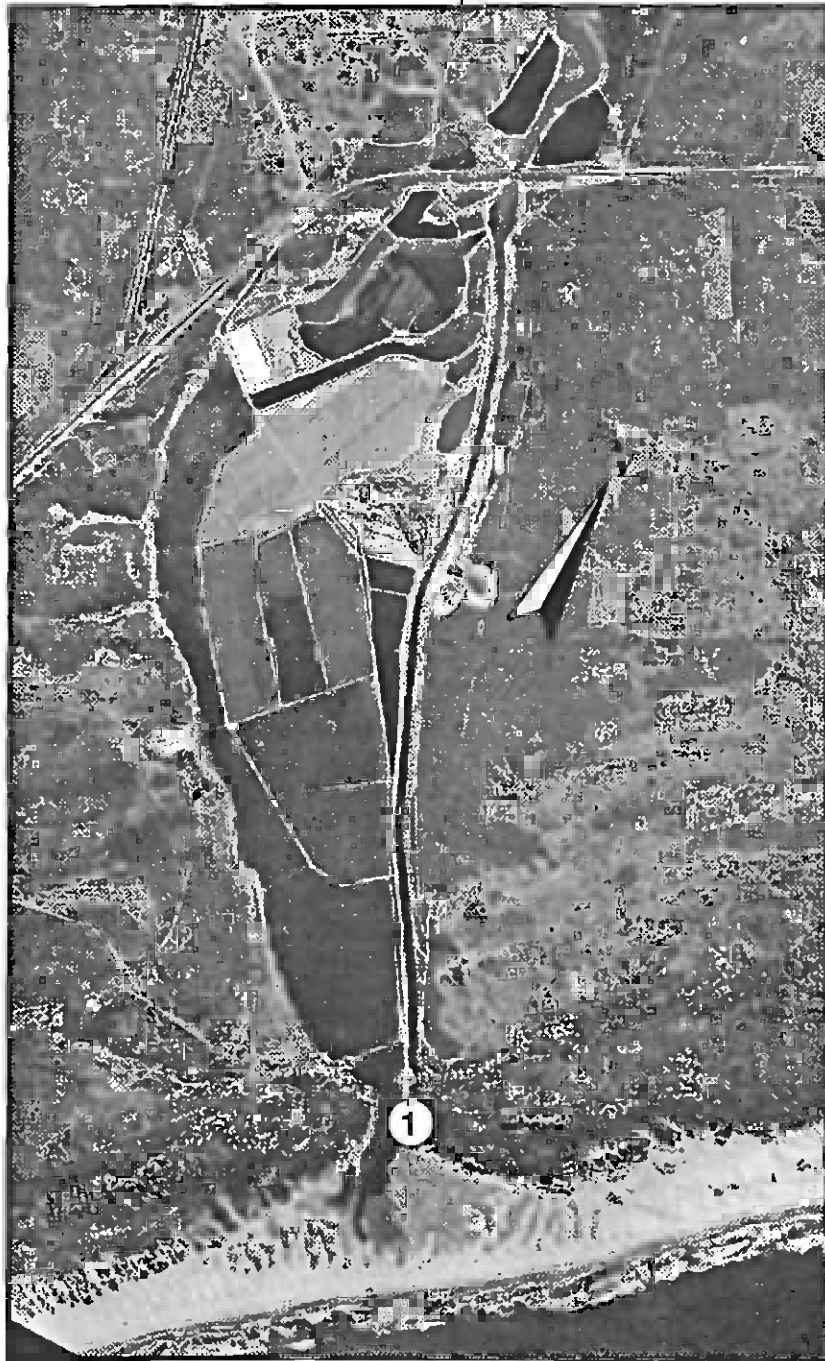
The biological health and aesthetic appearance of the Koega were both rated poor while the overall water quality of the system was good. Overall, the Koega is regarded as being in a moderate to moderately poor condition with a composite score of 5 out of 9.

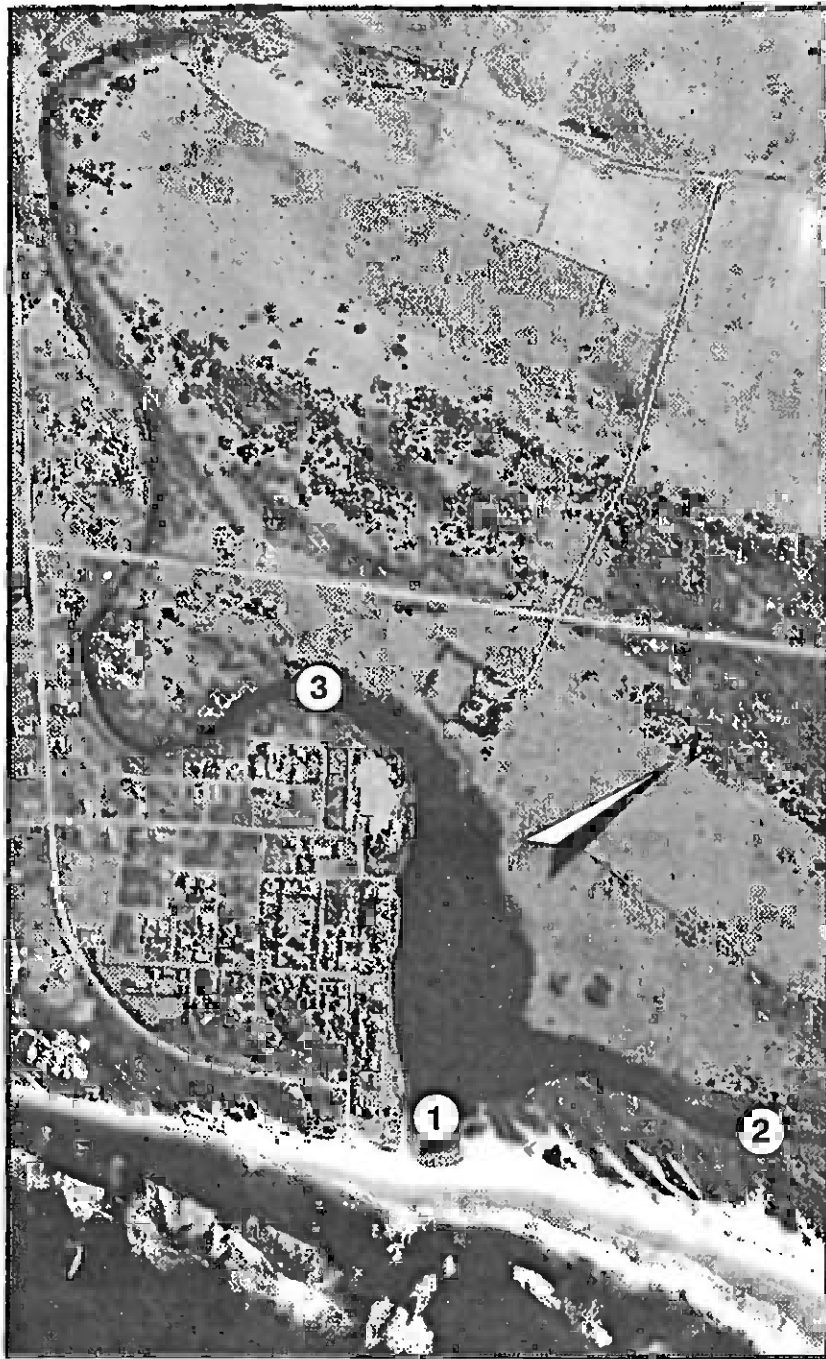
The biological status of the Boknes was satisfactory while the water quality and aesthetic appearance of the system was good. Overall, the Boknes is regarded as being in a moderately good condition with a composite score of 8 out of 9.

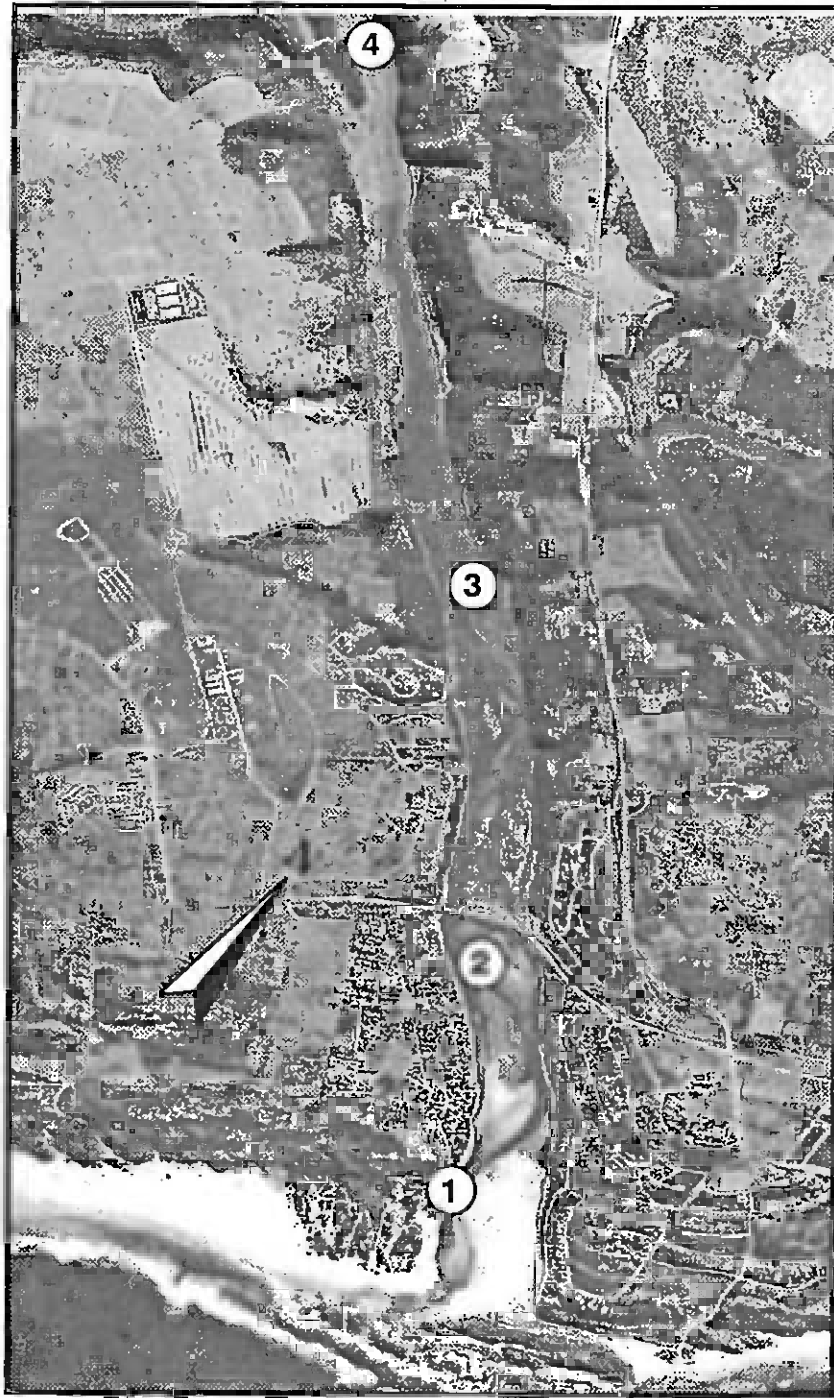
The biological status of the Bushmans was good with a very good overall water quality. The aesthetic state of the system was considered acceptable. Overall, the Bushmans is regarded as being in a good condition with a composite score of 8 out of 9.

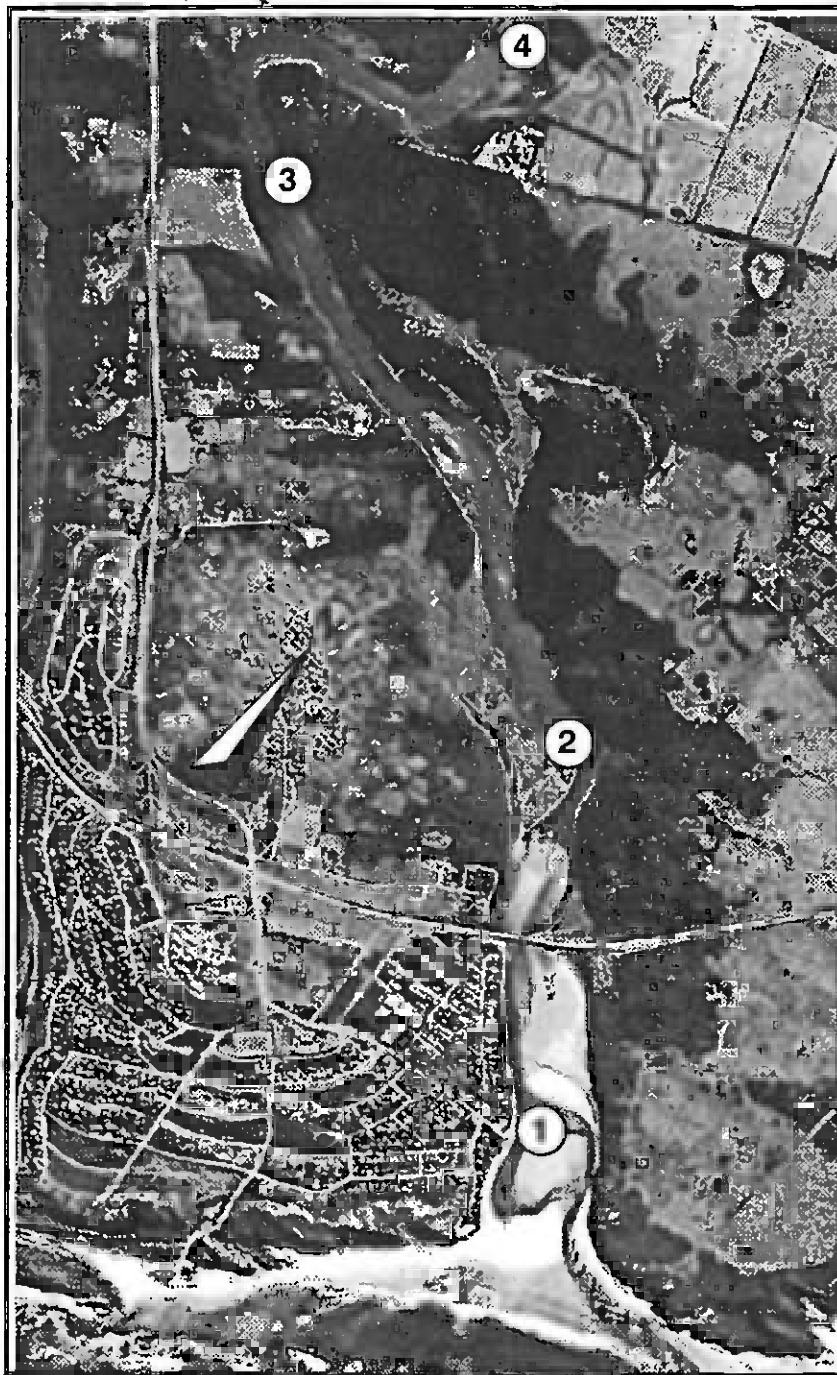
The biological status, overall water quality and aesthetic state of the Kariega were all rated good and the system had a composite score of 9 out of 9.

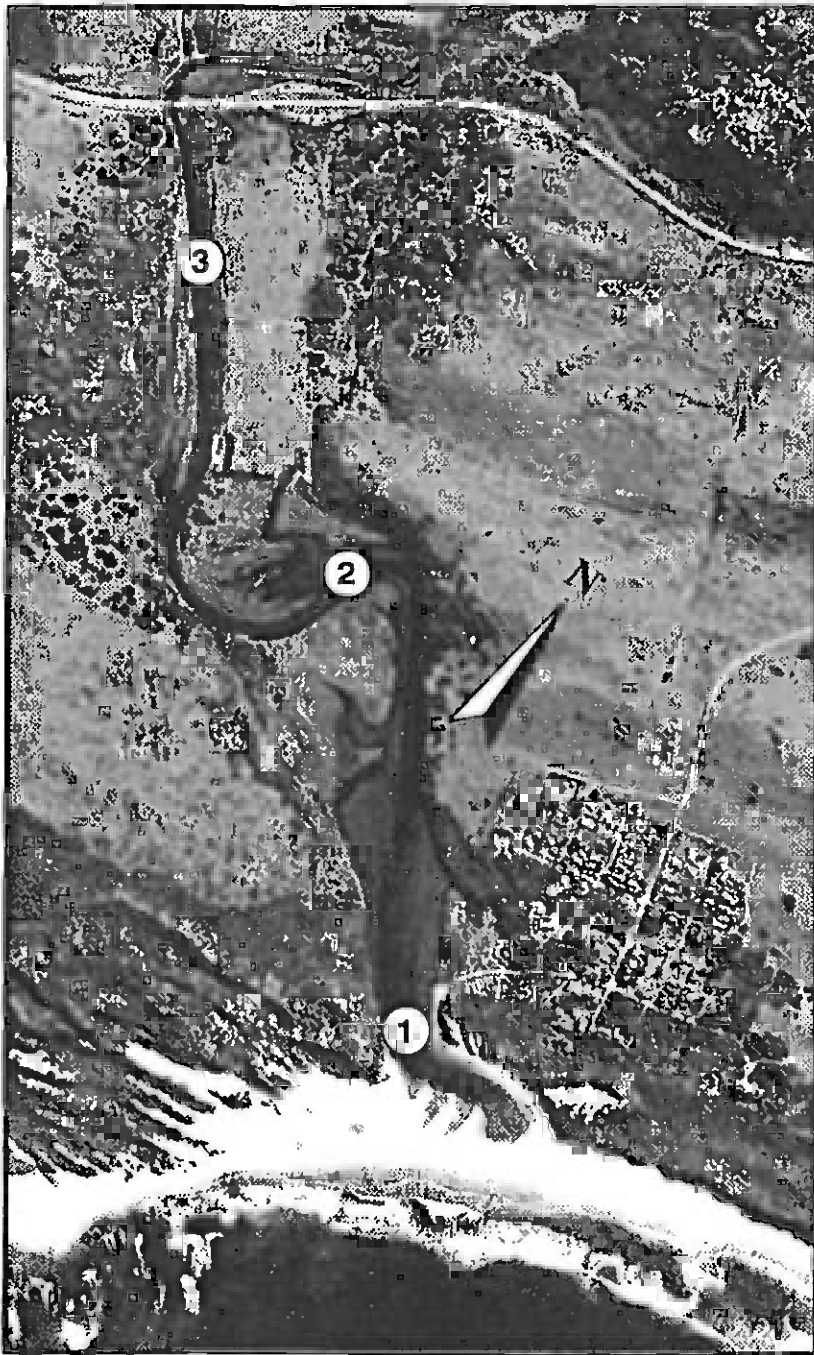
The biological status, the overall water quality and the aesthetic appearance of the Kasuka were all good. Overall, the system is considered to be in a good condition with a composite score of 9 out of 9.

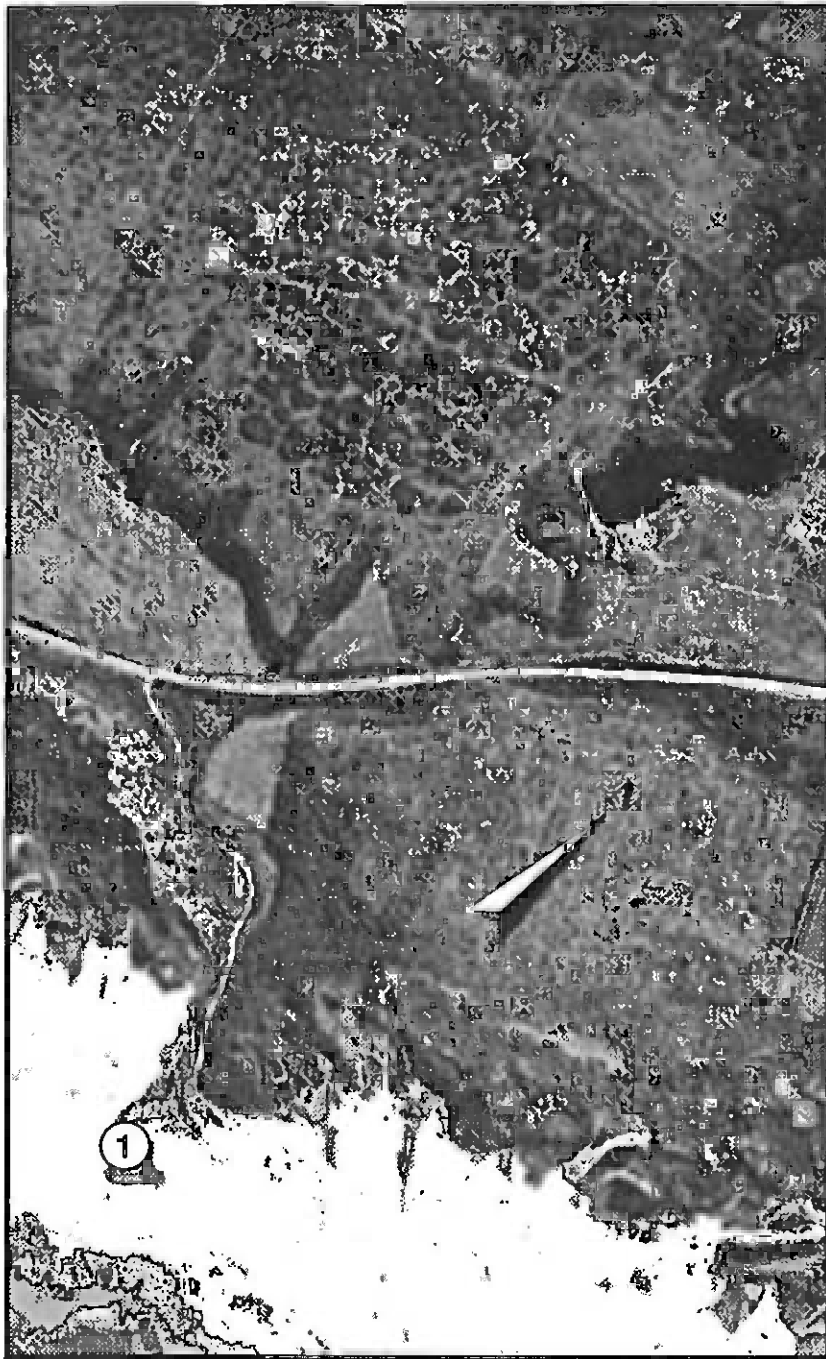
The biological status of the Rufane was rated good. Its overall water quality was moderate and its aesthetic appearance was good. Overall, the system is considered to be in a relatively good condition with a composite score of 8 out of 9.
