**HEALTH OF SOUTH AFRICAN ESTUARIES,  
GROOT (Wes) - GREAT FISH**

**Executive Report**

PREPARED BY: T.D. Harrison, J.A.G. Cooper, A.E.L. Ramm, R.A. Singh  
Coastal and Catchment Environmental Programme  
CSIR  
P O Box 17001  
CONGELLA  
4013

Project No. QH102  
March 1996

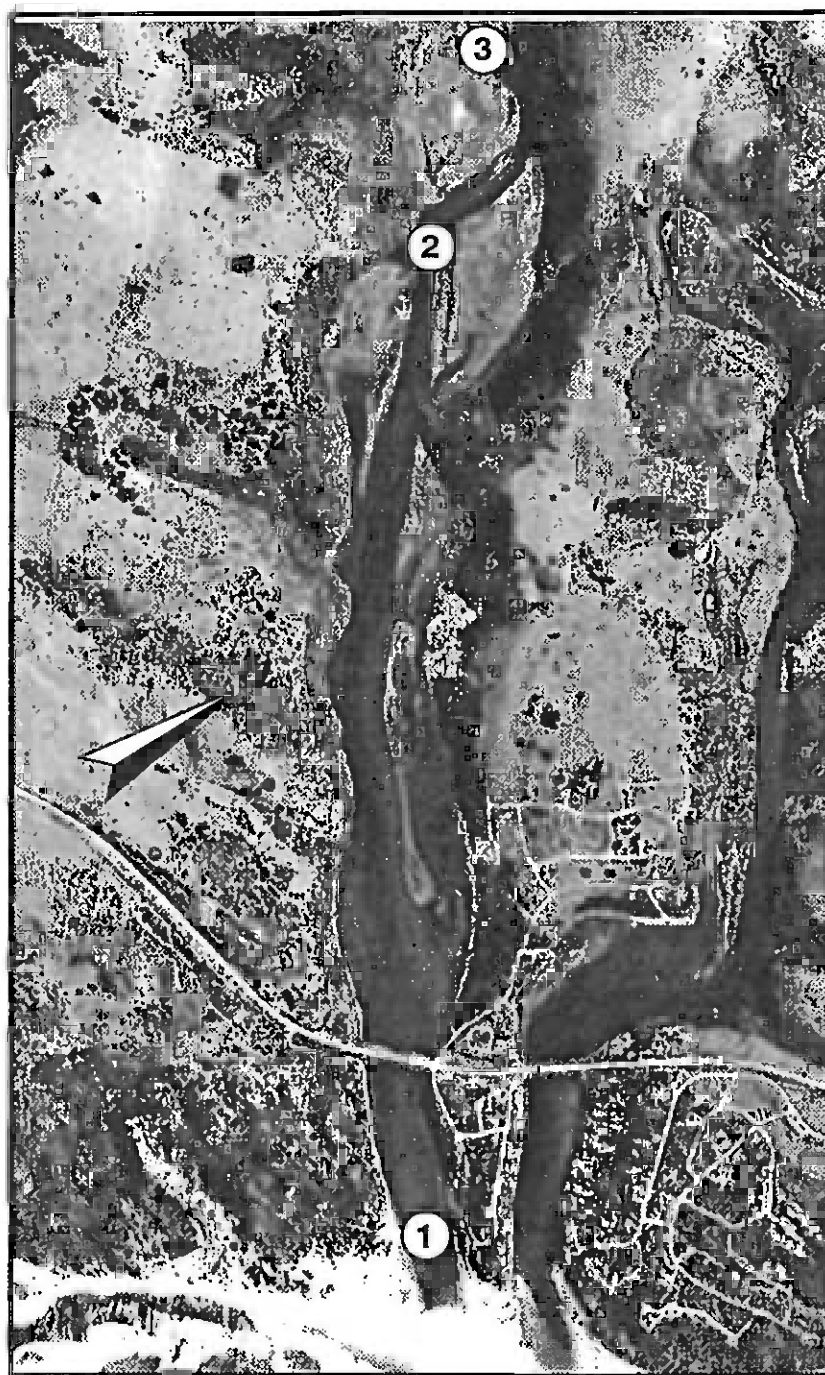
The biological status, overall water quality and aesthetic status of the Wes-Kleinmond were all rated good. Overall, the system is regarded as being in a good condition with a composite score of 9 out of 9.

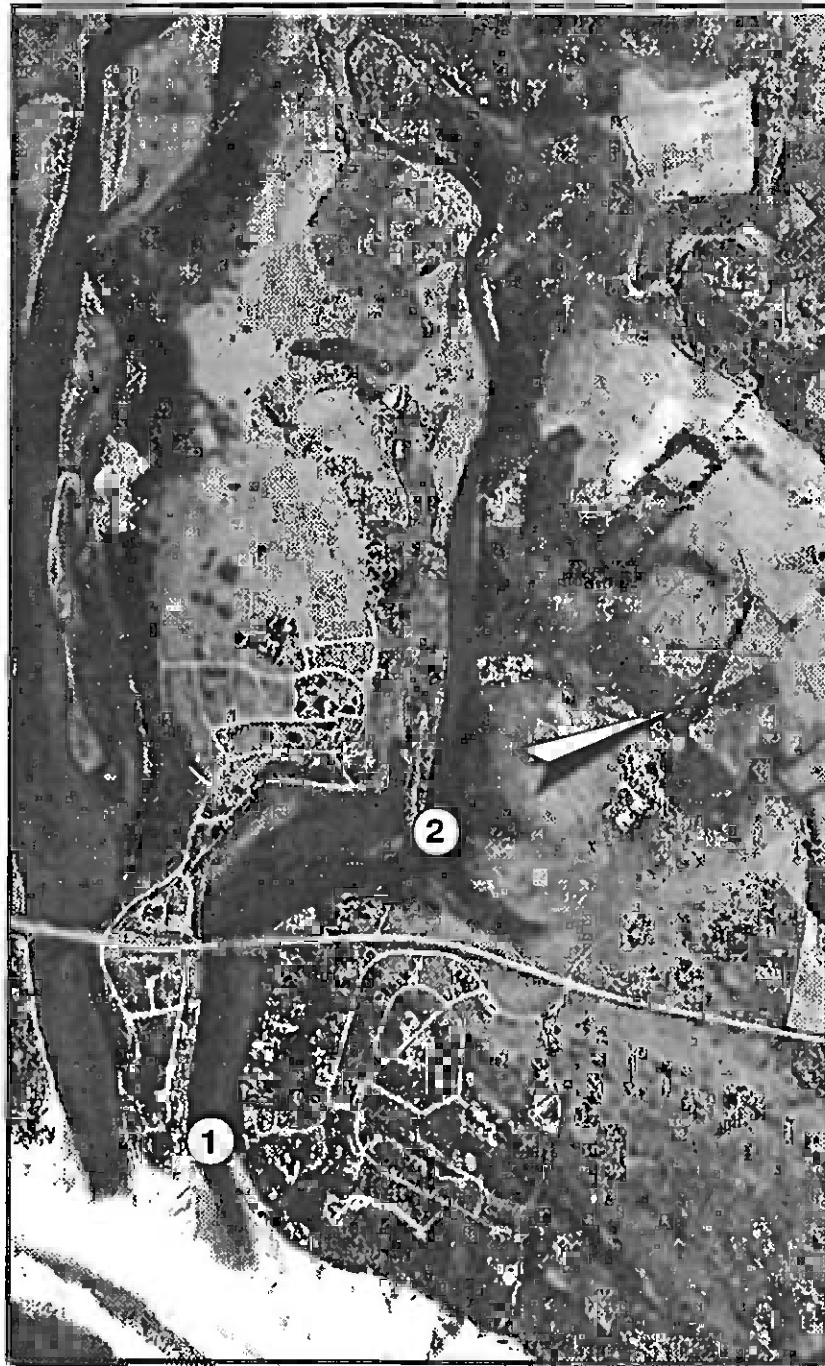
The biological status and overall water quality of the Oos-Kleinmond were both rated as good while its aesthetic appearance was considered acceptable. Overall, the system is regarded as being in a moderately good condition with a composite score of 8 out of 9.
