RECREATING A WETLAND AT AN ABANDONED SALTWORKS: TOWARDS A REHABILITATION PLAN

Johan Wasserman

MASTER IN SCIENCE

NELSON MANDELA UNIVERSITY

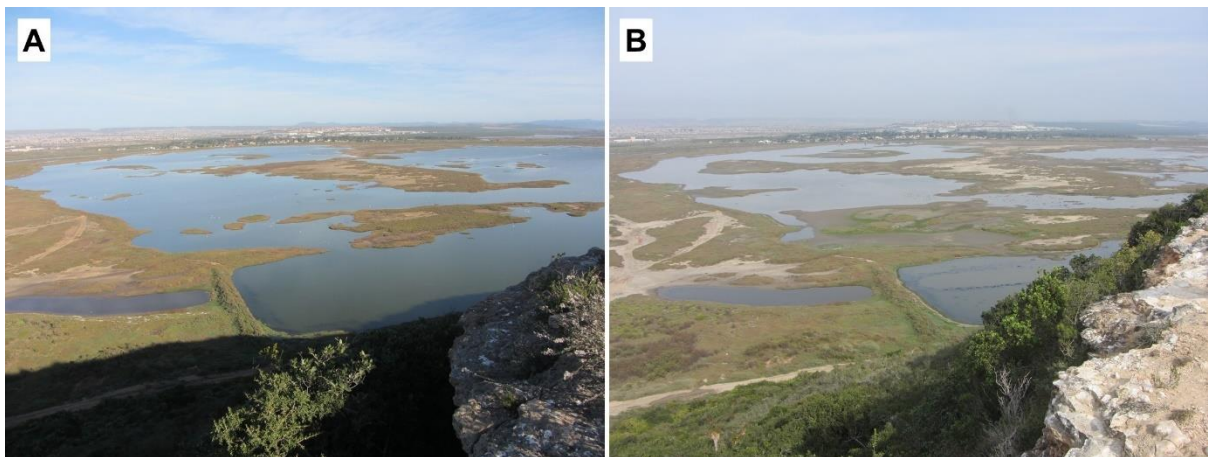
Figure 3.3 The Redhouse saltpan filled to maximum capacity (A) and with water at the lowest allowable level (B). Photos courtesy of Paul Martin and captured in 2013 and 2014, respectively.

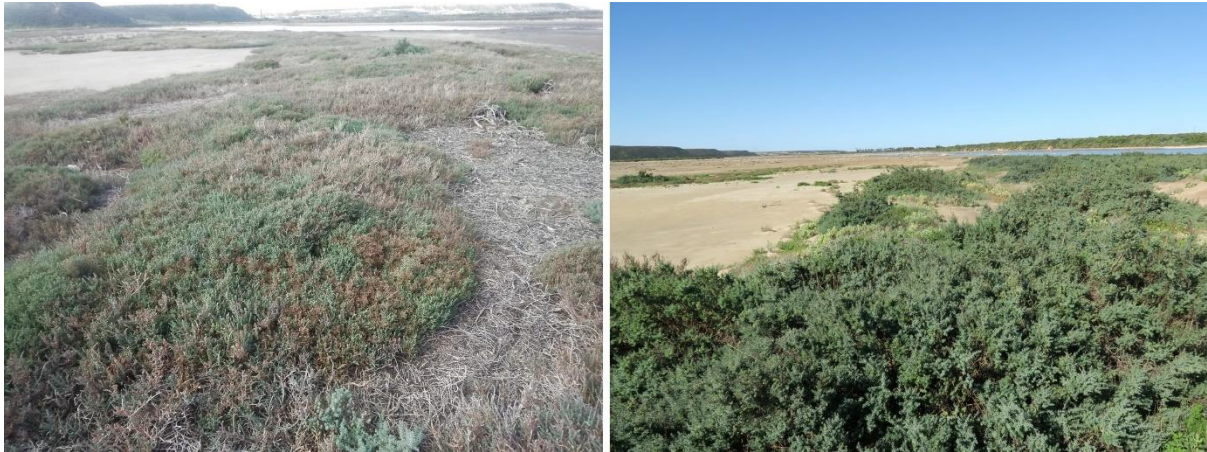
Figure 3.4 The salt marsh vegetation at the abandoned saltworks.

Vegetation cover within the salt pans is sparse and patchy and mostly limited to hummocks. Most areas of lower elevation lie bare and a salt layer is visible on the surface of the sediment in some areas. The vegetation composition within the salt pans resembles the surrounding supratidal and floodplain salt marsh. Communities are highly monospecific with *Salicornia pillansii* being the dominant species. Other species include *Disphyma crassifolium*, *Suaeda fruticosa*, *Atriplex lindleyi* subsp. *inflata*, *Bassia diffusa*, *Psilocalon dinteri*, *Spergularia media* and *Sporobolus virginicus*. Vegetation cover is mostly limited to the hummocks in the salt pans. Prior to abandonment, submerged macrophytes (*Ruppia cirrhosa* and *Enteromorpha* spp.) had been recorded in the Redhouse salt pan (Martin and Randall, 1987). Another striking feature at the saltworks is the widespread presence of remnant reef clusters formed by the invasive Australian tubeworm *Ficopomatus enigmaticus* (Figure 3.4).

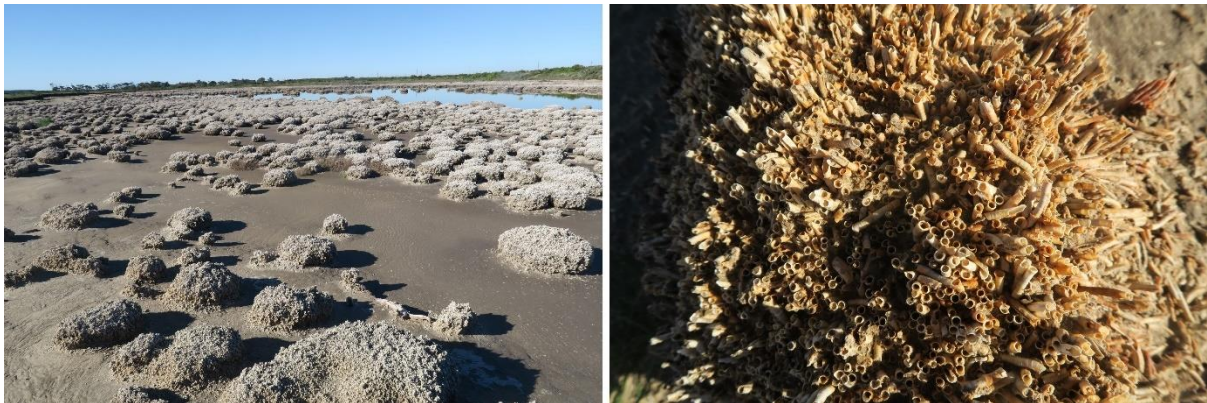
Figure 3.5 Remnant reef structures formed by the Australian tubeworm *Ficopomatus enigmaticus* lie scattered across the abandoned saltworks.

Another factor that could maintain the desired clear water regime at the saltworks but was not accounted for in the nanocosm experiment (and should not be overlooked) is the potential presence of the Australian tubeworm *Ficopomatus enigmaticus* at the saltworks. These polychaetes aggregate in colonies and can form calcareous reef-like structures. Remnants of such structures cover extensive areas of all of the saltpans (Figure 3.5). The tubeworms are efficient filter feeders and can filter large volumes of water quickly and improve water quality by decreasing turbidity and chlorophyll-*a* concentrations very effectively (Davies et al., 1989; Bruschetti et al., 2009). At high densities, they have the potential to inhibit eutrophication and phytoplankton blooms (Bruschetti et al., 2008; 2018). Such top-down control has been shown to be able to hinder the symptoms of eutrophication in a shallow coastal lagoon for over two decades (Pérez-Ruzafa et al., 2019).

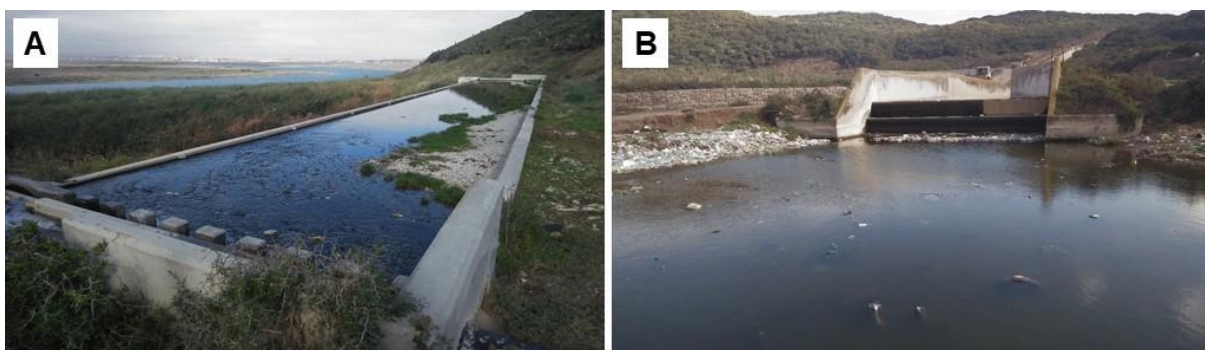
Figure 3.6 The Motherwell artificial wetland, with the Redhouse saltpan in the distance (A) and the adjacent Motherwell Canal (B).

The MWAW became operational in early 2010, prior to which the polluted Motherwell stormwater canal discharged straight into the estuary. The stormwater greatly exceeded the general guidelines for recreational use as stipulated by the Department of Water Affairs, and the canal had long been recognised as a major point source of water pollution to the estuary (Emmerson, 1985; Scharler, et al., 1997). In order to effectively treat the stormwater, SRK Consulting (Pty) Ltd (2010) determined that the wetland would need to be approximately 4.5 ha in size in order to meet the hydraulic requirements of the Motherwell Canal. However, the wetland constructed was just 0.8 ha in size due to a lack of space, and just 20% of the runoff from the canal was diverted into it. Initial monitoring revealed that the artificial wetland was successfully decreasing concentrations of bacteriological pollutants (total coliforms, faecal coliforms and *Escherichia coli*) (SRK Consulting (Pty) Ltd, 2010). However, nearly all of the runoff from the Motherwell Canal has since been diverted into the artificial wetland and the efficiency of the wetland has been reduced. The MWAW is currently still effective at removing bacteriological pollutants, but nutrient concentrations are not being decreased before the stormwater is discharged into the estuary (Stroebel, 2019; Lakane, 2020).

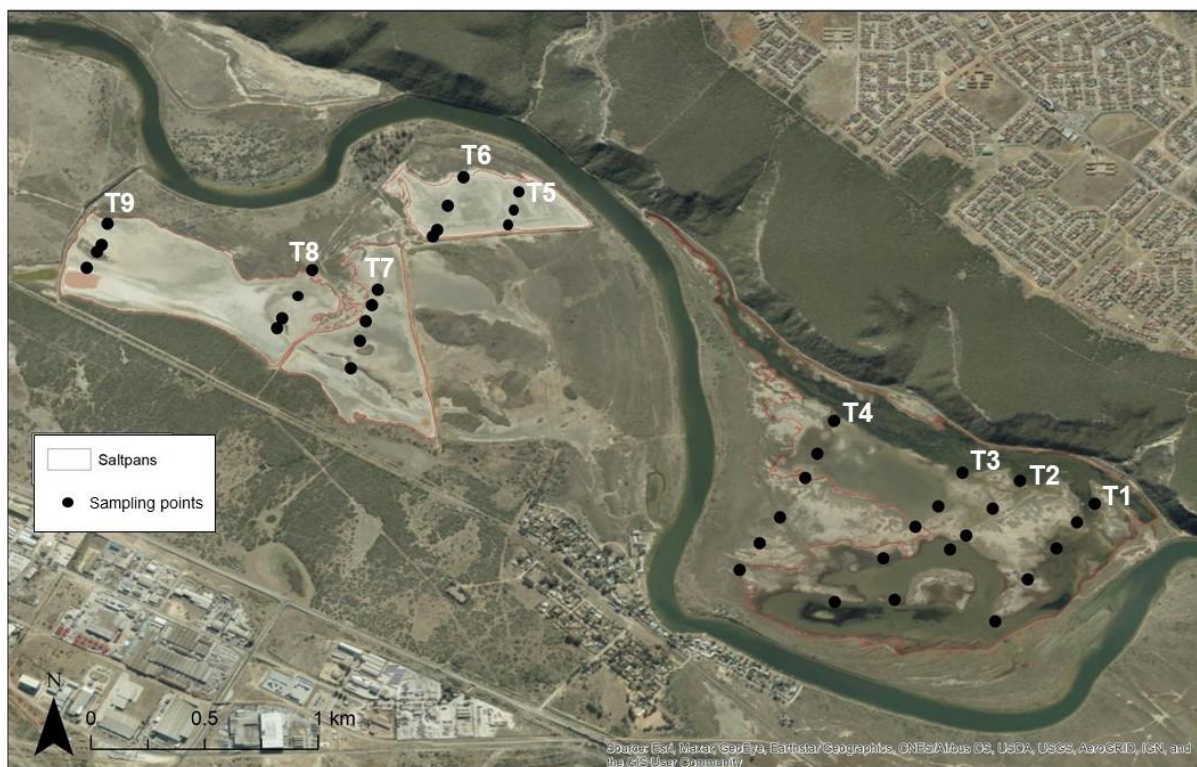
Figure 4.1 Layout of sampling points along the nine transects at the abandoned saltworks. The boundaries of the saltpans were delineated based on the water level when they were filled to maximum capacity.

Environmental conditions (groundwater and sediment characteristics) and vegetation distribution were investigated across nine transects at the abandoned saltworks (Figure 4.1). Four transects were laid out in the large Redhouse saltpan and five at the smaller Bar None saltpans. All data were captured during a single sampling occasion on 1 September 2019. Sampling points were subjectively chosen to represent vegetated and unvegetated areas and areas of dead vegetation. The coordinates of the sampling points are presented in Appendix 2. At each sampling point, groundwater characteristics were captured, sediment samples collected, and vegetation composition and cover recorded. The elevation at each sampling point was derived from a digital terrain model (Appendix 3), which was obtained from a LiDAR survey (at 1 m spatial resolution) carried out in 2019 by Nelson Mandela Bay Municipality (NMBM).

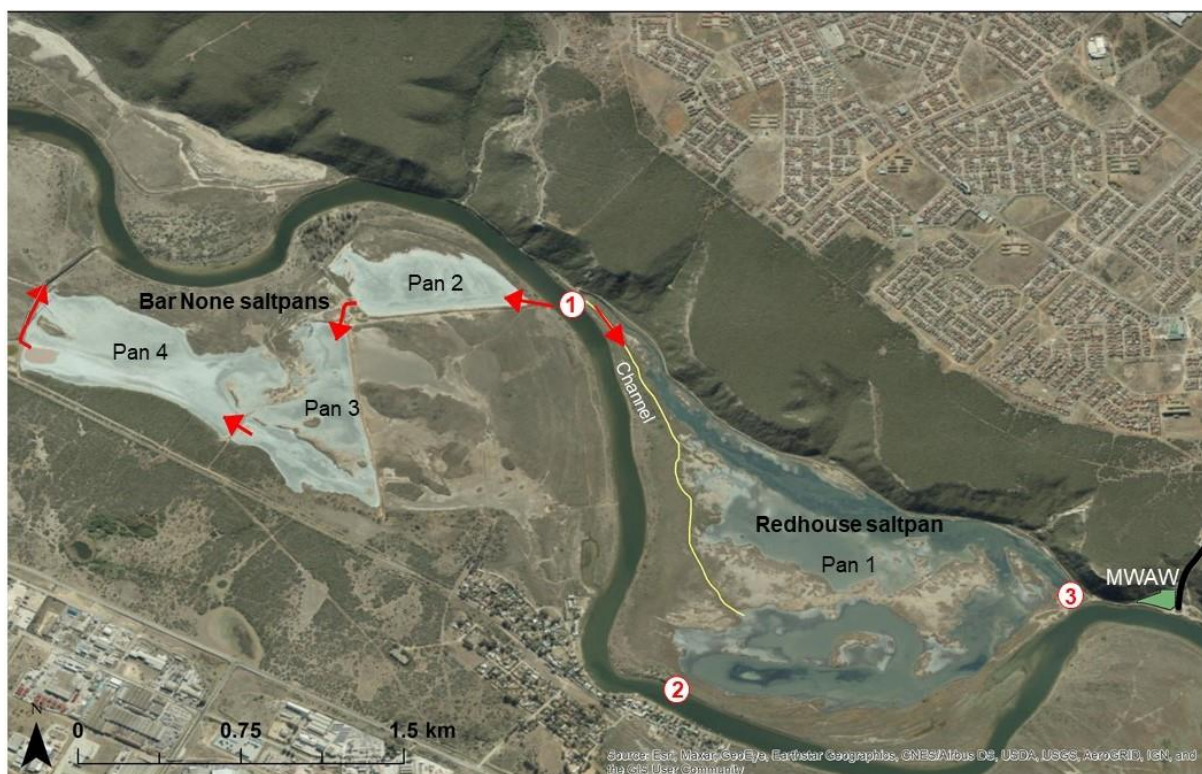
Figure 5.2 The abandoned saltworks with the proposed water sources for filling the saltpans indicated. The Motherwell artificial wetland (MVAW) is represented by a green polygon, while the proposed sites to pump estuary water are indicated with the red numbers. The yellow arrow indicates the orientation of the pipe necessary to fill the Redhouse saltpan with stormwater and the red arrows indicate how estuary water can be pumped into, and flow through, the saltpans.

While estuary water can be used to fill all of the saltpans, stormwater could only feasibly be used to fill the Redhouse saltpan. The Redhouse saltpan lies just 400 m from the outlet of the MVAW from which the stormwater would be diverted, while the Bar None saltpans lie nearly 3 km away on the opposite side of the estuary and at a higher elevation. As no land-based pump will be used in this rehabilitation project, it will not be practical to divert stormwater to the Bar None saltpans. For the Redhouse saltpan, however, a pipe could be built to divert the stormwater into the north-eastern corner of the saltpan. This point lies approximately 1 m lower than the outlet of the MVAW, allowing the stormwater to be gravity-fed into the saltpan.

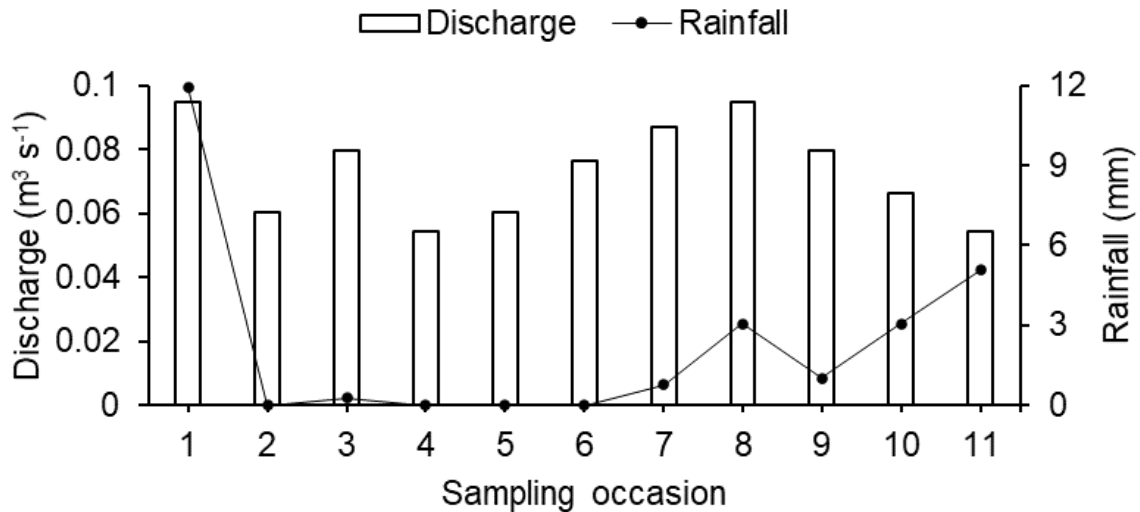
Figure 5.3 Discharge of stormwater into the Motherwell artificial wetland (MWAW). Rainfall on the day of sampling is indicated on the secondary axis. Details of sampling occasions are provided in Appendix 7.

The rate of stormwater discharge from the artificial wetland was temporally stochastic (Figure 5.3). Discharge was positively correlated to rainfall, although the relationship was neither strong nor significant ($r = 0.57$, $p = 0.08$). The mean discharge of stormwater exiting the MWAW was 0.073 m³s⁻¹ which is equivalent to approximately 264.3 m³ hr⁻¹ or 6442.2 m³ day⁻¹. From the mean rate of discharge, it can be estimated that it would take approximately 120 days to fill the Redhouse saltpan with stormwater. However, discharge is not constant and filling the saltpan can be expected to take between 93 to 162 days if the maximum and minimum discharge values recorded in this study are considered, respectively. Comparatively, it would take one week of continuous pumping (i.e. 168 hrs) to fill the Redhouse saltpan with the pump that was previously used at the saltworks – it is being planned to use this same pump for the rehabilitation project (F. Collier, pers. comm., 2020). At this pumping rate, it would take approximately 67.4 hrs (nearly three days of continuous pumping) to fill all three of the Bar None saltpans. It should be noted that these estimates do not account for loss through evaporation or gain through precipitation.

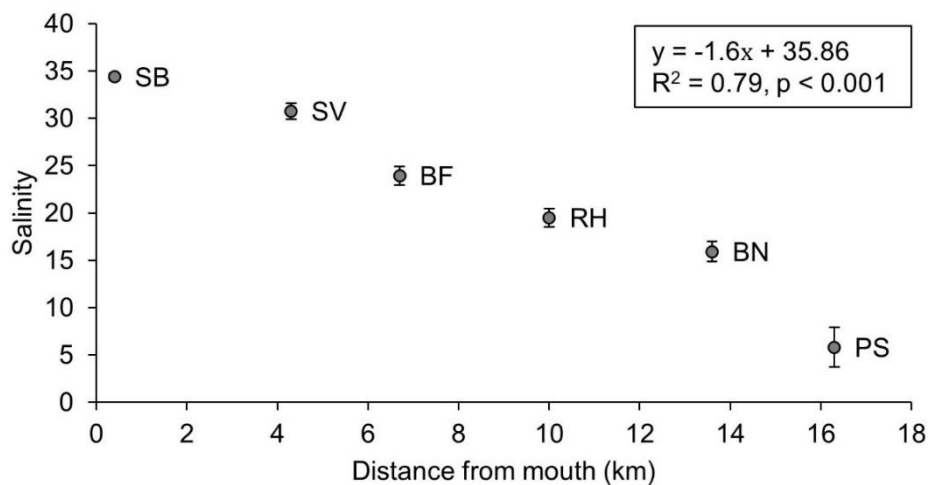
Figure 5.4 Salinity at the six sites sampled in Swartkops Estuary (mean ± SE, n = 18). The relationship of salinity with distance from the estuary mouth is shown in the textbox.

A distinct longitudinal salinity gradient persisted in Swartkops Estuary ($F = 82.31$, $p < 0.001$), ranging from salinity typical of marine environments at the mouth (SB) to near fresh at the head of the estuary (PS) (Figure 5.4). This is typical of permanently open estuaries that receive persistent riverine input. The highest mean salinity levels were recorded in summer months (November 2019 and February 2020), while the lowest were recorded in winter months (July 2019 and June 2020). A vertical salinity gradient was also recorded ($F = 5.32$, $p < 0.01$), particularly between surface and bottom waters ($p < 0.01$) but also between surface and middle waters ($p = 0.04$). The vertical salinity gradient was more pronounced in winter months, especially at sites further upstream (RH and BN).
