**EMA-C 8899**

**AN EVALUATION OF THE EFFECTS OF THE  
CONSTRUCTION OF A VIADUCT ACROSS THE TIDAL  
FLATS IN THE VICINITY OF THE WHITE BRIDGE, KNYSNA**

submitted to  
**SCOTT AND DE WAAL INCORPORATED**

October 1988

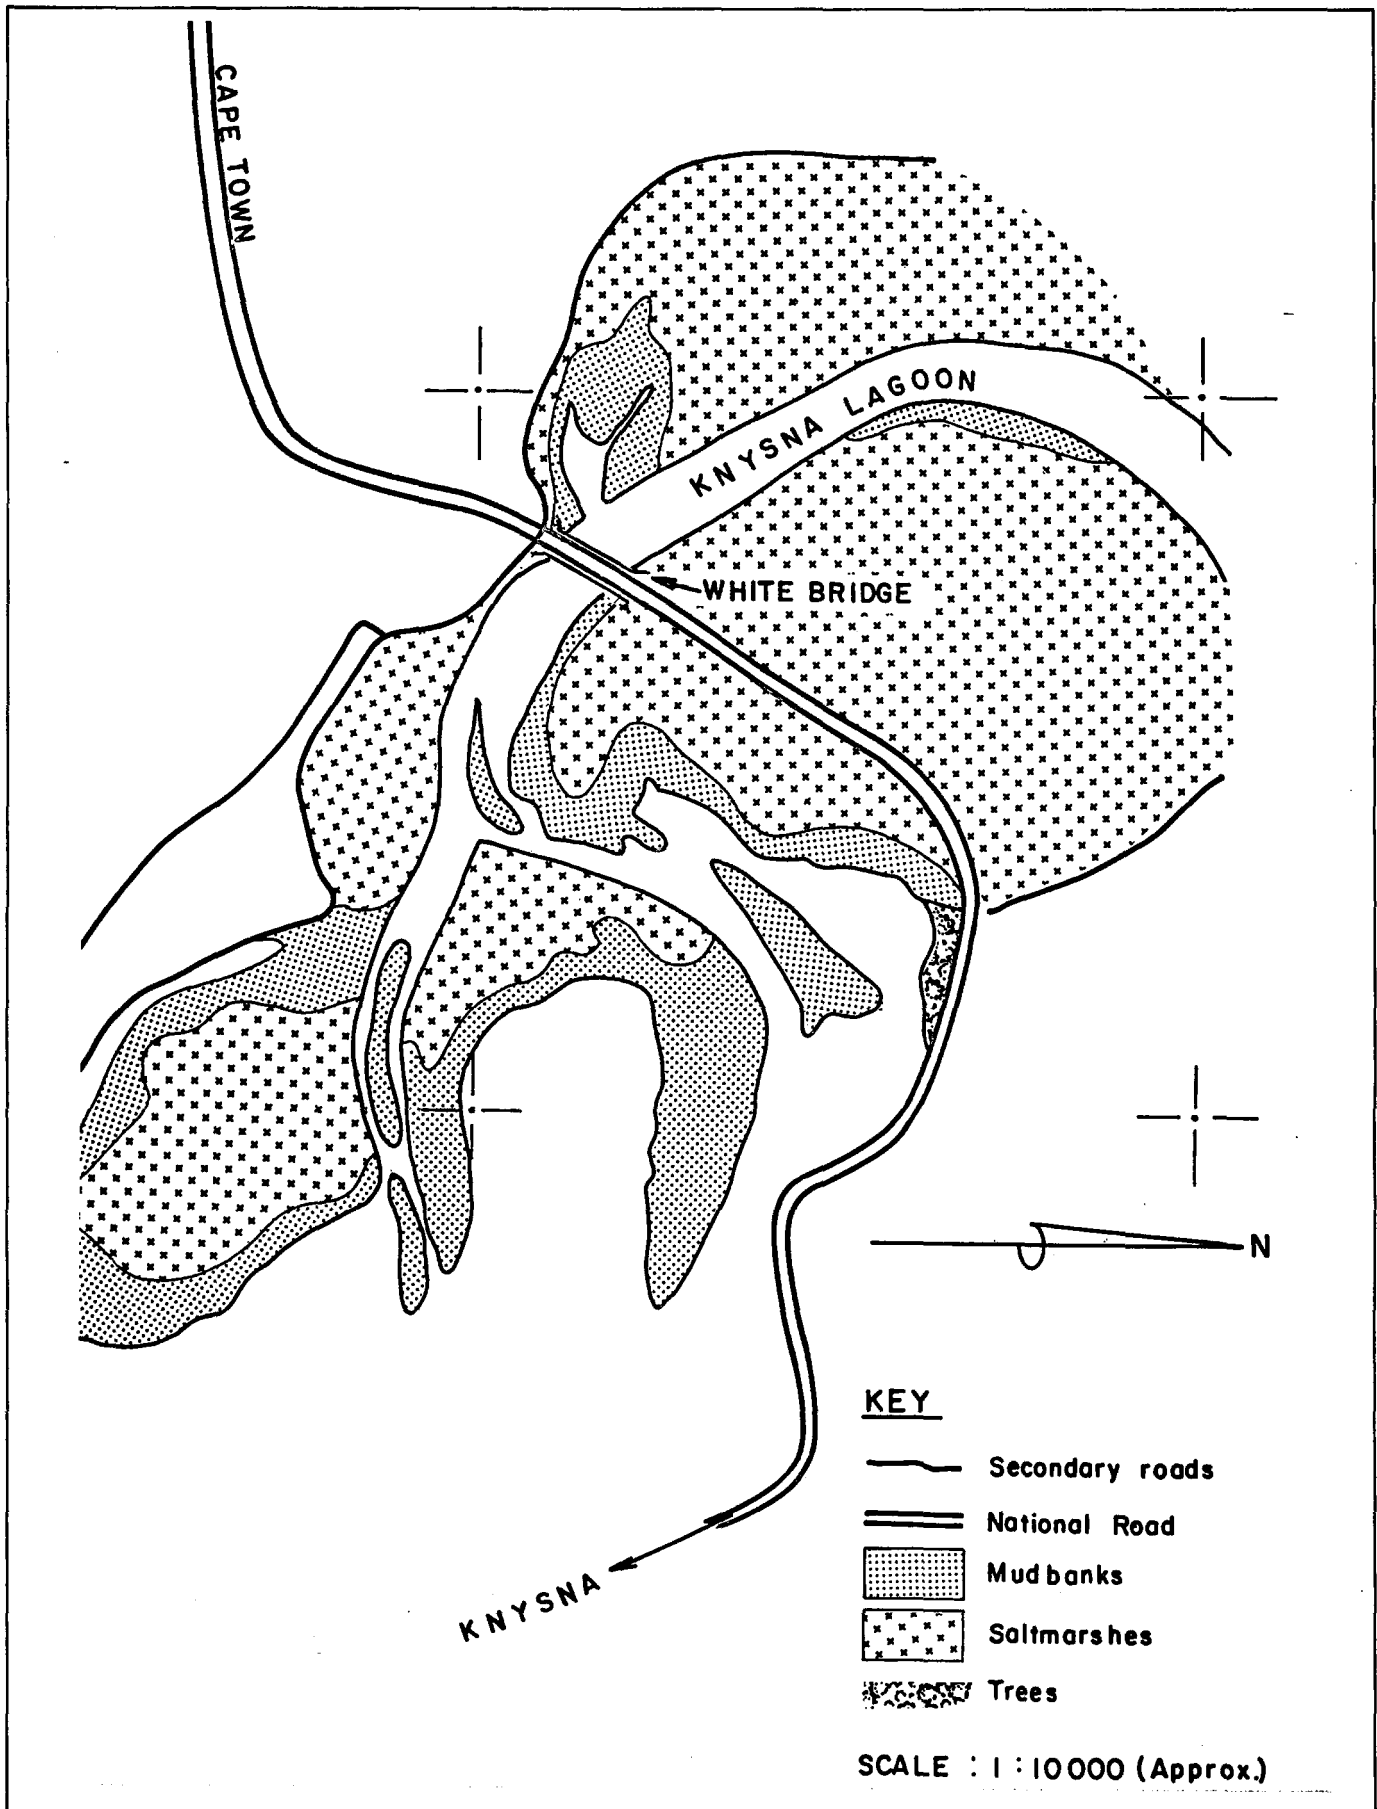
FIGURE 4(b)

1958: HISTORICAL CHANGES TO THE WHITE BRIDGE MARSH
