CSIR REPORT C/SEA 75/13

HYDROGRAPHIC SURVEY OF SEDGEFIELD LAGOON

**COASTAL ENGINEERING AND HYDRAULICS DIVISION
NATIONAL RESEARCH INSTITUTE FOR OCEANOLOGY
COUNCIL FOR SCIENTIFIC AND INDUSTRIAL RESEARCH**

TECHNICAL COMMITTEE FOR WILDERNESS/SWARTVLEI AREA
DEPARTMENT OF PLANNING AND THE ENVIRONMENT

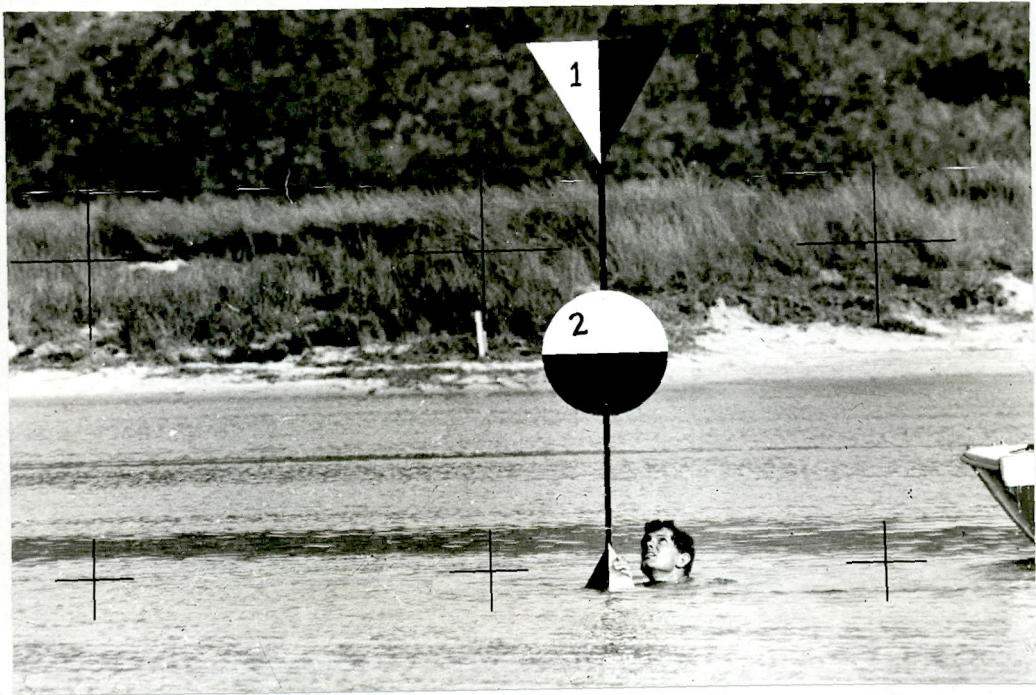
PLATE

EXAMPLES OF PHOTOGRAPHIC SURVEYING
WITH A TARGET Note the reference level crosses

The levels along each survey line were determined using a newly developed photographic technique. A camera equipped with a tele-photo lens was set up level over a survey peg on one bank and was lined up with a survey peg on the opposite bank. The linesman followed the survey line carrying a specially constructed staff/target. When the water was too deep for wading, the target was used from a boat. At each point of measurement a photograph of the target was taken. From the photograph it was then possible to calculate the level of the target in relation to camera datum and hence to the survey peg, and also the distance of the target from camera position or the survey peg. This method of surveying is particularly suitable when it is not possible to hold the staff/target still for any length of time e.g. in a swift flowing current or from a moving boat (see Plate 1).

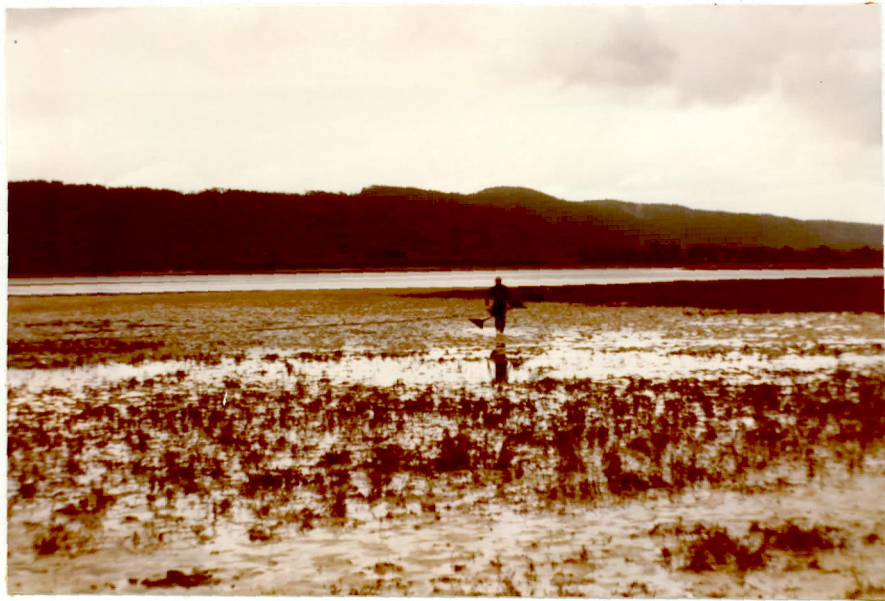
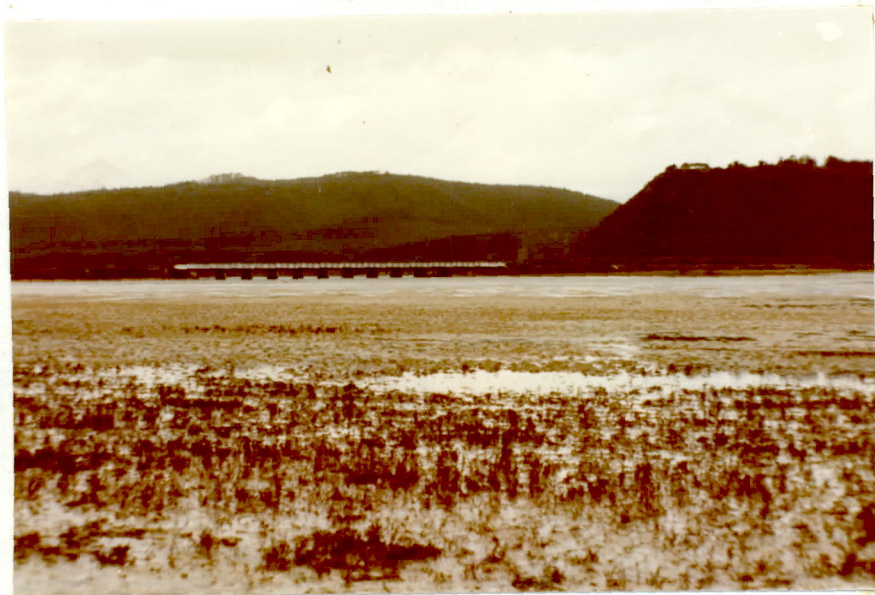
TYPICAL CONDITION OF FLOOD PLANE, AT
LOW WATER, NEAR NATIONAL ROAD BRIDGE

The results of the hydrographic survey are presented on the 1:5 000 scale plan of the survey area (Figure 1) and in the cross-sections of the survey lines (Figures 2 to 9). The actual values of the measurements are given in Tables II and III for reference. The overall accuracy of the survey lines is estimated to be within $\pm 0,03$ m in level and $\pm 0,25$ m in distance. This is considered realistic in view of the soft nature of lagoon bottom and the flood planes (see Plate 2).

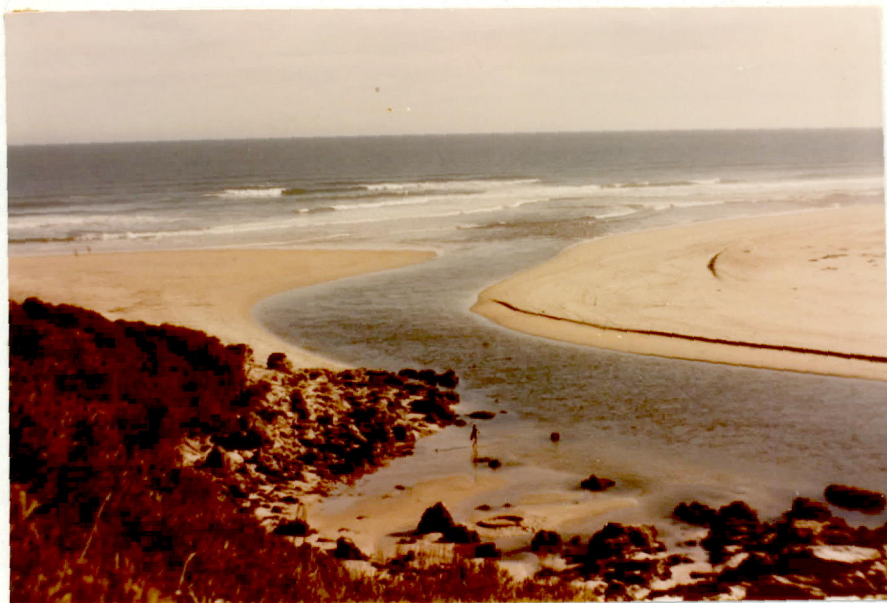
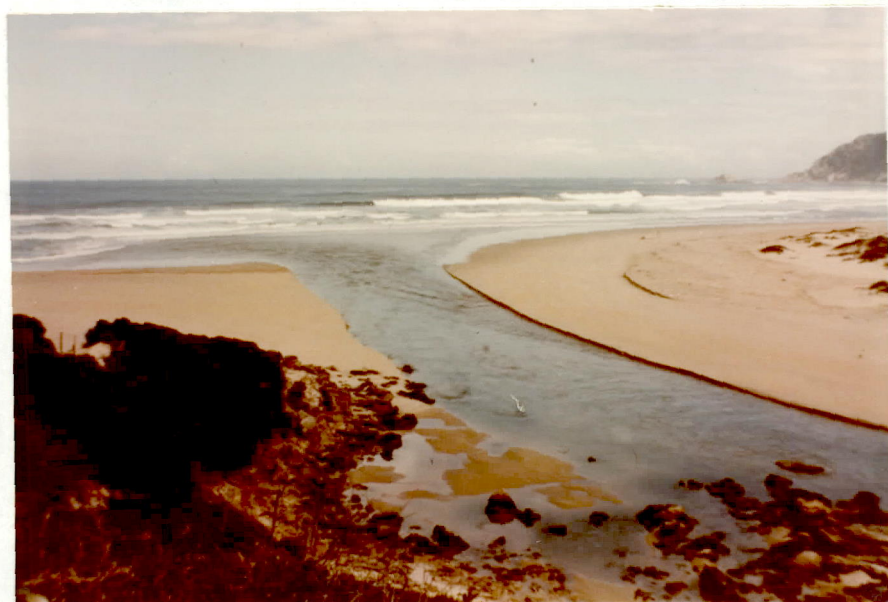
PLATE

ESTUARY MOUTH AT LOW WATER

a) 4-4-1975. b) 14-4-1975.

Section 36, nearest to the mouth, was surveyed on three occasions, on 5th, 7th and 12th April. Comparison of the changes between the three surveys of line 36 is shown in Figure 10. Little change took place in the section between the surveys on 5th and 7th with the exception of accretion of 0,15 m on the left bank. The survey done on 12th a few hours after high water springs, showed fairly significant changes. The main flow channel silted up by about 0,4 m and at the same time erosion of about 0,7 m took place on the right bank shifting the main channel by about 10 m to the right. The change in the general configuration of the river mouth from 4th to 14th April, 1975 is illustrated in Plate 3. Plate 4 shows the turbulence and sediment in suspension near the river mouth about 4 hours after high water on 14th April, 1975.

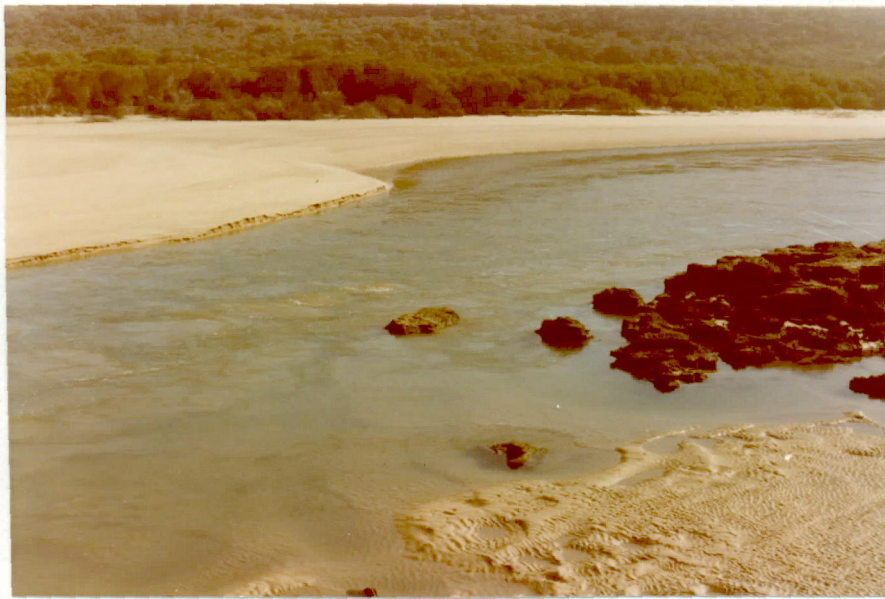
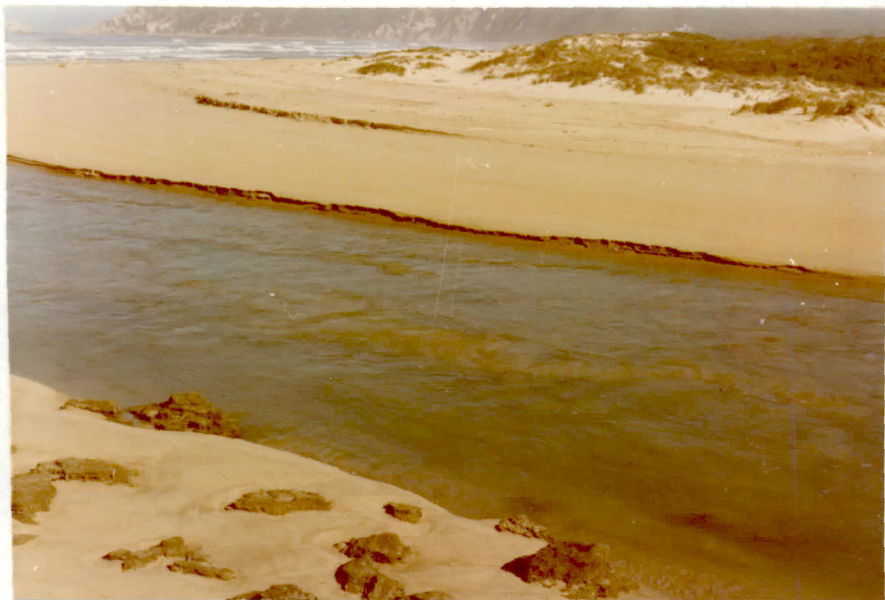
TURBULANCE AT THE ESTUARY MOUTH AT LOW WATER ON
14-4-1975 . Note sediment in suspension and rock
boulders in the channel

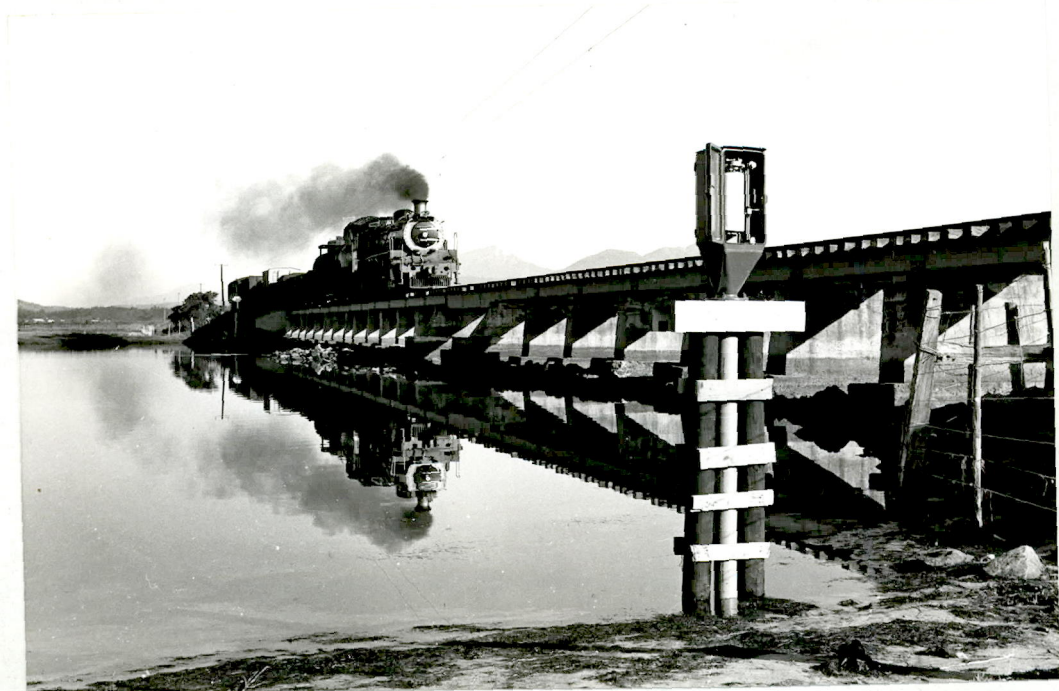
TIDE RECORDERS No. 2 AND 3 AT THE RAILWAY
BRIDGE

- No. 1 Nature Conservation recorder in Swartvlei
- No. 2 NRIO recorder upstream of railway bridge
- No. 3 NRIO recorder downstream of railway bridge
- No. 4 NRIO recorder about 1,5 km downstream of N.R. bridge
- No. 5 Nature Conservation recorder about 1 km upstream of estuary mouth.

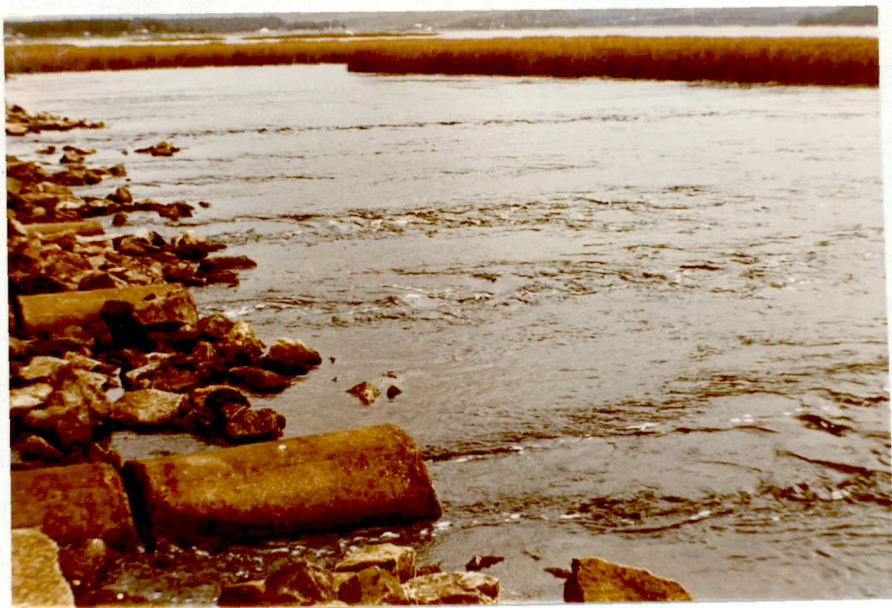
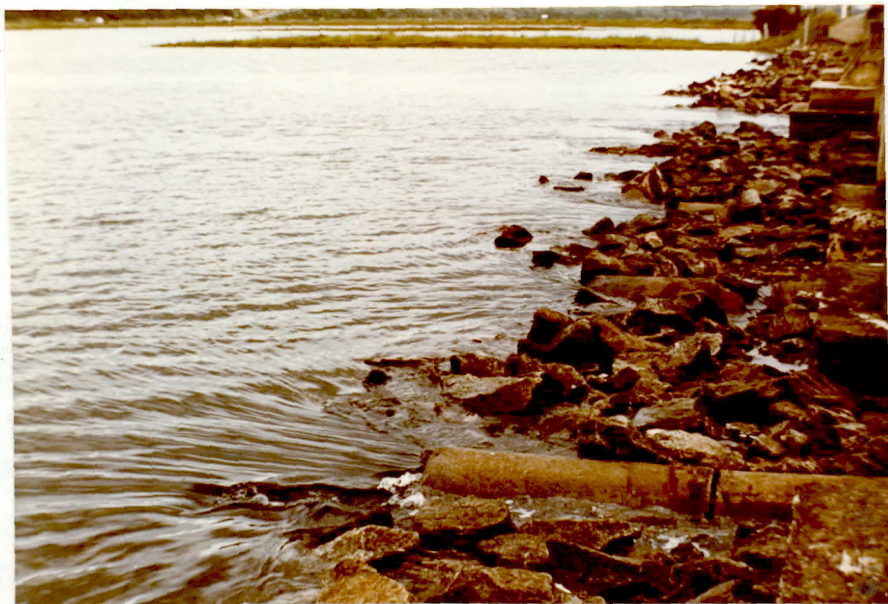
PLATE

CULVERTS AT THE RAILWAY BRIDGE DURING
TIDAL INFLOW ON 14-3-1975. a) UPSTREAM OF
BRIDGE. b) DOWNSTREAM OF BRIDGE

The levels of the 19 culverts under the railway bridge were measured and the results are shown in Figure 14 and Table IV. It would appear that some of the culverts have settled over the years, assuming they have been installed level to start with, resulting in a vertical misalignment of up to 0,5 m between the upstream and downstream sides. Also, some of the culverts appear to be obstructed by stones. Examples of the conditions of the culverts are shown in Plate 6 and 7.

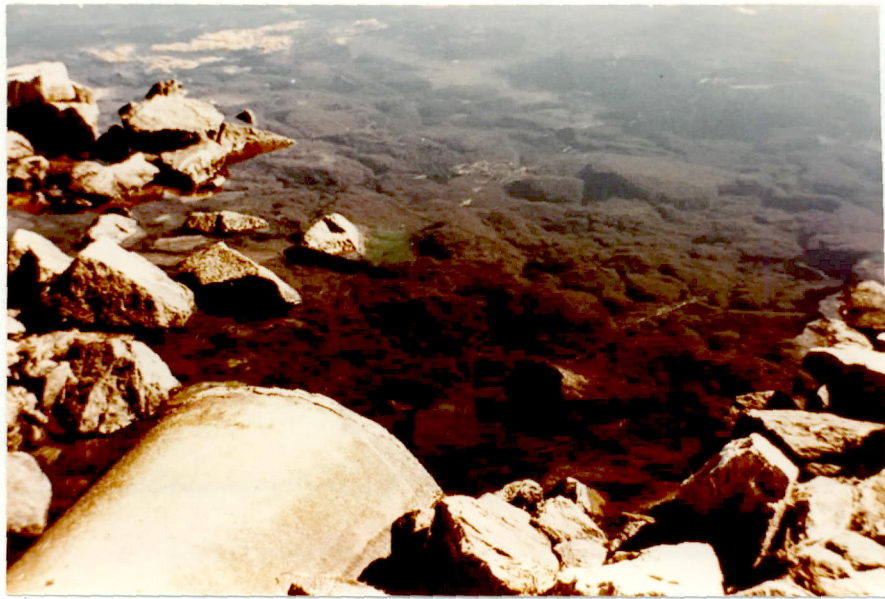
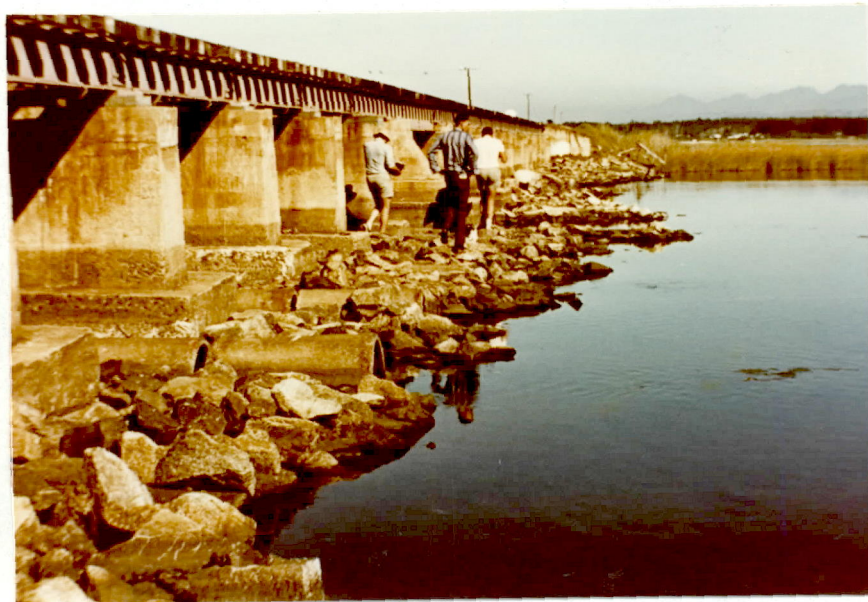
PLATE
7

TYPICAL CONDITION OF CULVERTS UNDER
THE RAILWAY BRIDGE AND THE ROCK
FOUNDATION OF THE PIERS

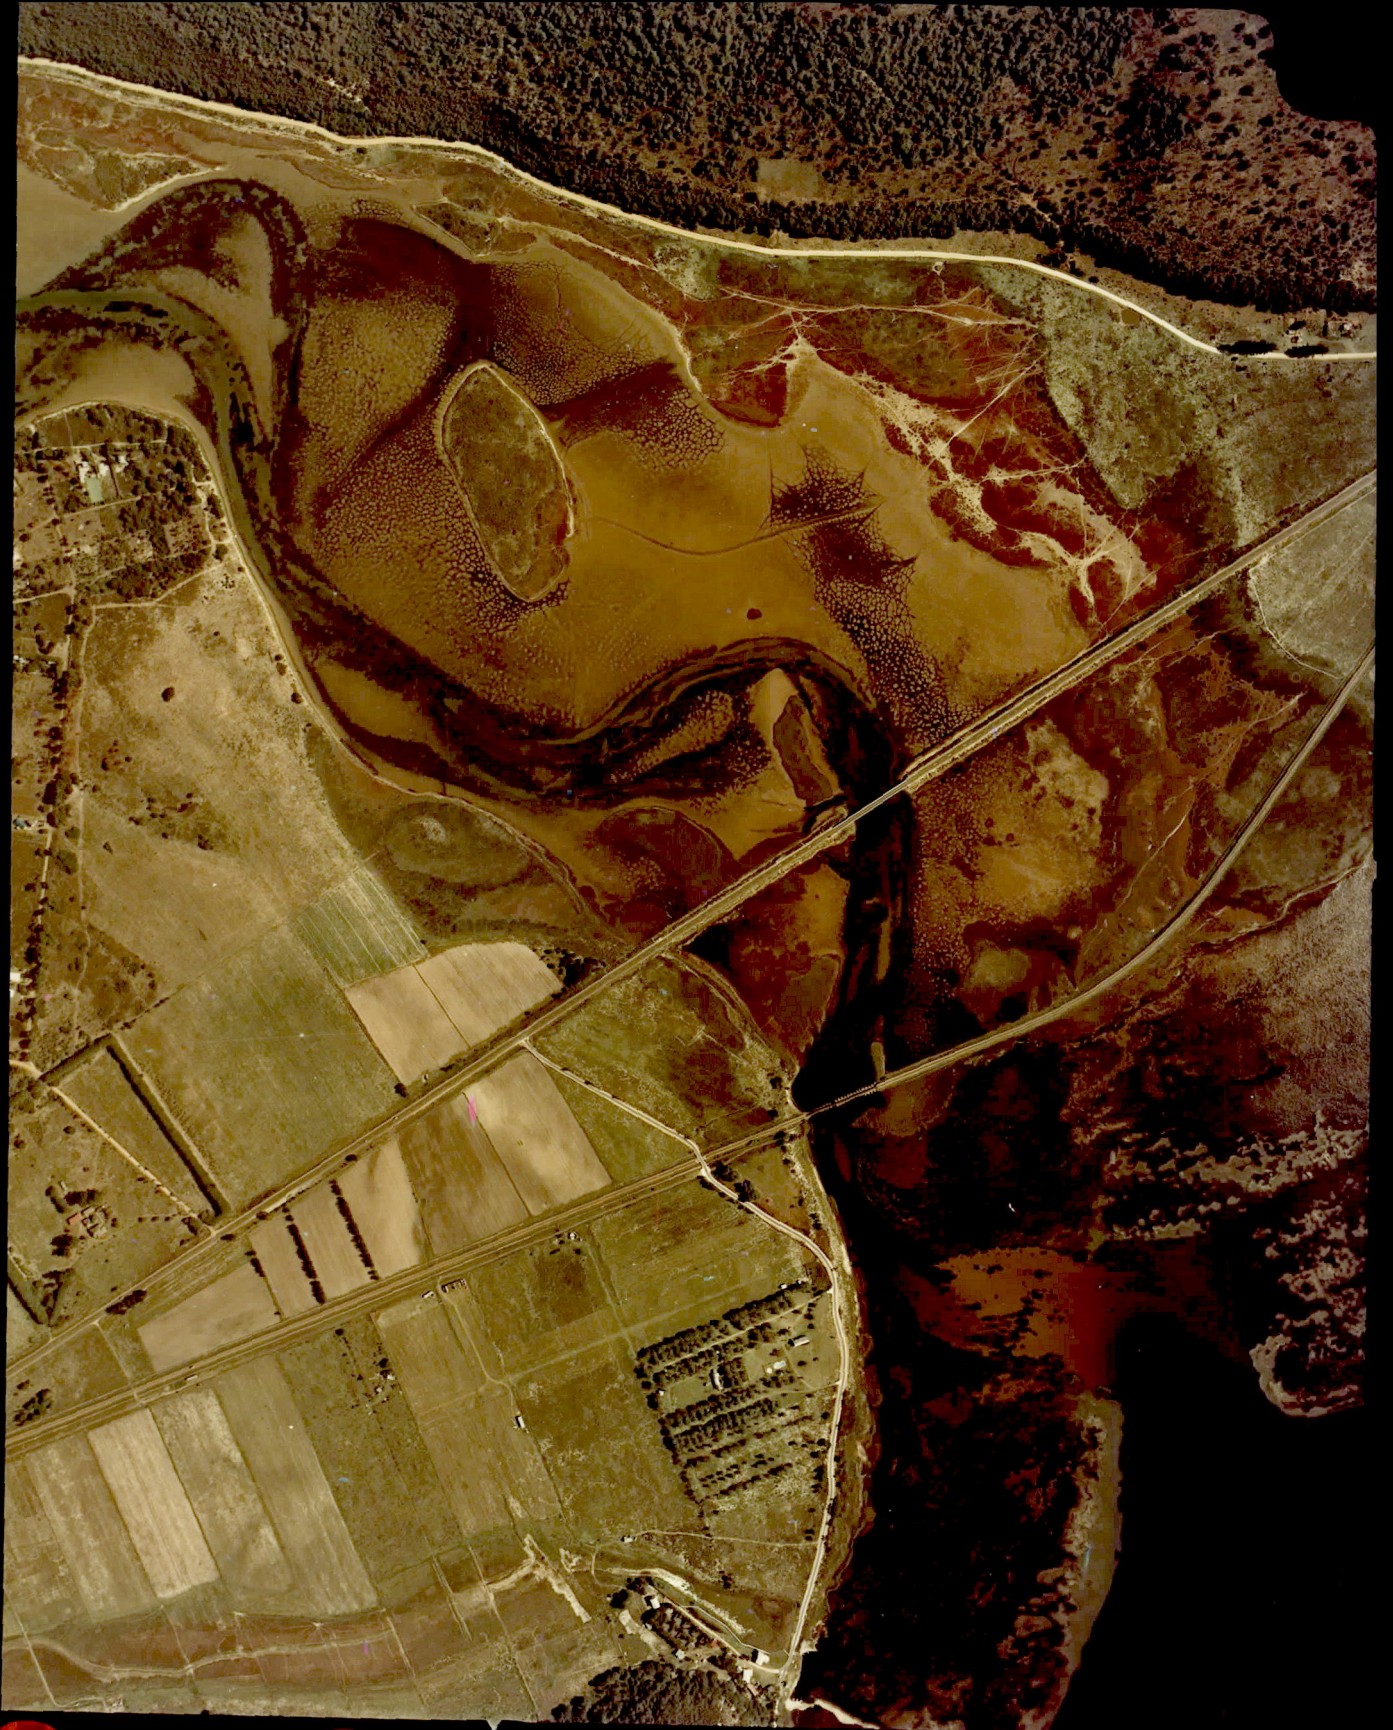
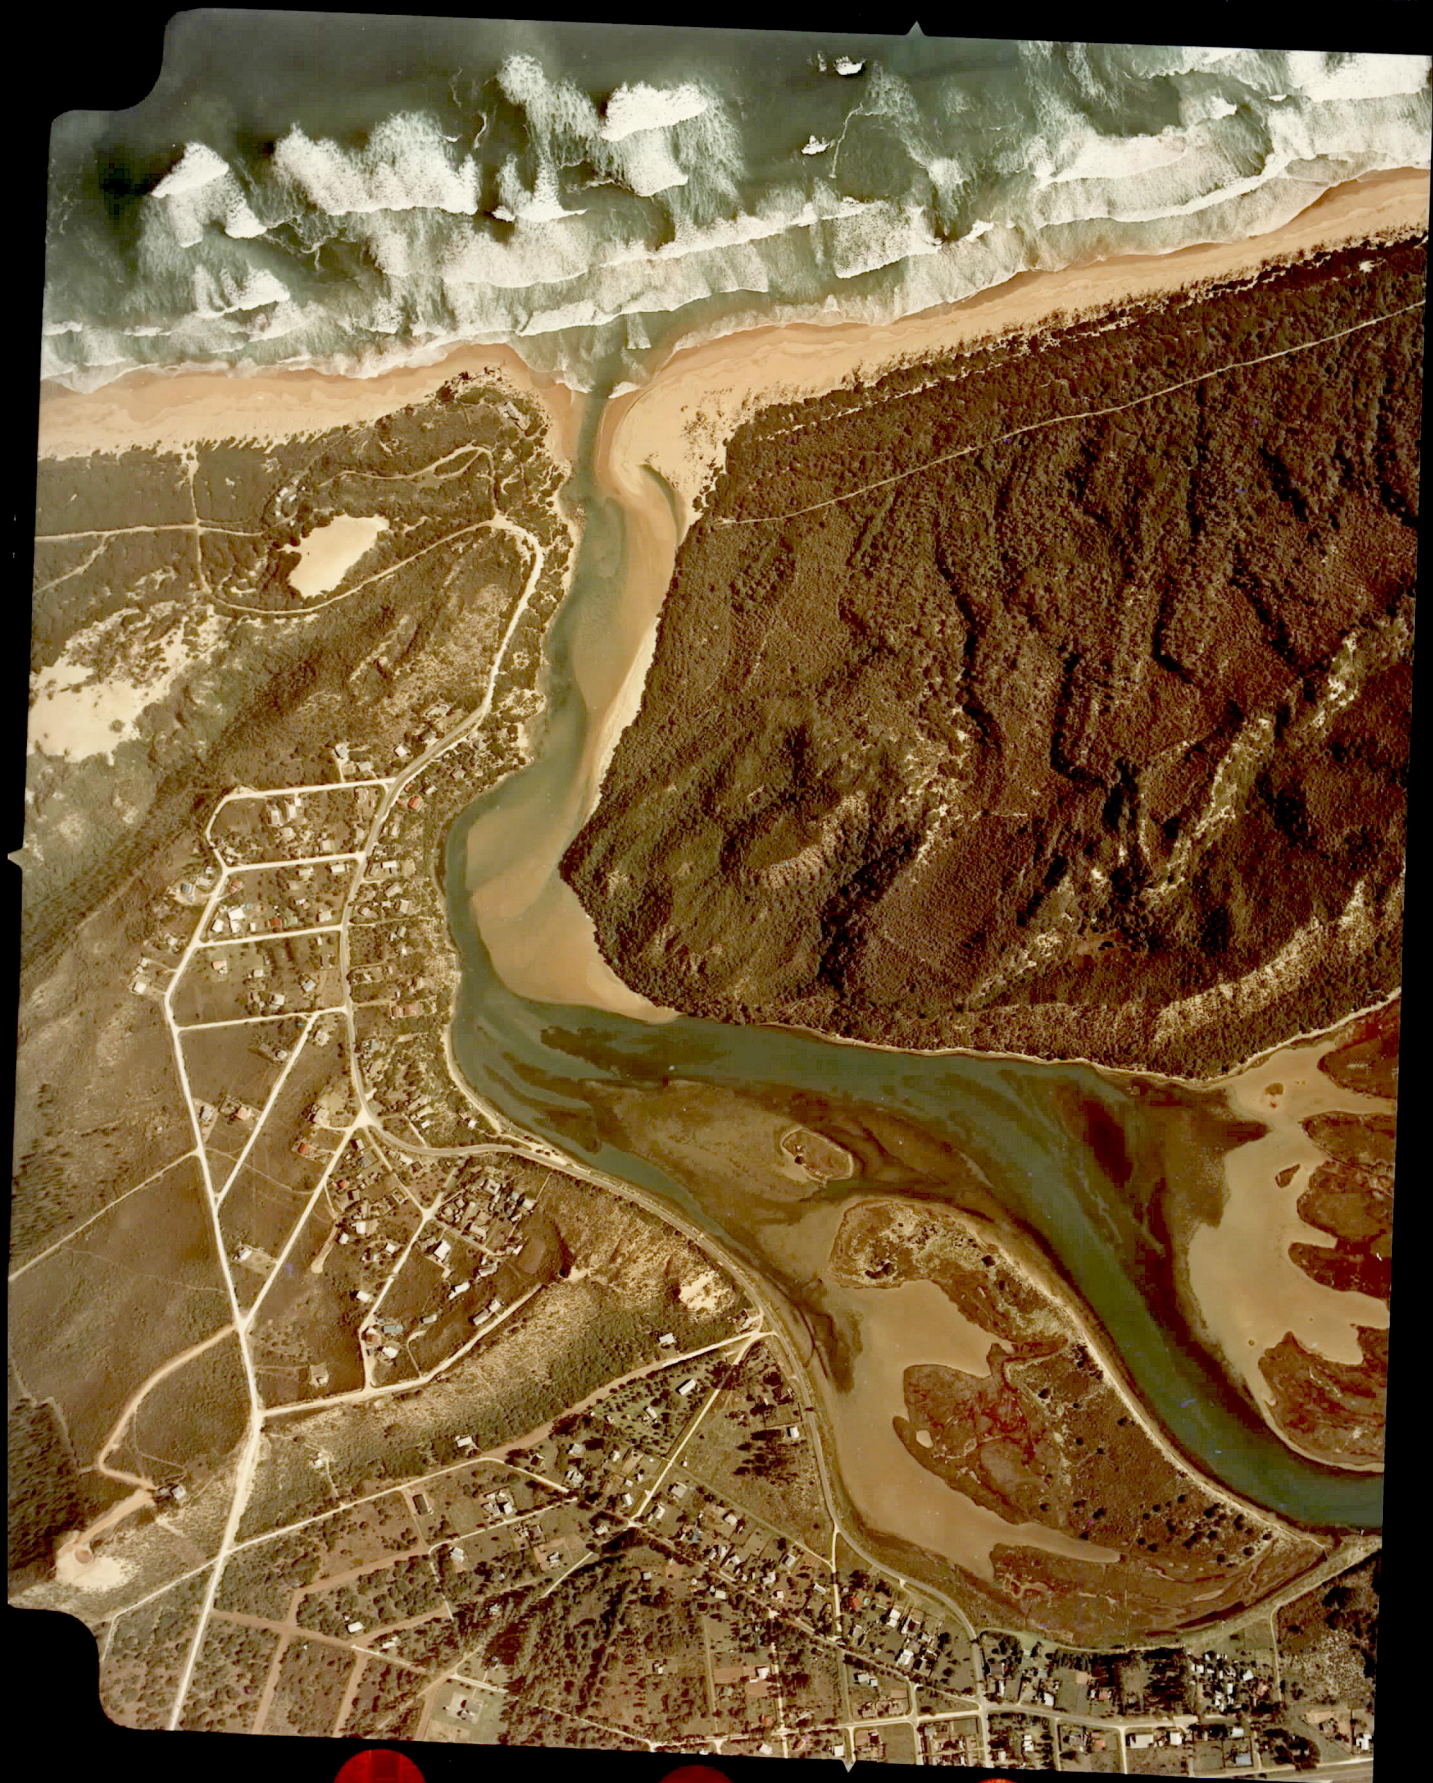
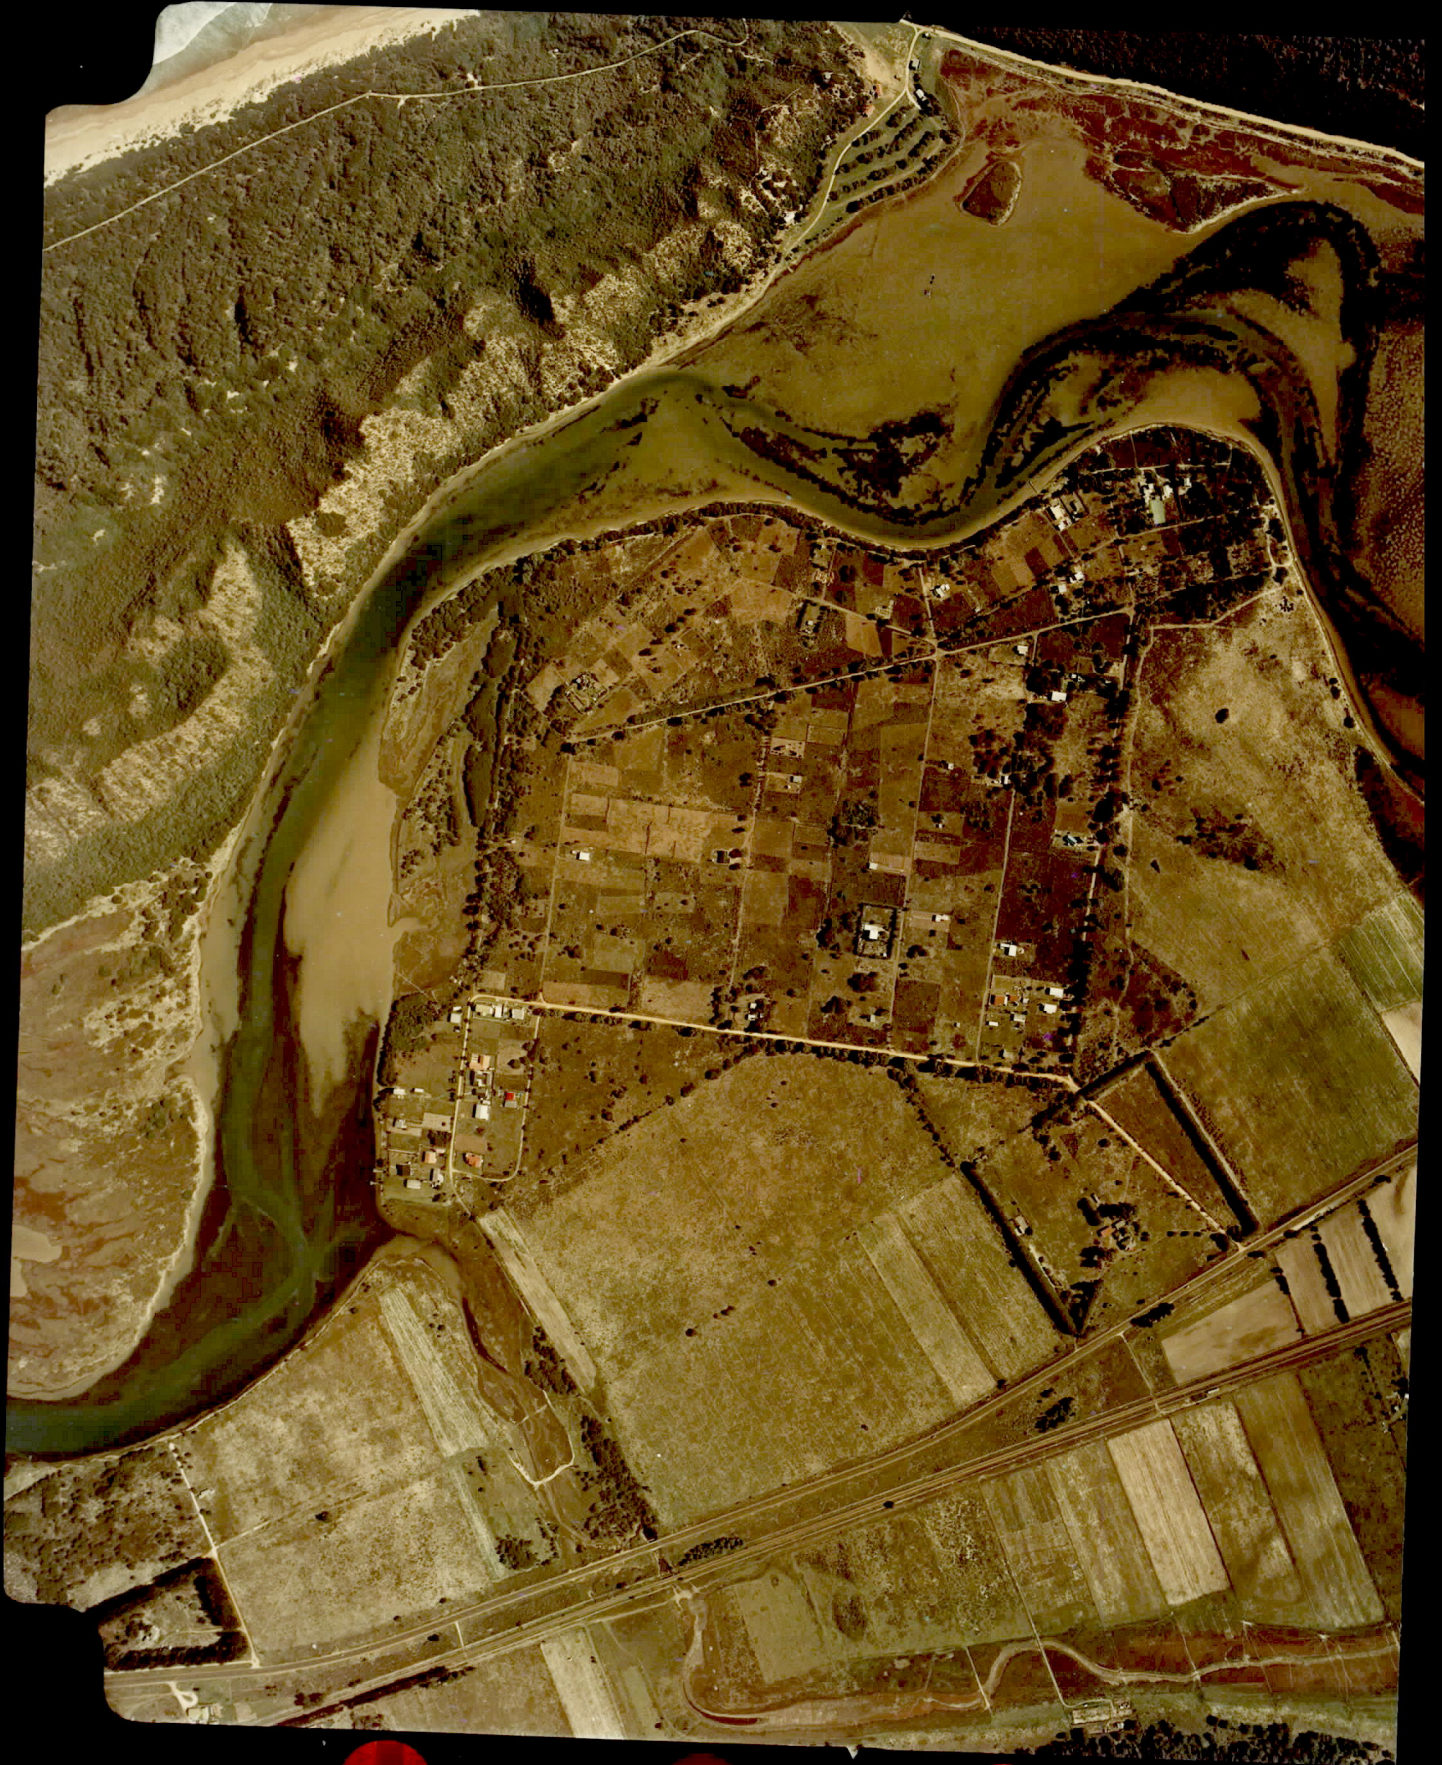
NOTE: Top level refers to invert, bottom level to stones when present on centreline.

Culvert I.D = 0,76 m wall thickness 0,06 m
