HYDROLOGICAL / HYDRAULIC STUDY
OF NATAL ESTUARIES

DATA REPORT No. 5

MZUMBE NS 26

ESTUARINE DYNAMICS (CESD)
NRIO / CSIR
STELLENBOSCH

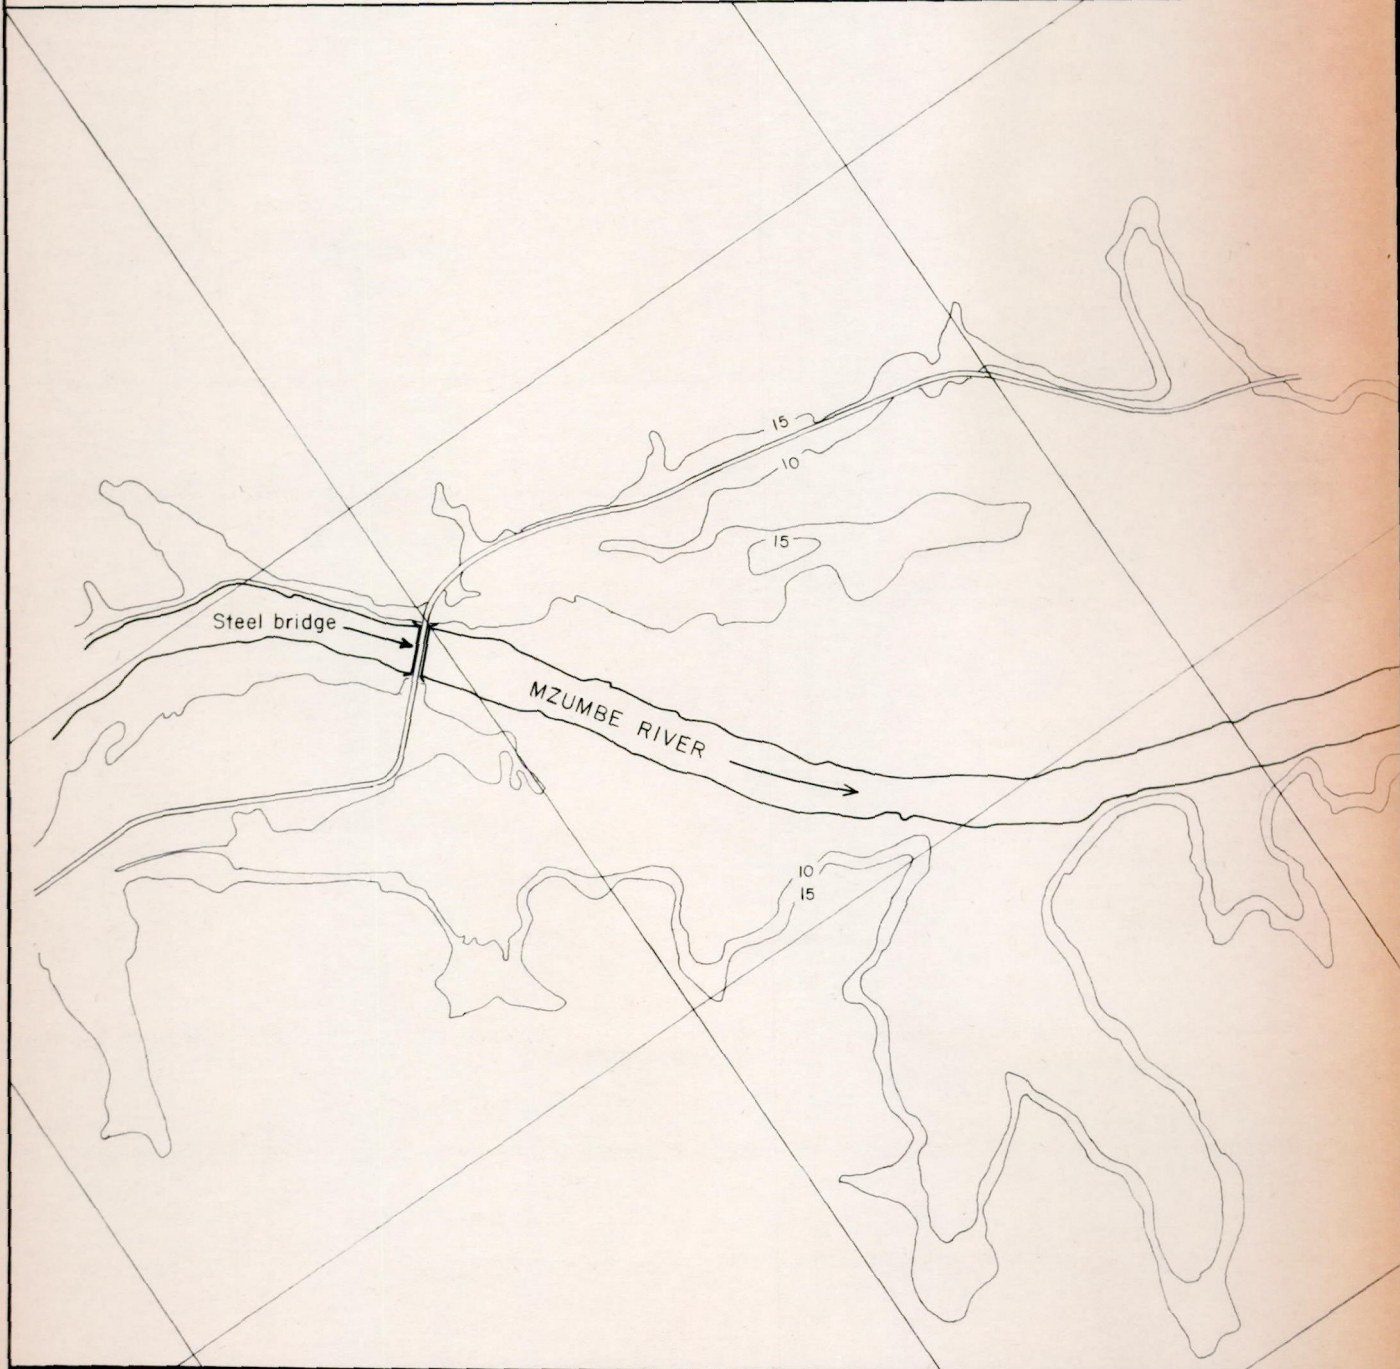
FIGURE
NS 26/1

LOCALITY MAP

40%. Upstream of the proposed freeway bridge (for location see Figure NS 26/1) the river is relatively stable but downstream, in that section which is largely estuarine, the river is markedly unstable. Quantitatively these facts are clearly seen in Table NS 26/VIII on lateral stability and in Figure NS 26/2 showing thalweg displacement. The effect of the canalisation on the sinuosity and the river's natural response to readjust is seen in Figure NS 26/3. Qualitatively the river's adjusting may be seen in Photographs NS 26/4 - 6. The latter photographs also show the extent of recent sedimentation in the estuary.

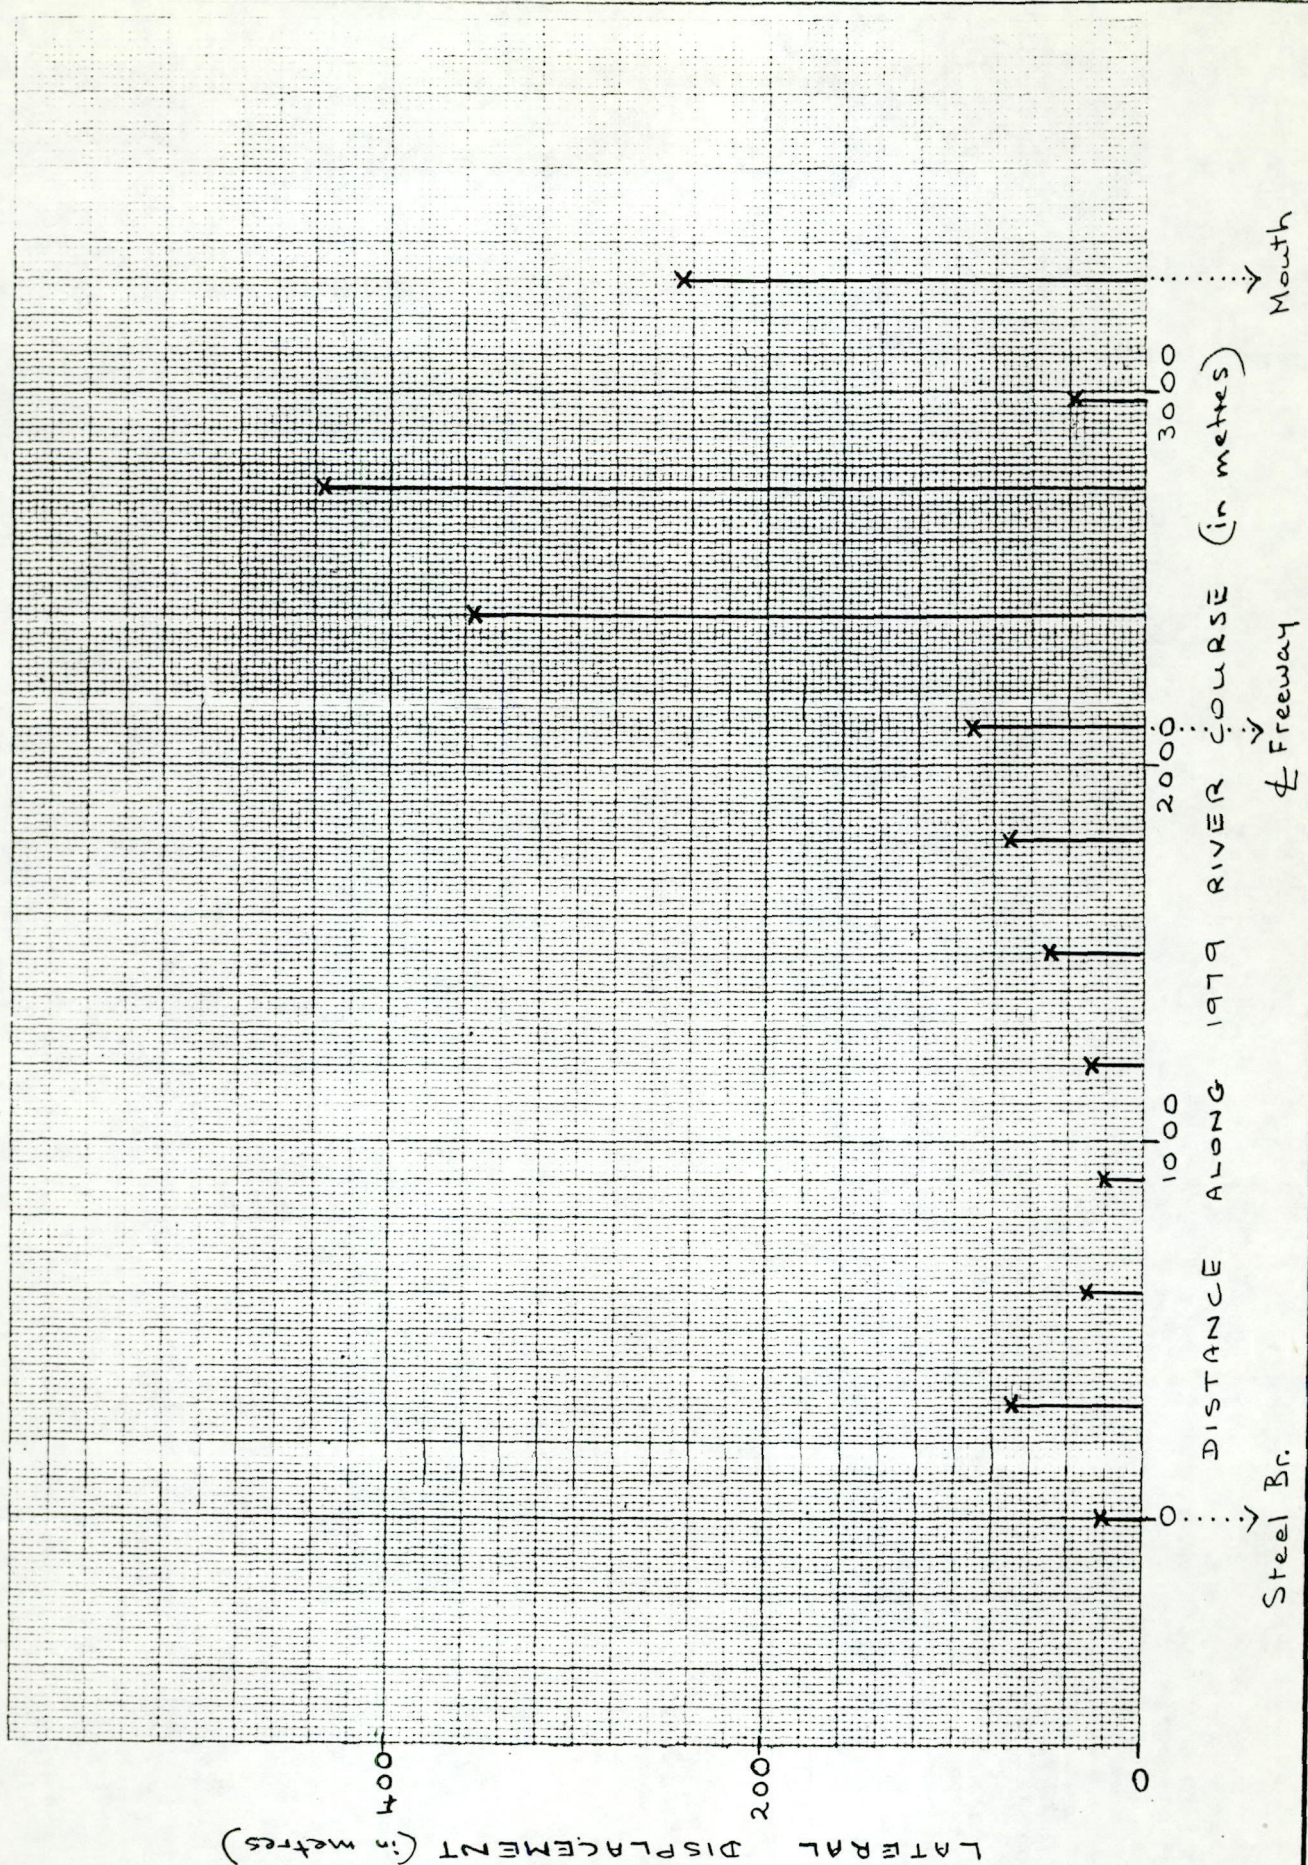
FIGURE
 NS 26/2

THALWEG DISPLACEMENT: 1937-79

Details of the classification of the lower reaches of the Mzumbe River for 1937, 1955, 1959, 1966, 1976 and 1979 are given in Tables NS26/I - VI. Photographs of the river course for the same years are shown in Photographs NS26/1 - 6. Details of river widths and lateral stability appear in Tables NS26/VII and VIII and an abstract of results in Table NS 26/IX. A locality map is given in Figure NS26/1. Thalweg displacement and sinuosity for 1937 - 1979 are shown in Figures NS 26/2 & 3.

The key to the instability of the reach is given by the high average lateral displacement (122 m) with an average coefficient of variation of 40%. ...

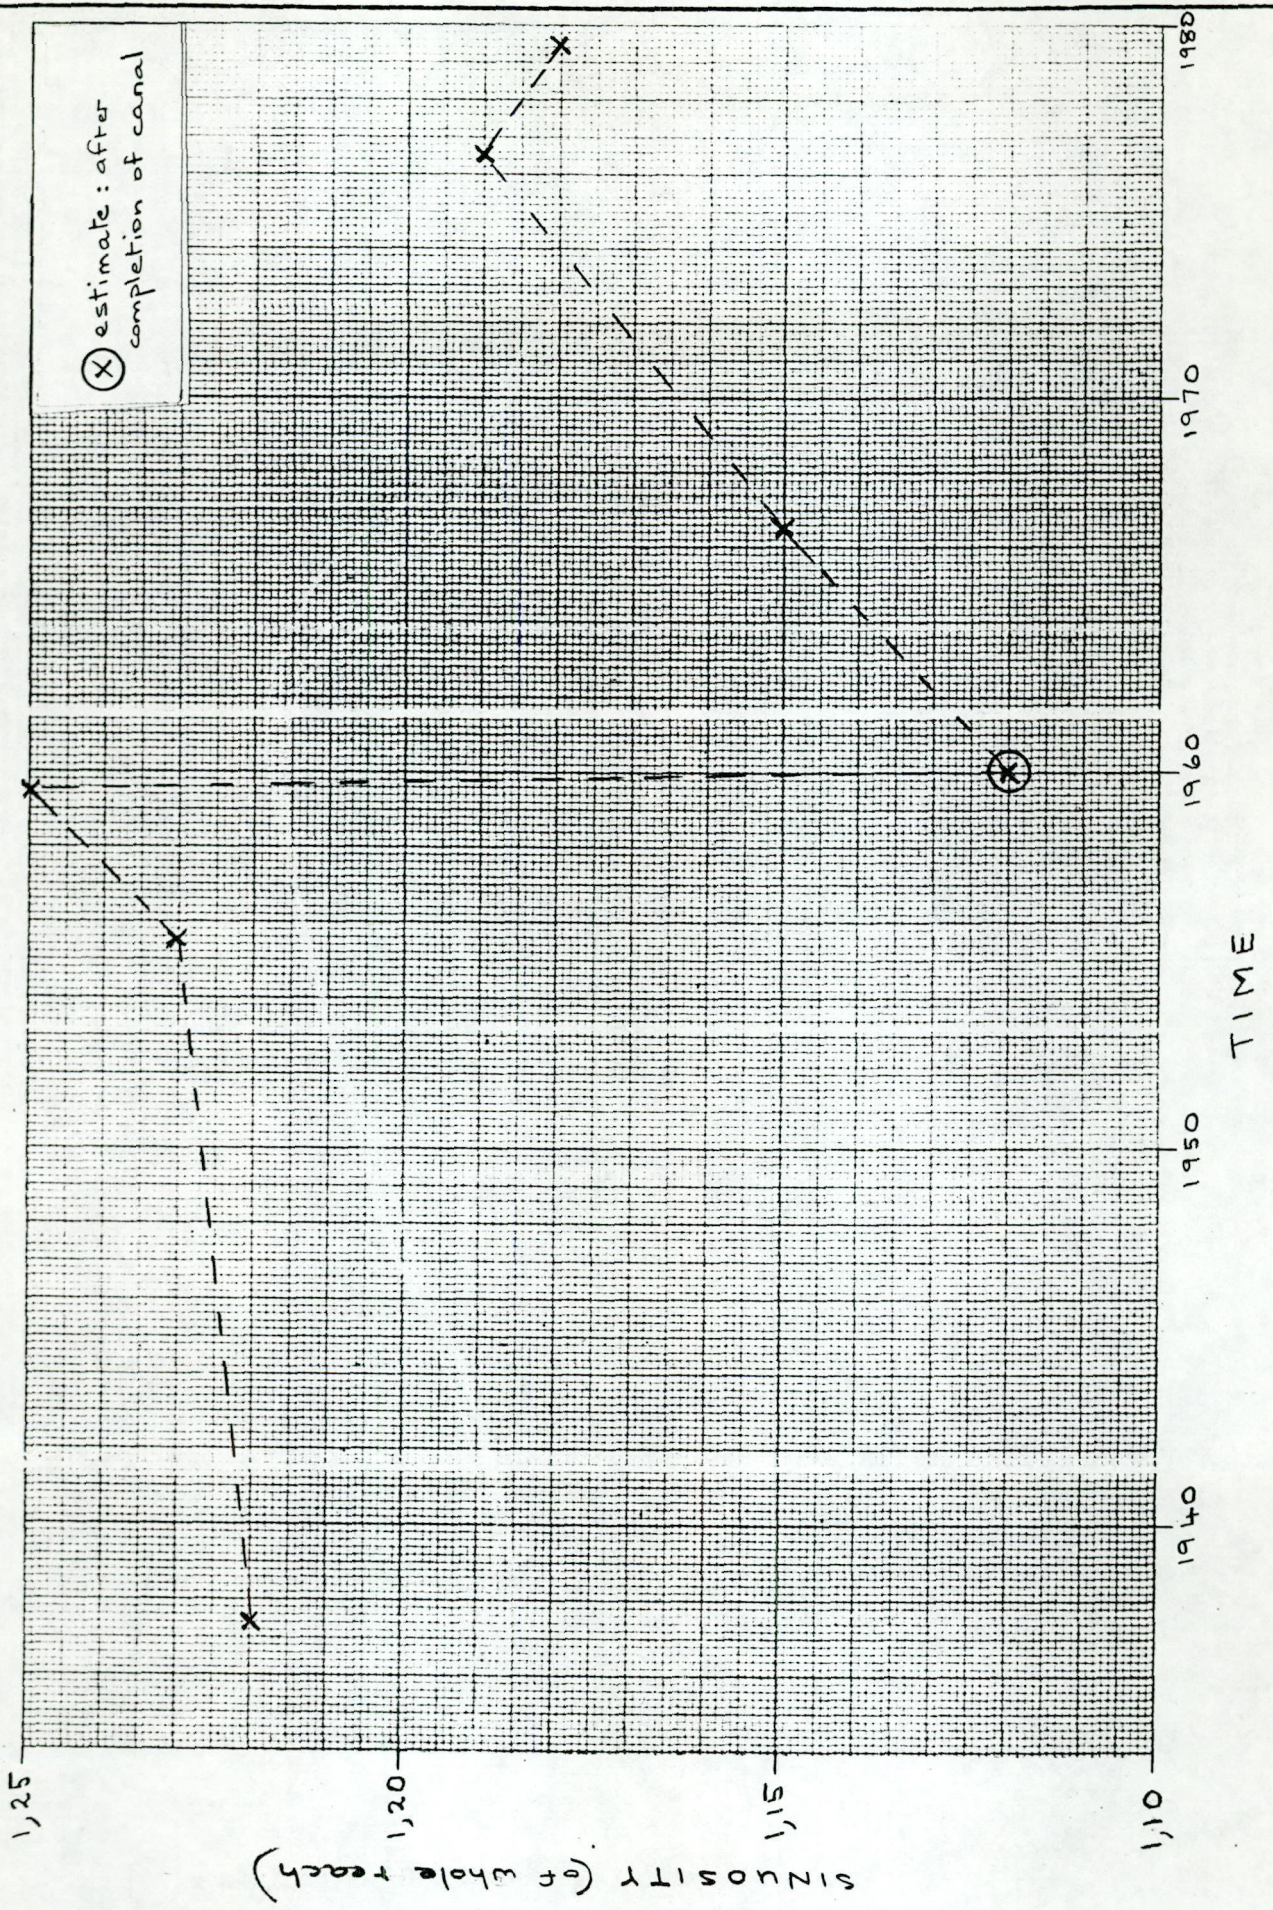
FIGURE
 NS 26/3

(X) estimate: after completion of canal

NATAL ESTUARIES: MZUMBE
 SINUOSITY: 1937 - 79

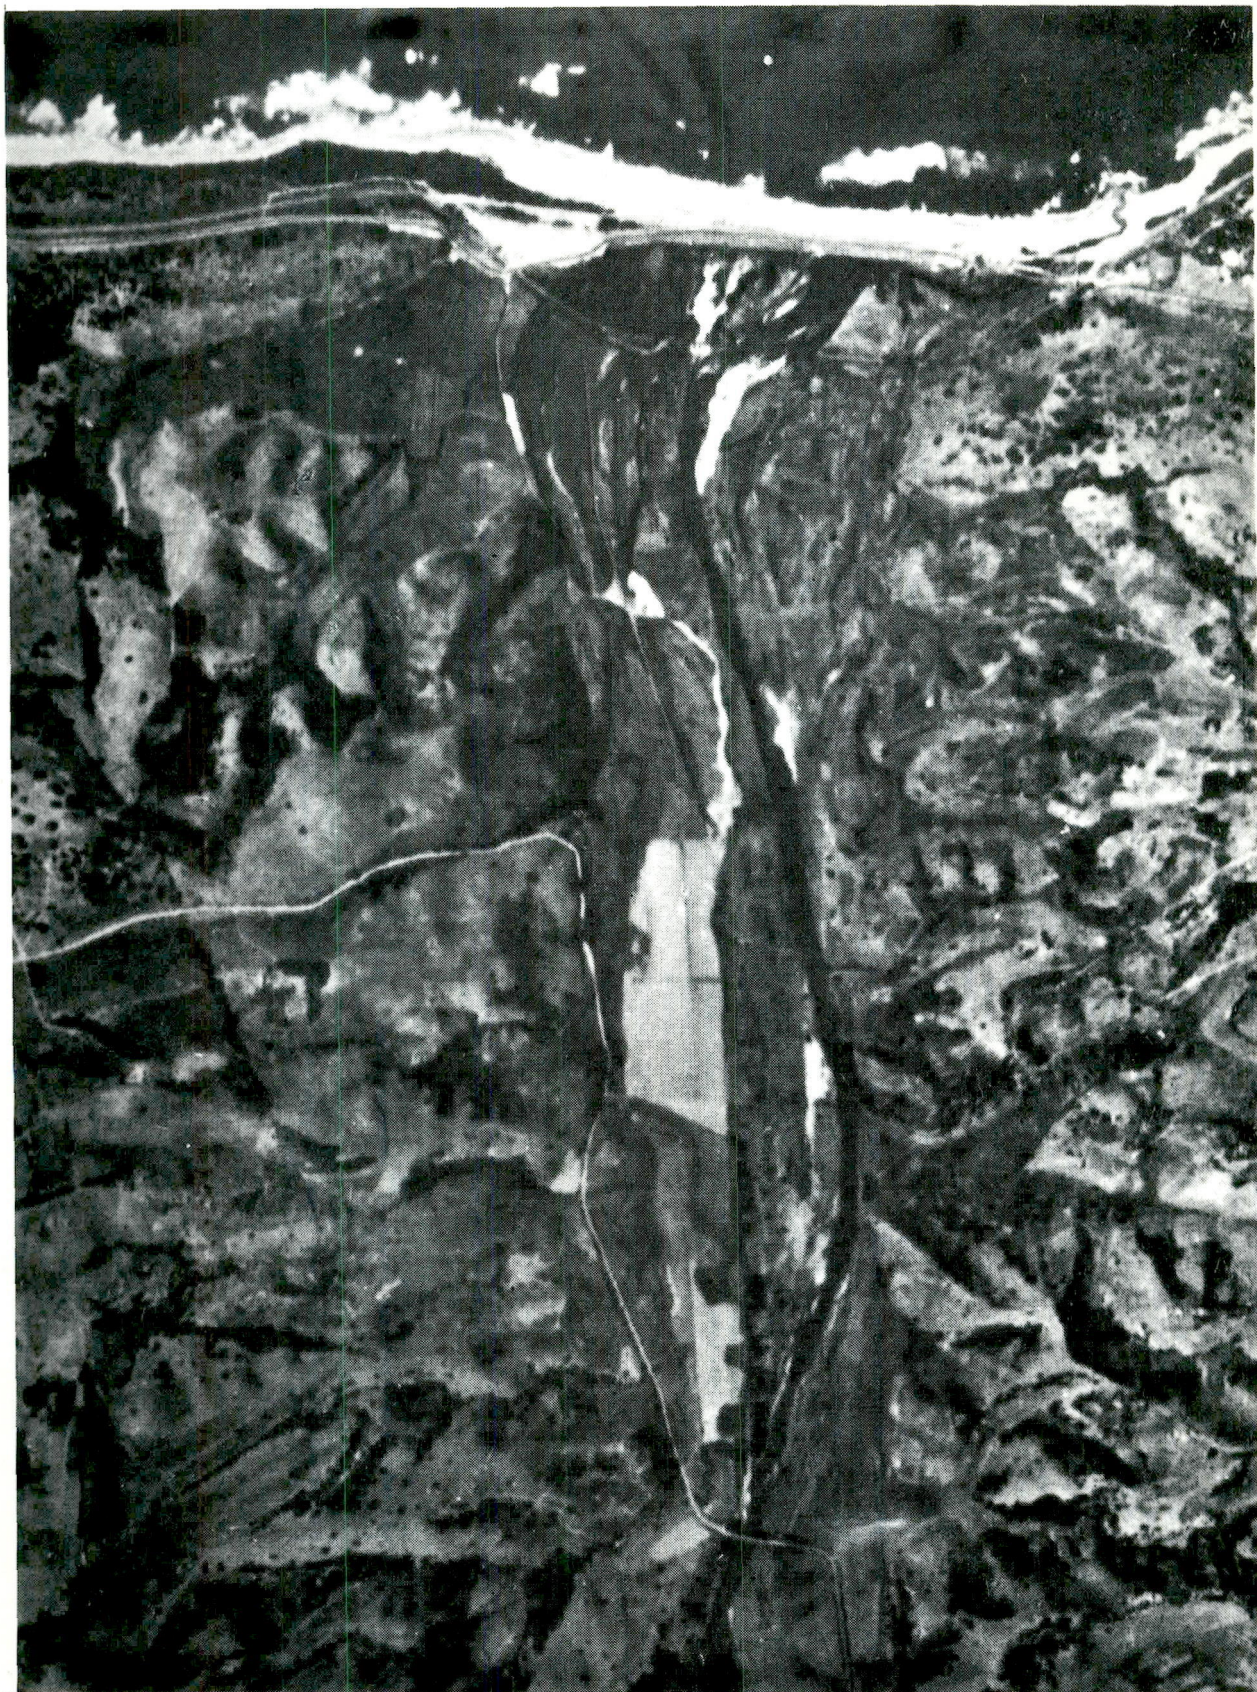
PHOTOGRAPH
NS 26/1

2 - 5 - 37

SCALE: 1:14 500 approx.

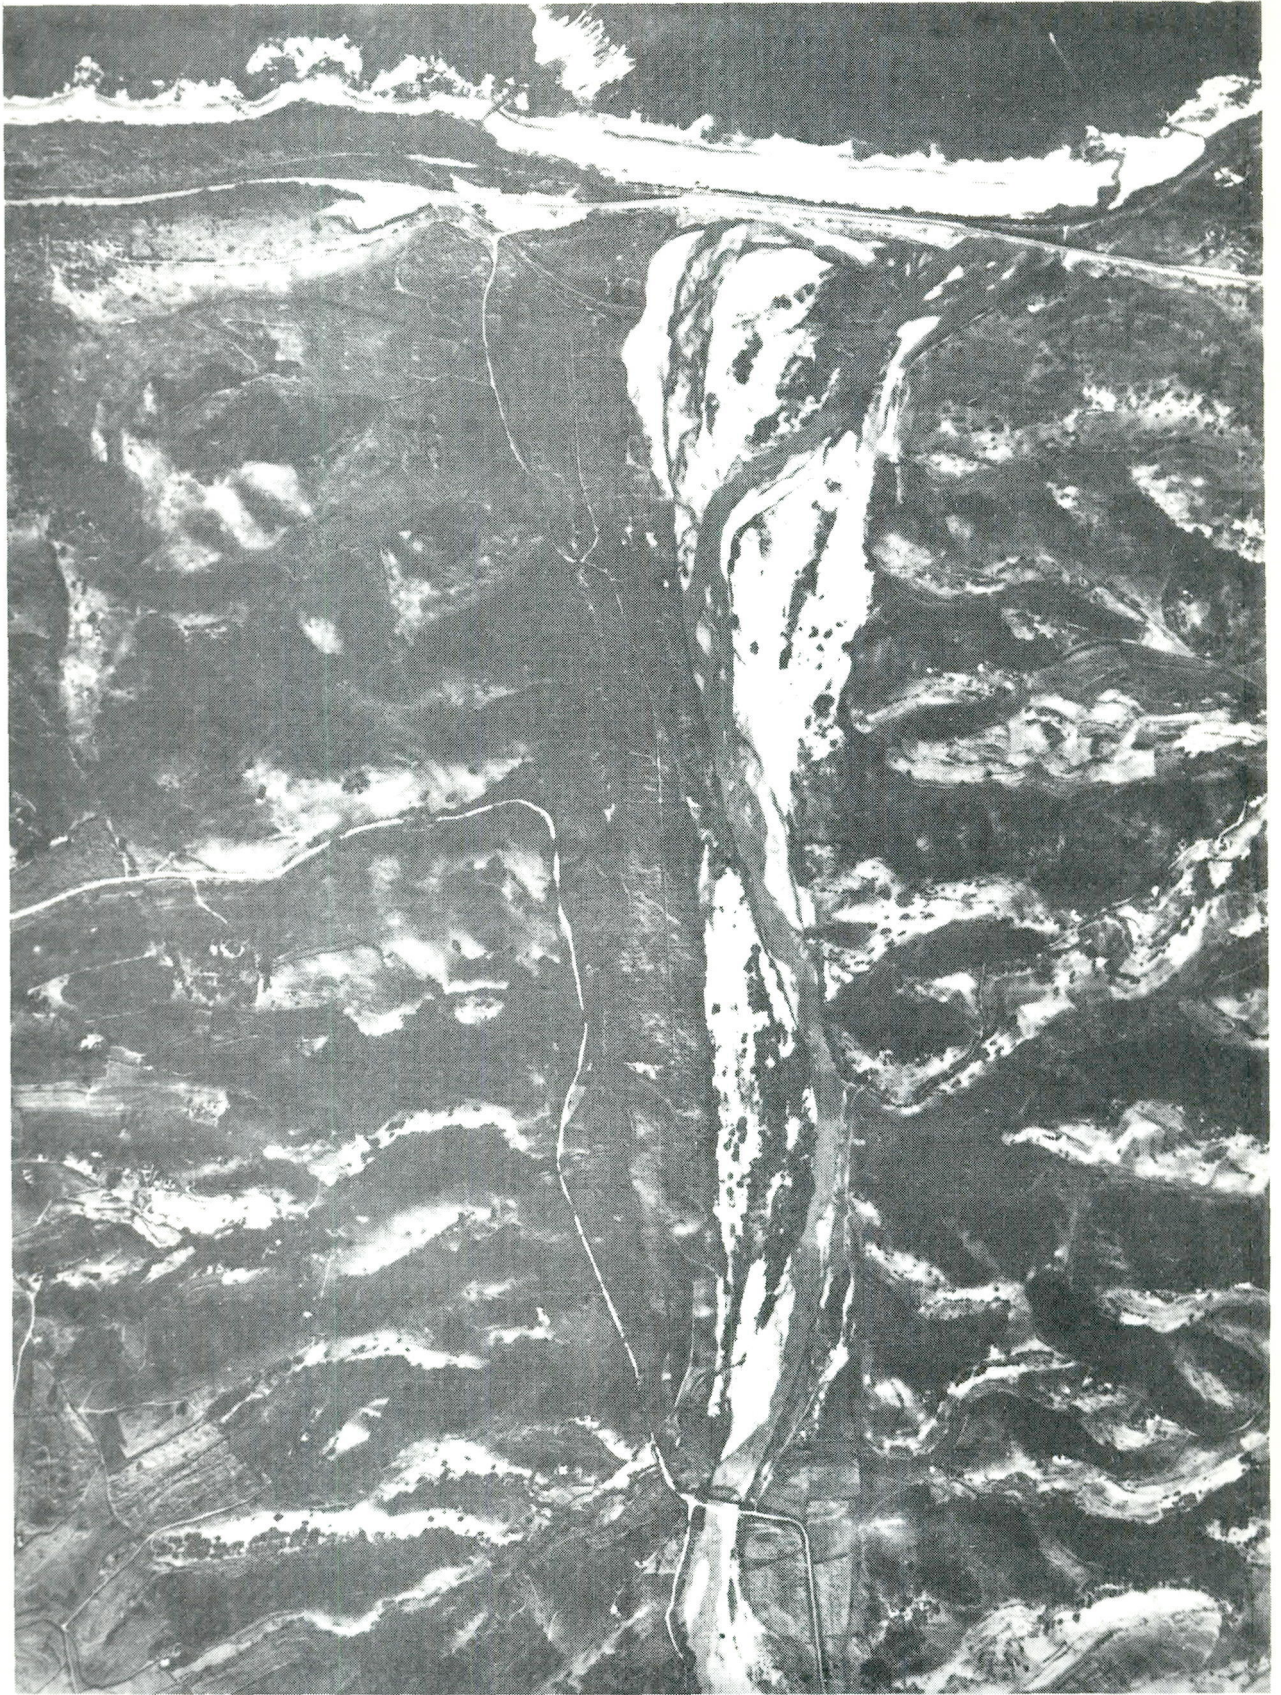
PHOTOGRAPH
NS 26/4

10 - 6 - 66

Under natural conditions, the Mzumbe River course was diverted near the mouth by a long, southerly-extending sand-spit, behind which sedimentation occurred. During major floods, the spit would be breached, allowing the river to flow almost straight out to sea. The building of the old railway line bridges in the 1930's, approximately 300 m inland from the spit (see Figure NS 26/1 and Photograph NS 26/1), still allowed this function. Since the 1950's, however, the spit at the mouth has been stabilised in order to accommodate the national road and the railway line. It was nevertheless breached once more during the major flood of May 1959. Following this flood a canal was built, approximately 800 m upstream of the road bridge, in an effort to divert the river flow towards the road and rail bridges. The silted-up remnants of this canal may be seen in Photograph NS 26/4.

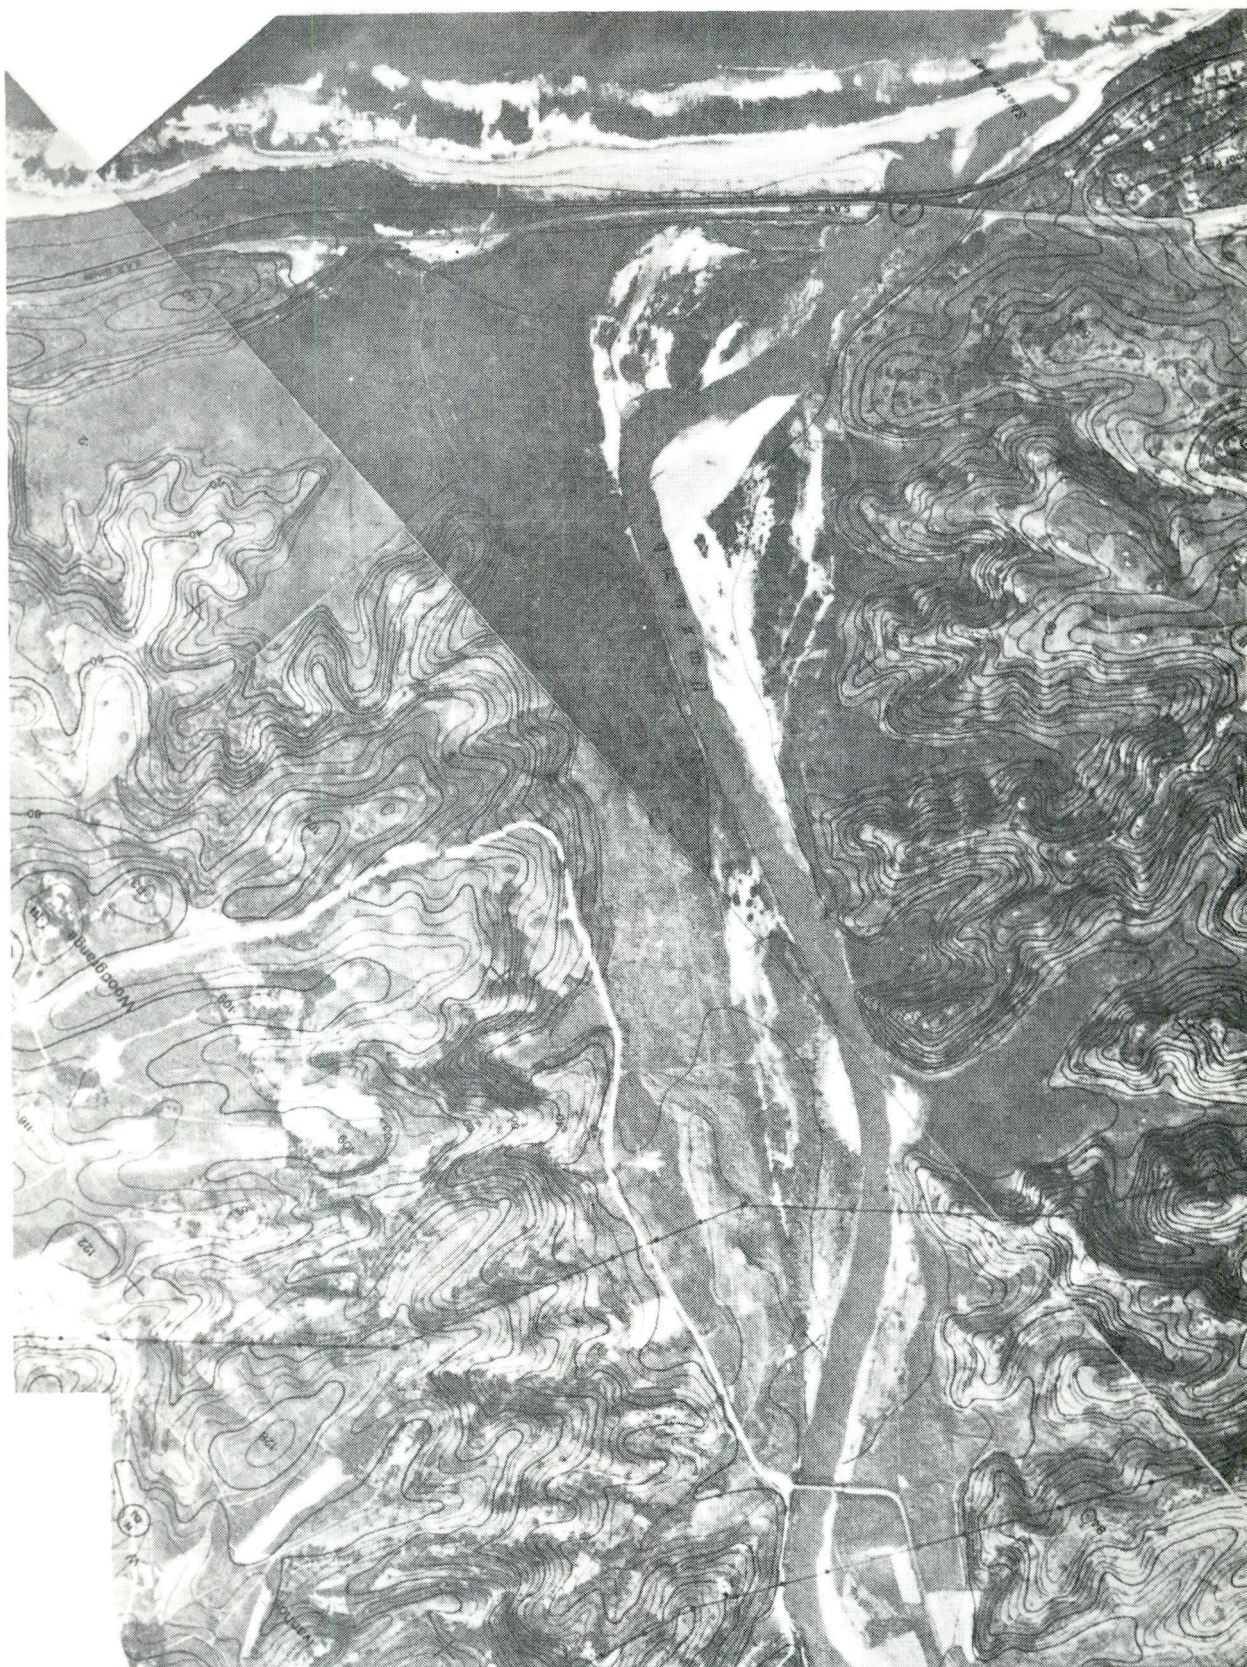
SCALE: 1 : 14 900 approx.
