**HYDROLOGICAL/HYDRAULIC STUDY
OF CAPE ESTUARIES**

THE SONDAGS ESTUARY

NRIO MEMORANDUM 8303

DATA REPORT No. 1
SONDAGS CSE 5

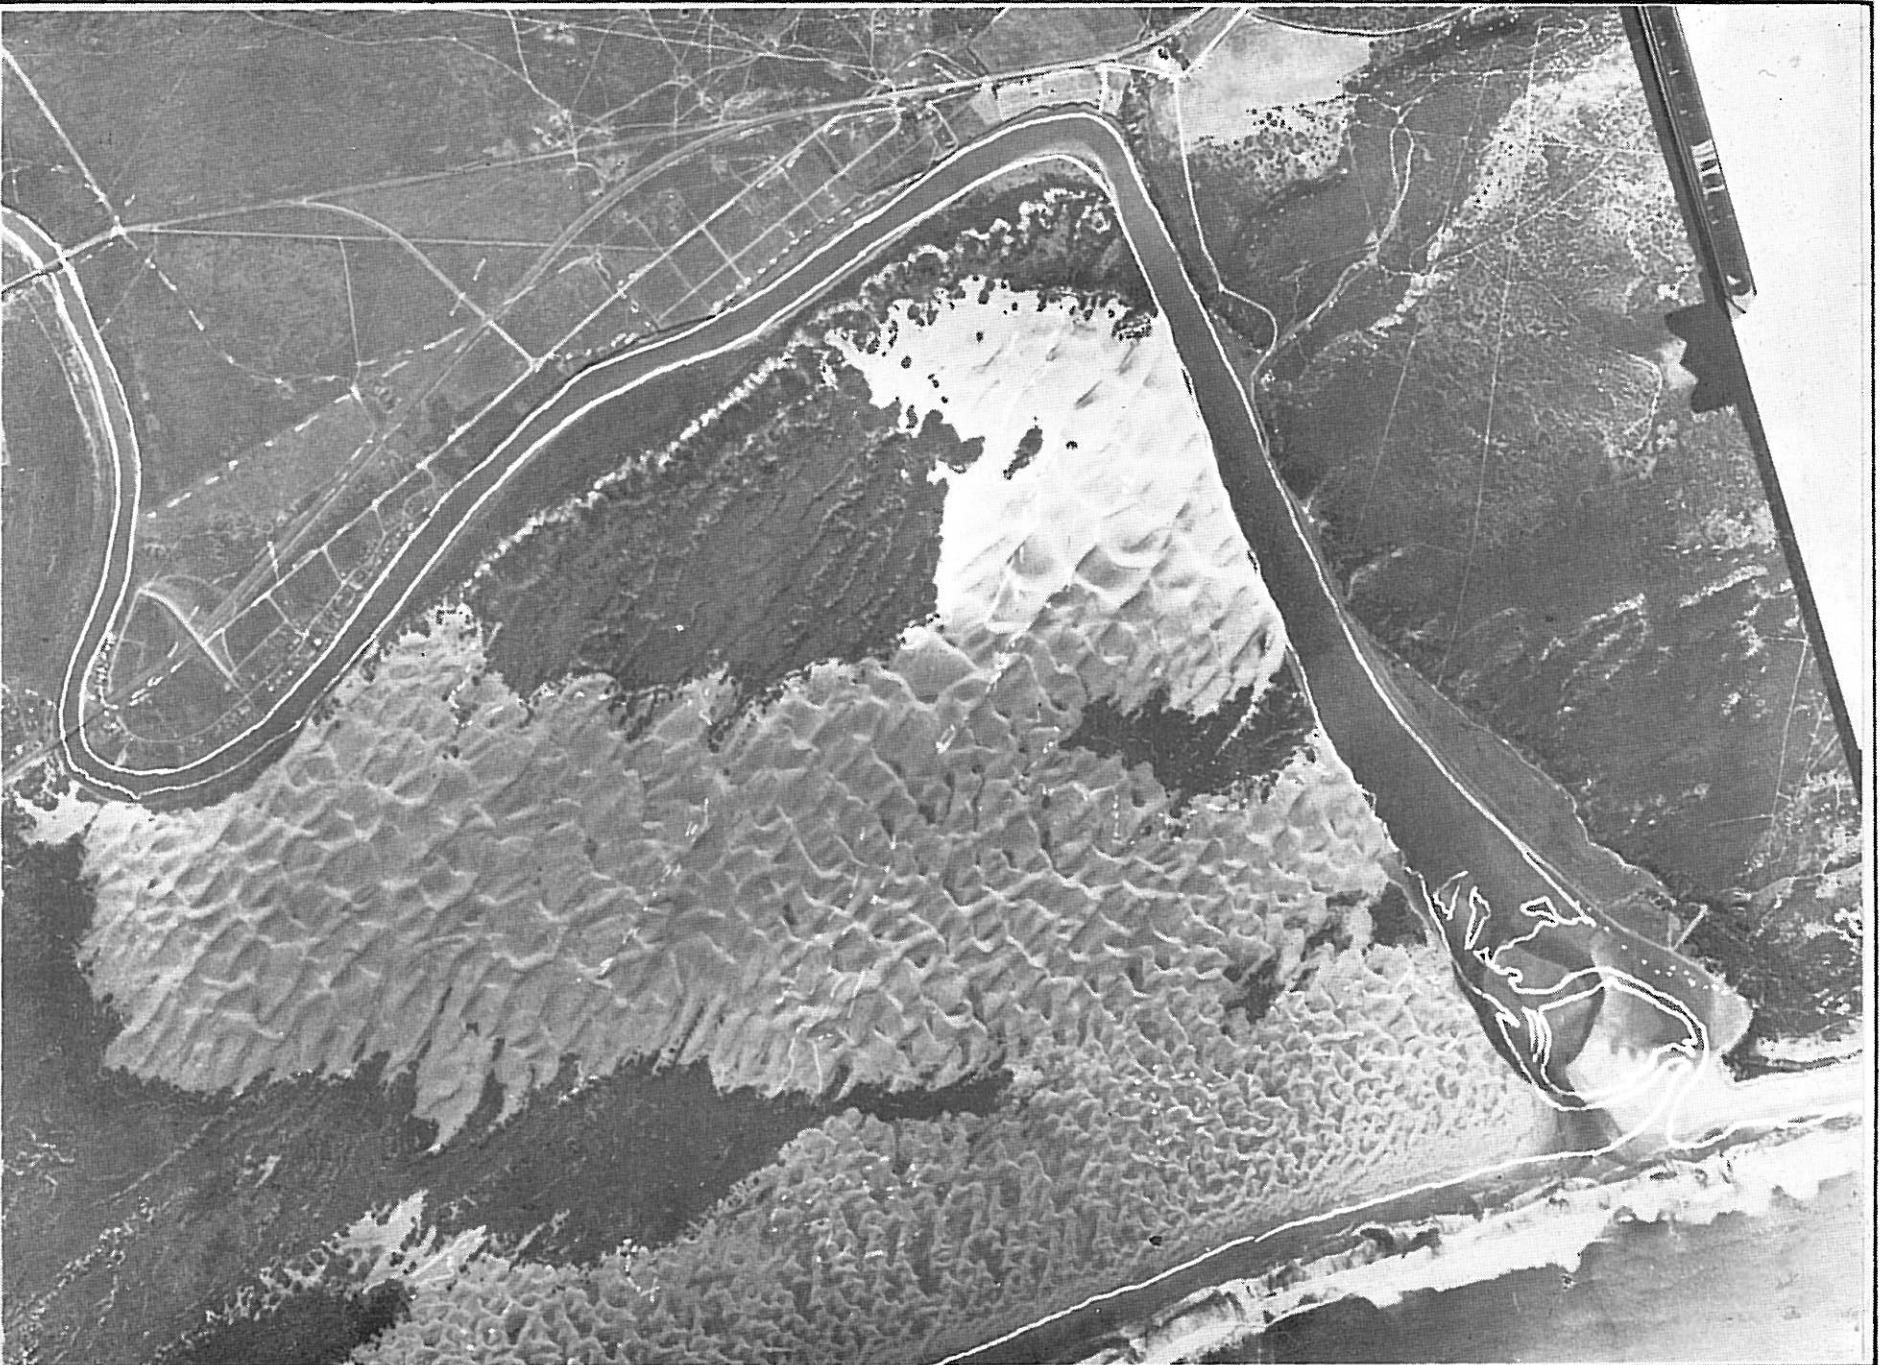
CSE 5/1

(APRIL 1939 RIVER COURSE SUPERIMPOSED)

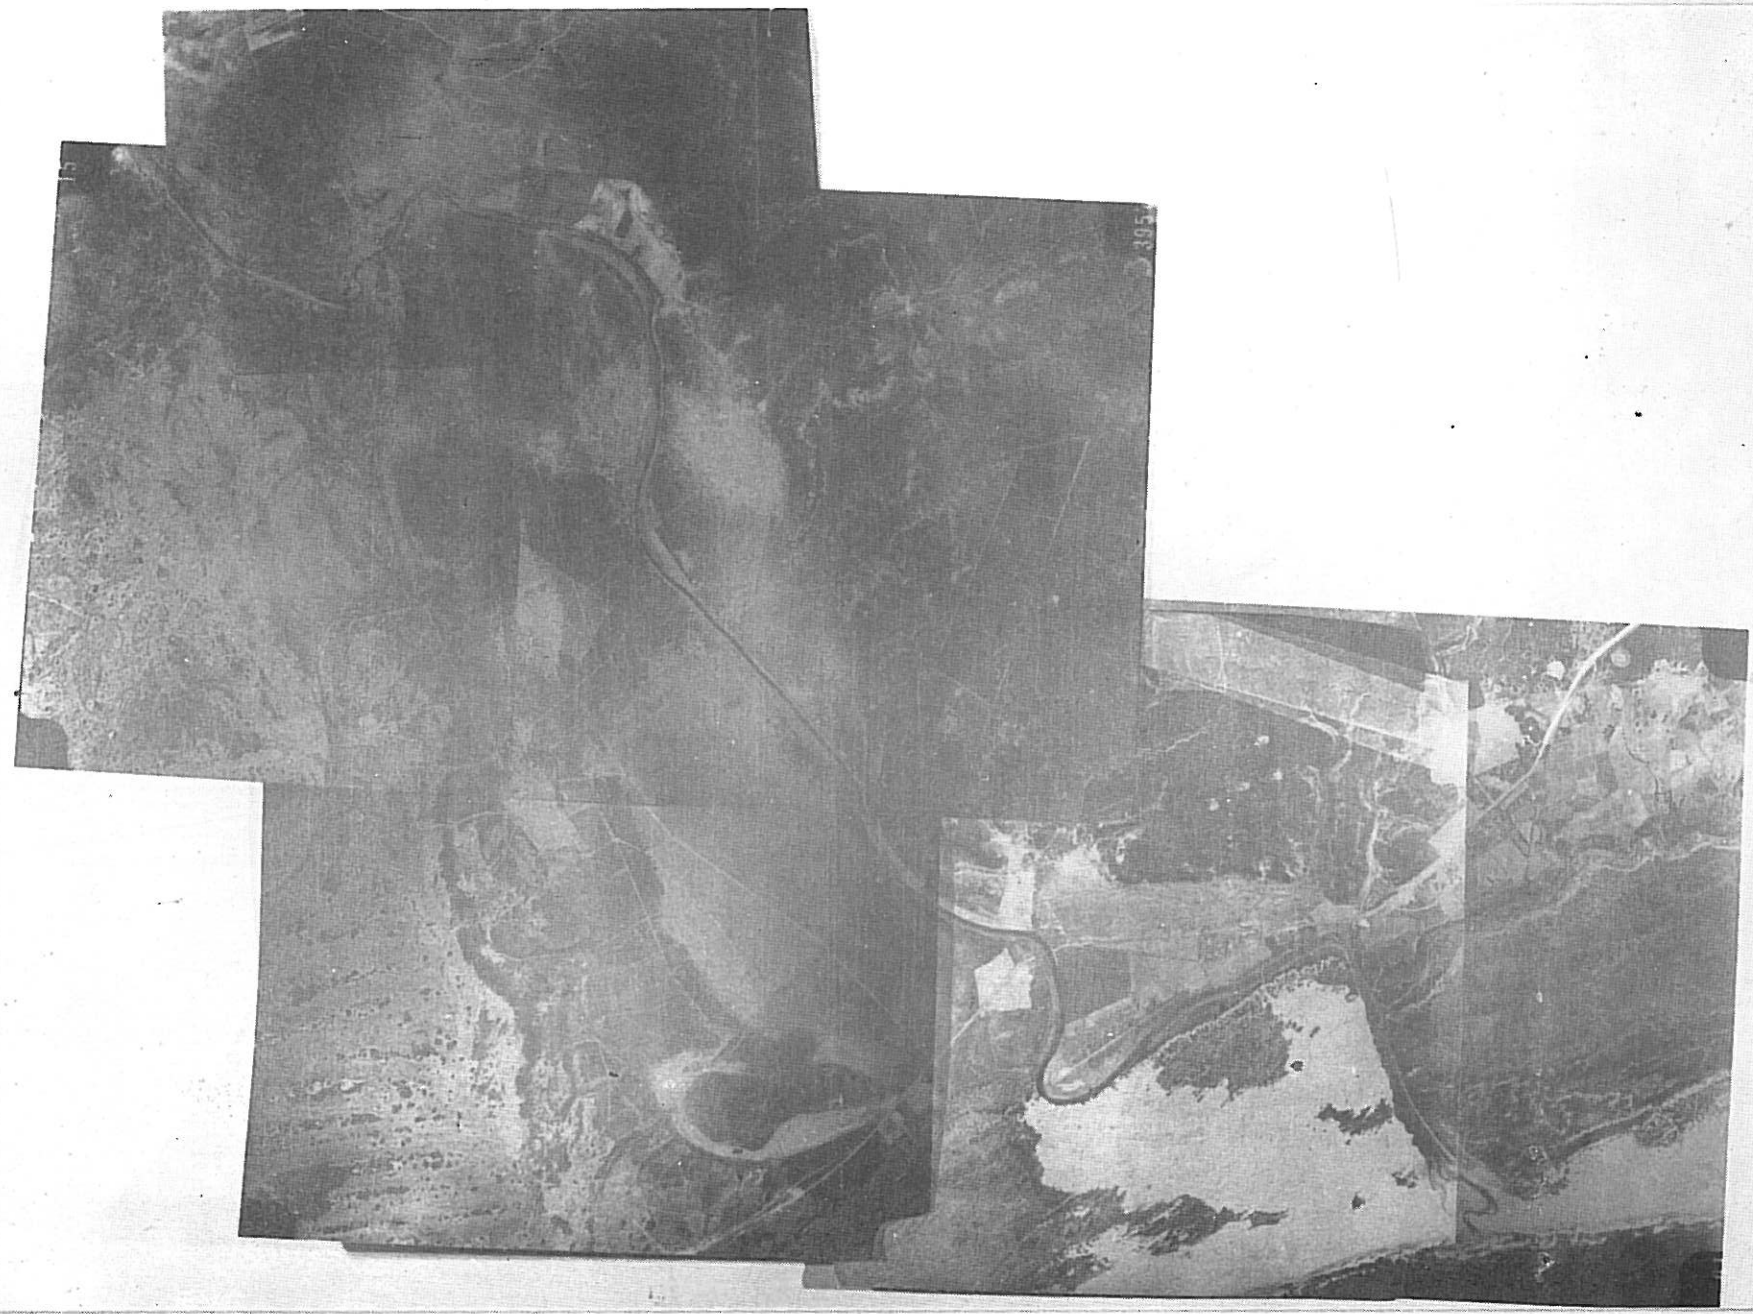
CSE 5/3

SEPTEMBER - NOVEMBER 1960

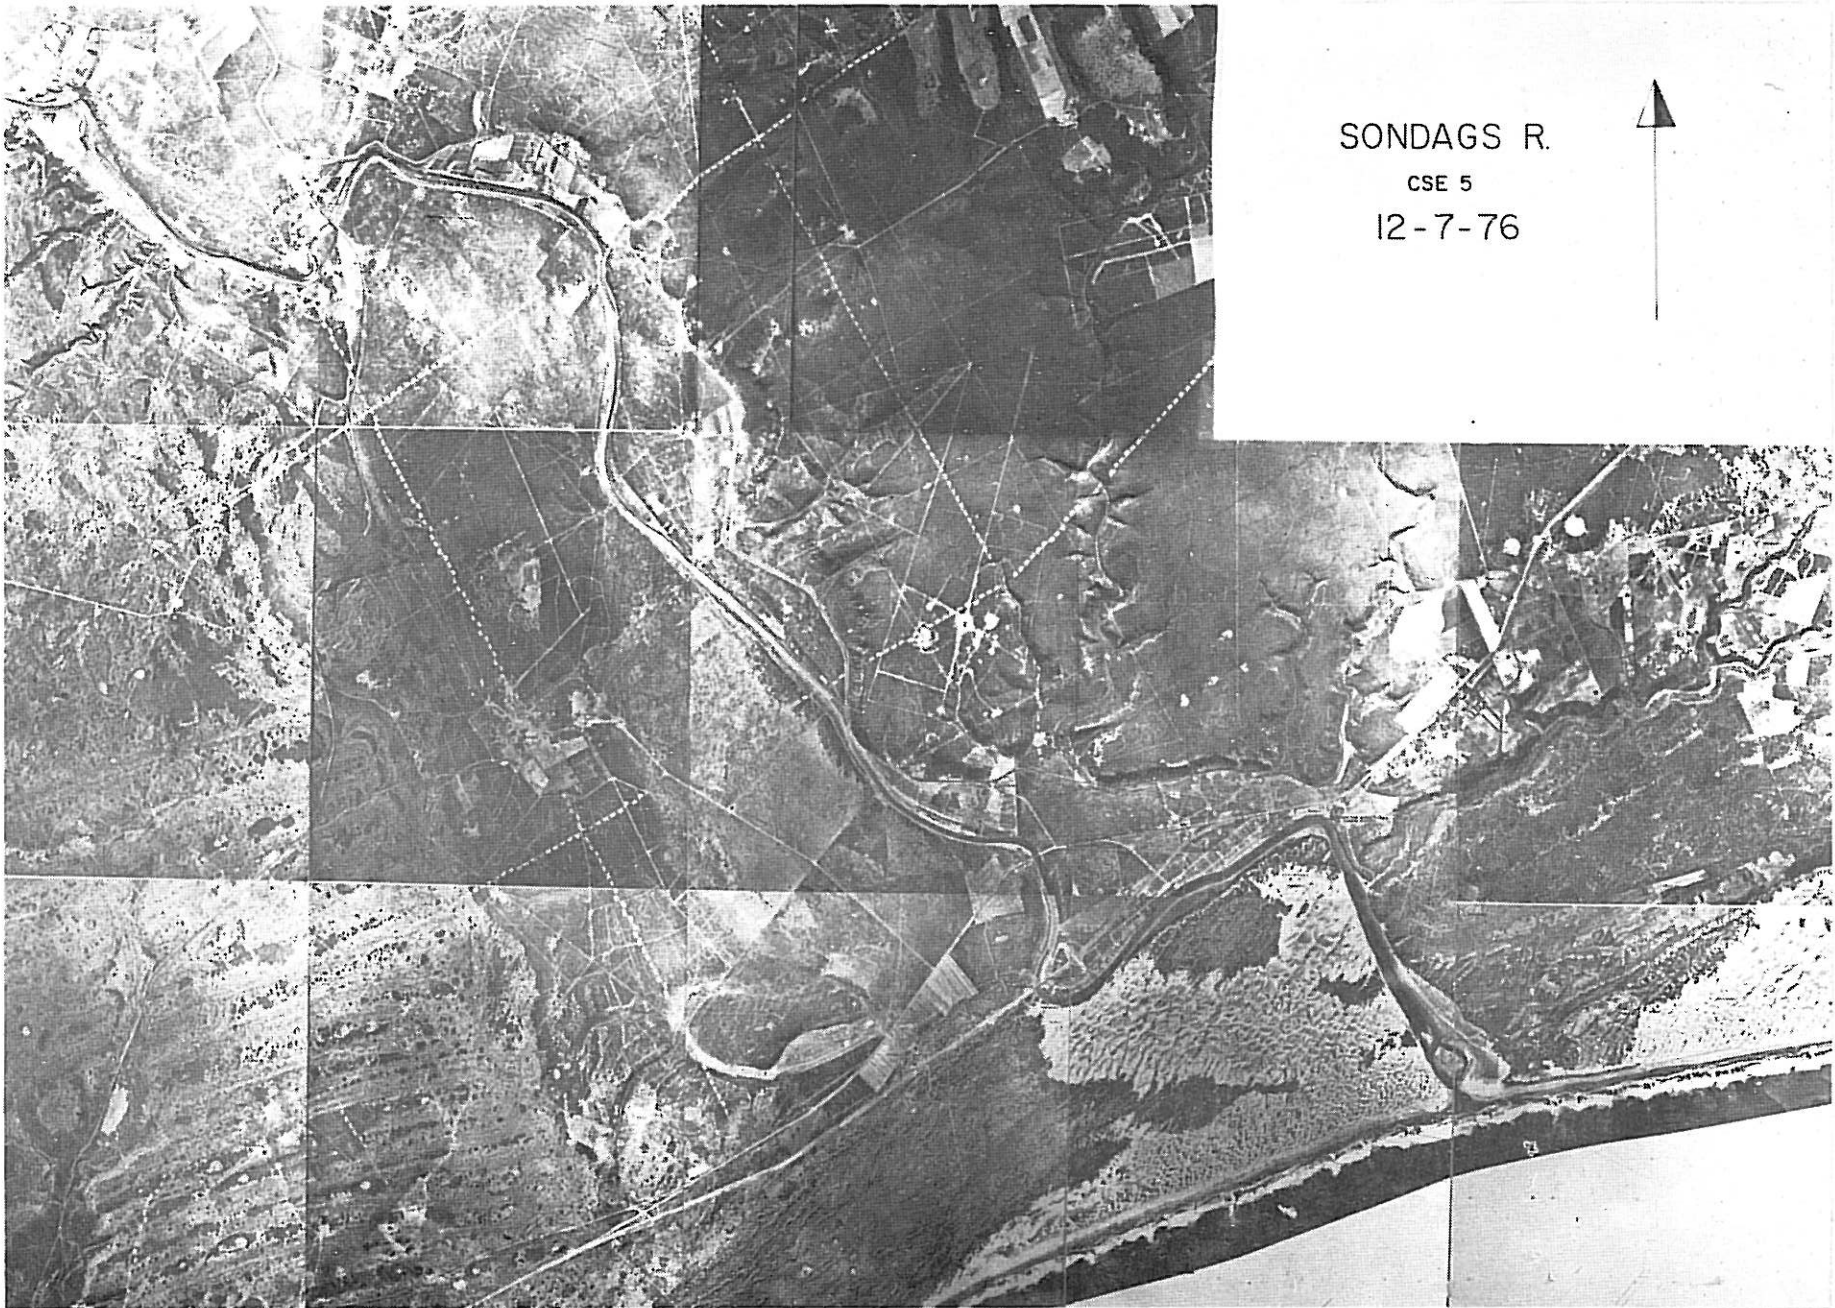
PHOTOGRAPH
CSE 5/5

CAPE ESTUARIES: SONDAGS
12-7-76
(ORTHOPHOTO SERIES)

The mouth of the Sondags remains open but the sand-spits at the mouth are a variable feature. It appears that following a very long dry period, as seen in Photograph CSE 5/2, the main spit growth is from the right bank and follows the direction of the littoral drift. However, following a major flood when an outer bar develops as a marked feature, a spit forms from the left bank and this may be the dominant spit for a long period (Photo CSE 5/5).
