**REPORT ON THE INVESTIGATION OF SILTATION IN THE
GREEN HOLE, KNYSNA
AND TECHNICAL EVALUATION OF REMEDIAL MEASURES**

submitted to
The National Parks Board of Trustees
Coastal Areas

January 1989

CSIR CONTRACT REPORT

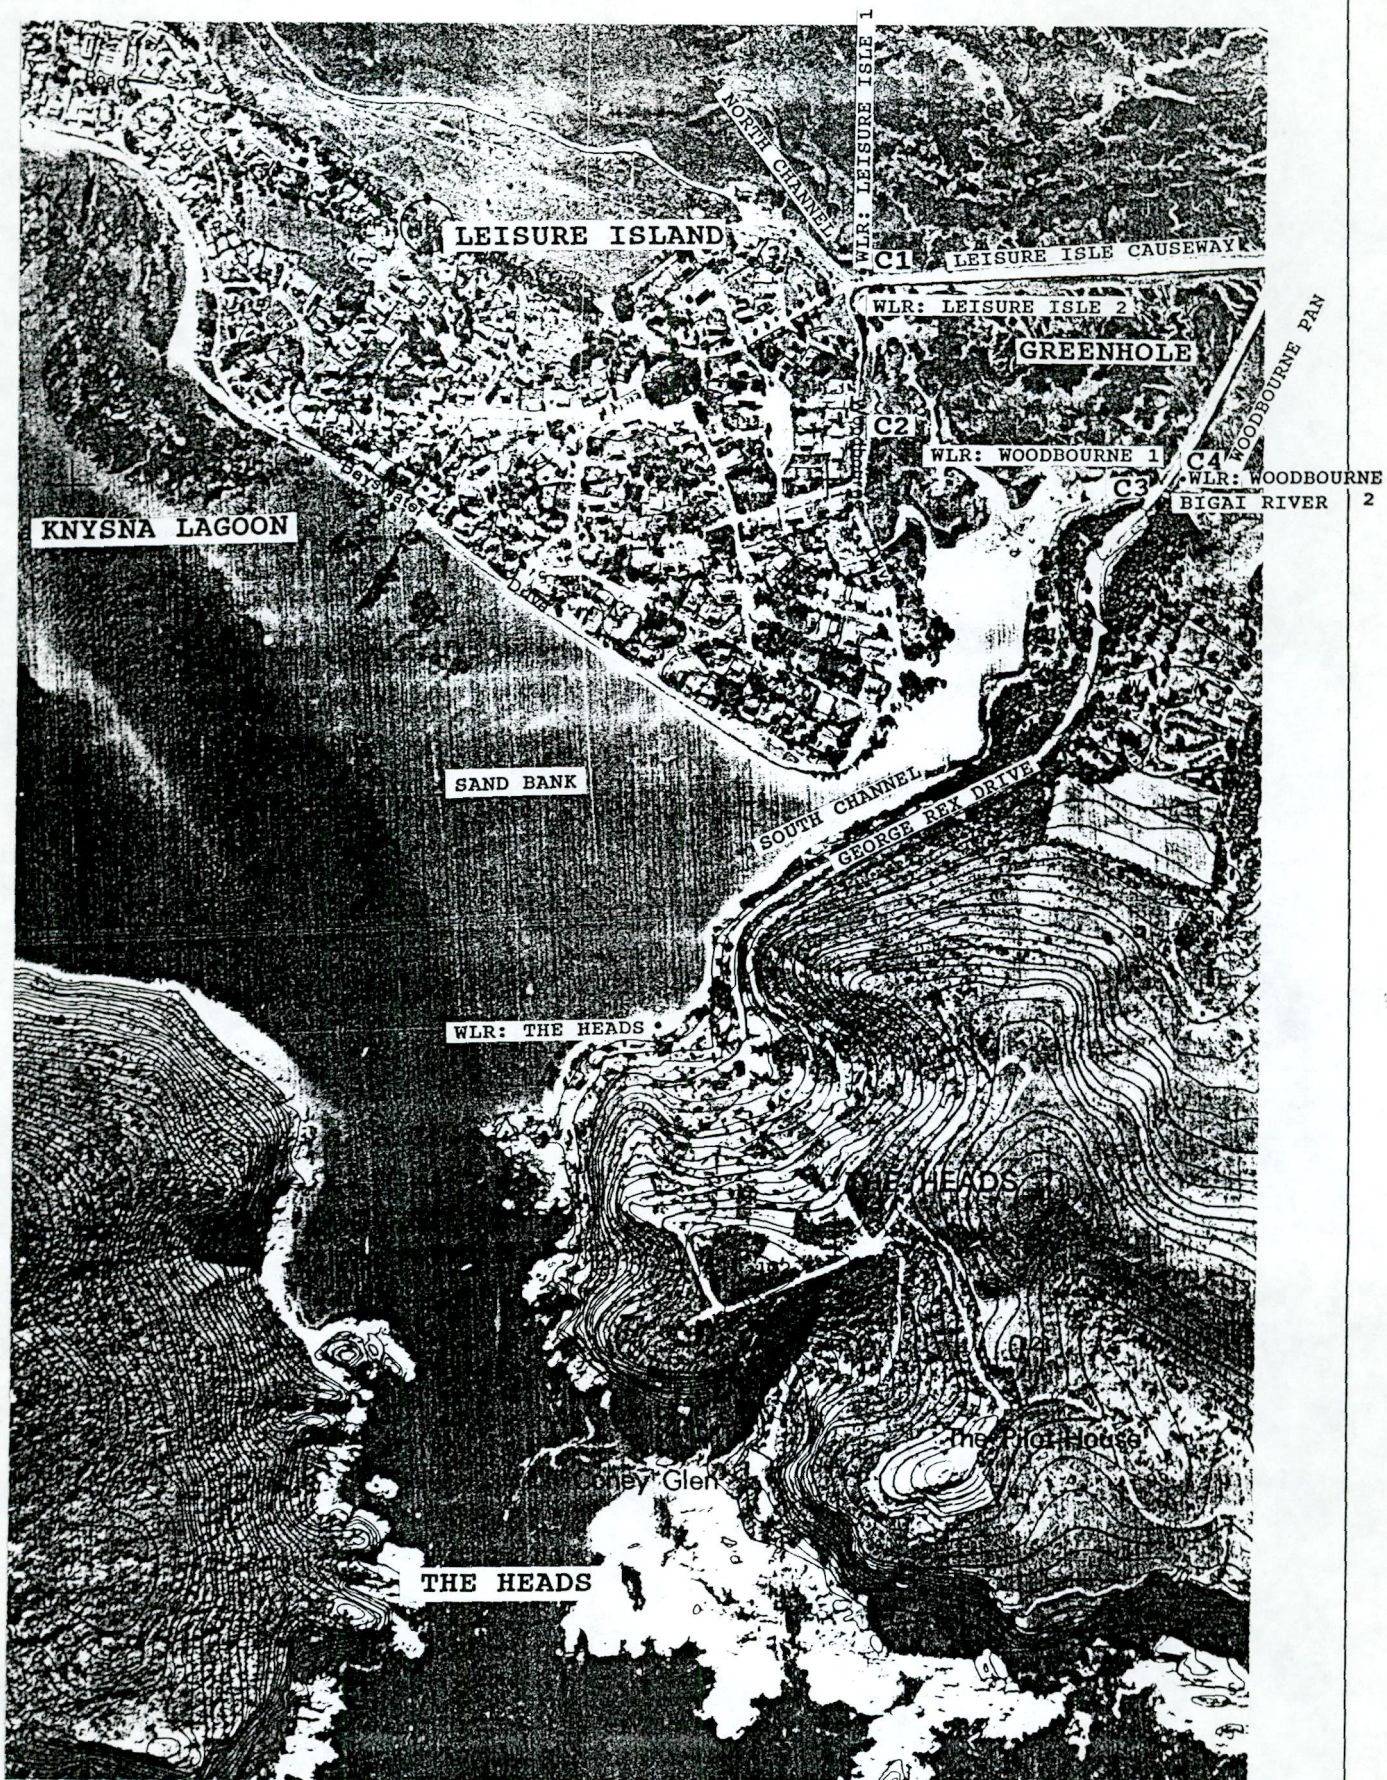
FIGURE 5

The analysis, summarised in Figure 5, shows a predominance of fine sand (FS) over the full length of the core. Surface samples taken at the southern entrance to the Green Hole (Section 2.4 and Table 1) show similar characteristics, which are indicative of a common source.

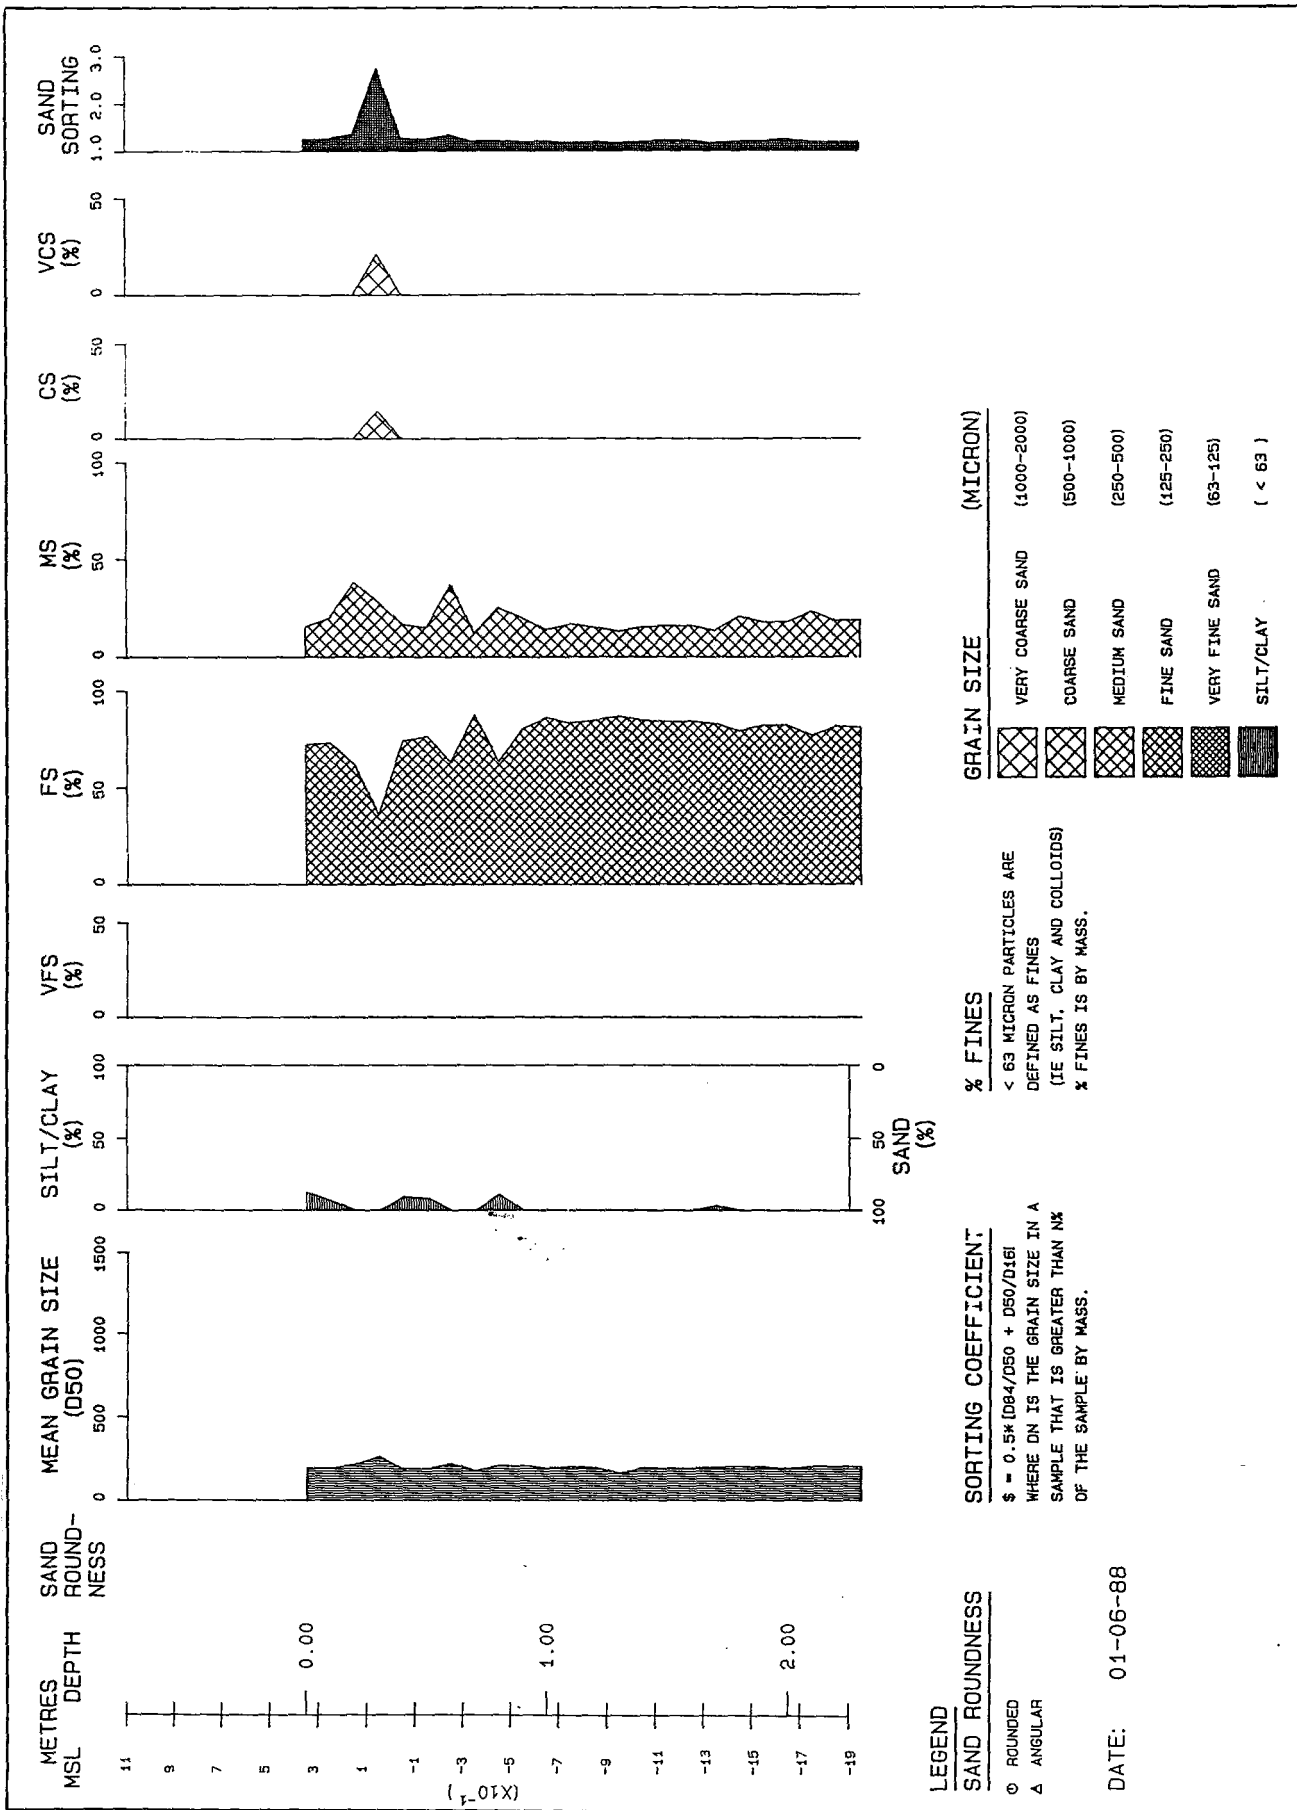
FIGURE
 6

Three S/C layers can be seen at the surface and at the -0,1 m, -0,4 m and -1,4 m (MSL) levels. These correspond to a reduction in the FS content and an increase in the medium sand (MS) content at the -0,1 m and -0,4 m levels (Figure 6).

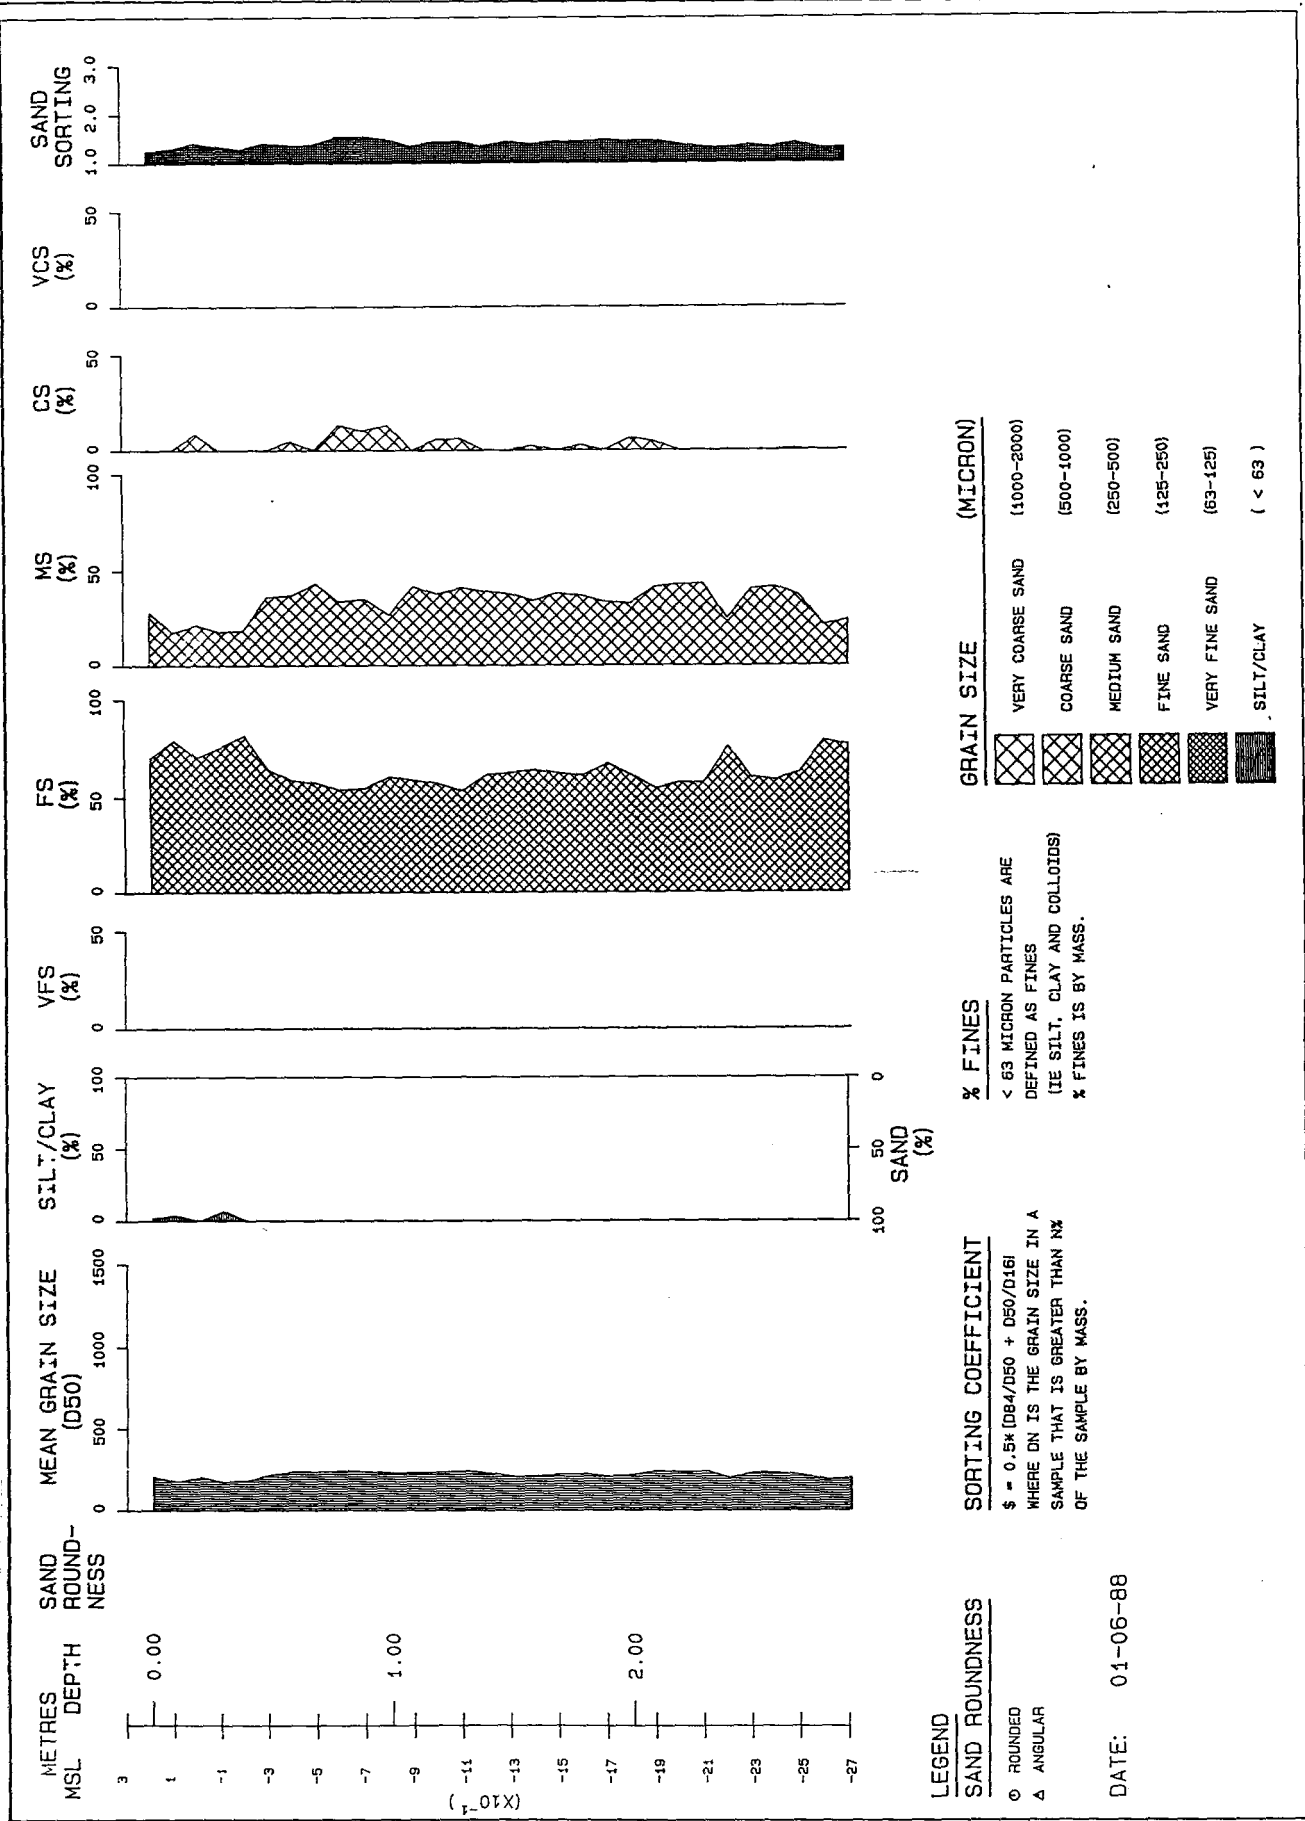
FIGURE
 7

CS occurs intermittently down to a level of - 1,9 m (MSL) and is indicative of scouring associated with high flow velocities. FS predominates over the whole depth, although a significant percentage of MS is present (Figure 7).

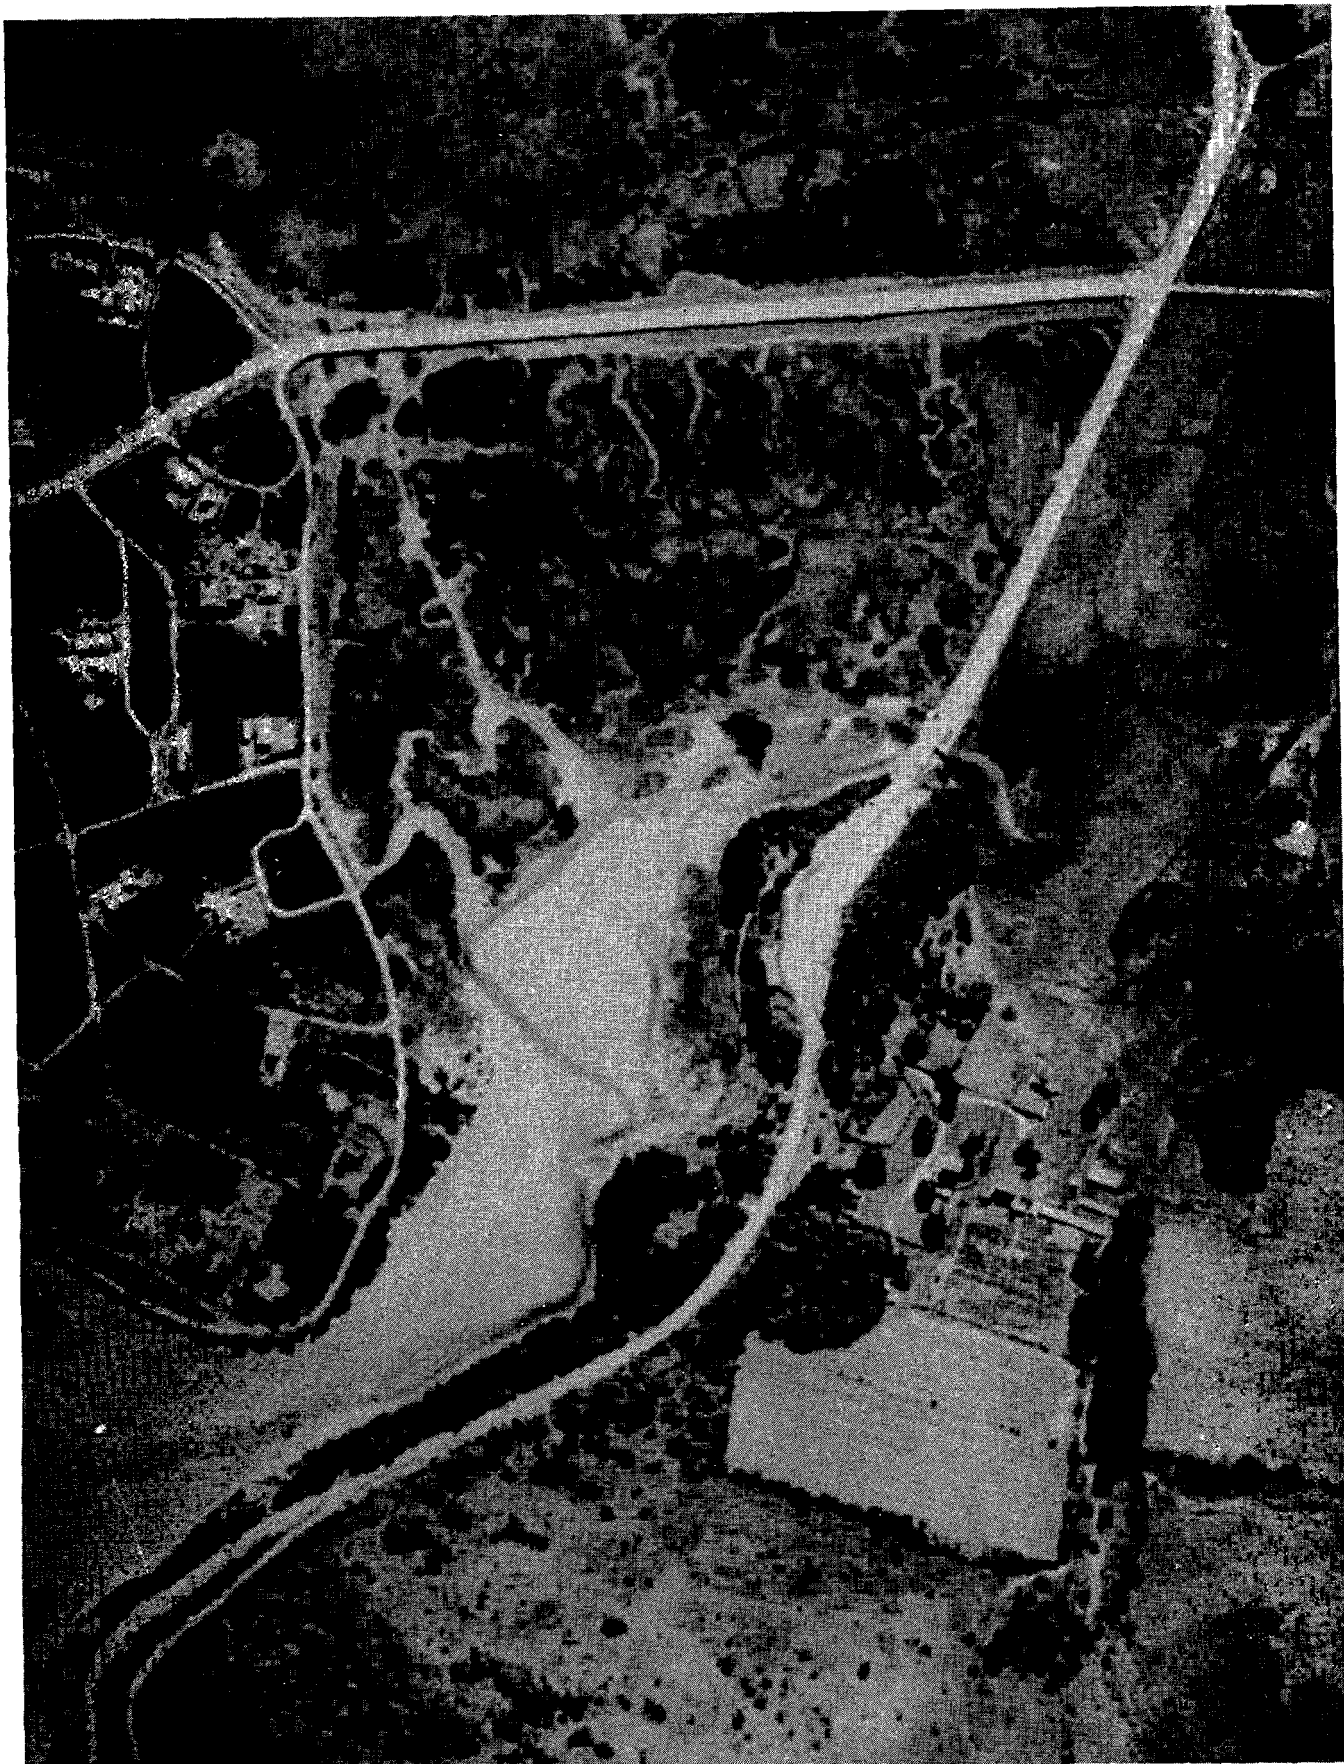
FIGURE
14

The old 4 m box culvert was replaced by 12 30-inch diameter concrete pipes in 1954. The pipe inverts were approximately at MSL (CSIR, unpublished report, 1965). The smaller pipe culverts introduced an increased obstruction against the in and outflow of the Green Hole through the Leisure Island causeway and as a result most probably increased the outgoing tidal flow rate in the channel between the island and The Heads. The resulting higher flow velocities during outgoing tides had a large scouring potential that removed a percentage of the total sediment transported into the area during the previous high tide. Thus a deeper channel would have been maintained. An aerial photograph of 1968 (Figure 14) still shows a reasonably deep channel at this position.

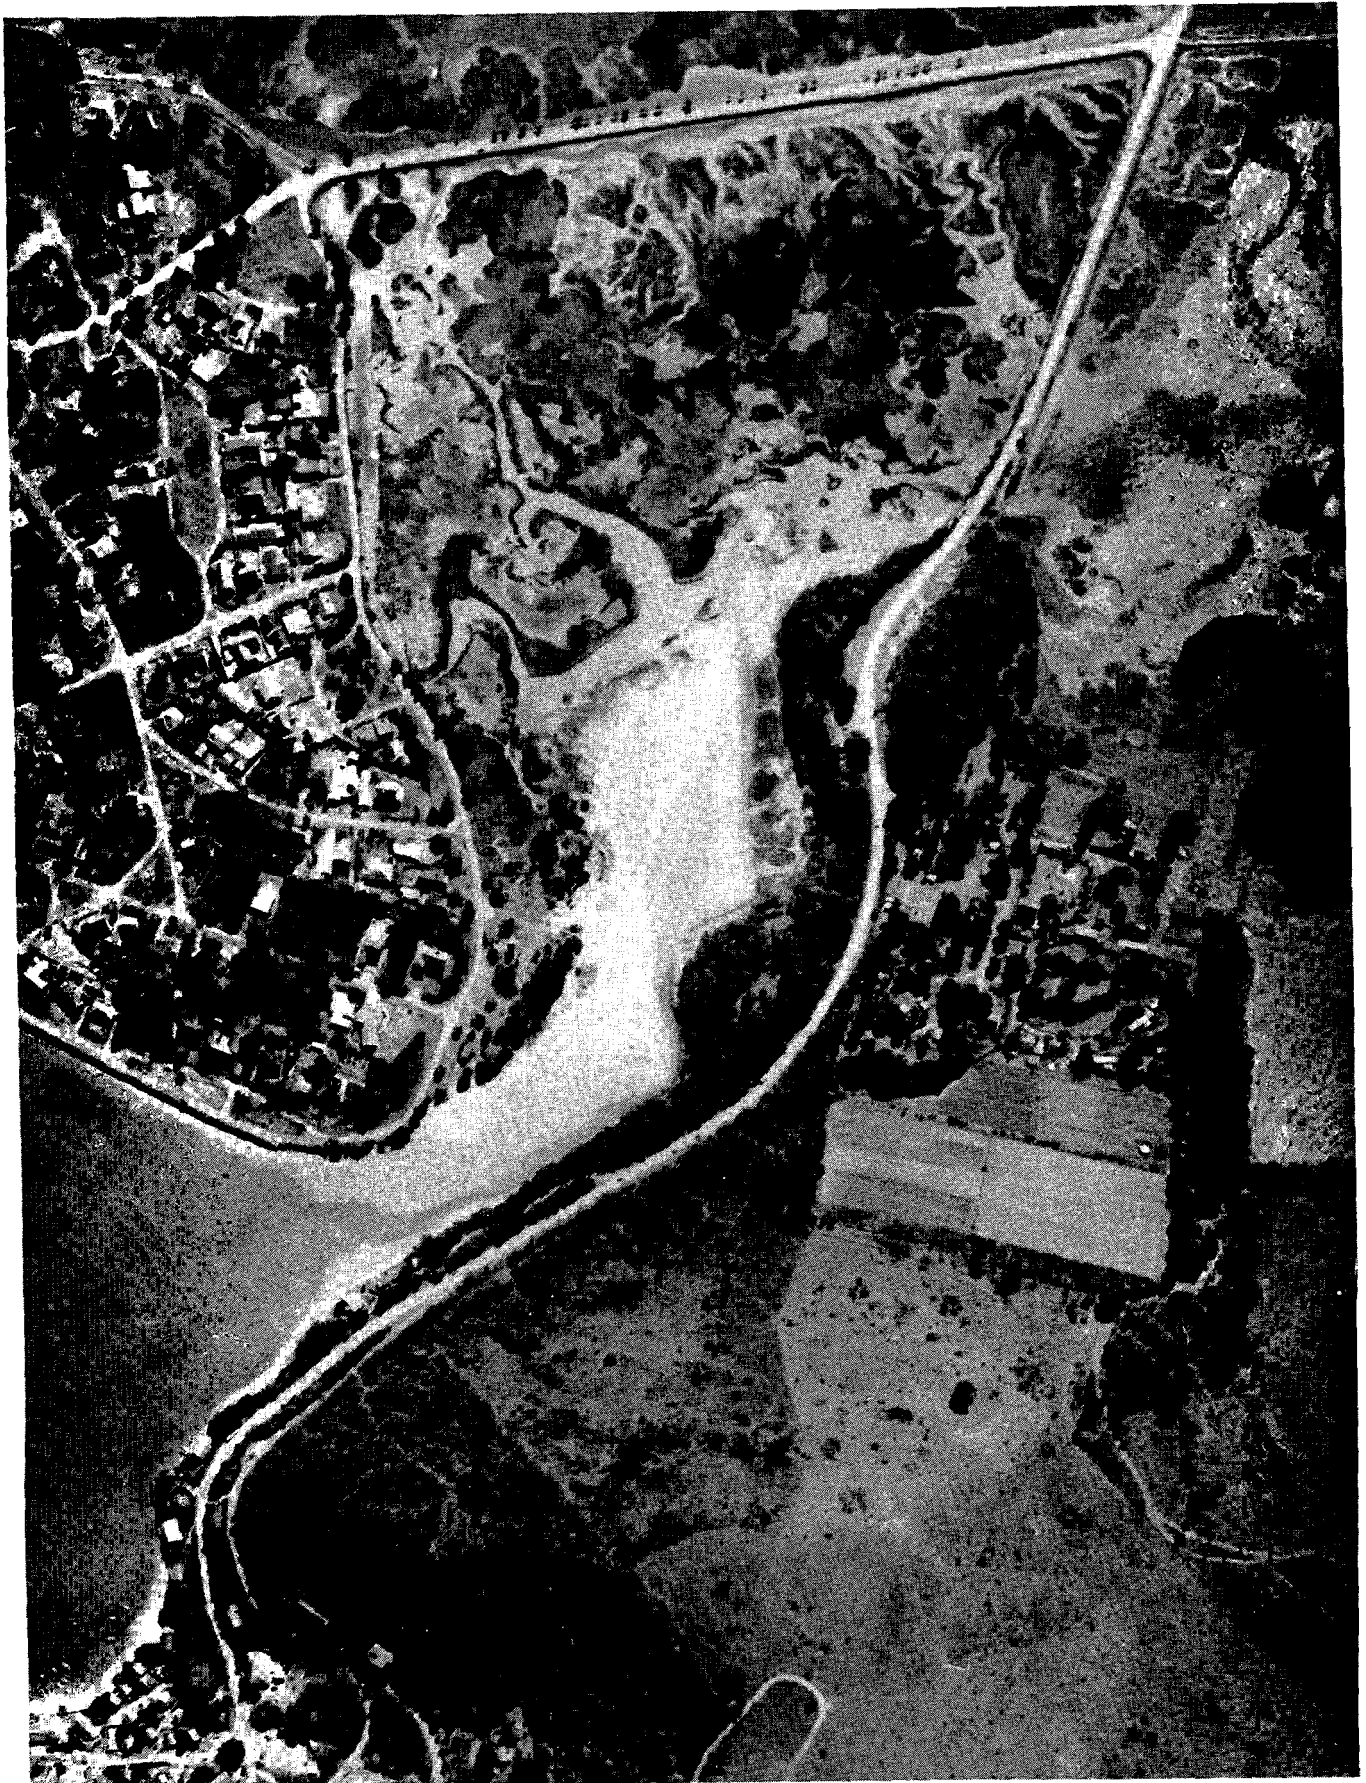
FIGURE
15

An analysis of aerial photographs taken over a period of about 50 years (Section 2.8) showed that significant sedimentation had taken place within the southern channel at The Heads. In particular the increase in the vegetated area along the shore of Leisure Island is indicative in this respect. The increase in sand build-up in this channel is especially noticeable over the period 1979 to 1987 (Figures 15 and 16).

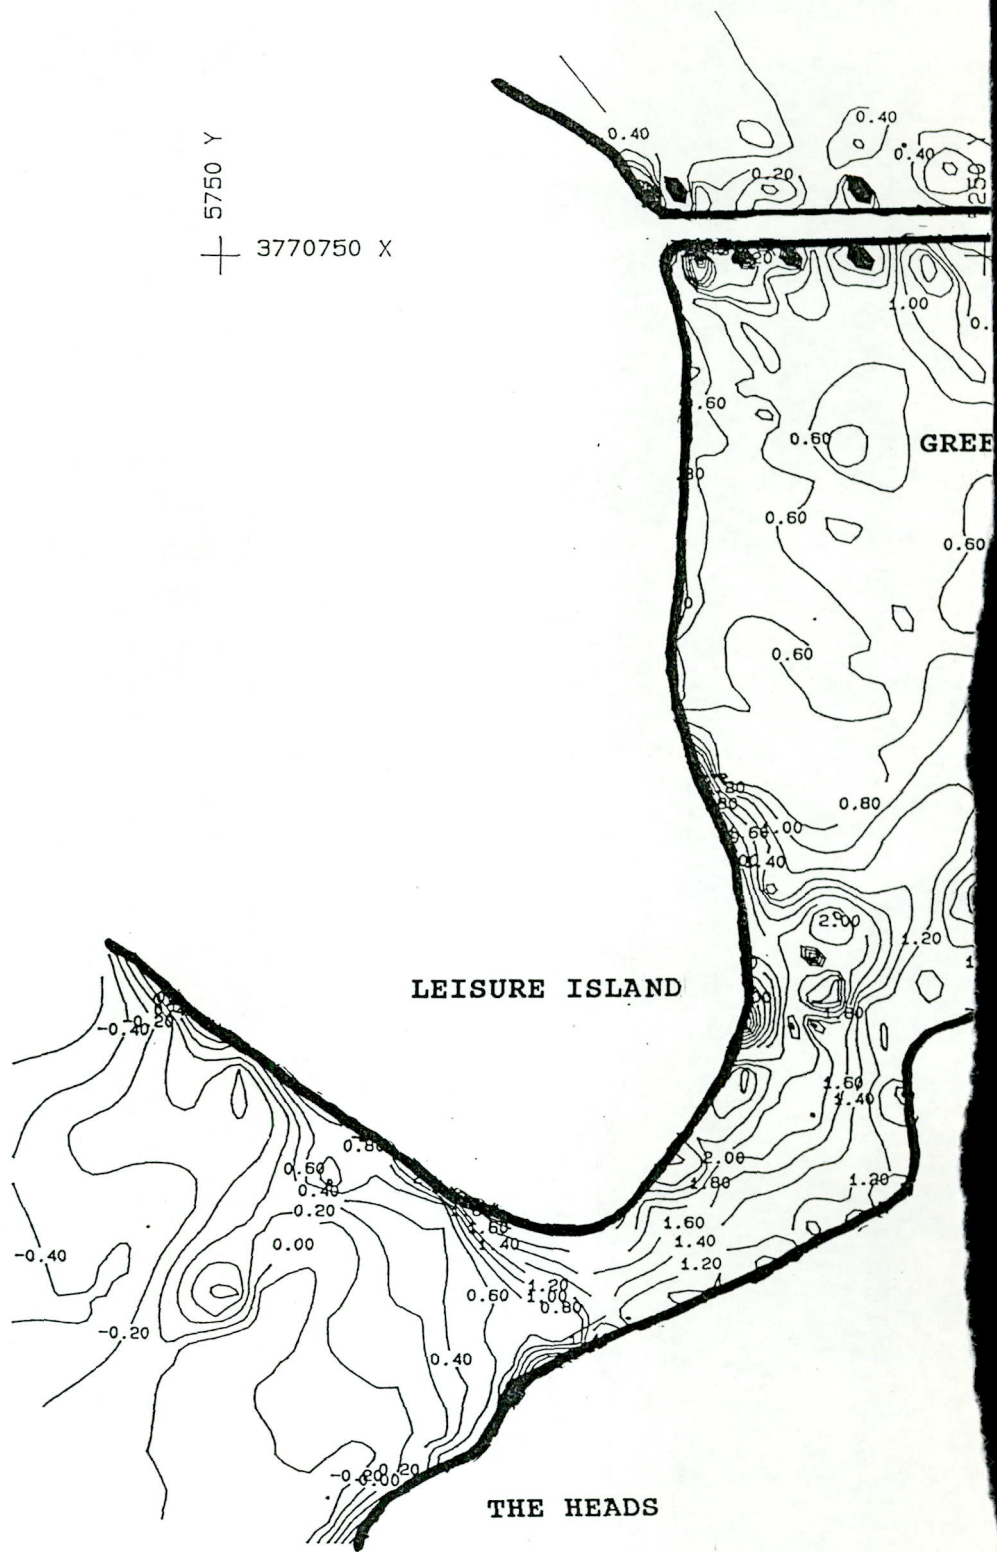
FIGURE
 17

Since it is very difficult to quantify level changes from aerial photographs (for example the amount of sedimentation taking place in the Green Hole), a comprehensive topographical survey was carried out during May 1988 (Figure 17). A detail of this survey around the Leisure Island culverts is shown in Figure 18, while Figures 19 and 20 show cross-sections and longitudinal sections.

As described in Section 2.9 a comprehensive topographical survey was carried out during May 1988 (Figures 17 to 20). This can serve as reference for future monitoring of siltation in the Green Hole.
